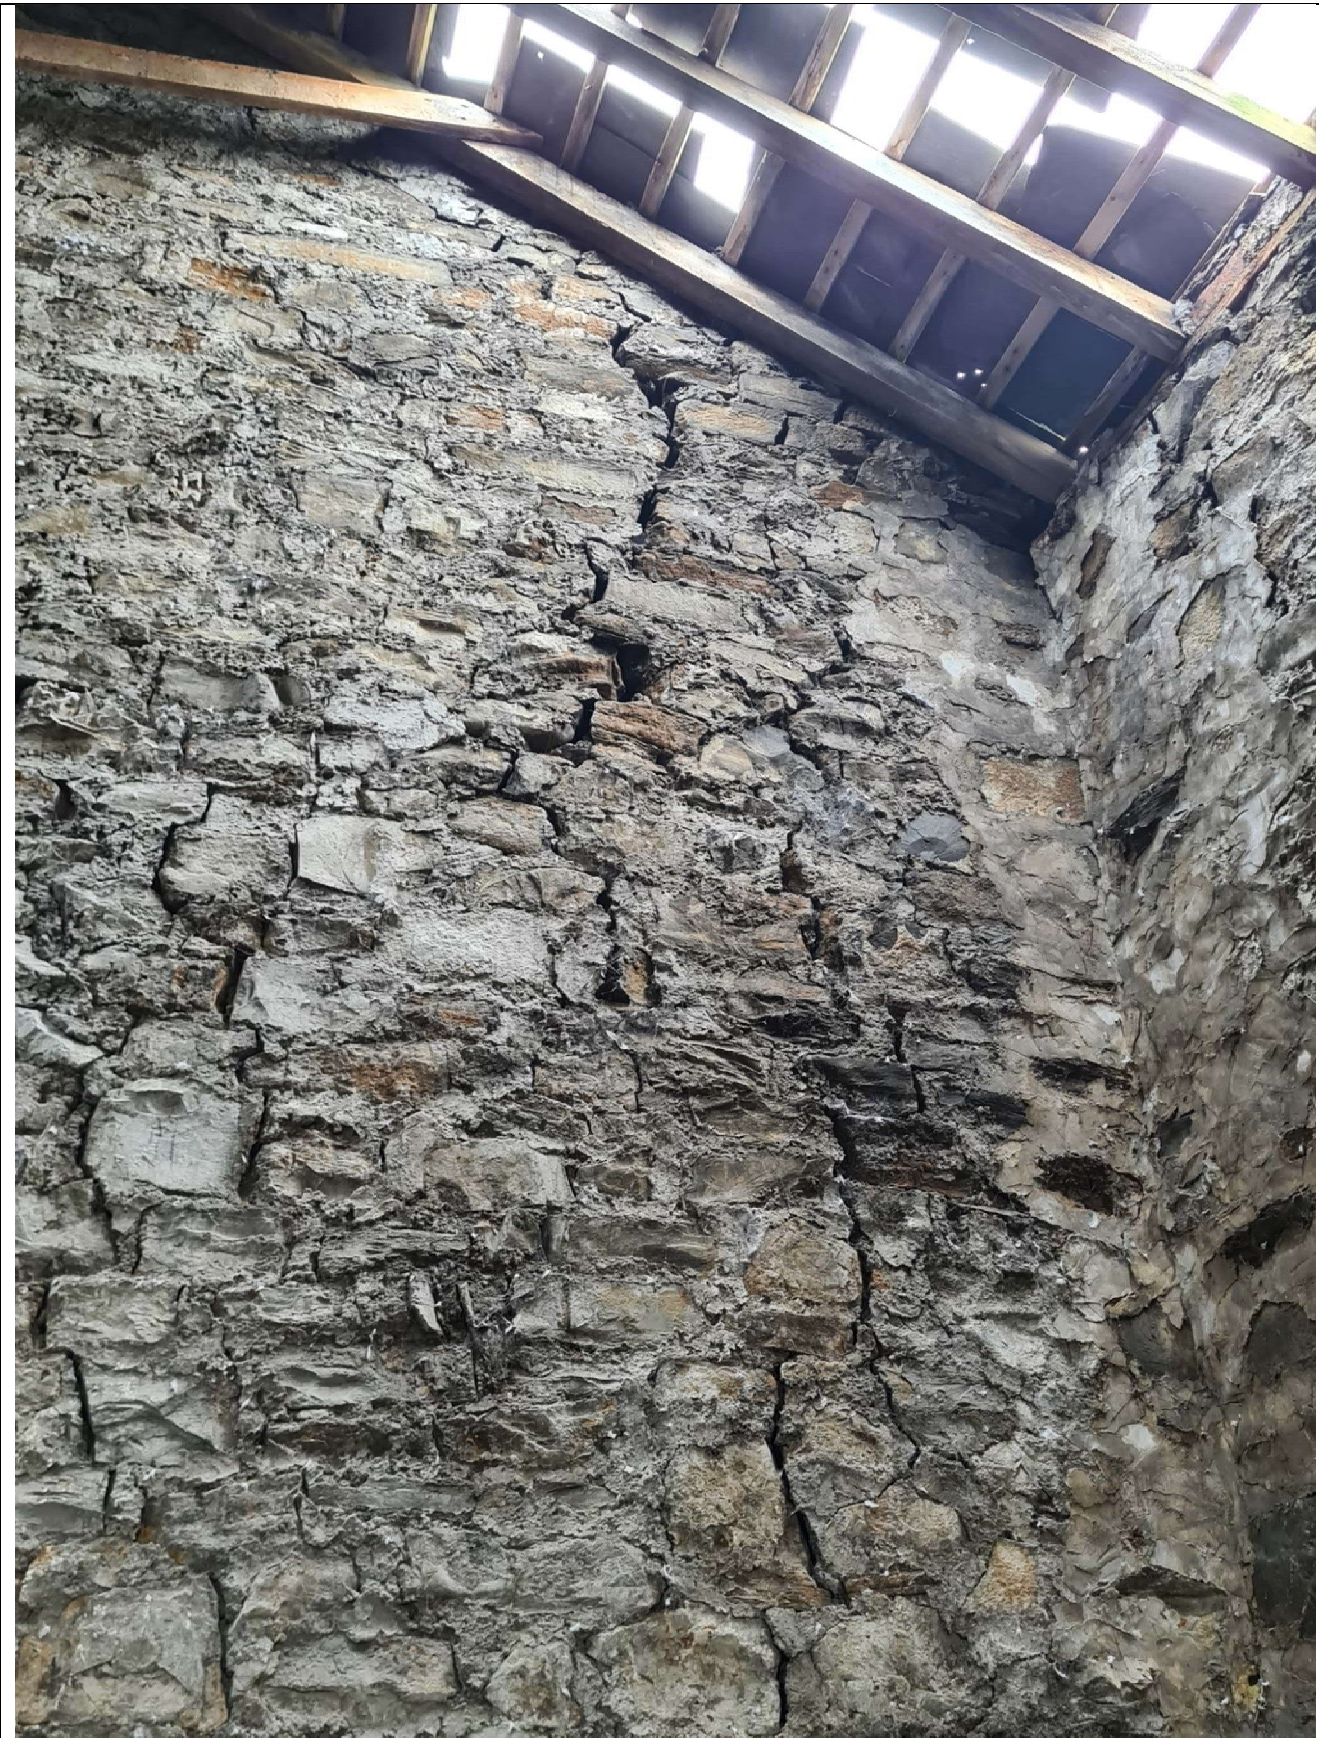
IN20 – Eastern section elevation facing south, severe distortion, vertical cracks and inappropriate repointing

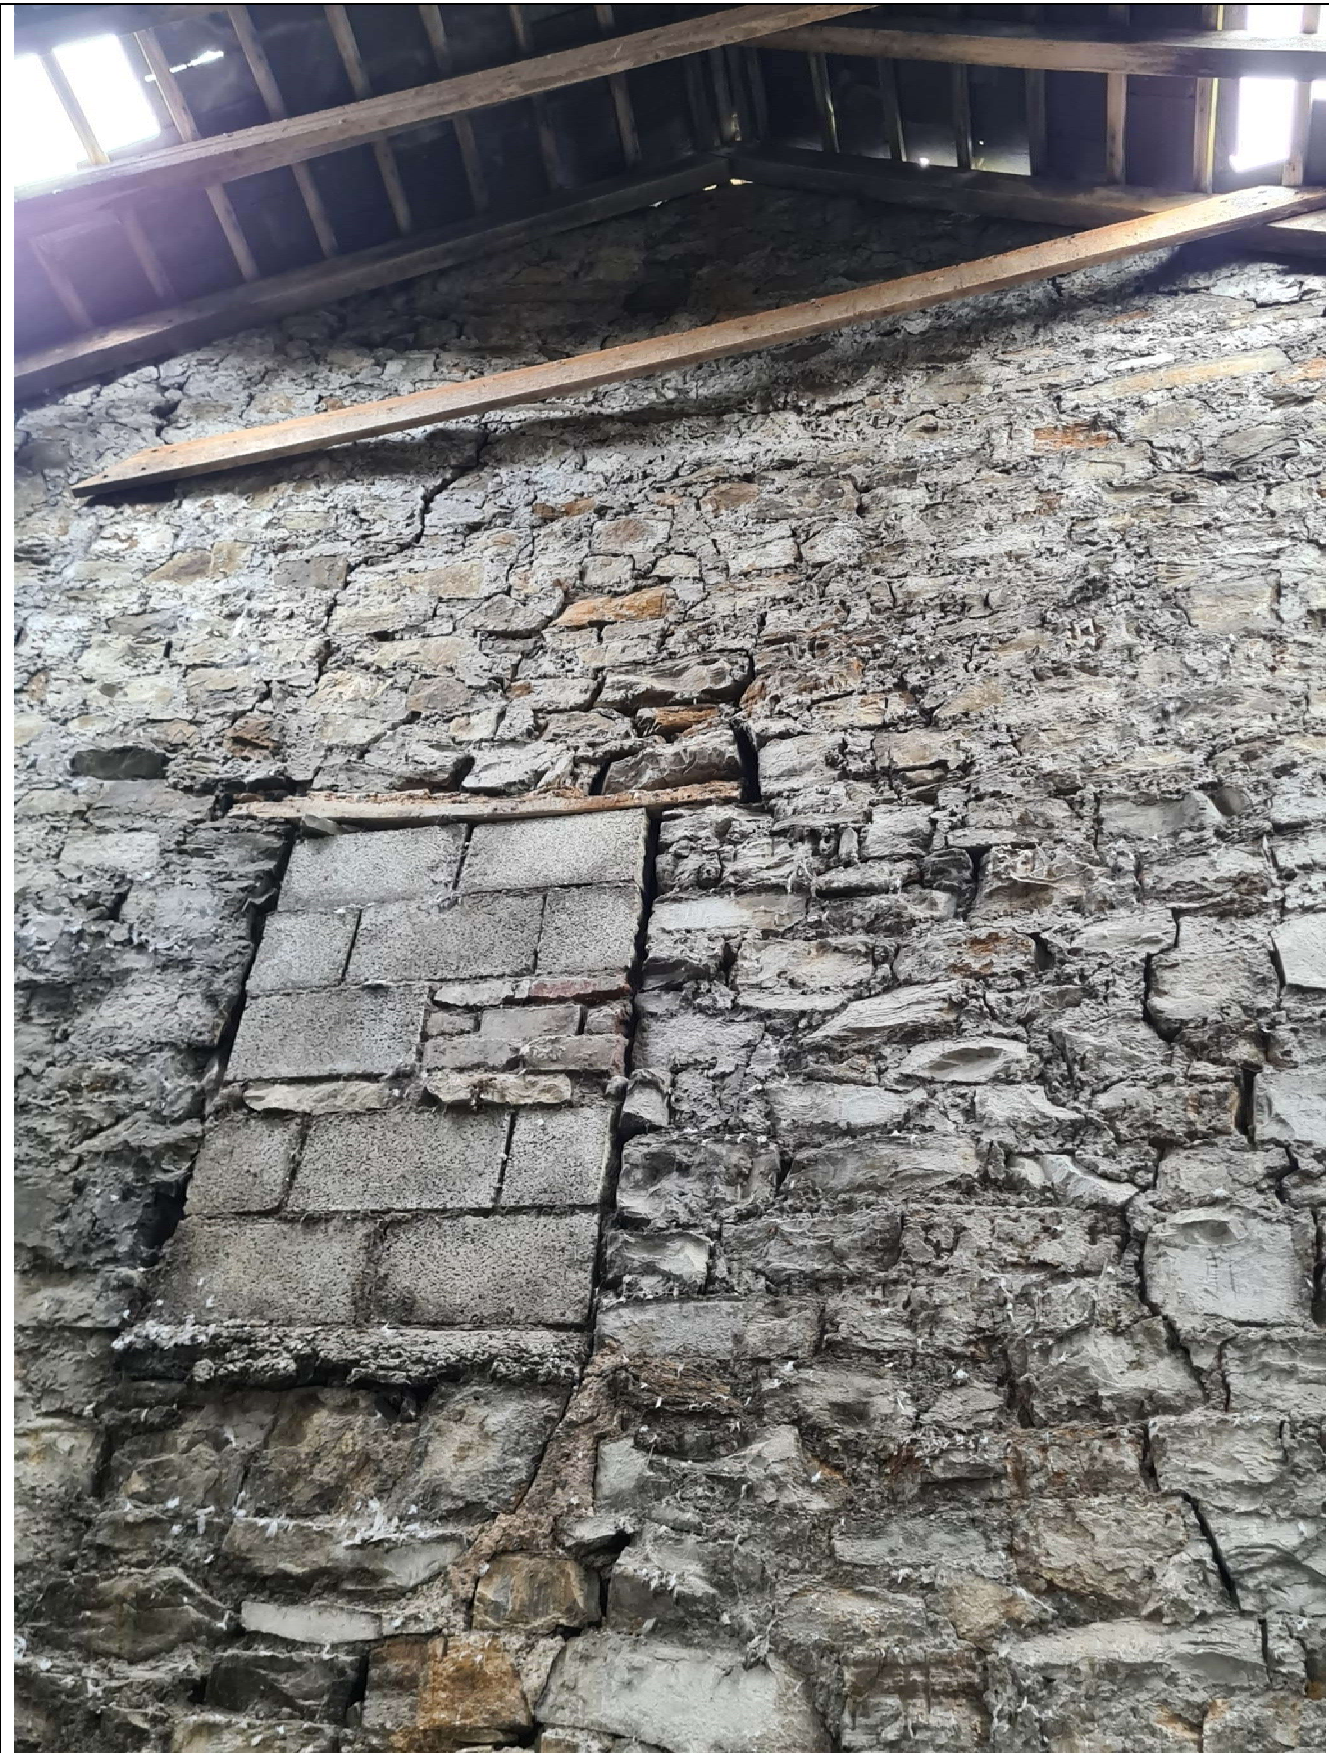
IN21 – Eastern section elevation facing south, failed collar tie at roof, severe cracking and distortion, inappropriate in-fills
