VISUAL TREE ASSESSMENT AT 1 COLLEGE COTTAGES SLAIDBURN ROAD, NEWTON

**Prepared for: Mr D PADLEY
Lancashire County Council
County Hall
Room D1
Preston
PR1 8RE**

**8th February 2010
Ref:SPH/VTa-01/08.10**

TERMS OF REFERENCE - To carry out a visual tree inspection (VTA), decay detection at ground level and Risk Assessment upon 1 mature ash tree at the above site.

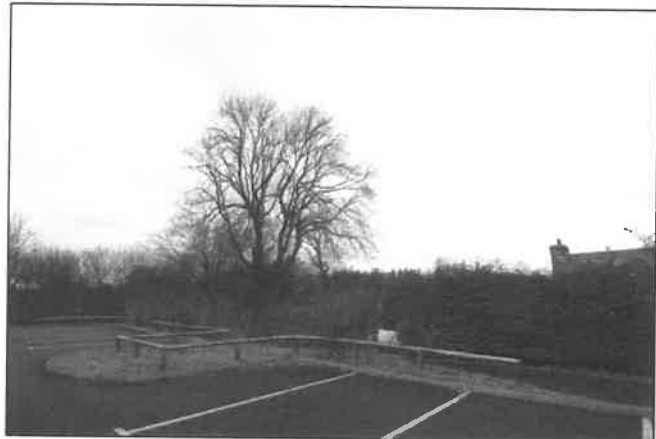
PHOTOGRAPH 2

- 6.3 We conducted a visual inspection from the public car park and both sides of the boundary wall. As we approached the site the canopy was visible above the surrounding features (see photograph 2 to the right) and the structural condition appeared good with normal physiological attributes.

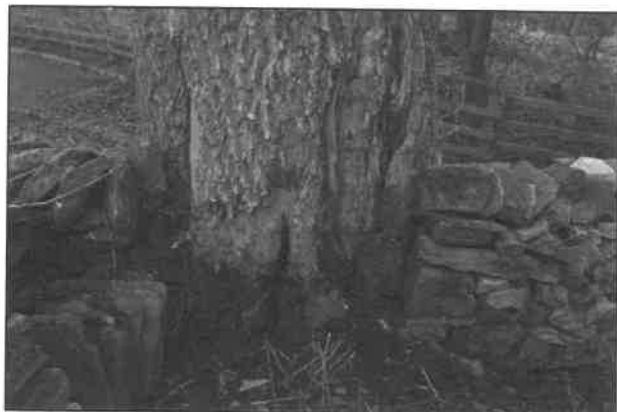
PHOTOGRAPH 3

- 6.6 The main stem has a large area of necrotic (dead bark) on the North side from ground level up to 1.2m AGL, (see photograph 3). Fruiting bodies of the fungi *Daldinia Concentrica* (King Arthur's cakes) were seen on and around the surface of the wound. Callous growth at the margins of the wound exhibit signs of deterioration although no obvious signs of advanced decay were observed in the vicinity of the wound.

- 7.1 The damage observed at the base of the main stem is located on the same side as the stone collection and it is reasonable to assume this is used for controlled burning of debris. The damage to the stem is typical of that associated with fire. The death of tissues in this location also corresponds to die back (deadwood in the canopy) and it is reasonable to assume that the fire damage is the main Causal agent.

- 7.2 *Daldinia concentrica*, the fungus observed on the surface of the wound acquired its common name of 'King Arthur's Cakes' due to, apparently, their resemblance to the cakes which the king burned! This fungus is very common and widespread in Britain. It is frequently seen growing on dead branches, mainly on Ash and is a good indicator of areas of dead wood.

- 8.1 Carry out a 20% crown reduction in order to reduce the wind load and mass upon the main stem. This work should be undertaken within the next three months.
- 8.2 Conduct a follow up VTA in July 2011.

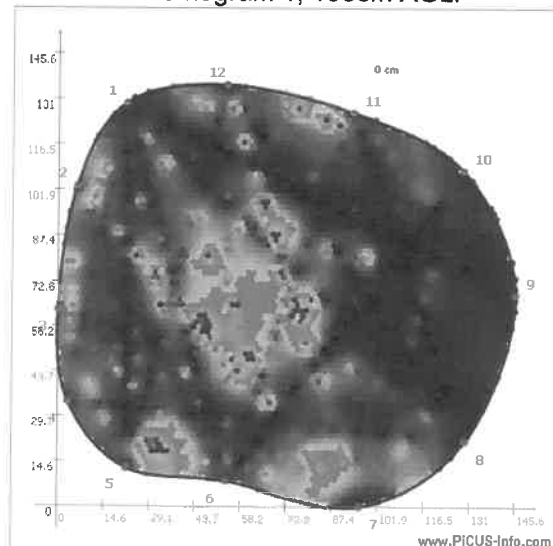
Picus Tomogram 1, 100cm AGL.

- 7.4 Picus tomogram 1 shows an area of incipient decay associated with the damaged stem (fire) and coalescing decay from the cavity above. Picus tomogram 2, shows a larger area of incipient decay associated with the cavity and we believe it is coalescing with decay from below.

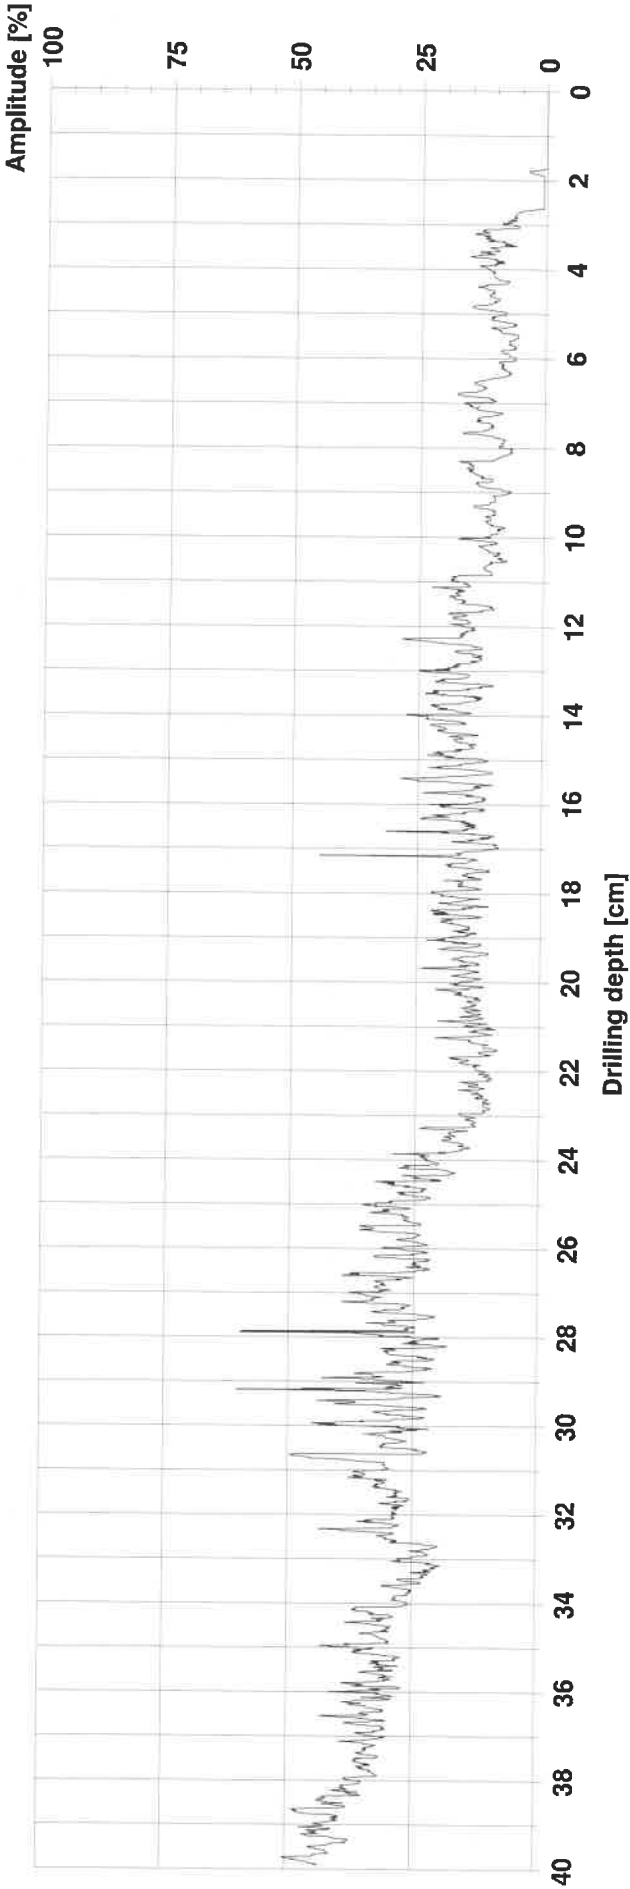
No decay evident

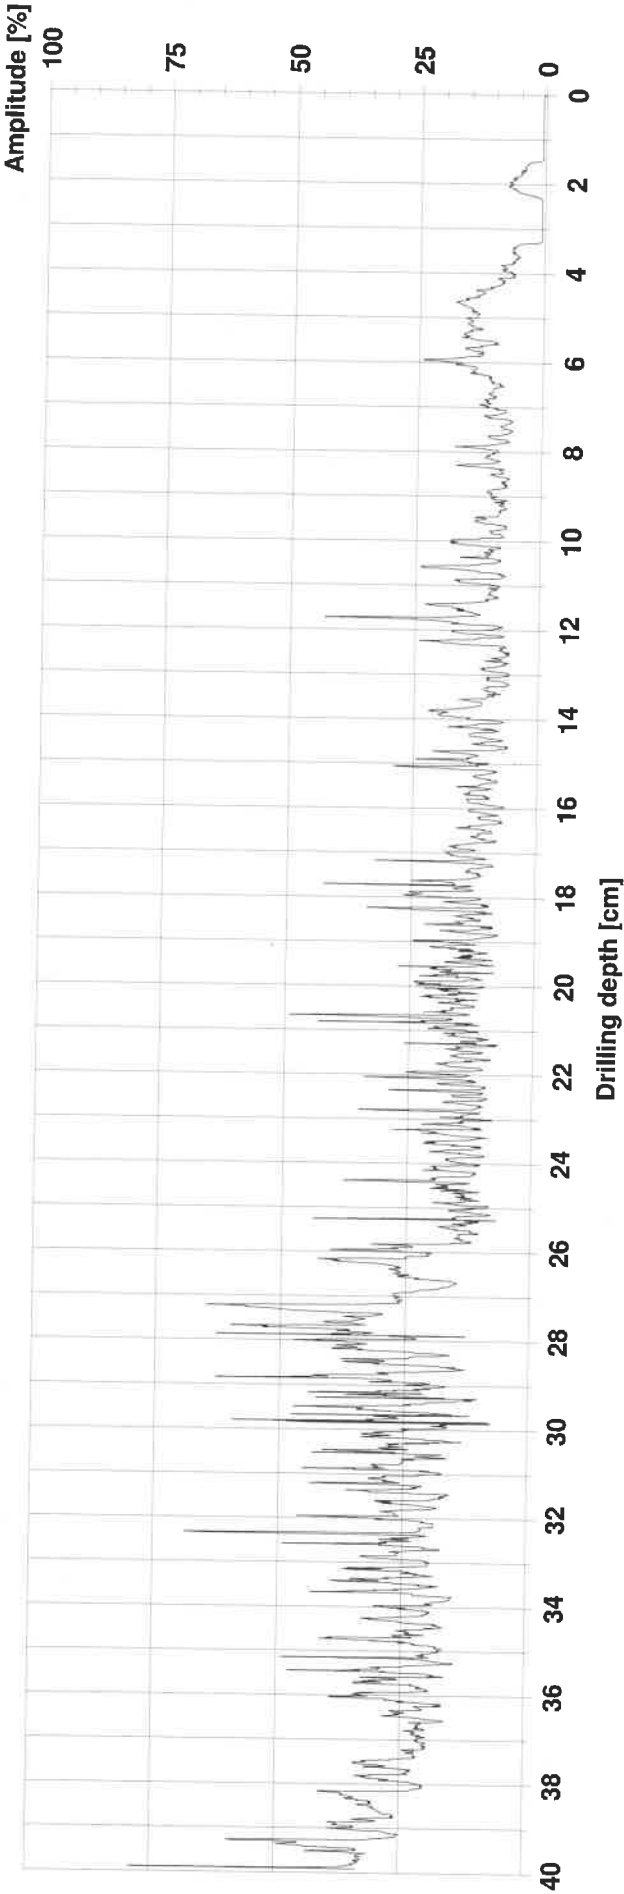
No significant decay present

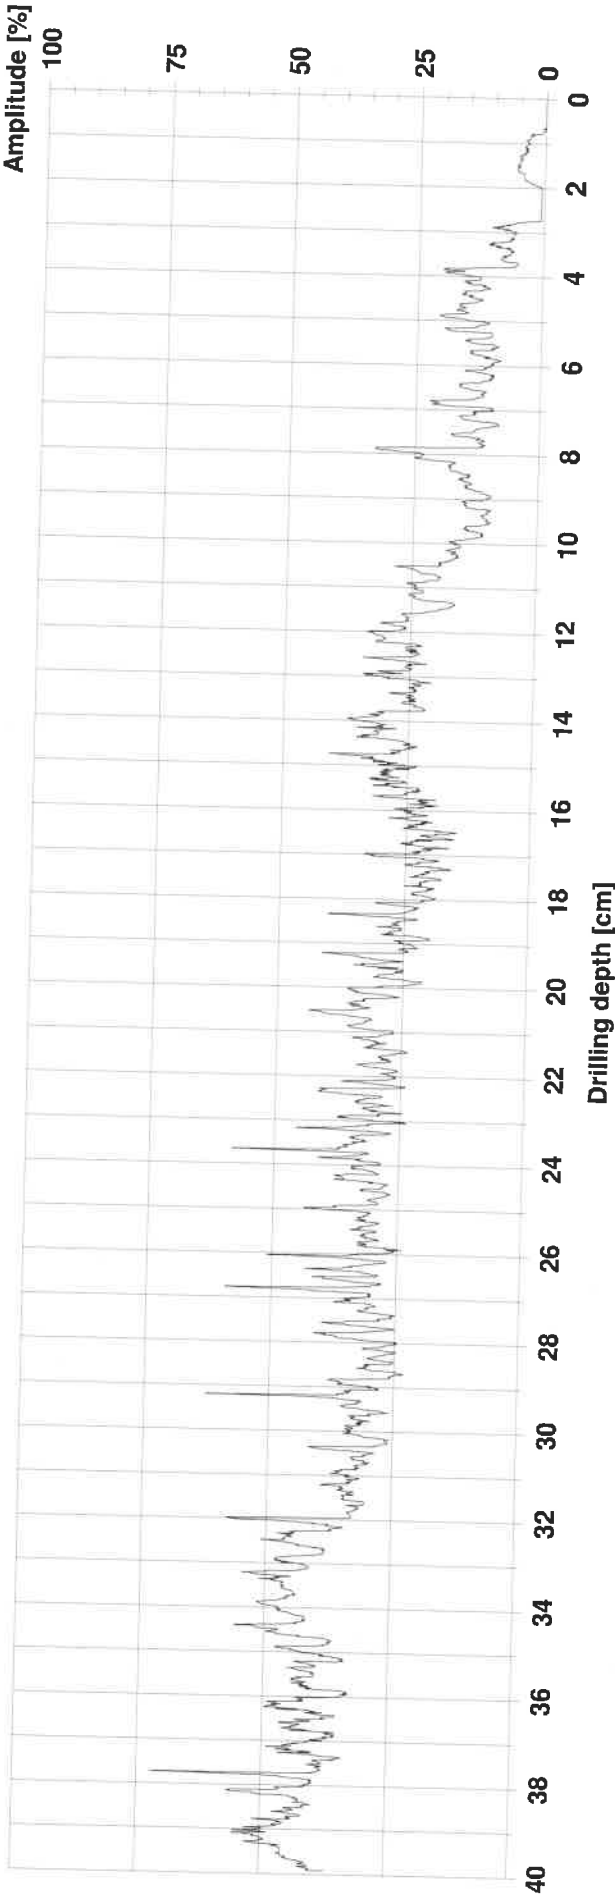
No significant decay

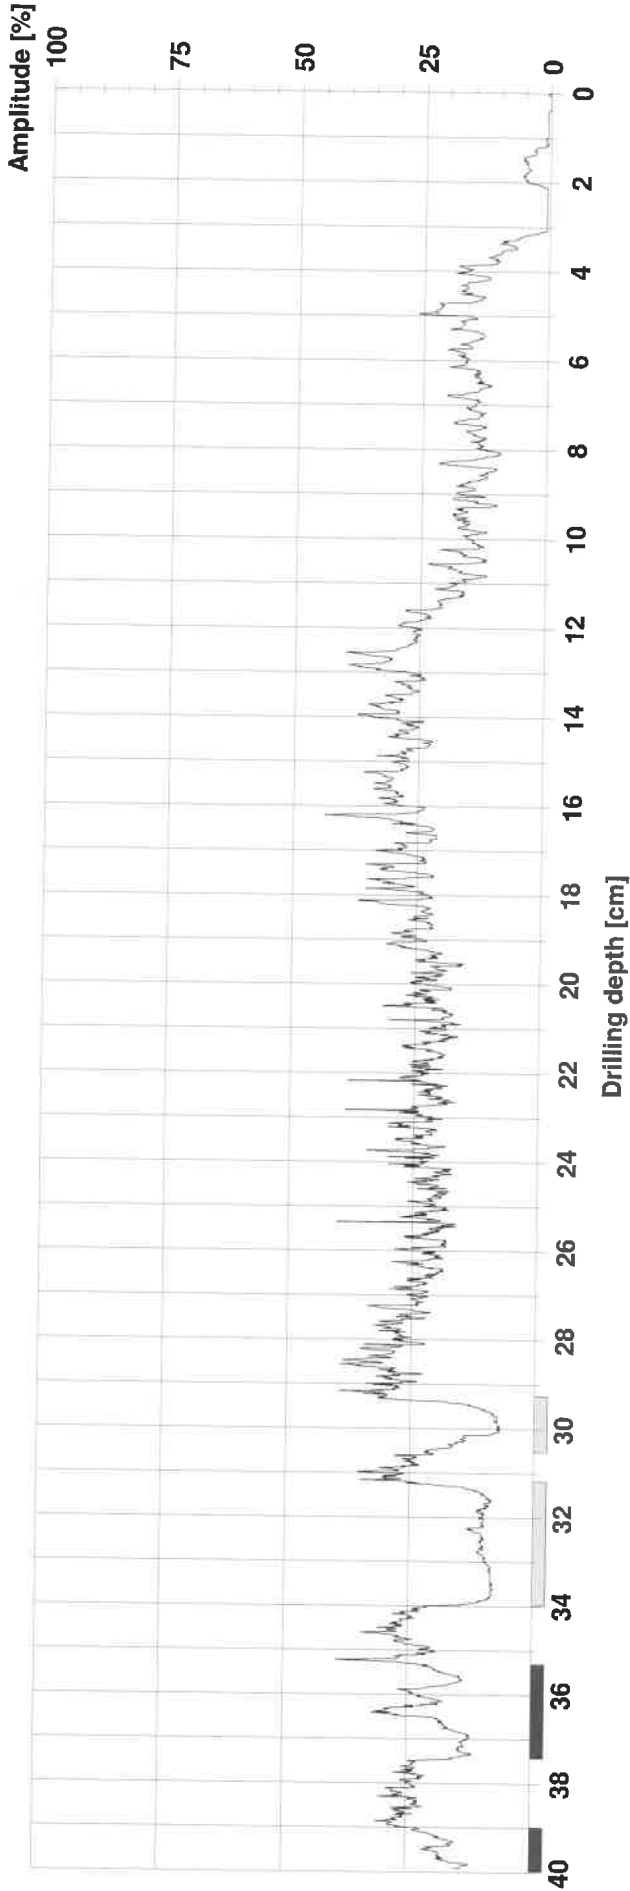
- 7.5 Resistograph tests 5 and 6 clearly identify the area of stem decay and residual wall remaining around the cavity. Test 4 shows clear signs of incipient and advanced decay.

From	29,3 cm	to	30,5 cm	:	Decay
	From	31,2 cm	to	34,0 cm	:	Decay
	From	35,3 cm	to	37,4 cm	:	Incipient decay
	From	39,0 cm	to	40,0 cm	:	Incipient decay
	From	0,0 cm	to	0,0 cm	:	
	From	0,0 cm	to	0,0 cm	:

Decay present beyond 29cm

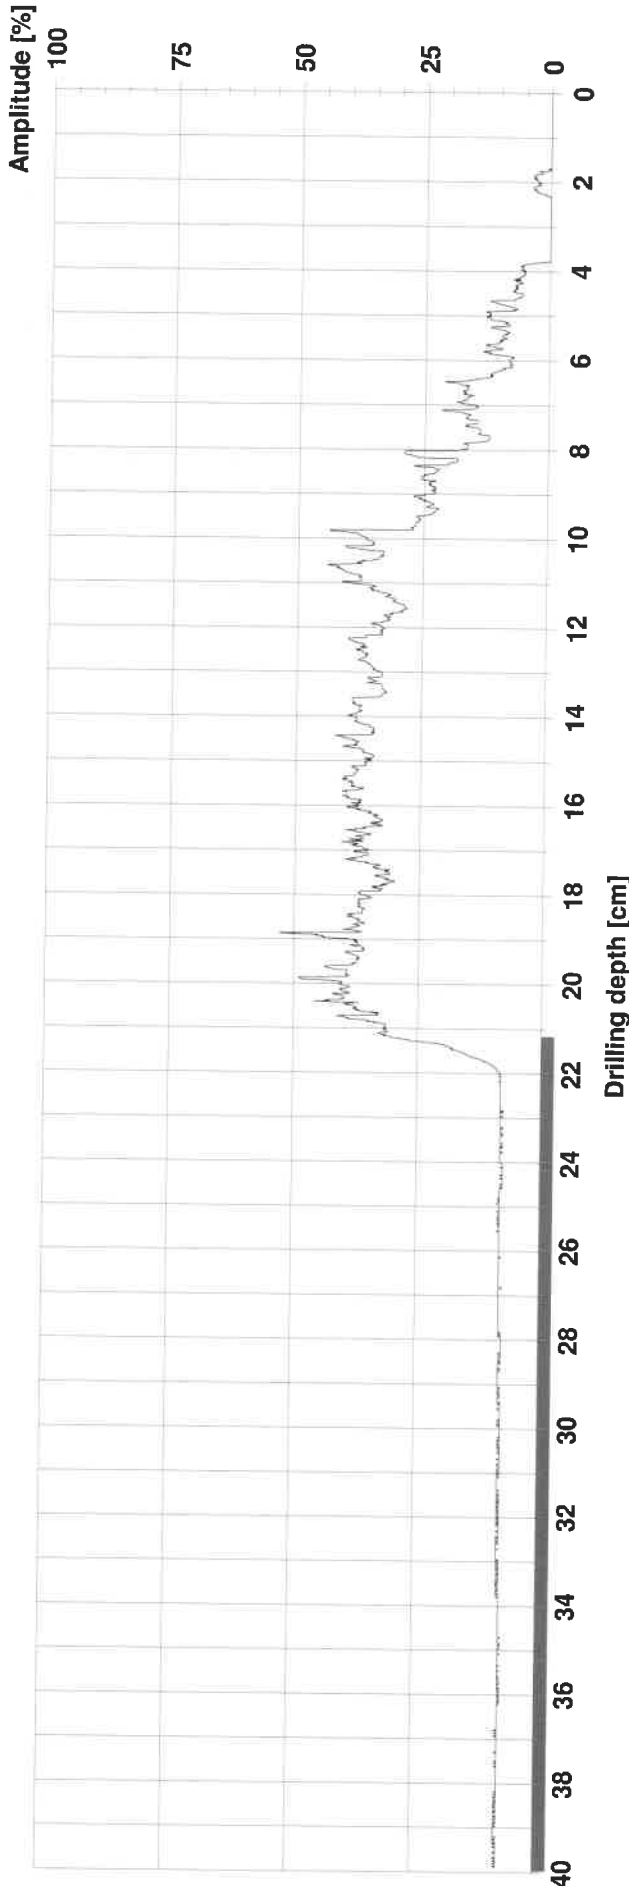
From	21,2 cm	to	40,0 cm	: Cavity
From	0,0 cm	to	0,0 cm	:
From	0,0 cm	to	0,0 cm	:
From	0,0 cm	to	0,0 cm	:
From	0,0 cm	to	0,0 cm	:
From	0,0 cm	to	0,0 cm	:

Cavity detected at 21cm, sampled 60cm below cavity opening

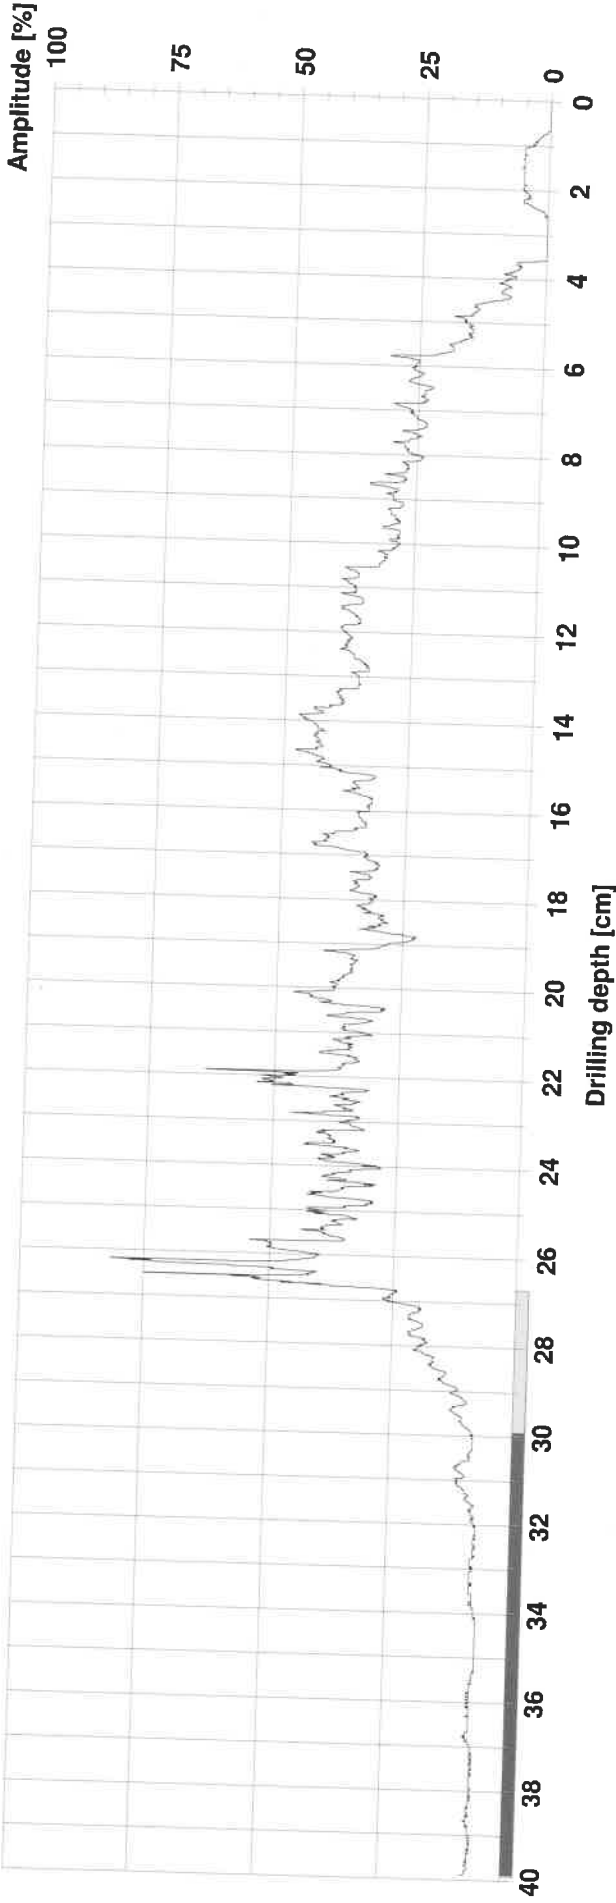
From	26,7 cm	to	29,9 cm	: Decay
From	29,9 cm	to	39,9 cm	: Cavity
From	0,0 cm	to	0,0 cm	:
From	0,0 cm	to	0,0 cm	:
From	0,0 cm	to	0,0 cm	:
From	0,0 cm	to	0,0 cm	:

Decay beyond 27cm with cavity from 29cm, sampled at 60cm below the cavity opening.
