Tree Report for Proposed Detached Dwelling

Woodacre Cottage

Prepared by Daniel Byrne

12th July 2022

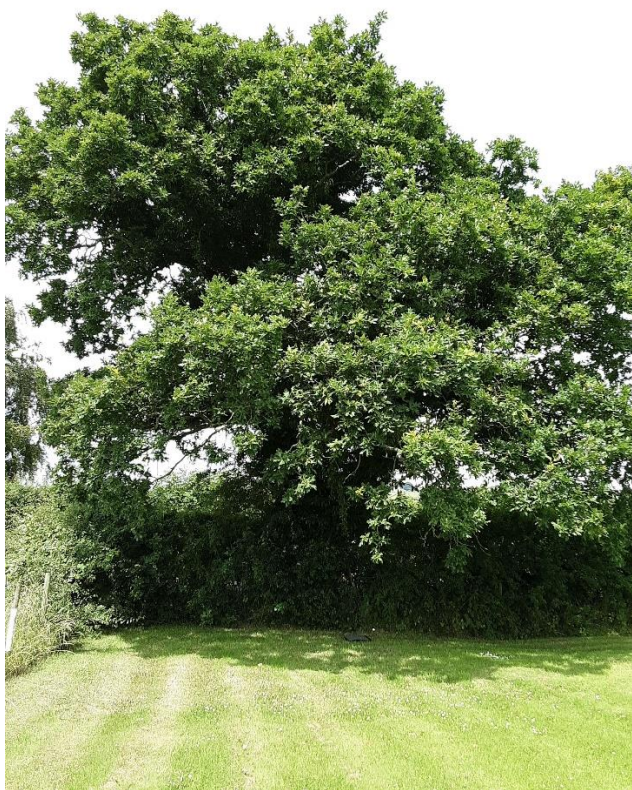
T1 and T2 are both situated in the hawthorn hedge along the north boundary of the site. Both trees are visible from inside and outside the site, they are both mature English oak trees. The proposed plans show that the driveway to the site is to be installed between these two trees and the outer extent of both trees RPAs could be affected by construction techniques, new surfacing or soil compaction from vehicles, plant, and machinery.

T1 and T2 both have lower branches that hang from 1m above ground level on the southern sides of their stems that would need pruning to a minimum of 2.4 meters to enable vehicular access and improve lines of sight for access and egress to the proposal.

Tree Number	Species	Height (m)	Dbh (mm)	Crown Spread	Age	Condition	Comments	Category Rating
T1	English Oak	9	700	N - 6 S - 8 E - 6 W – 6	Mature	Good	Minor deadwood. Primary union at 2m obscured by Ivy. Cannot assess thoroughly at base and stem.	A1
T2	English Oak	10	720	N - 6 S - 9 E - 7 W – 7	Mature	Good	Minor deadwood. Primary union at 3m. Ivy obscures base and stem.	A1
G1	Birch Sycamore Rowan Beech Laurel	Av. 4	Av. 170	Av. 3m	Young to Semi mature	Fair	Planted area with mixed species, laurel forms outer extent of hedgerow	C
H1	Hawthorn Hedge	2	N/A	N/A	Mature	Good	Hedge on boundary	N/A

- c) The outer sections of the RPAs of T1 and T2 will be affected when the surfacing for the driveway of the proposed dwelling access is constructed. Any work that may encroach into the RPAs must be done with care. On this site, if working near or within the RPAs of T1 or T2 is necessary, special precautions or specific construction techniques should be undertaken. Adverse impacts should be minimised following specific surfacing techniques (See appendix 4).

- e) Barriers should be installed to protect the RPAs of T1 and T2 and G3. The approximate location for the barriers is shown on the plan in appendix 4 along with illustrative guidance in appendix 3. The precise location should be agreed before any development activity starts.

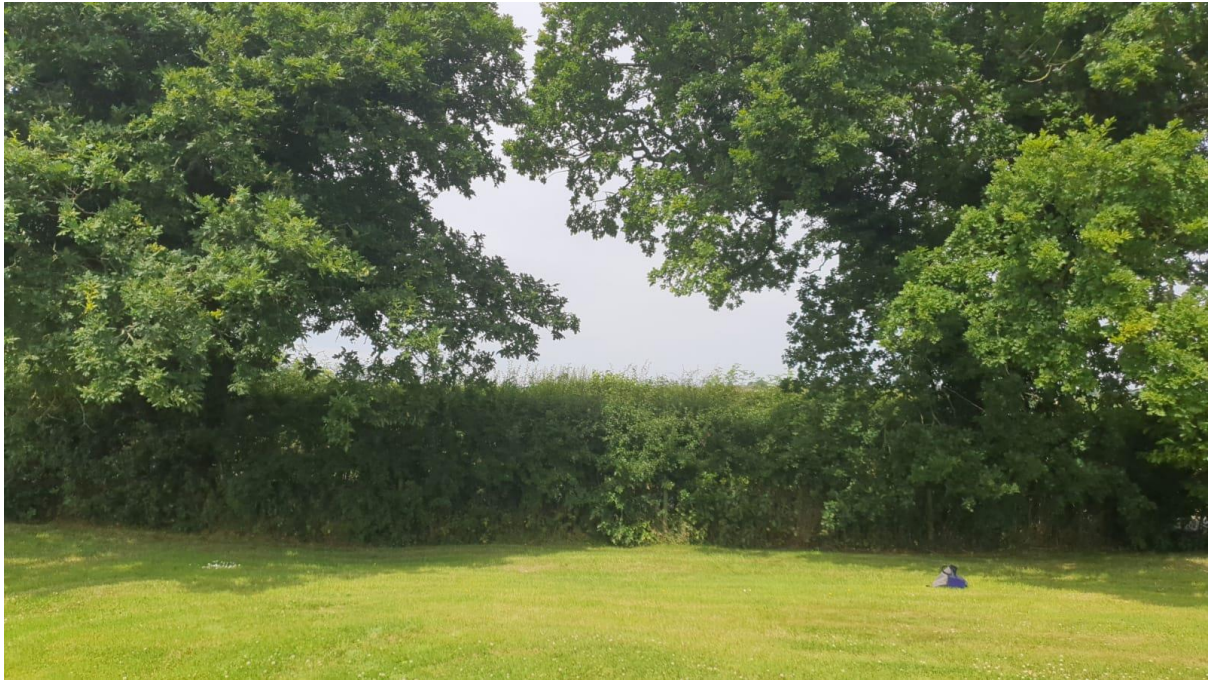
There is a section of hawthorn hedge between T1 and T2 that would need to be removed to facilitate the entrance to the proposed dwelling and improve sight lines for access and egress.

T1 and T2 in relation to hawthorn hedge section

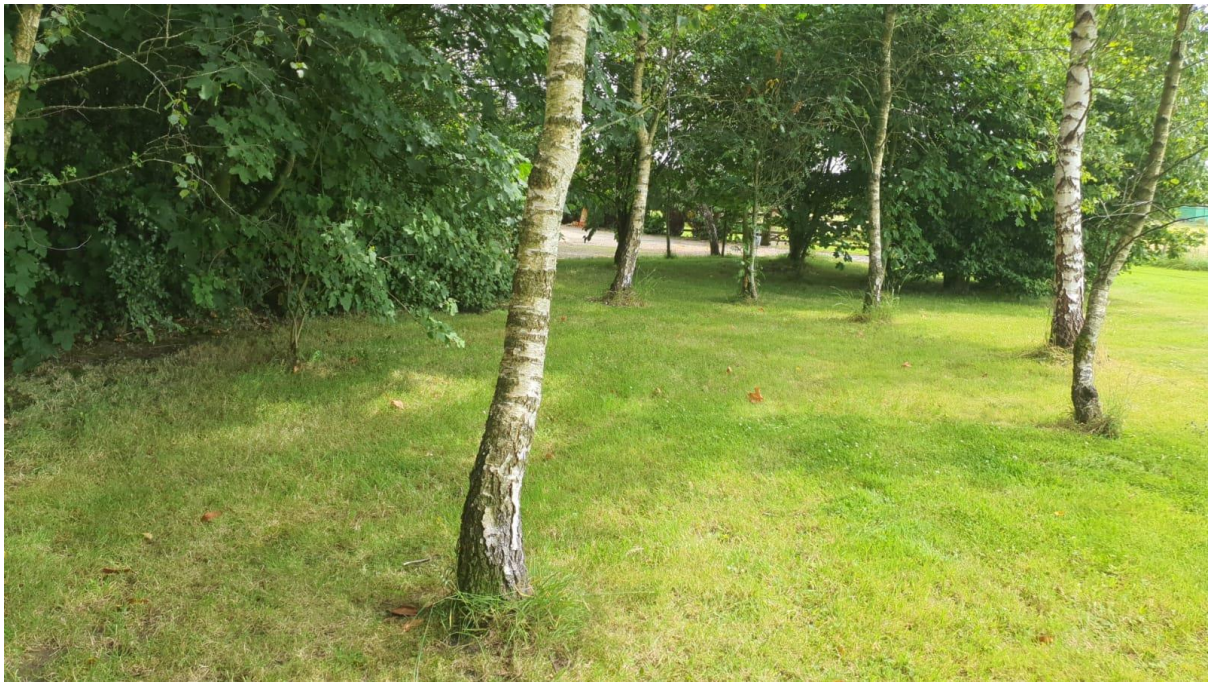
G1 is a group of young and semi - mature trees to the west of the proposal. G1 consists of mainly birch, with rowan, sycamore, laurel, and beech present also. The RPAs of the group would not be directly affected by the construction of the current proposal but could be impacted by soil compaction from plant and machinery or damage from construction materials/chemicals.
