CONVERSION APPRAISAL REPORT

**A PLANNING APPLICATION FOR THE PROPOSED CONVERSION OF A
FORMER WATER TOWER AND VALVE HOUSE INTO ONE DOMESTIC
DWELLING**

FORMER PUMPING STATION
OFF VICARAGE LANE
WILPSHIRE
BLACKBURN
BB1 9HY

Prepared by: Paul Fay for and on behalf of Gary Hoerty Associates
Our Ref: Tur/155/3074/PF
Date: June 2022
Client: Mr J Turner

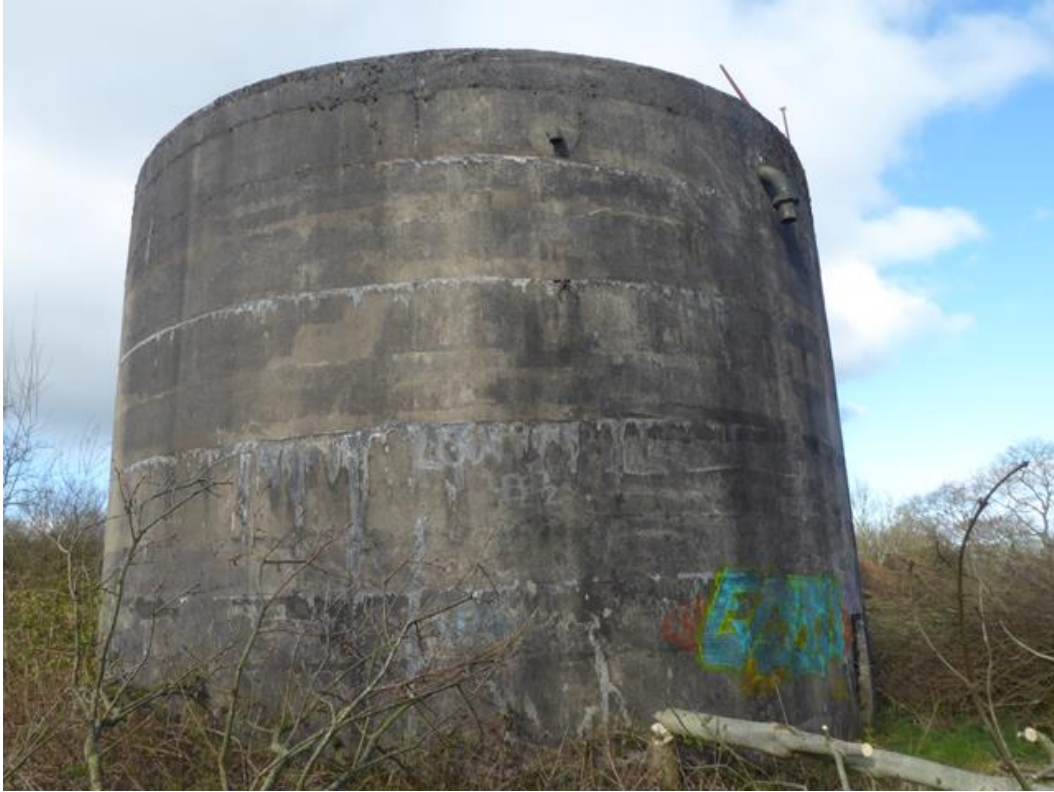
All elevations are constructed from solid, reinforced concrete panel construction. Generally, the walls are reasonably straight and do not show signs of outward deflection. The walls feature no existing openings.

Photo 1: Water Tower Easterly Facing Elevation

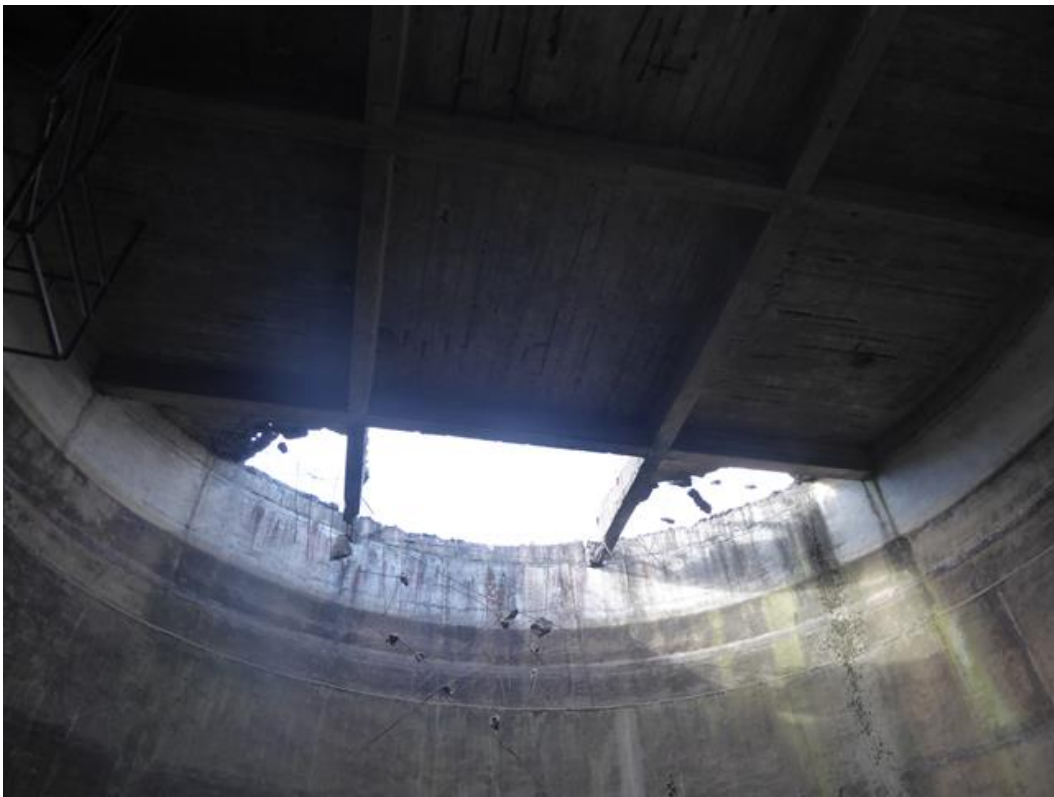
Generally, the roof to the water tower is in a poor condition, with evidence of a large part missing. Internally the roof is supported with reinforced concrete beams.

Photo 2: Water Tower missing roof

With reference to the proposed plans Tur/155/3074/02, the existing roof of the water tower is to be retained, repaired and retrospectively insulated. The roof over the valve house will be proposed to be a warm deck flat roof. Existing rainwater goods are to be replaced.

Remove the corroded steel sections that formed part of the roof of the single storey building and replace with a new flat roof structure. Repair the reinforced concrete roof of the water tower as necessary.

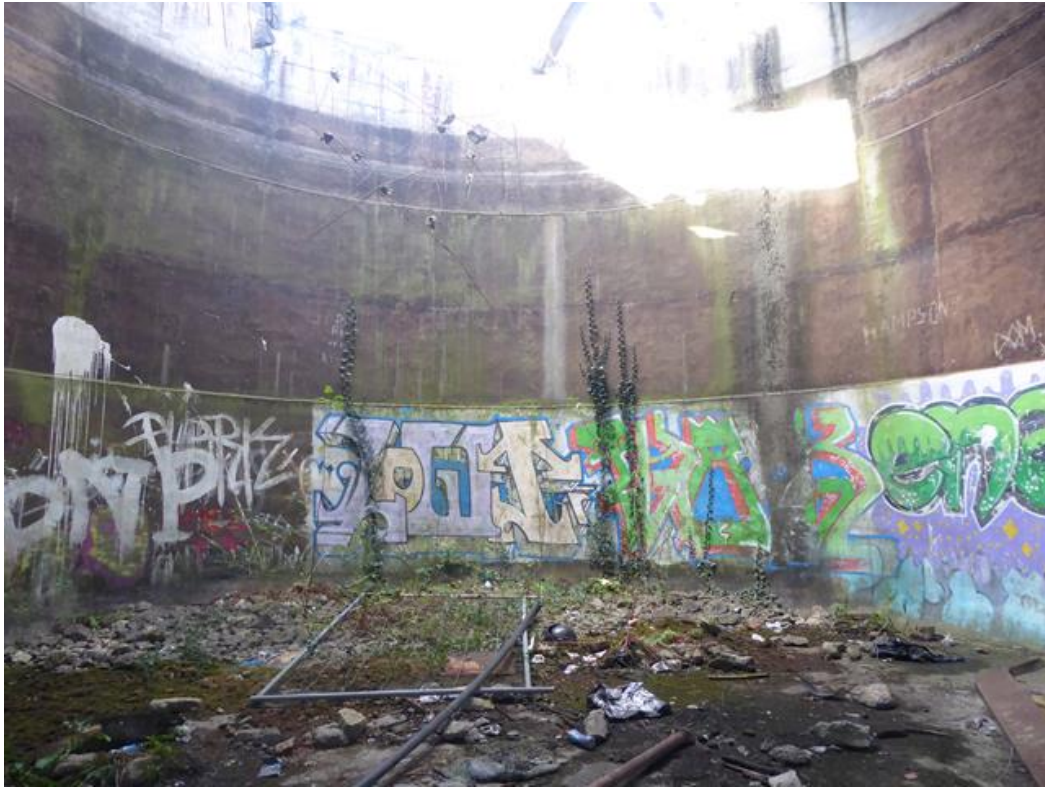
Photo 3: Water Tower interior

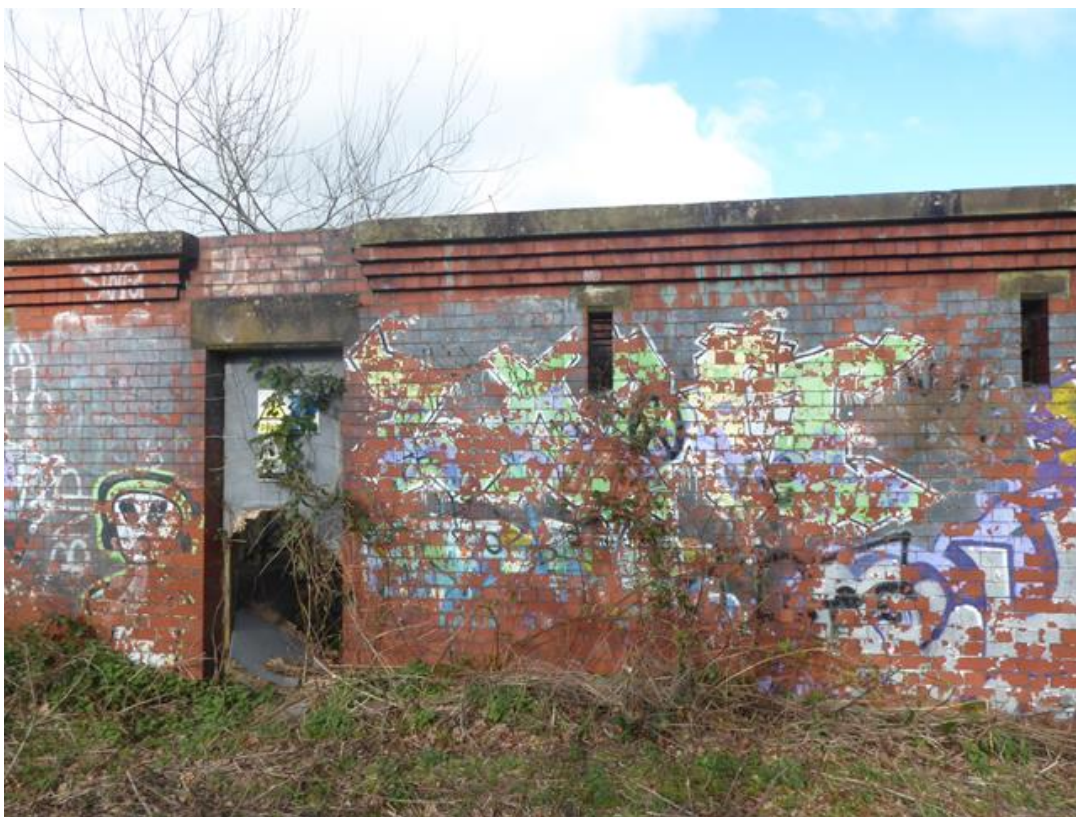
Constructed of solid, red facing brick walls approximately 215mm thick. The Easterly elevation features a door opening with a stone head. The remainder of the elevation features narrow, high level, windows with stone heads. There are no real signs of structural movement to the wall. Most mortar joints look in reasonable condition, however there is some localised repointing required.

Photo 6: Valve House Easterly Facing Elevation

Re-point all external walls with mortar where required. Construct new 100mm thick internal block lining wall off the raft foundation slabs and tie the existing and proposed lining walls together with cavity wall ties; 750mm c/c horizontally and 450mm c/c vertically. Concrete lintels to be inserted into the block lining wall to support new openings internally. Larger openings are to be supported by a steel lintel, with a steel plate welded to the bottom to carry the outer brick soldier course. Steel is to be designed by a structural engineer. Insert new windows and doors to seal the building. The block lining wall is to be skimmed to finish. The reveals of all doors and windows are to be lined with insulated plasterboard and skimmed to finish. Clean all external faces to finish. Render the water tower with K Rend to finish.

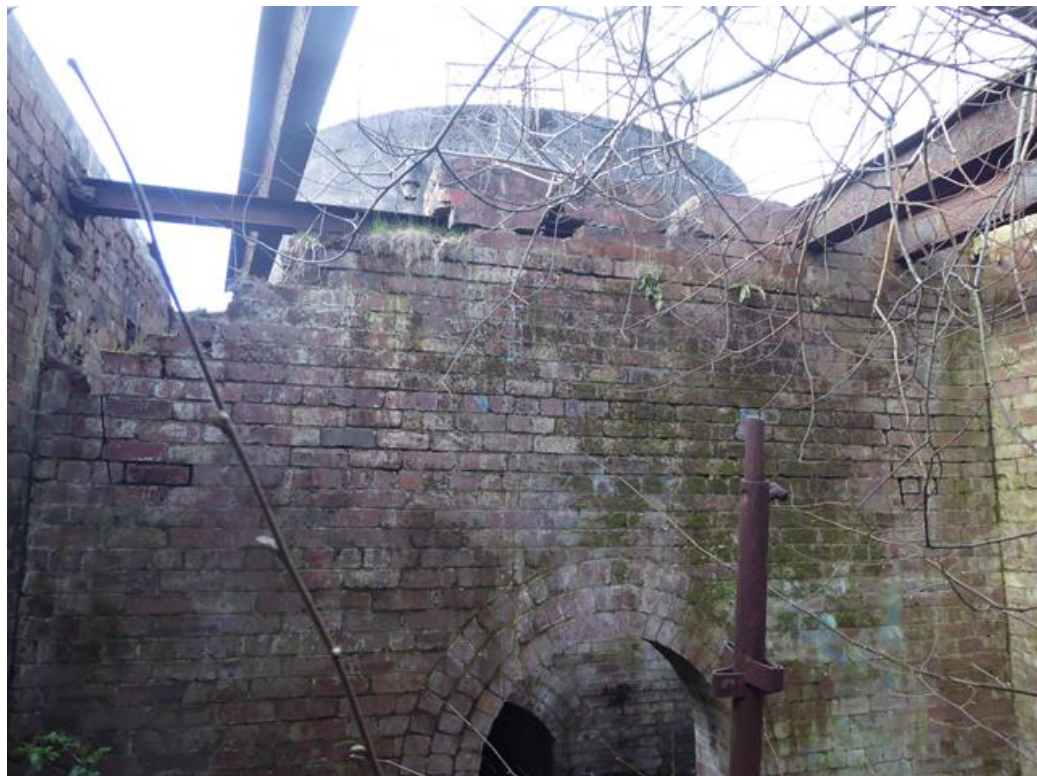
With reference to the existing plans, see drawing reference: Tur/155/3074/01, accompanied with this planning application, the buildings considered in this report are the single-storey red brick former valve house and the adjacent, multi-storey, concrete water tower building. The roof over the brick building is missing and the roof over the water tower comprises a reinforced concrete deck.

Photo 10: Valve House interior and Missing Roof

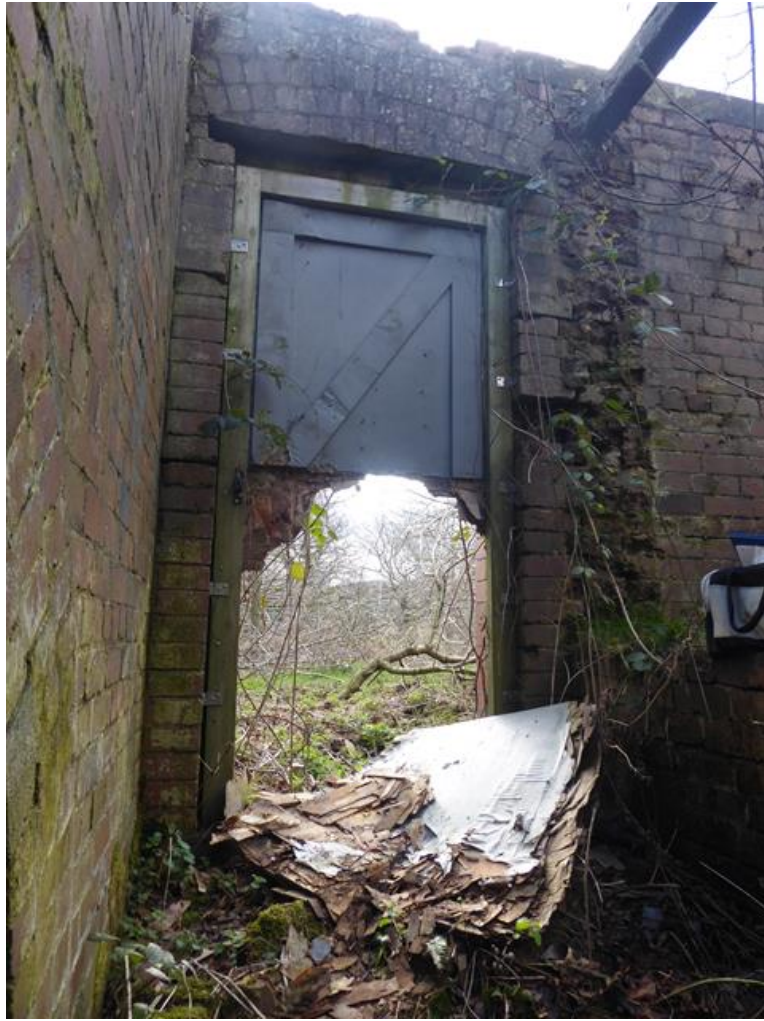
Photo 11: Valve House Door Opening
