Structural Inspection Report Knott Gate Farmhouse, Slaidburn

John Forrester Ltd

Ref: L39613.001/JRP/WEL

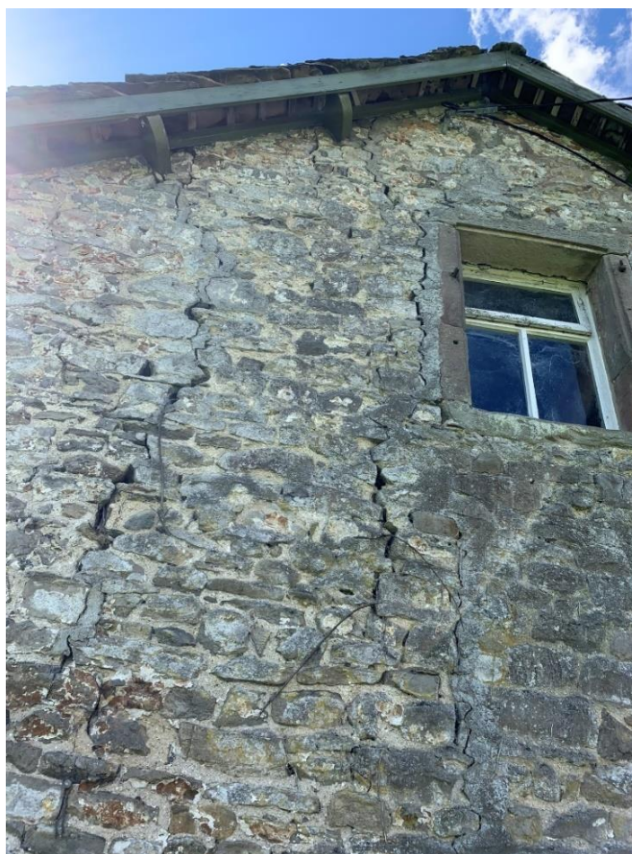
Gable Wall

There are significant cracks on the external walls.

The gable wall cracking is directly below the bearing points of the purlins and lintels over the window has failed.

The cracking and movement is of a historic, long standing nature and simple precast concrete lintel crack stitching, re-seating of beams and purlins will stabilise the structure, restraint of the walls tying the floors to walls and localised rebuilds will ensure standard refurbishment works can be undertaken as outlined on the Mason Gillibrand Architect's drawings. See the following typical repair details.

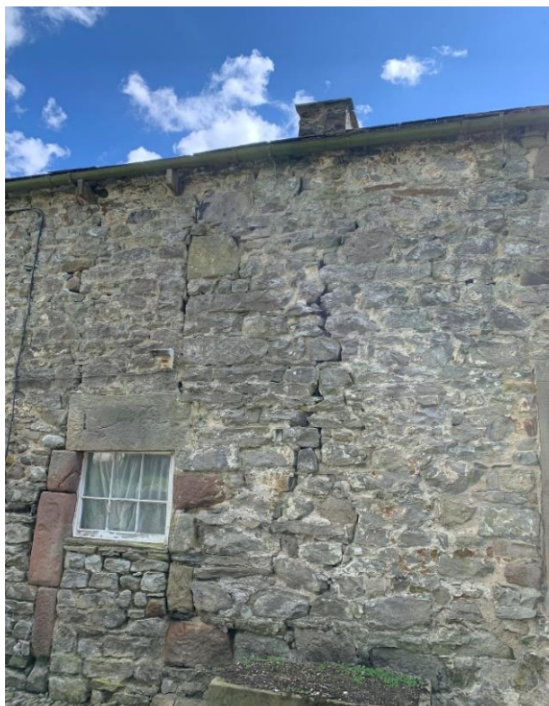
Front Wall

Parts of the wall have been remodelled in the past to create windows and doors etc.

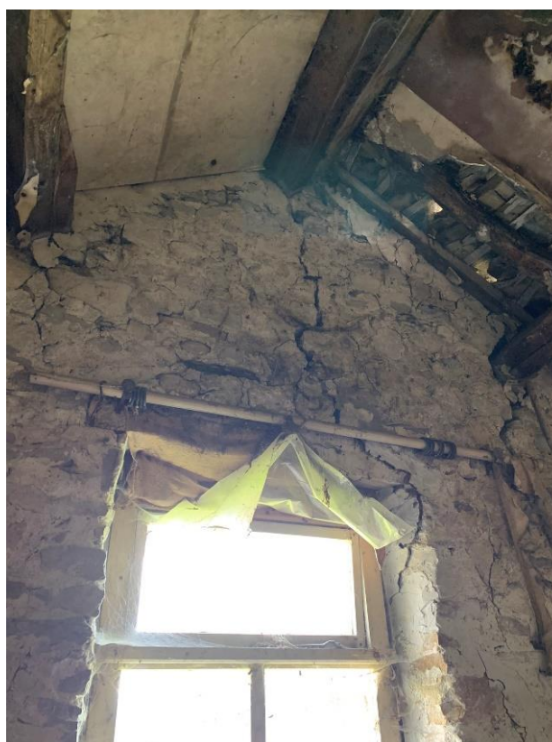
Internal Gable Wall

The gable end has moved away from the front and rear walls, leaving vertical cracking internally.

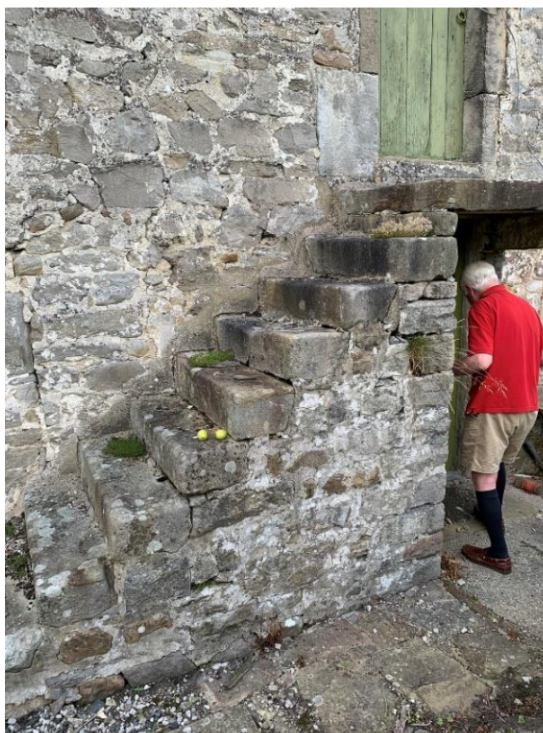
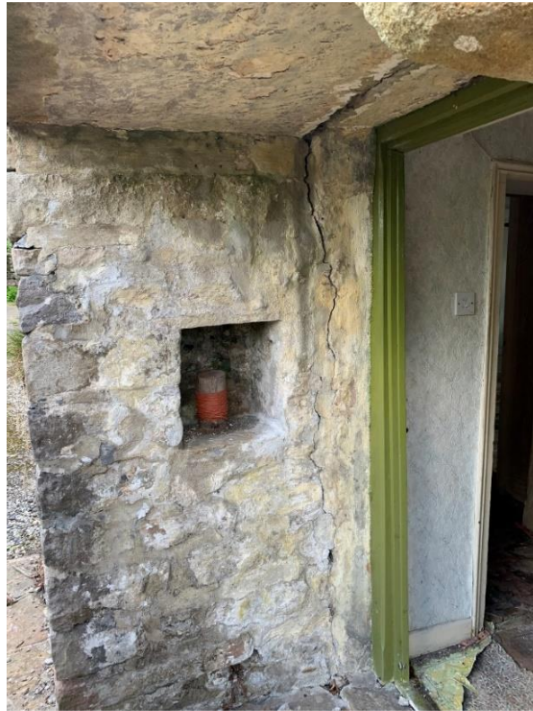
Minor Cracking between stairs and rear wall
