**DESIGN AND ACCESS STATEMENT**

**OXENHURST FARM  
BACK LANE  
NEWTON IN BOWLAND  
CLITHEROE  
BB7 3EE**

Doc Ref: 101560 – D&A

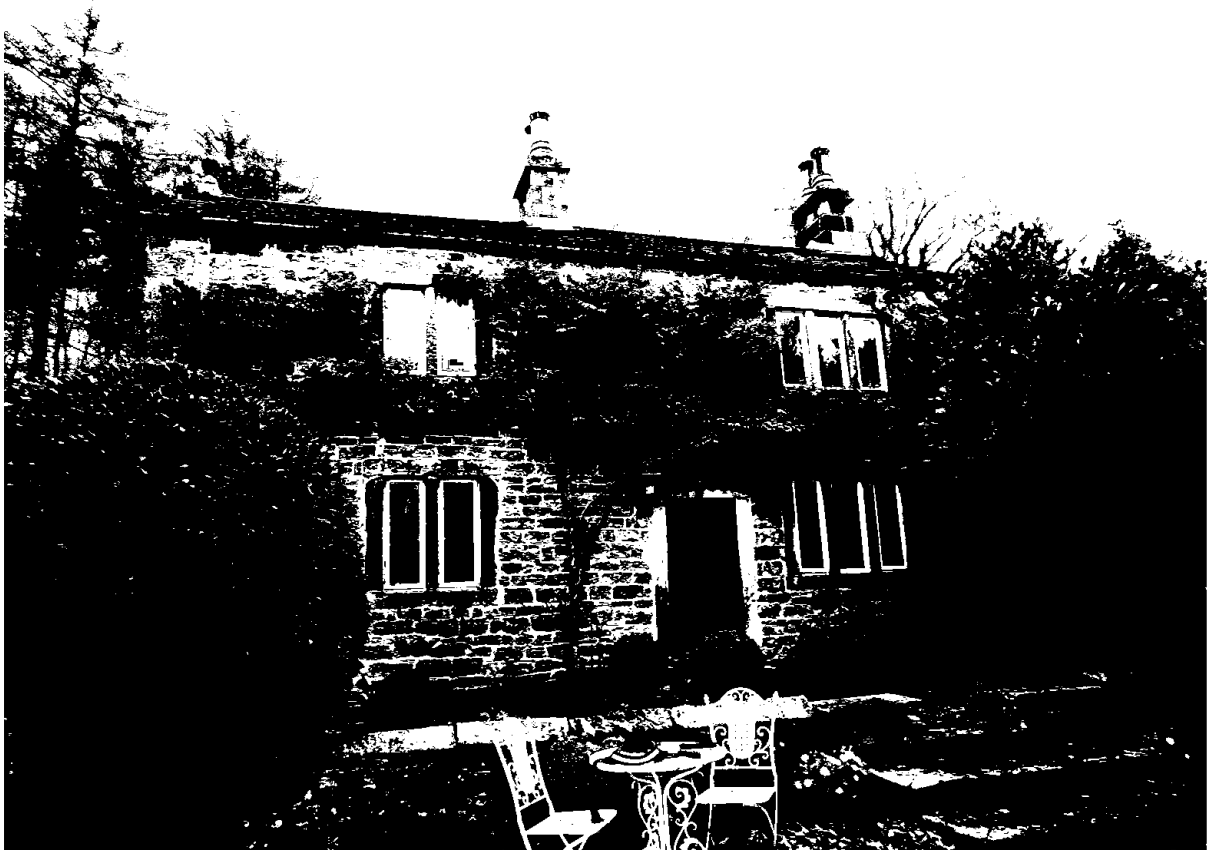
View from front

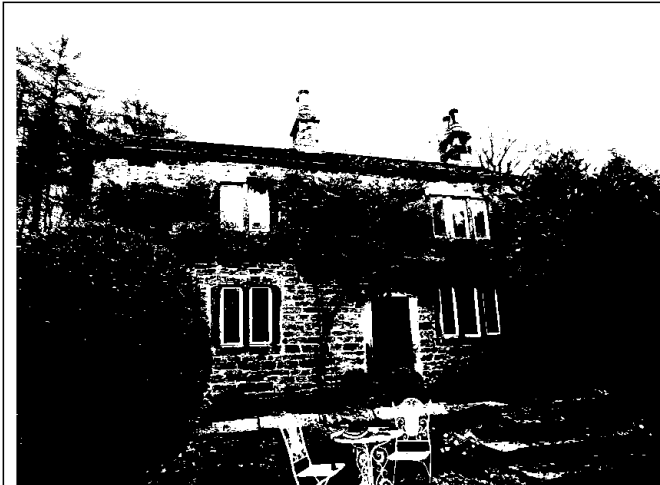
Photo 1 – Front elevation

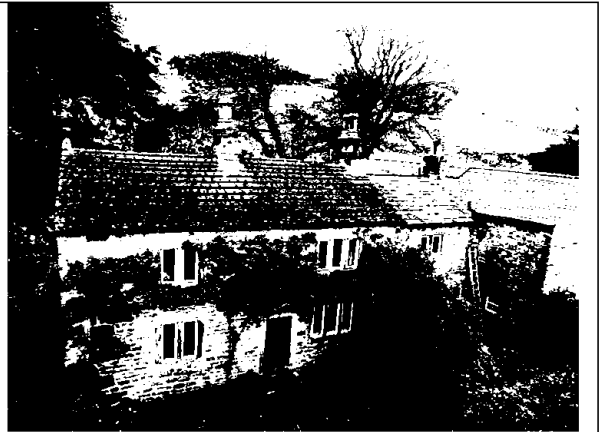
Photo 2 – Roof overview

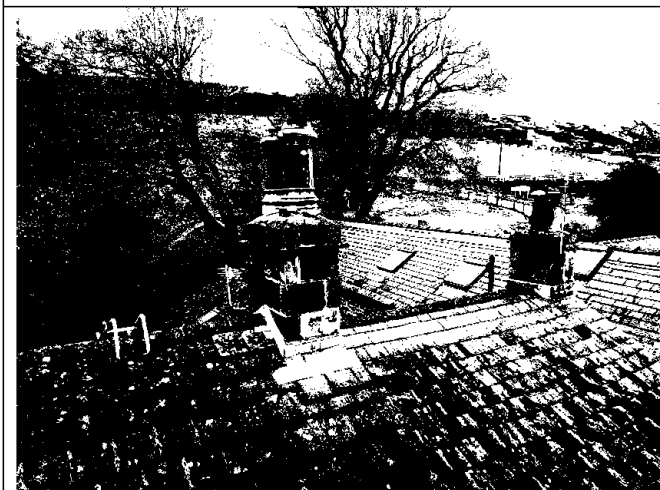
Photo 3 – Chimney to front elevation .

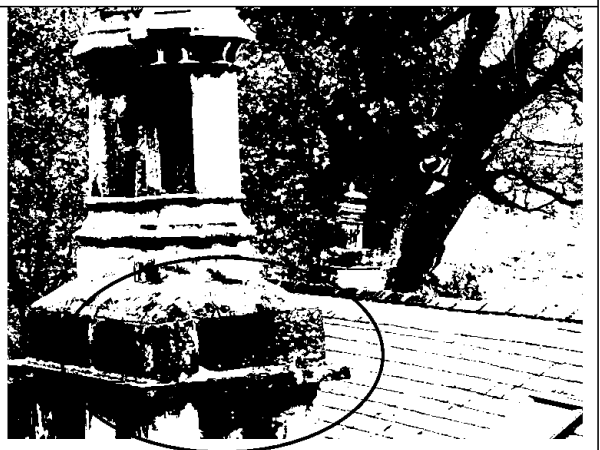
The chimney is of stone block construction and generally appears to be in fair condition, an internal inspection of the chimney was not possible during our visit. One of the stone blocks has previously split and had a mortar repair carried out and there is some deterioration of the mortar to the rear side of the chimney. These issues predate the fire. The chimney stack is topped with two decorative clay pots which do not appear to be damaged by the fire, the flaunching (mortar securing the chimney pots) has cracked and come loose around the bottom of the front pot, this damage appears to be recent and I would suggest is linked to the fire.

Photo 4 – Cracked and heat damaged flaunching to top of chimney

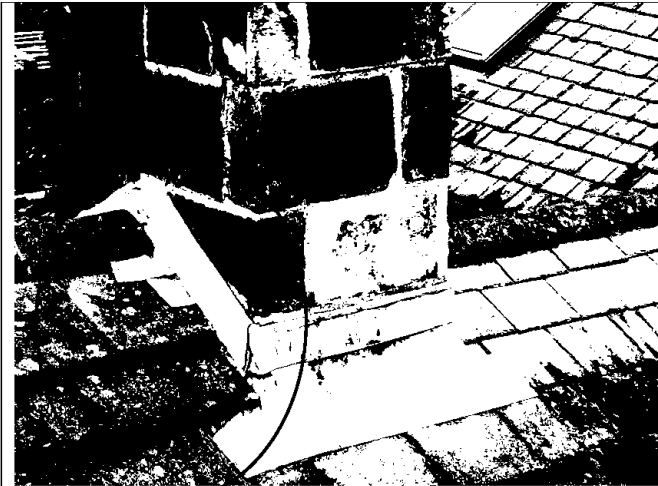
The lead flashing between the chimney and roof has been disturbed slightly on the front elevation with a section below the ridge tile having slipped, most likely as a result of foot traffic on the roof while fighting the fire. The lead soakers (strips of lead that lie under the tiles) could not be inspected and may have been affected by the heat from the chimney fire.

Photo 5 – Chimney – Slipped / displaced lead flashing

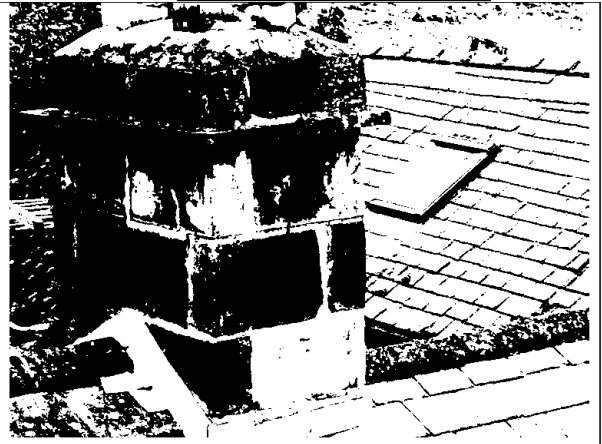
Photo 6 – Split stone

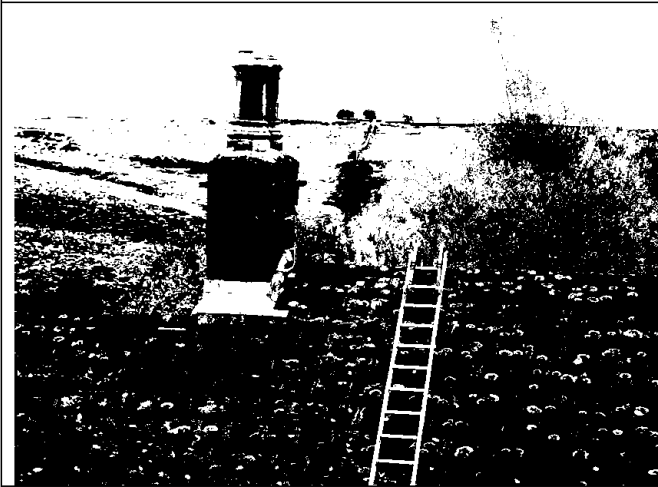
Photo 7 – Rear elevation of roof / chimney

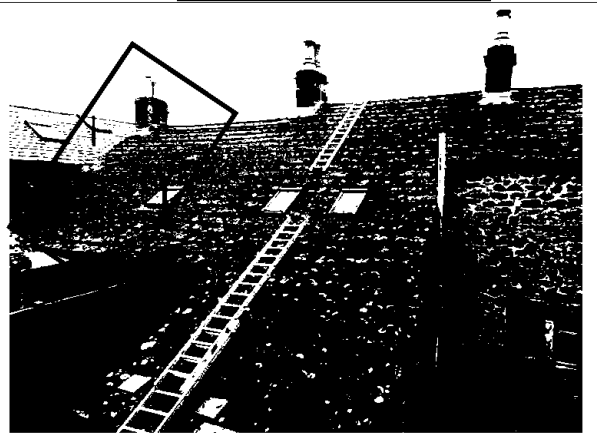
Photo 10 – Rear roof pitch extends down to near ground level. Red outlined area is the neighbours roof .

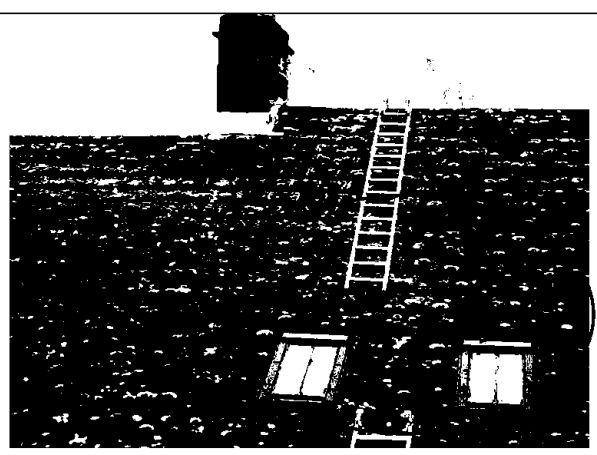
Photo 12 – Velux windows water ingress in area circled

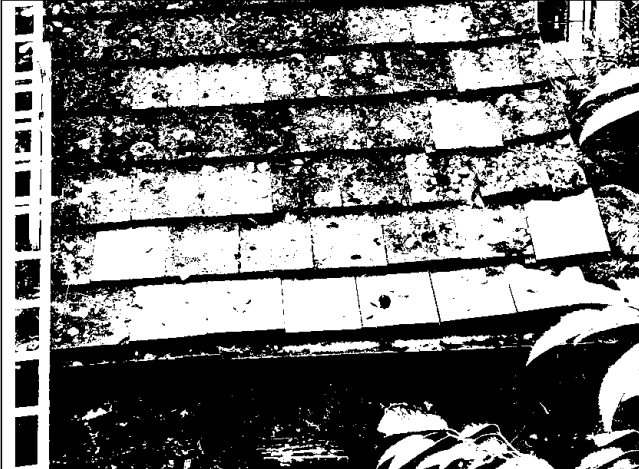
Photo 13 – Temporary Repairs

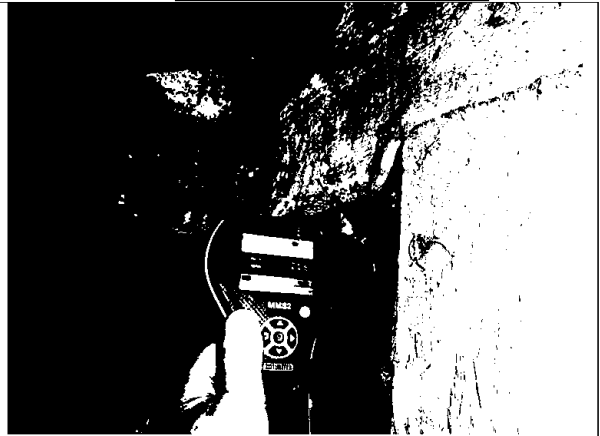
Photo 58 – Elevated moisture reading to ridge timber
