STRUCTURAL INSPECTION

BARN 2, DINKLING GREEN FARM

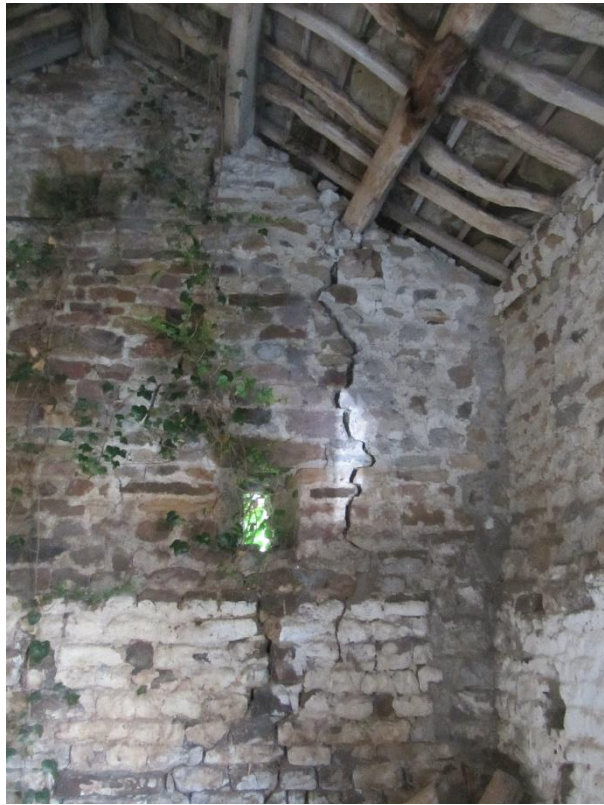
Photo 5 –Vertical crack on north gable wall

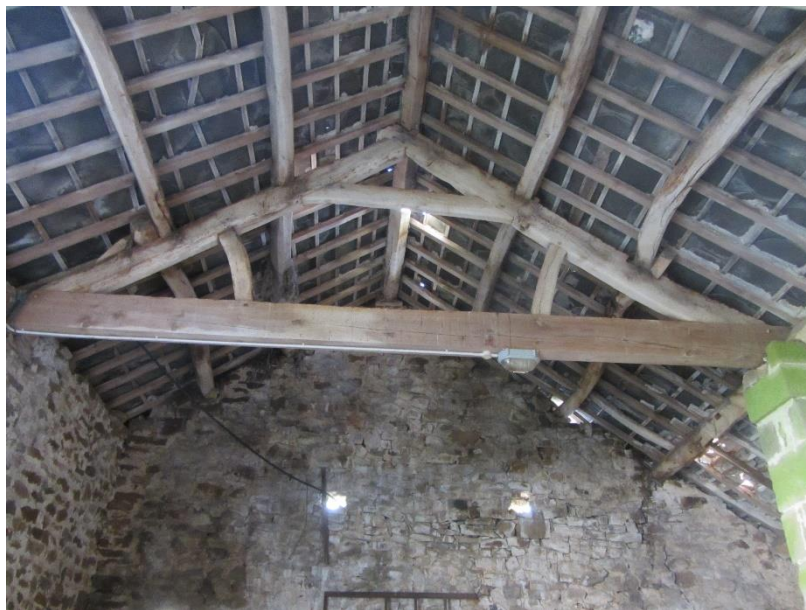
Photo 6 – Internal view of southern space looking south

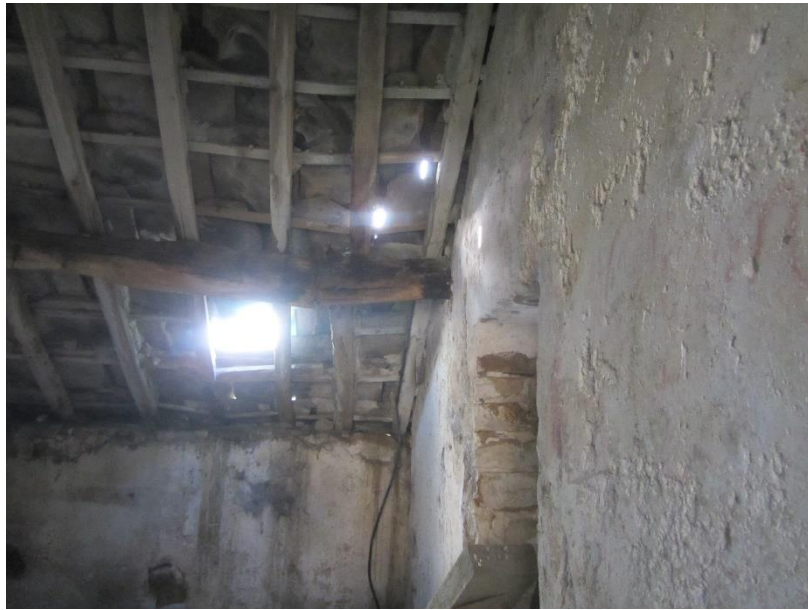
Photo 7 – Fractured purlin

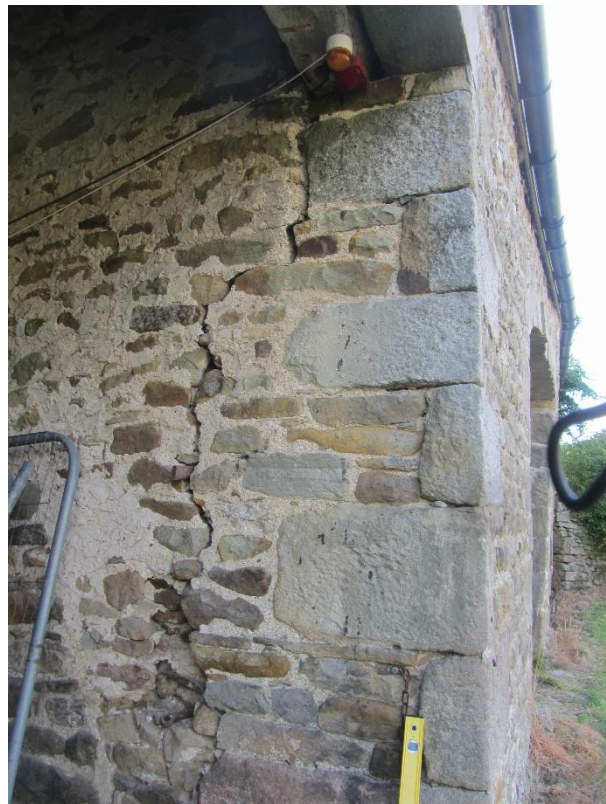
Photo 8 – Vertical crack in wall between northern and southern spaces

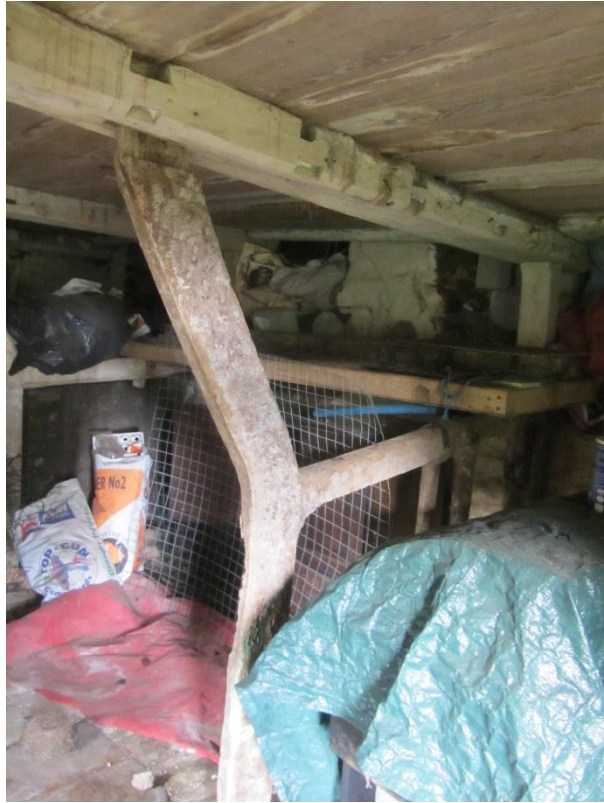
Photo 9 – Internal view of timber structure supporting loft floor

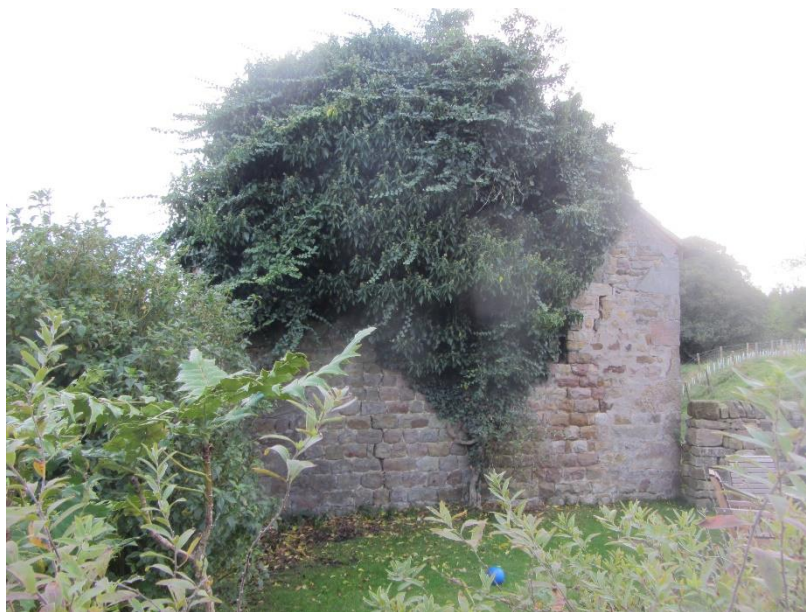
Photo 12 – Vertical crack in northern gable wall
