P9050/22/07

STRUCTURAL INSPECTION

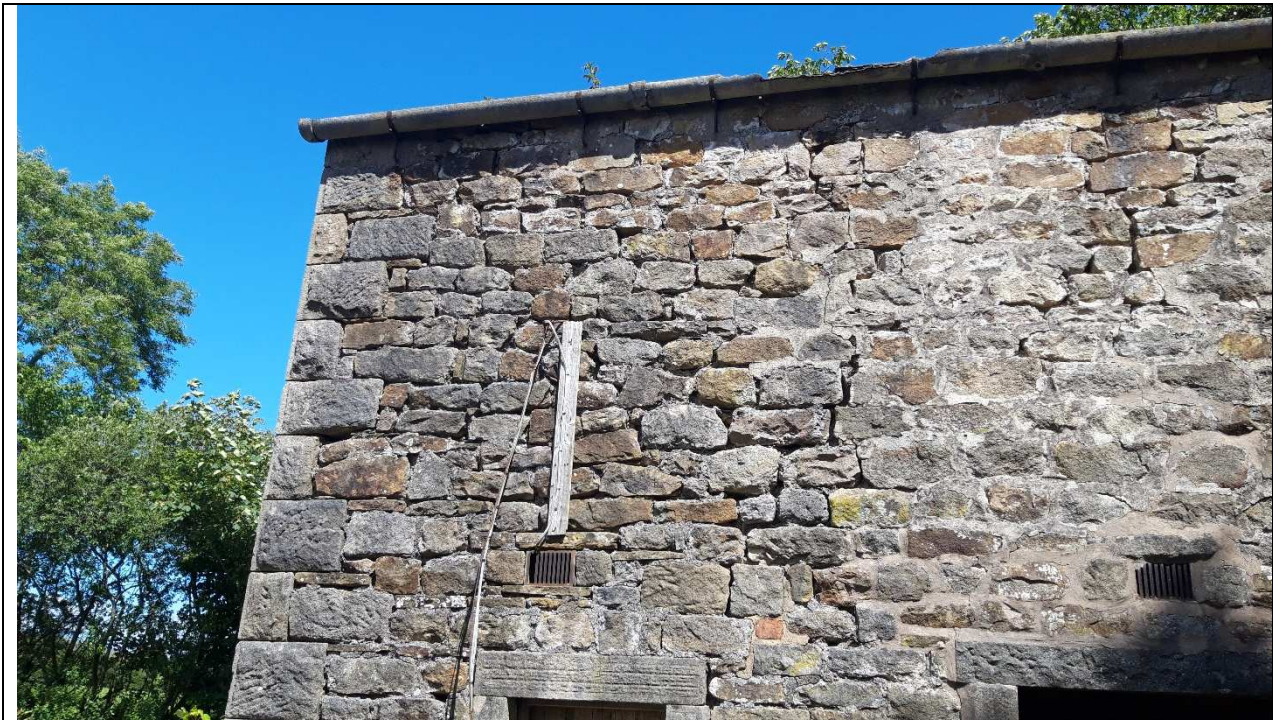
Cracking to Front Wall of South East Barn

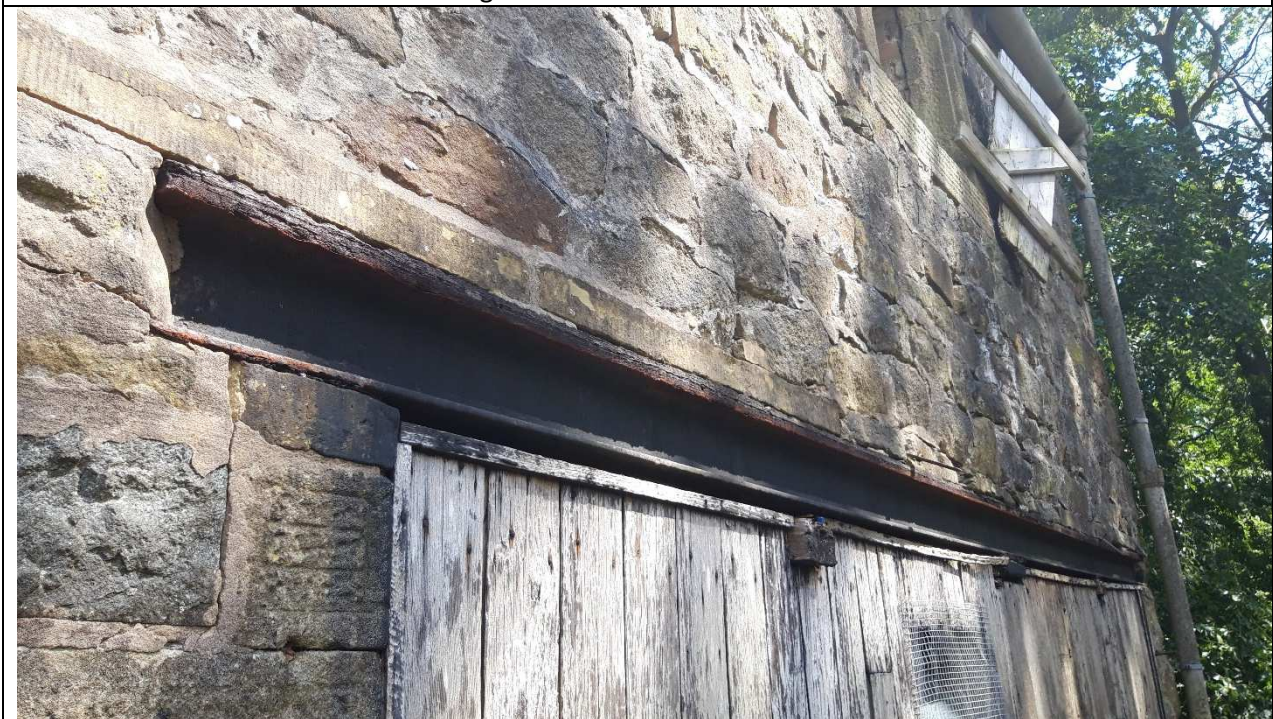
Corroding Beam Over Opening to Front Wall of South East Barn

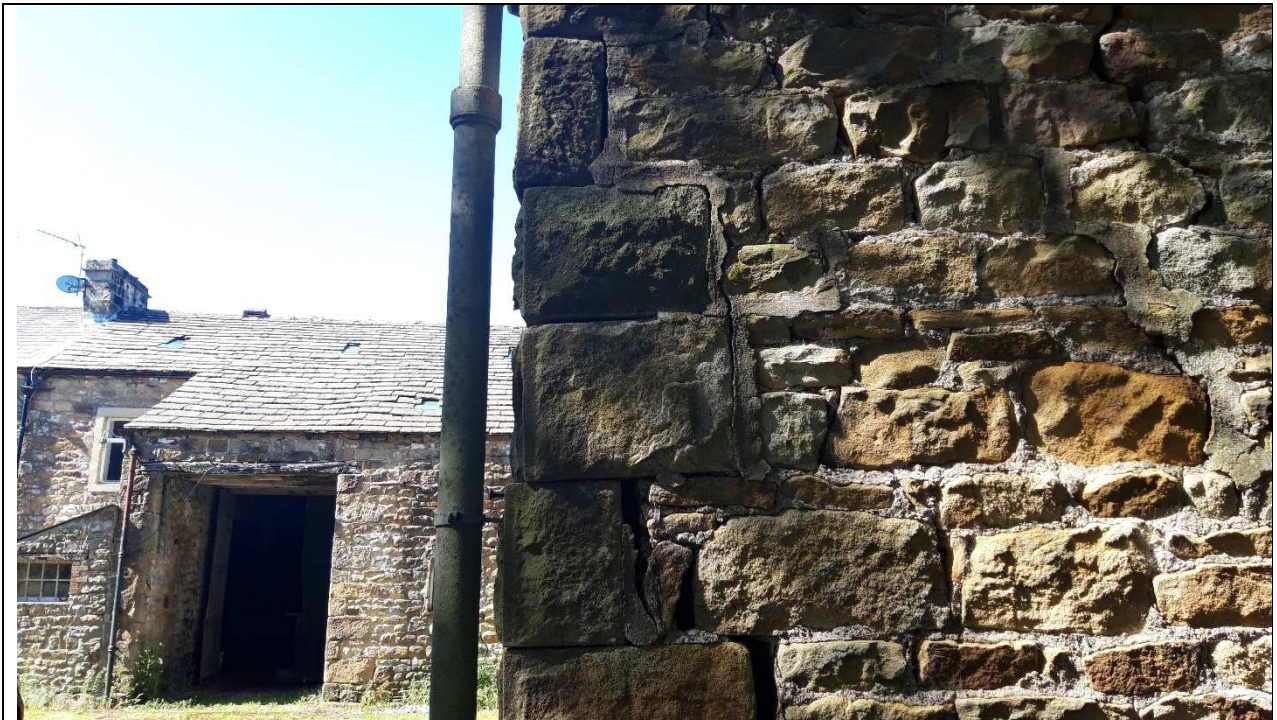
Cracking to Left End of South Elevation Wall of South East Barn Below Steel Bearing

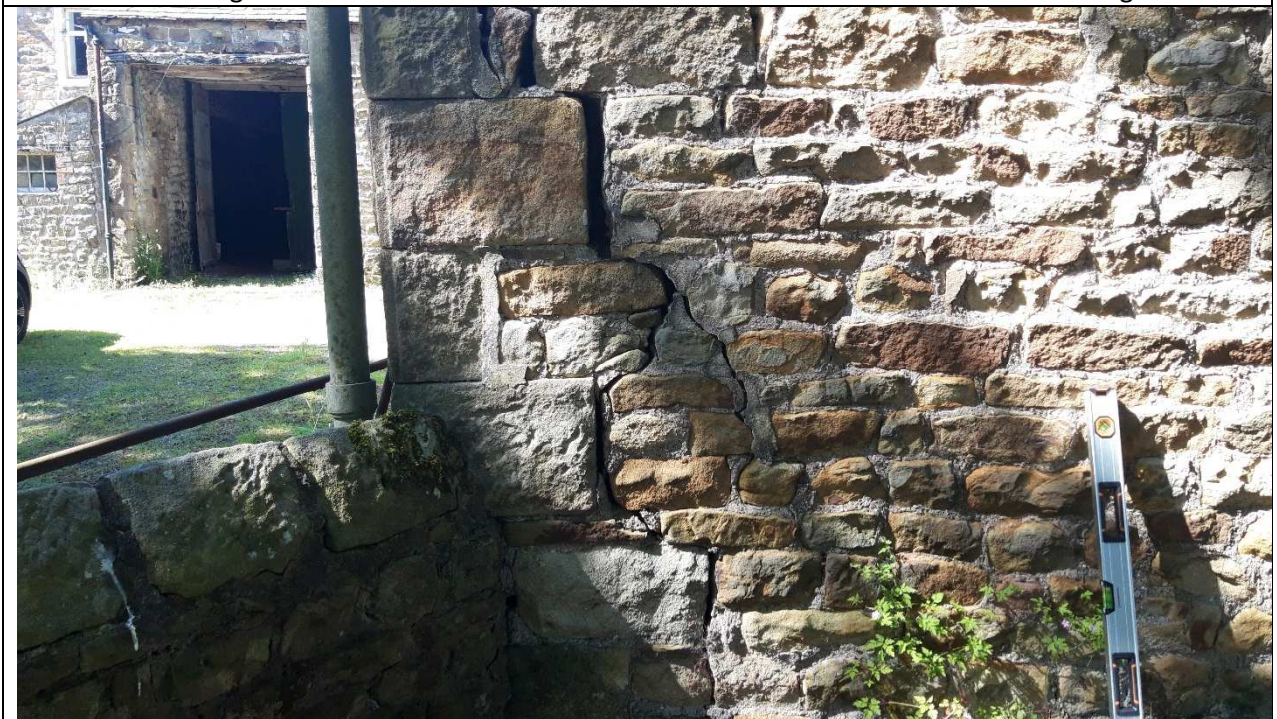
Cracking to Left End of South Elevation Wall of South East Barn at Base of Wall

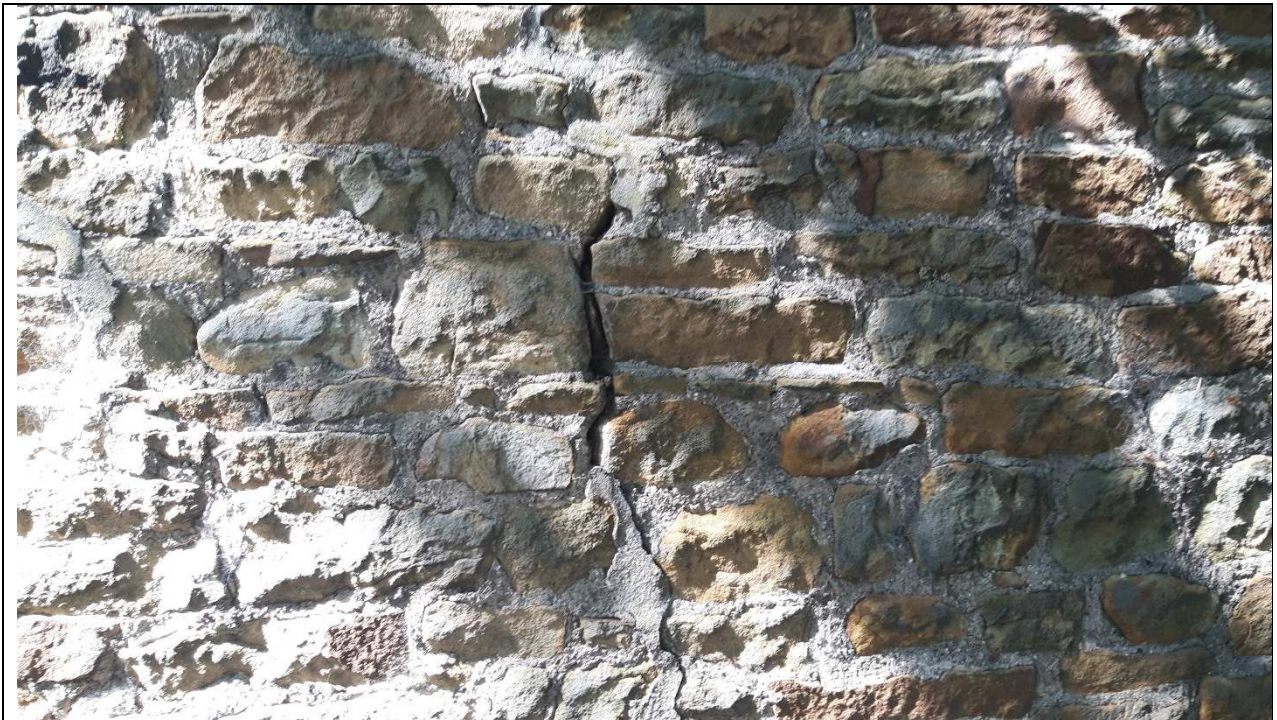
Crack to Mid-Point of South Wall to South East Barn

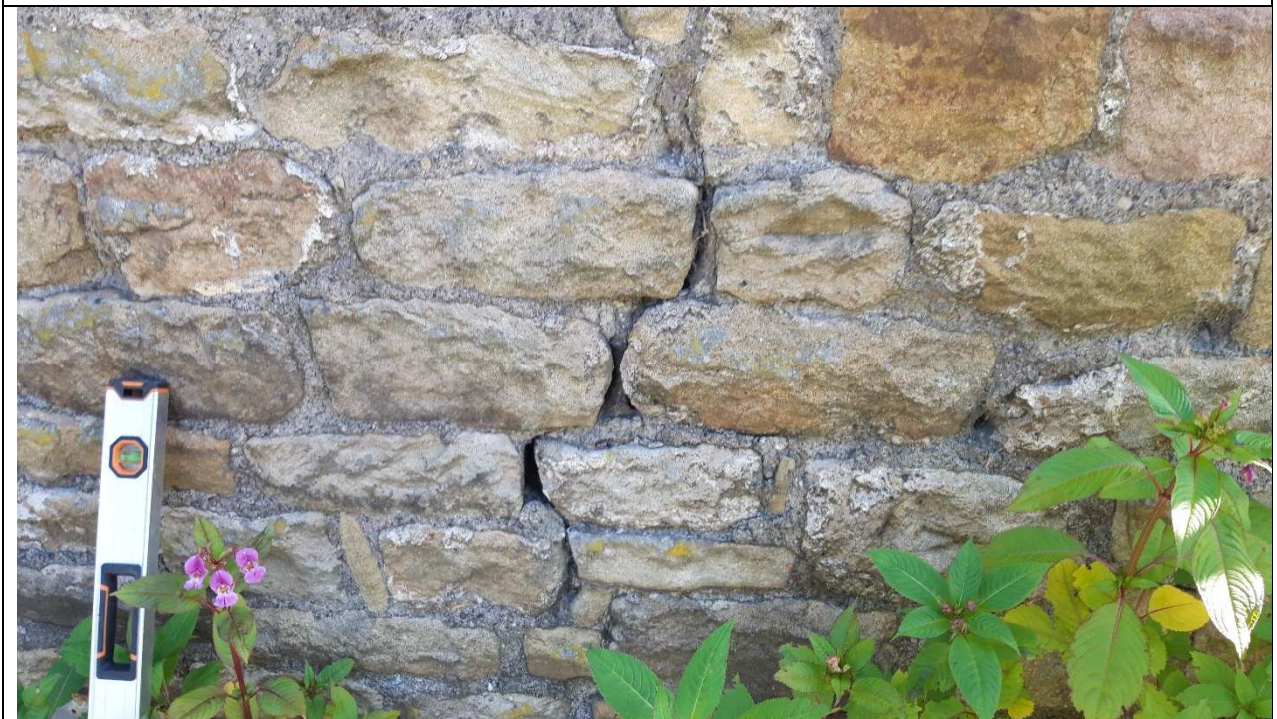
Crack at Base of North Wall of South East Barn

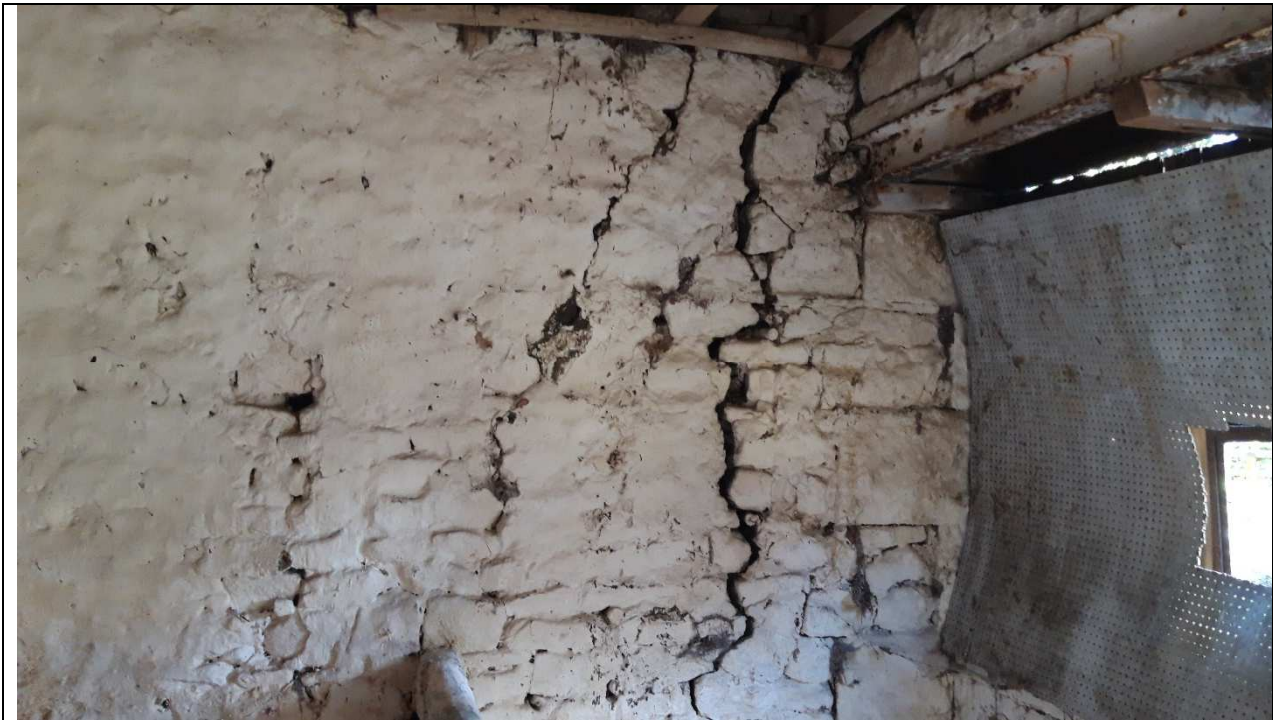
Large Crack Internally to South Wall of South East Barn

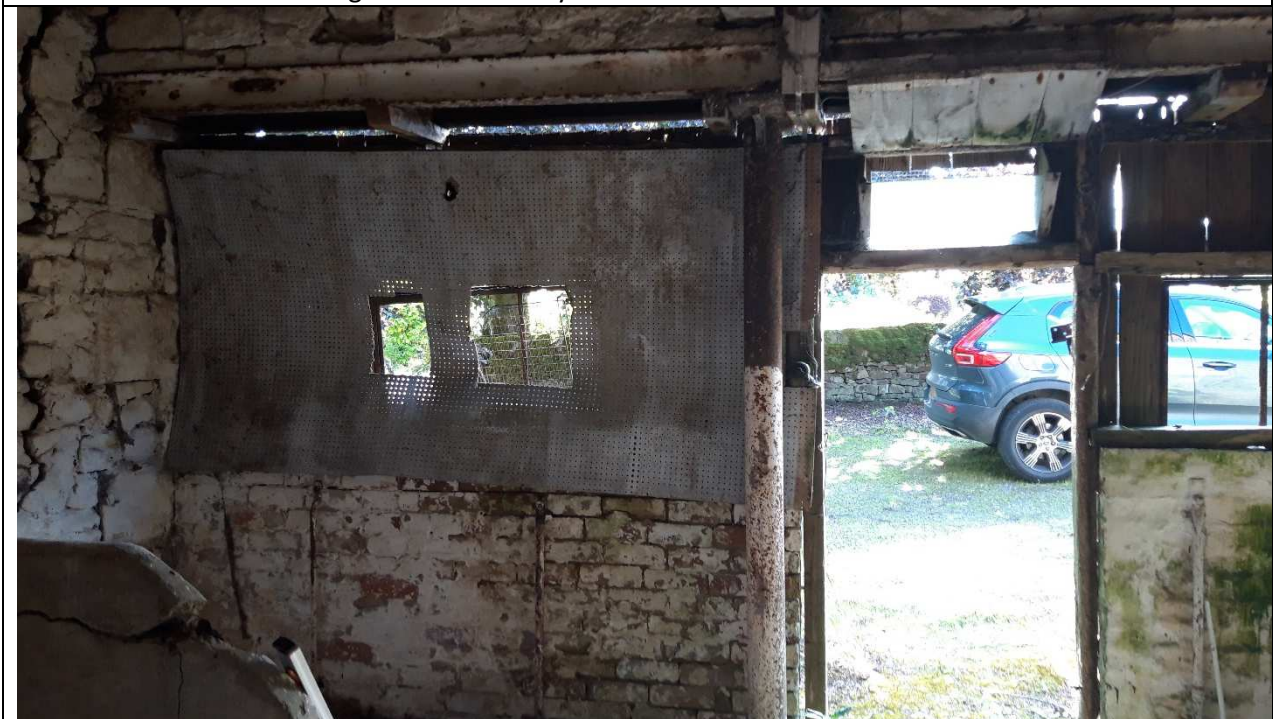
Corroding Frame to South East Barn

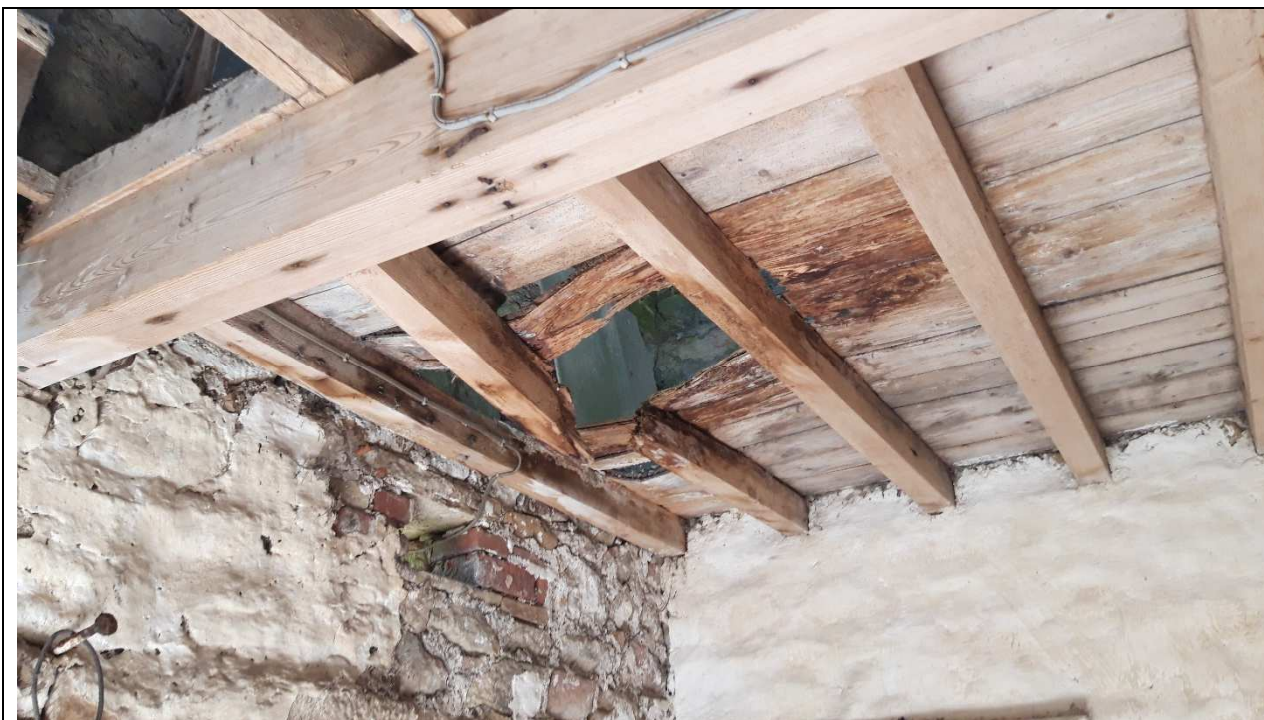
Damaged 1st Floor to South East Barn

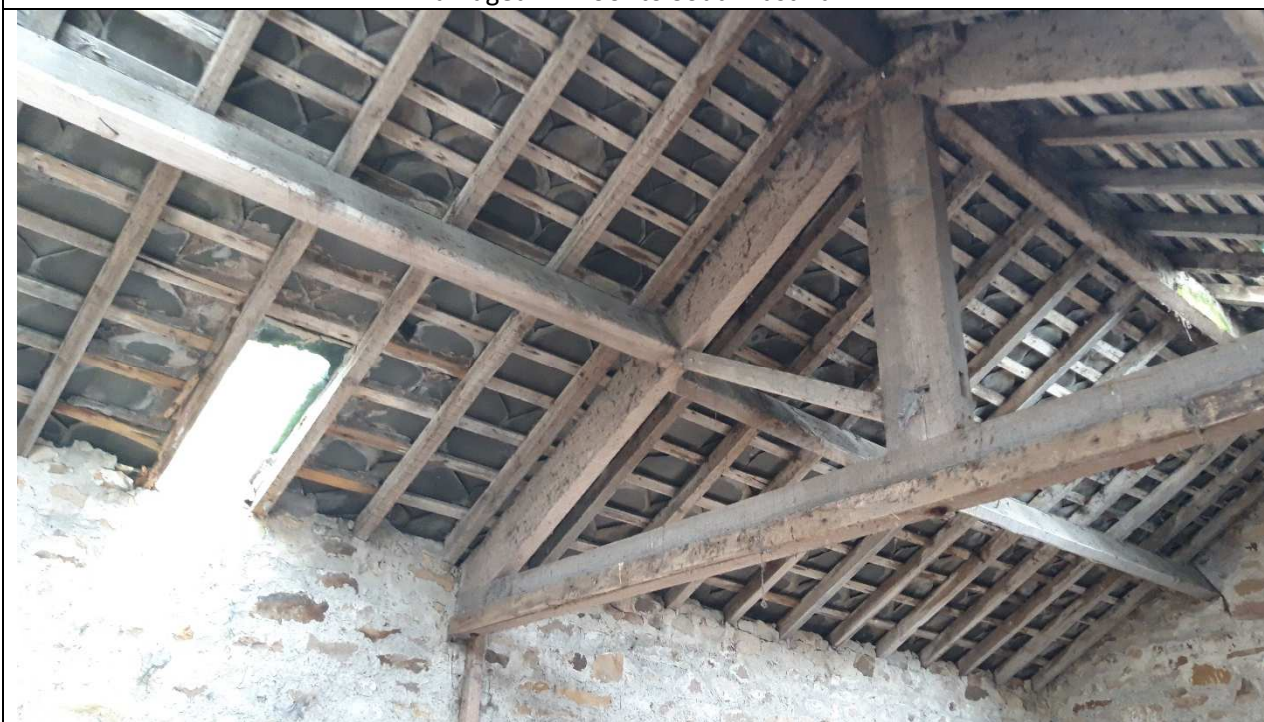
Roof Over South East Barn

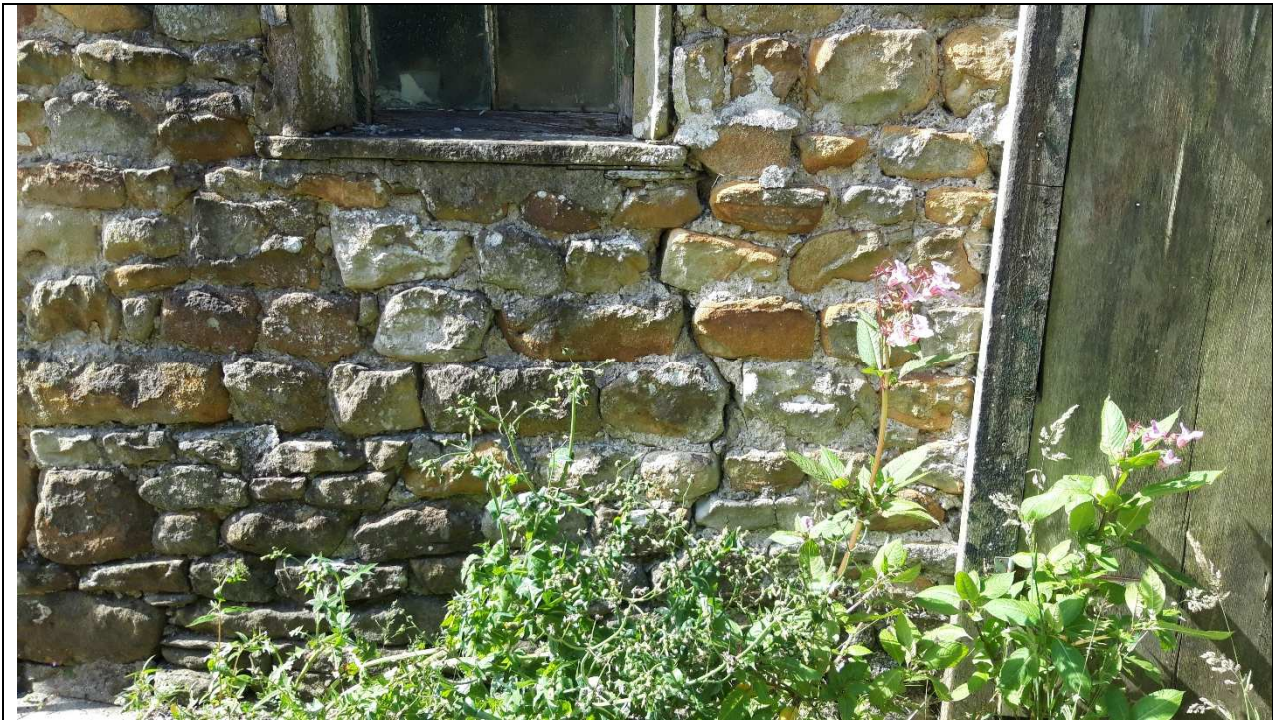
Crack Below Front Wall (South) to North West Barn

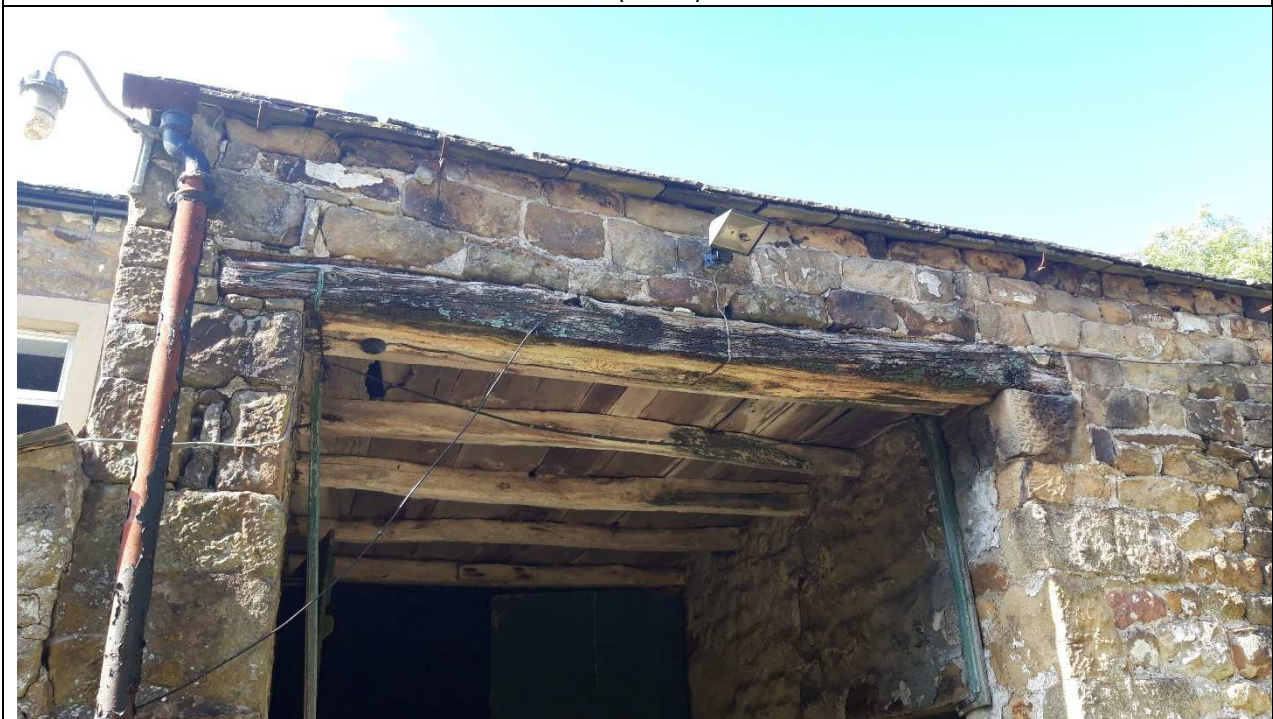
Lintel in Poor Condition to Main Door Over North West Barn Opening

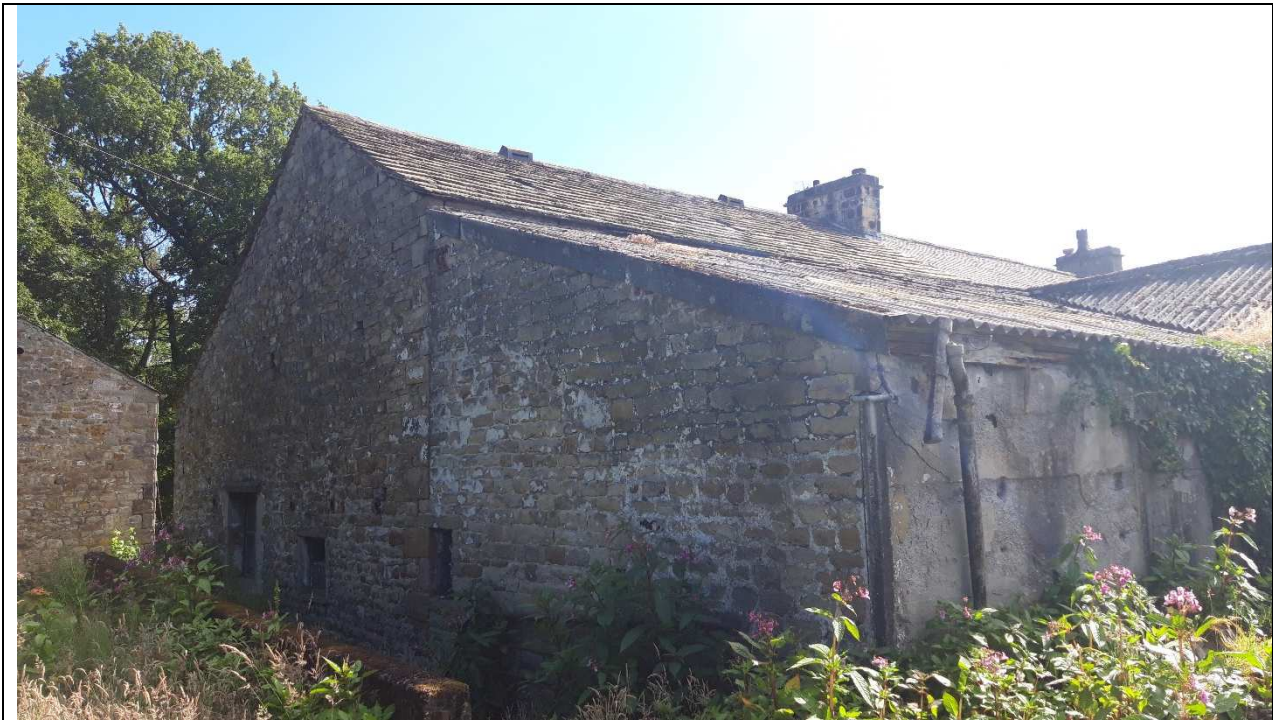
East Wall of North West Barn

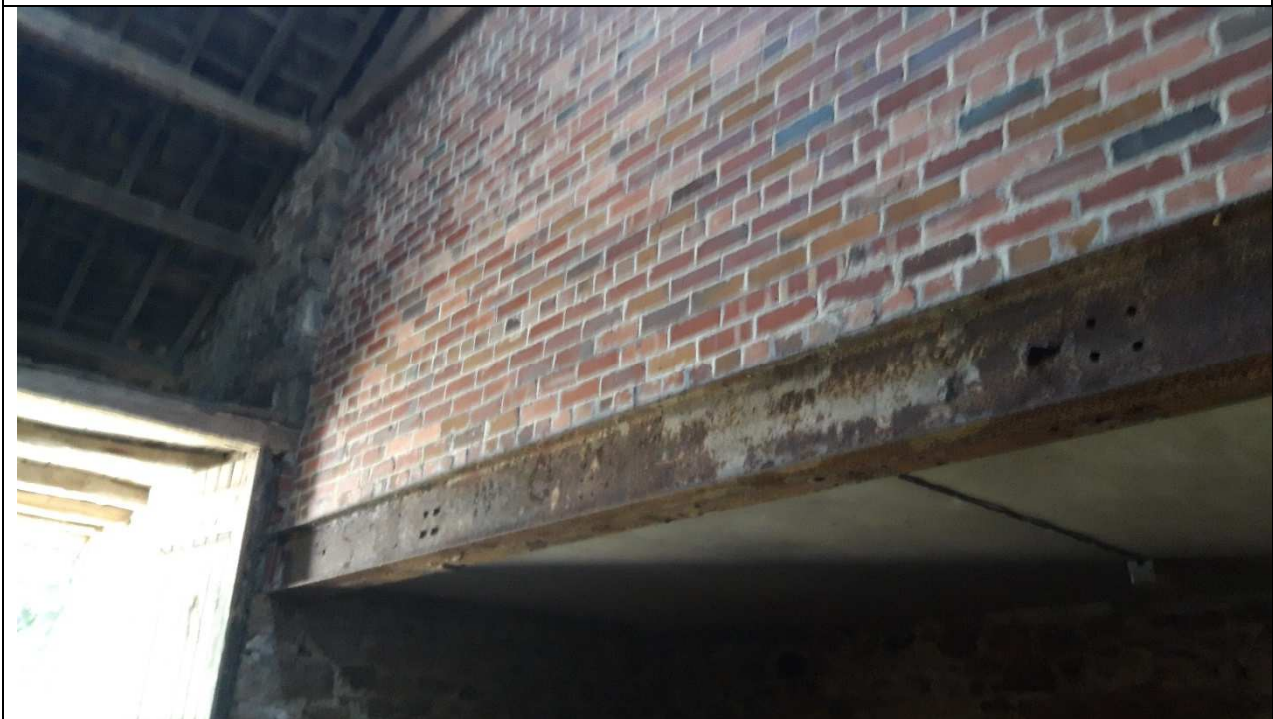
Corroding Beam Supporting 1st Floor and Wall in North West Barn

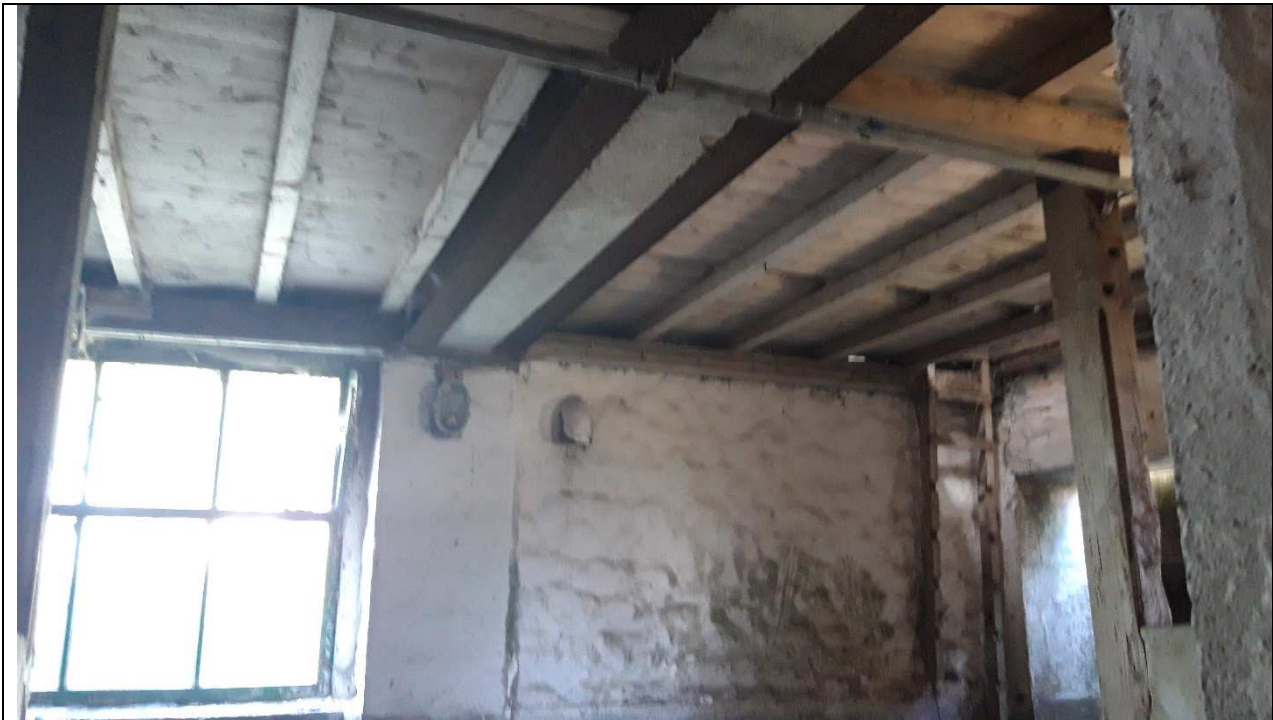
Lightweight Ceiling Over East Side of North West Barn
