Structural Report Concerning:
Outbuildings
Crow Trees Barn
Crow Trees Brow
Chatburn, Clitheroe
BB7 4AA

Our Ref: 2122173 / Crow Trees Barn, Clitheroe (Baker)

Report of Structural Inspection Concerning

Outbuildings (as per LMP Architects Provisional 05/05/22 Plan Sheet 22/018/E01)
Crow Trees Barn
Crow Trees Brow
Chatburn, Clitheroe
BB7 4AA

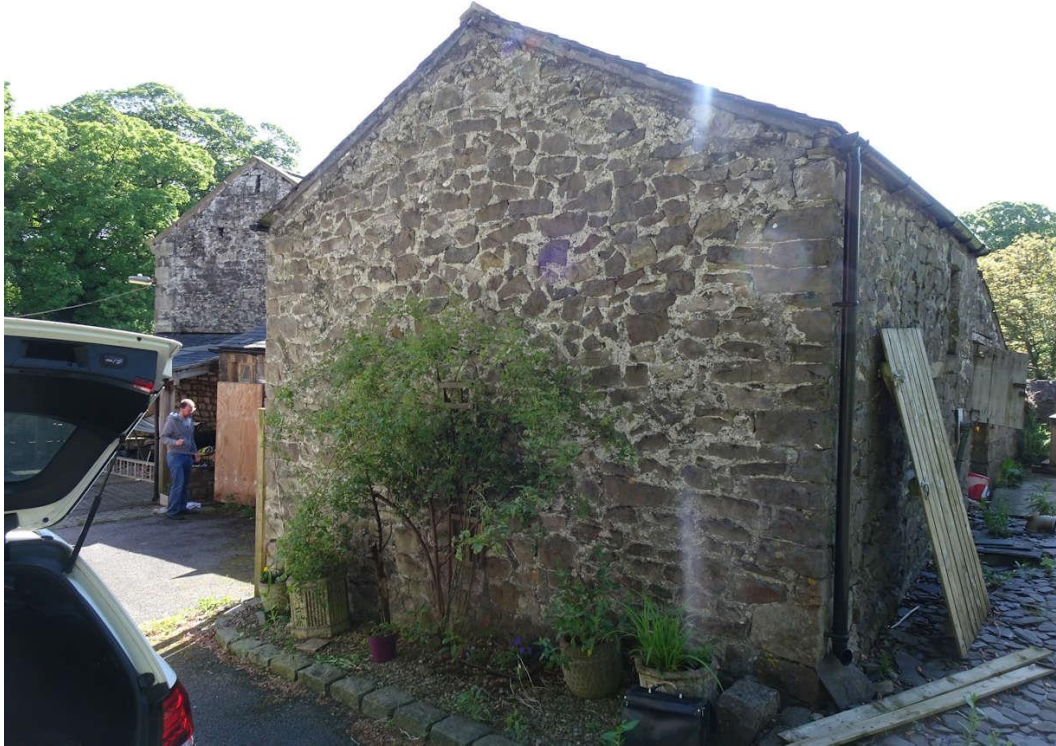
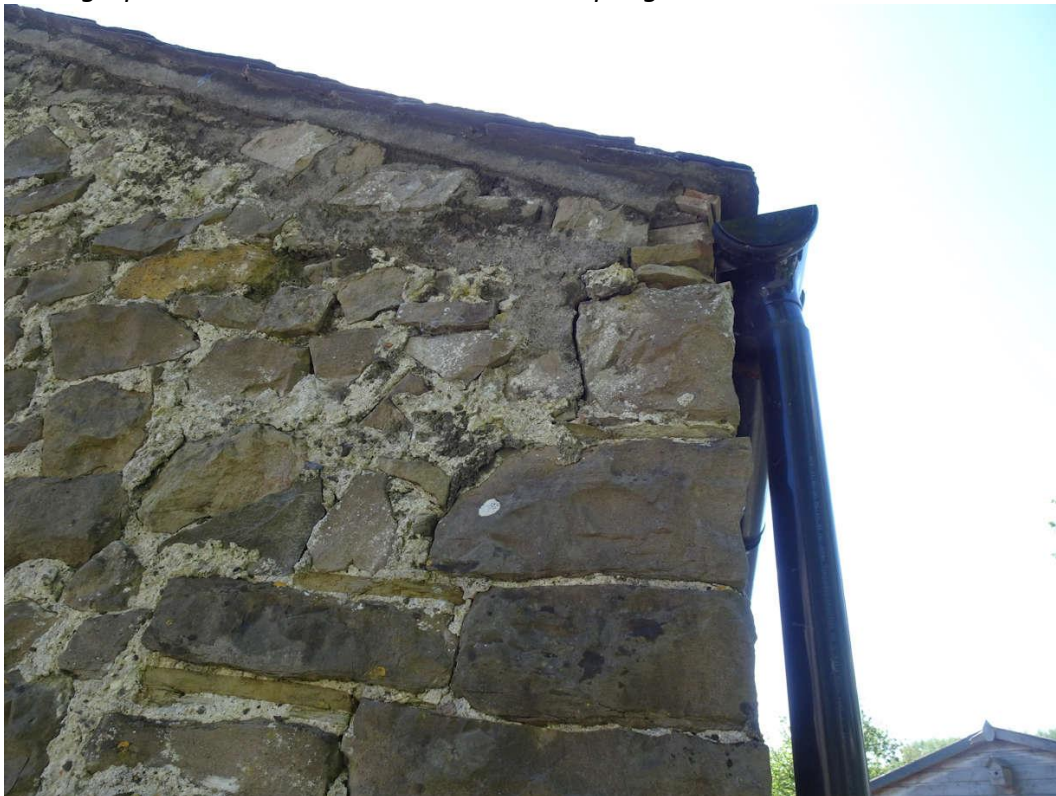
- Refer to Photographs 1 and 2
- Single storey height gable elevation; random stone with wide mortar beds; no modern repairs; wall thickness almost 500mm
- Local ground slopes down from right to left; mainly loose stone covered ground with rose bush against wall face
- No basal stone cracks
- Patch of some half square metre at top right corner with loose mortar
- Patch of stonework at bottom right corner with open mortar beds
- Three faintly cracked stones near right corner
- Faint vertical mortar cracking near right corner; corner verticality serviceable
- Several faint mortar cracks including at wall centre
- Wall profile tilts over to rear at top; +/-10/1000 distortion; inwards bulge; profile serviceable

Photograph 1: Bedroom Front Elevation

Photograph 2: Bedroom Front Elevation At Top Right

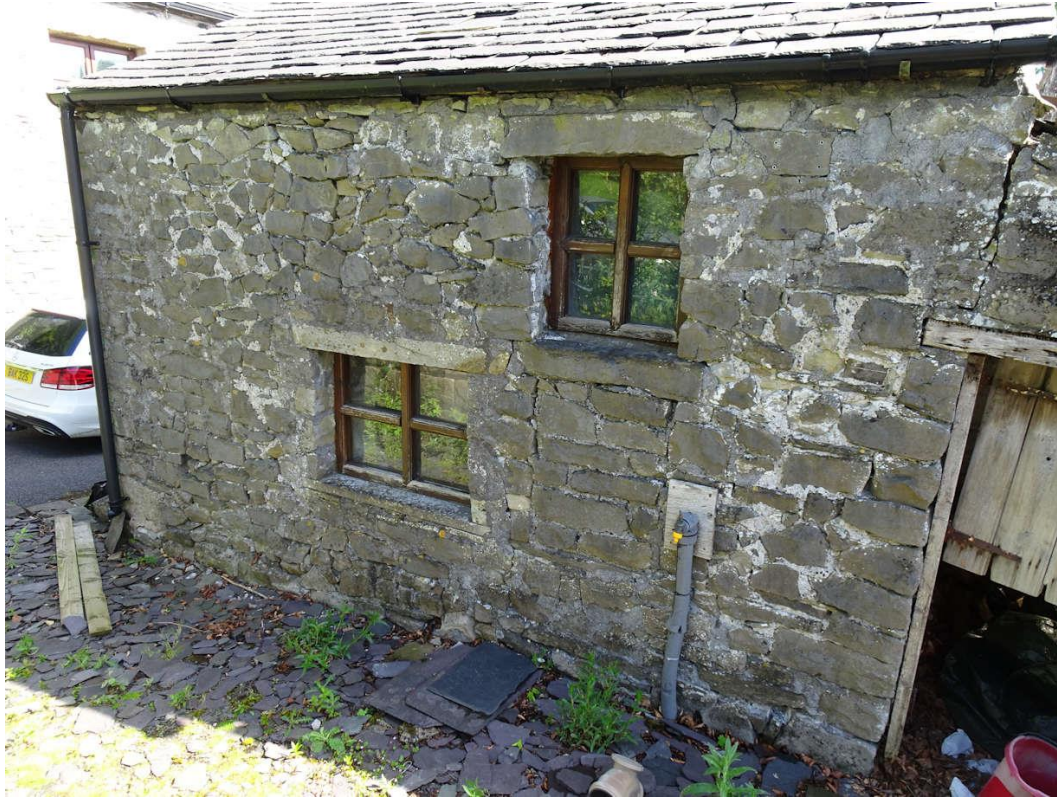
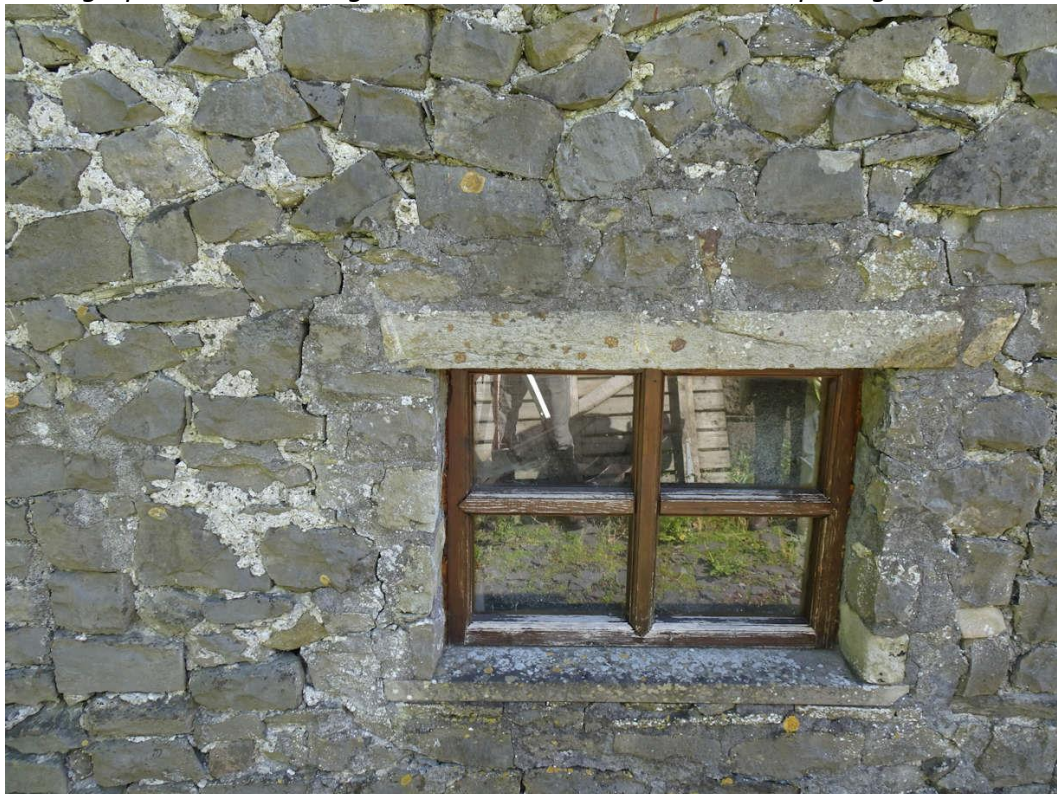
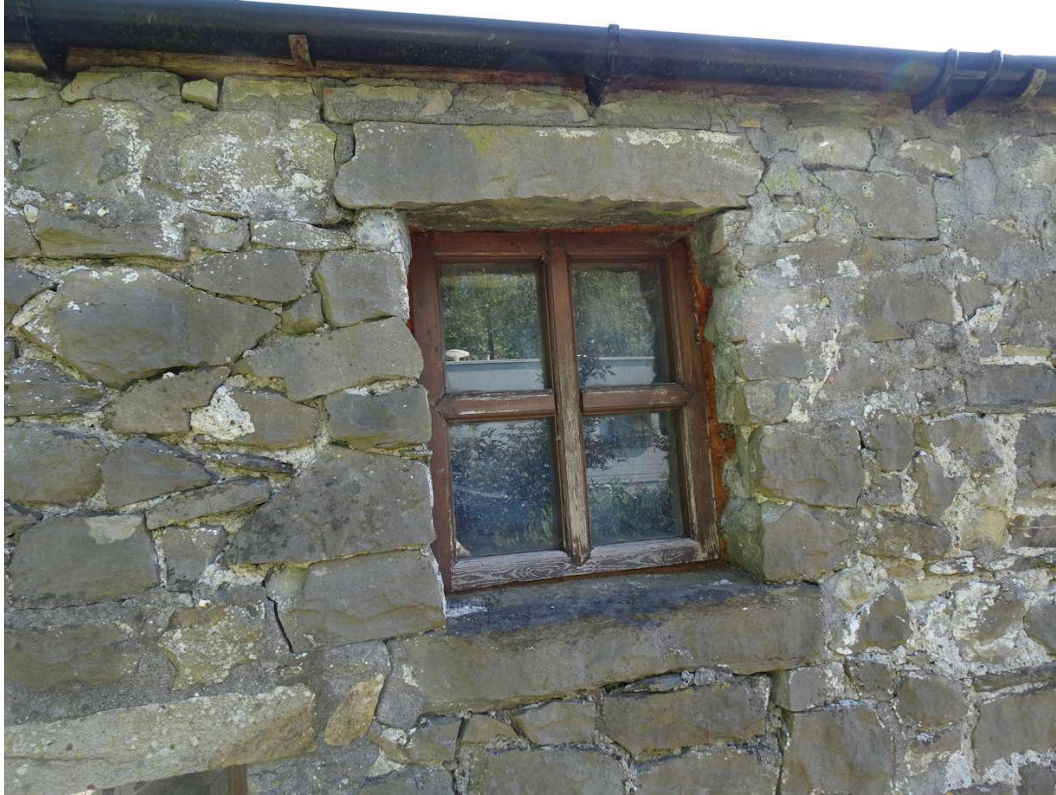
- Refer to Photographs 3 to 5
- Single storey height of some 2.6 metres, random stone, wall thickness measured 465mm; likely to be rubble filled masonry but not confirmed

- No cracking across base of wall; local outside ground some 400mm higher than inside floor level
- Local ground covered by slate chippings; plastic rainwater down pipe spills to open ground at front corner

- Open mortar beds; no signs of past/modern repairs to mortar beds
- Vertical crack forward of central window, extends above and below lintel; vertical crack to rear of central window extends to upper window sill stone level; crack widths 6-10mm; appear long standing

- Wall profile slightly bulging; tilts to right at top in region of 25-30/1000; serviceable

Photograph 3: Bedroom Right Side Elevation

Photograph 4: Bedroom Right Side Elevation Front Window Opening

Photograph 5: Bedroom Right Side Elevation Rear Window Opening

At all cracks on wall external and internal faces, of widths greater than 5mm as seen at present, scrape out the mortar, install crack stitching bars and repoint with mortar suitable for stonework. Other cracks need only be repointed with material suitable for stonework. Systems which may be used may include such as:

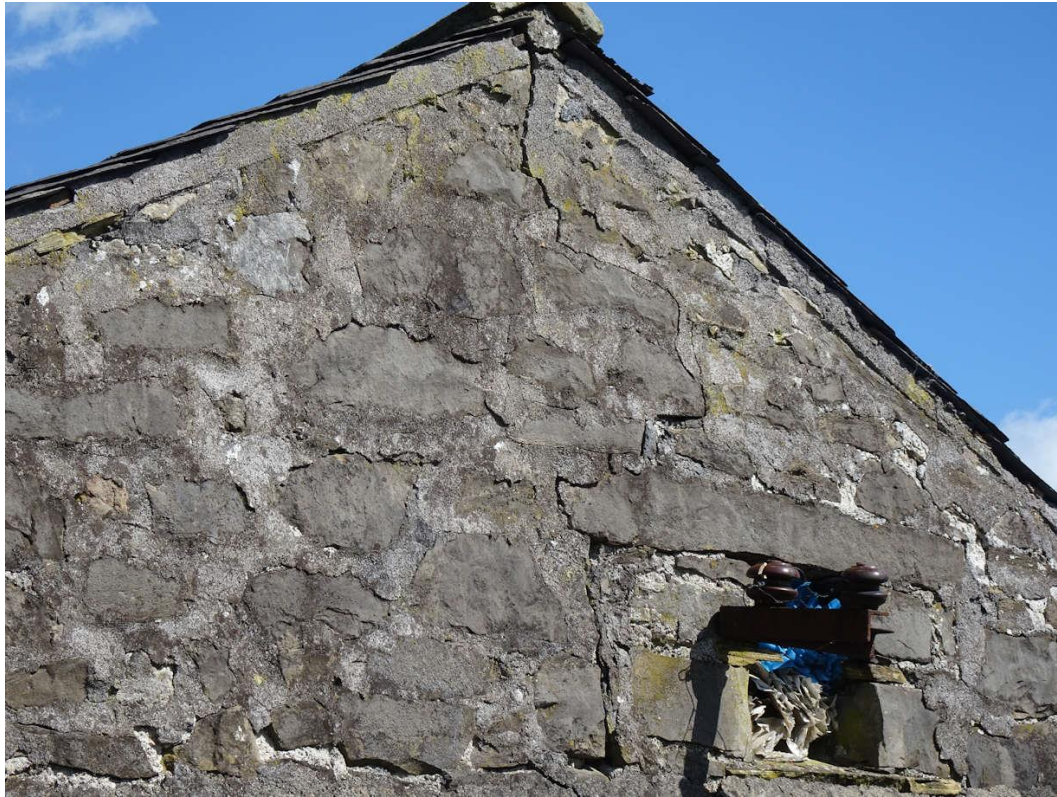
Photograph 7: Cracking In Bedroom Rear Elevation

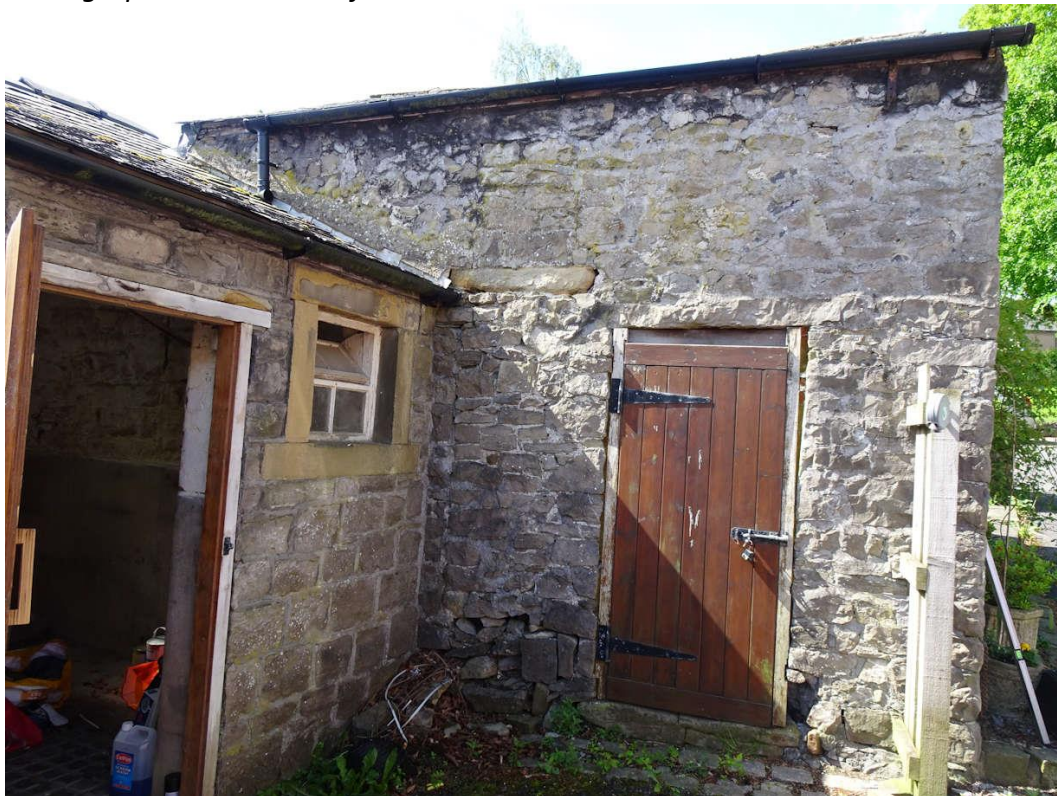
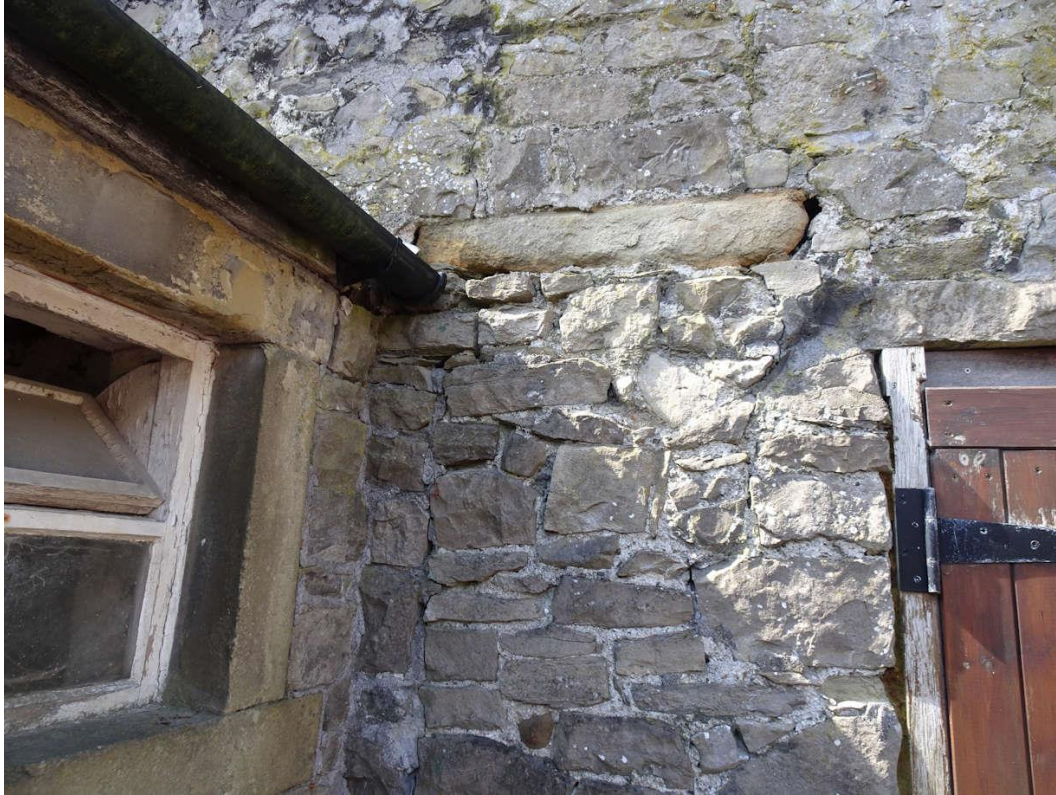
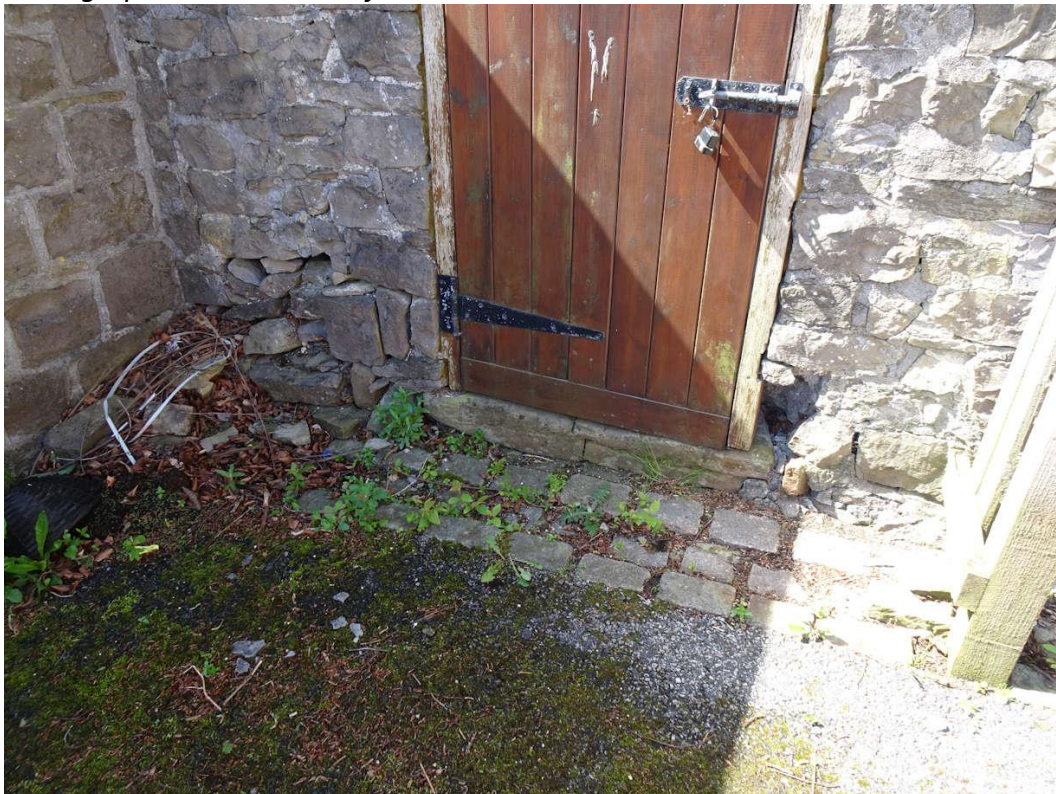
- Refer to Photographs 8 to 10
- Exposed external forward of dining room front elevation and above line of dining room roof pitched canopy
- Single storey height to some 3.3 metres; random stone with wide mortar beds; wall thickness measured at door 450mm; no apparent modern repairs

- Hard landscaped ground at base of wall
- Open patch of missing and loose stone of some half square metre at base of wall to rear of door; small open patch of missing basal stonework forward of door; early repairs required; no cracks above openings

- Door stone lintel supported by door timber frame at rear bearing; door stone lintel slopes down to rear 10/1000; hair mortar cracking above door front edge; faint gap between door frame and stonework, does not appear recent

- Stone lintel retained in wall to rear and above level of door top stone; long standing stone infill of assumed opening above; gap in mortar at front end with 3mm cracking below

- Vertical 3mm crack near corner with dining room front elevation
- Front corner tilts overs to front 10/1000; wall profile serviceable

Photograph 8: Bedroom Left Side Elevation

Photograph 9: Bedroom Left Side Elevation To Rear Of Doorway

Photograph 10: Bedroom Left Side Elevation At Ground Level

The open patches of open stonework at the base of the bedroom barn left side elevations are to be repaired/rebuilt as soon as possible.

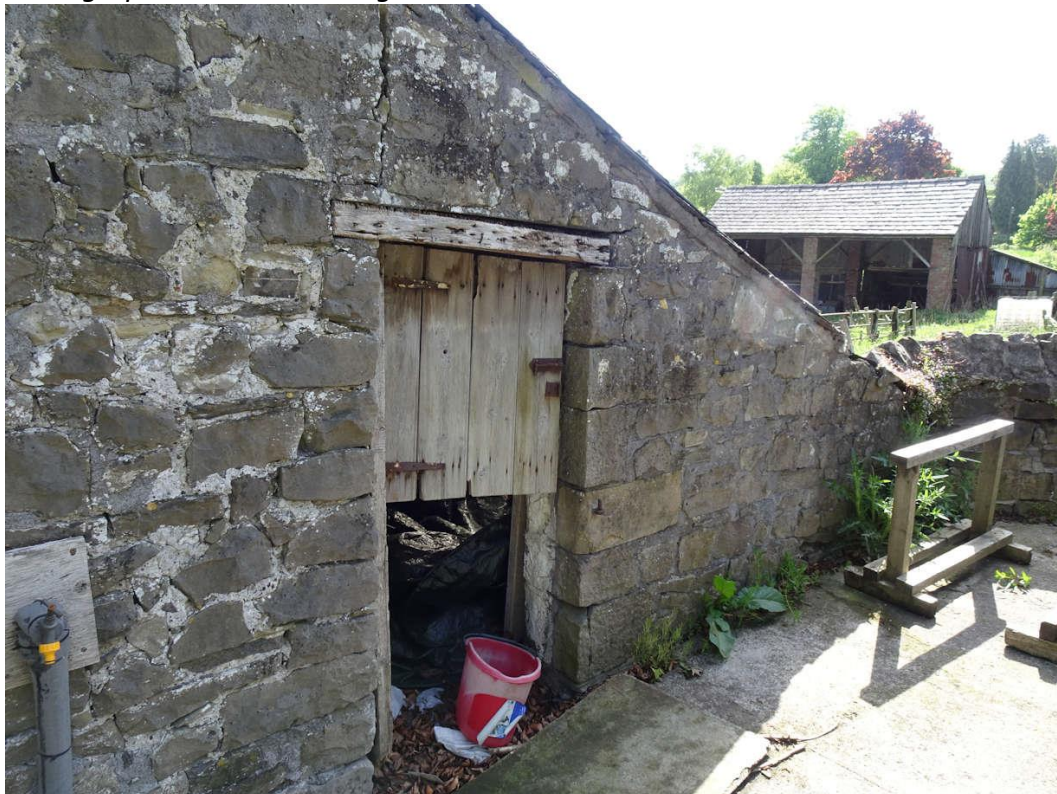
Photograph 12: Bathroom Right Side Elevation

- Refer to Photograph 12
- Taken to be long standing addition to the rear of the 'Bed 1' barn
- Low single storey height, reducing down to rear with line of pitched roof, from some 2.4m to 0.8m above local ground surface
- Random stone construction to some 320mm thickness as measured at door opening; no apparent modern extensive repairs to mortar beds

- Door opening at front end; timber lintel deteriorated, lintel slopes down to rear 75/1000
- Concrete covered ground next to base of wall; no marked surface disturbances
- Gap at front end at junction to 'bed 1' barn right side elevation stonework; width of gap increases towards top of wall to some 40mm
- Short mortar crack next to rear end of door lintel
- Wall profile at centre of wall length, tilts over to right at top 15-20/1000

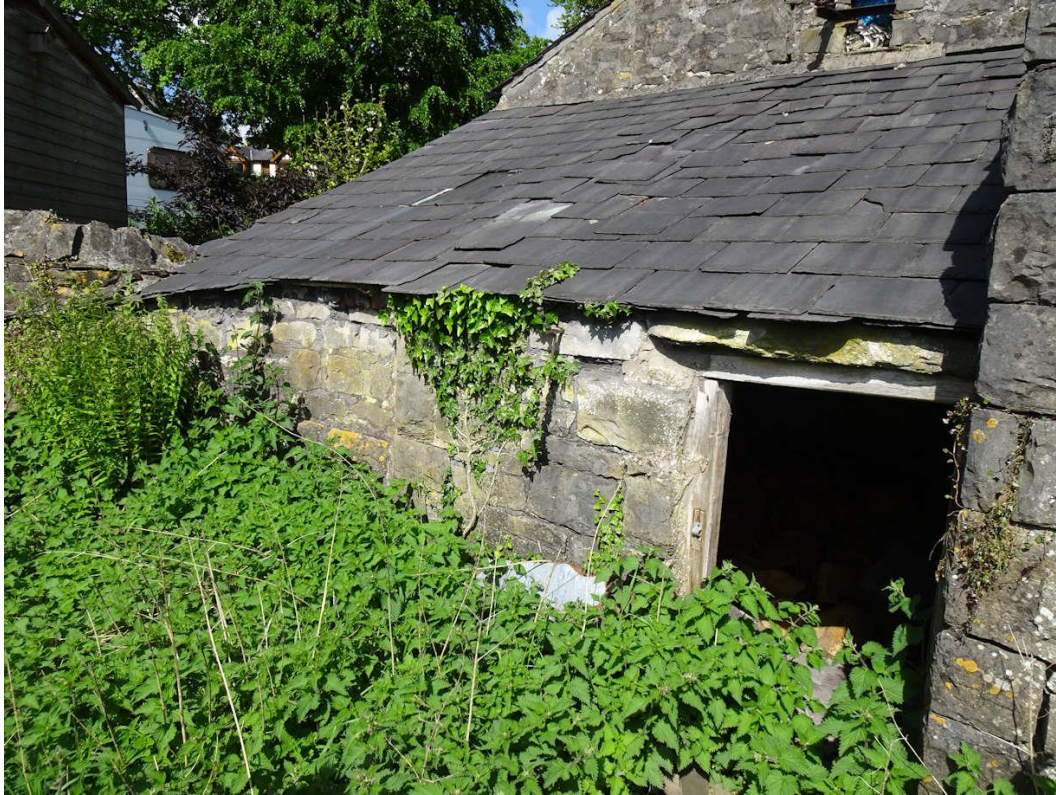
- Refer to Photograph 13
- Single storey height, regular/random stone; built in two sections of left dressing room and right bathroom; slightly different style of stonework at each section and step in face at junction
- Door at left end; stone lintel with support provided by timber frame of door unit and with crude mortar repairs at right bearing
- Base some half metre height of wall masked by dense stinging nettle growth
- Wall face distortion at junction of two apparent sections; no marked mortar openings at junction; serviceable

- Refer to Photographs 6 and 13
- Mono-pitched, slate roof, pitched down from bedroom rear gable elevation
- Profile serviceable; some loose slates
- No marked gaps across mortar flashing; short sections of loose and displaced flashing mortar

Photograph 13: Bathroom Rear Elevation & Roof Canopy

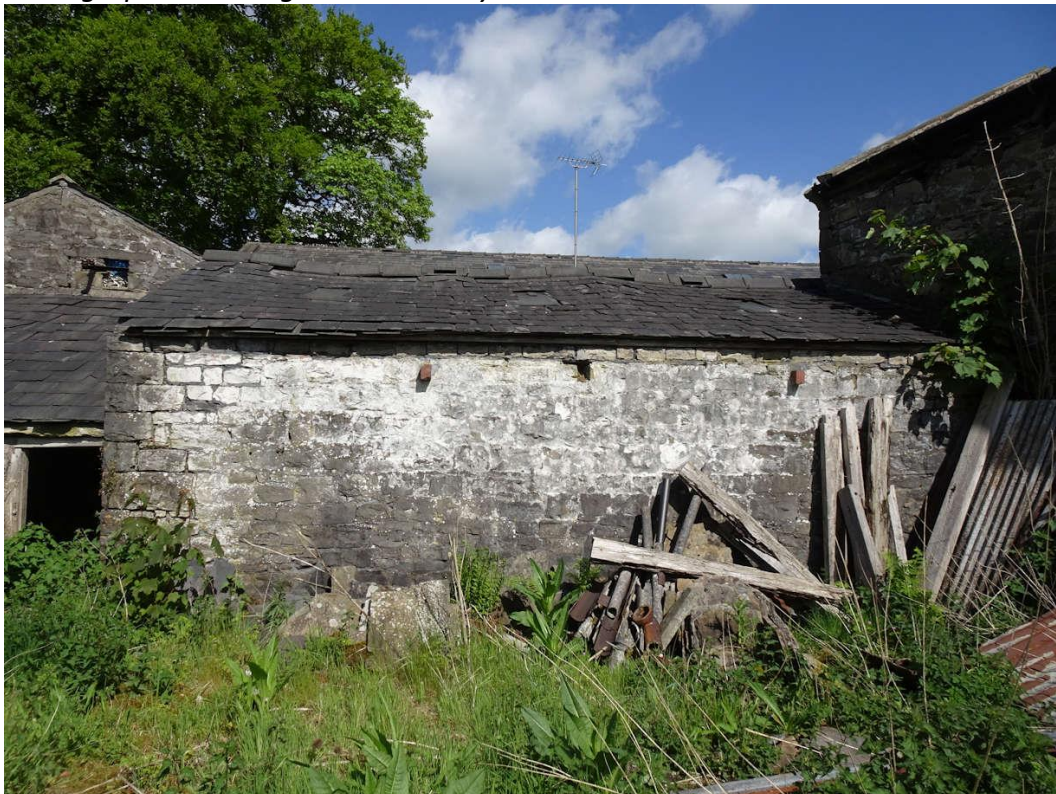
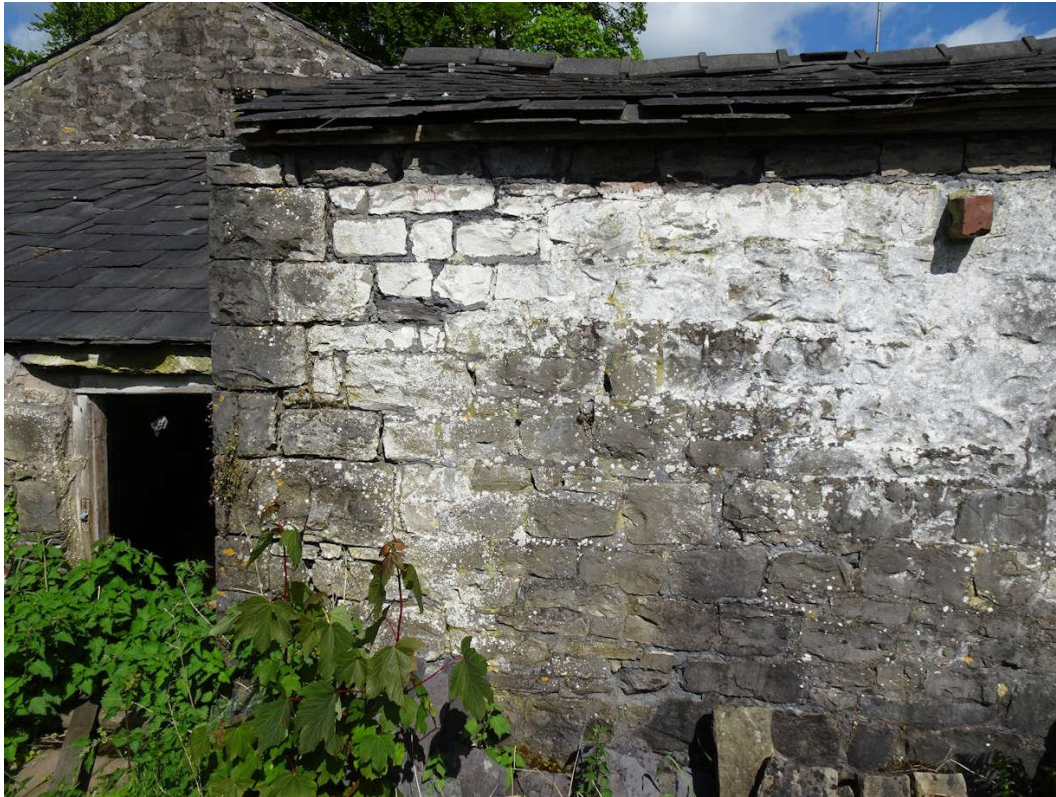
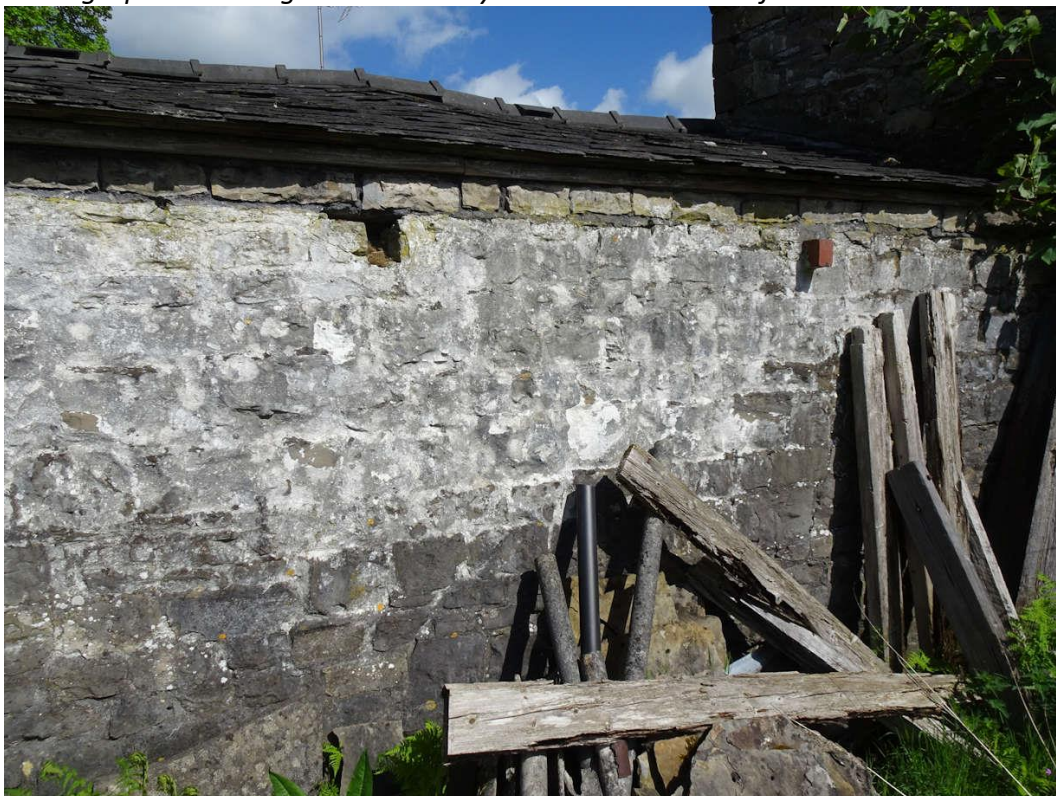
- Refer to Photographs 14 to 16
- Single storey height; regular/random stone
- Stored materials across base of wall face
- At right one metre length, including less than half metre width of corner return, open mortar beds and cracking of some 5mm width; repaired mortar beds at top of corner
- Appears that a top course of stone has been rebuilt or added; exposed timber wall plate deteriorated
- Wall profile vertical
- Left end of elevation against third party barn two storey stone wall

Photograph 14: Sitting Room & Utility Rear Elevation

Photograph 15: Sitting Room & Utility Rear Elevation At Right

Photograph 16: Sitting Room & Utility Rear Elevation At Left

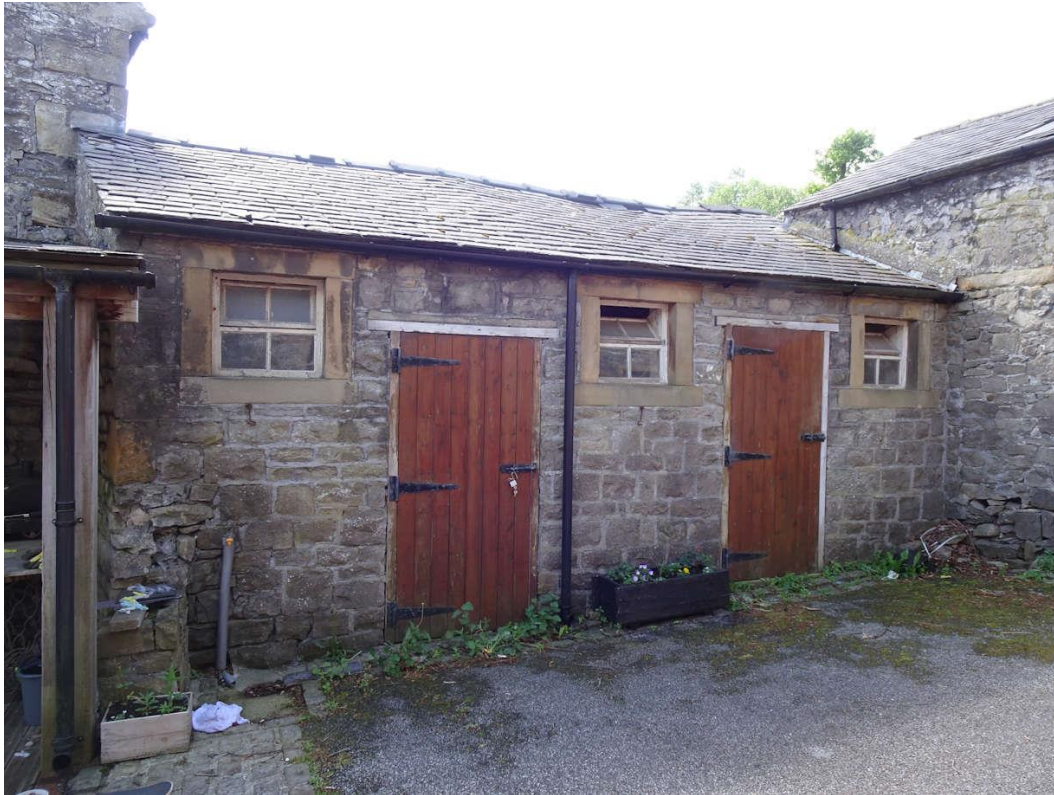
Photograph 17: Dining Room & Kitchen Front Elevation

- Refer to Photograph 17
- Single storey height; regular stone faced; appears to be later construction compared to bedroom barn building; wall thickness 350mm
- Two doors and three windows; stone frame surrounds to window openings; shallow stone and timber lintels above doors
- No cracks across base of wall; hard landscaped ground next to wall, channel for rainwater blocked by debris, central rainwater down pipe; gully at left end; slight ground slope down to left
- Left and centre window sill stones level and right stone slopes down to right
- At right window 4mm gap at stone edge
- Lost mortar at stonework at base of left corner over some one metre height
- Multiple hair mortar cracks
- Exposed timber wall plate; timber deteriorated
- Wall face profile at left and centre vertical and tilts over to front at top 10/1000 at right end of wall; serviceable

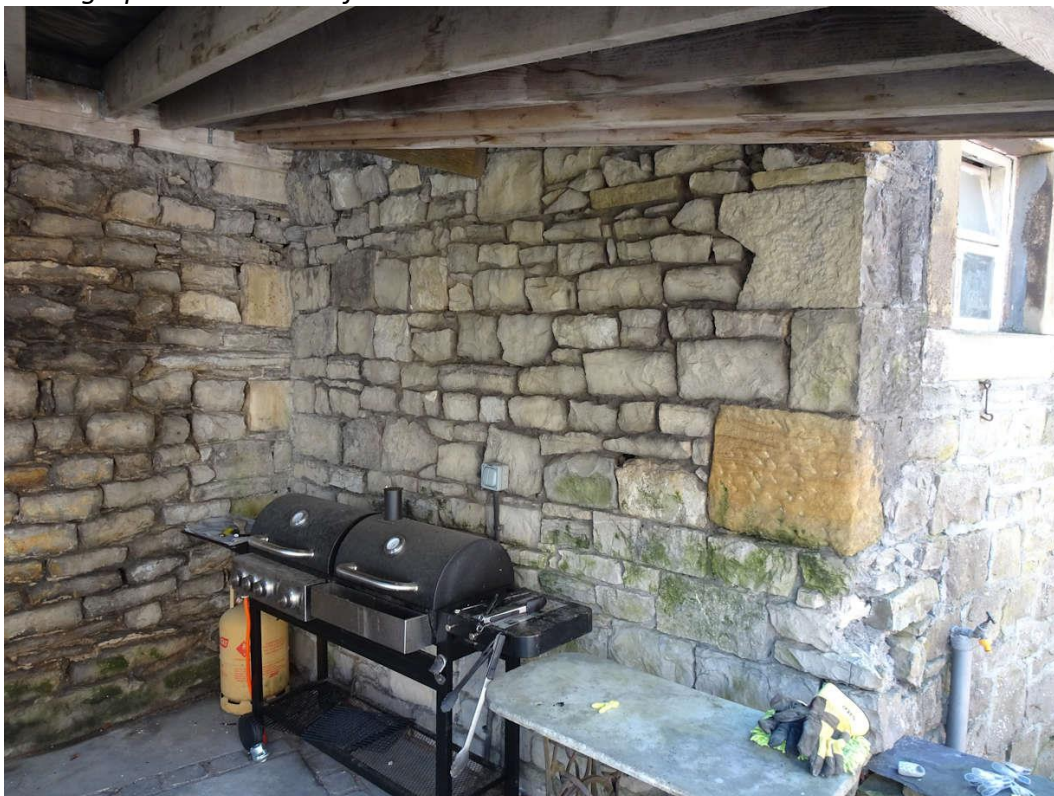
Photograph 18: Kitchen Left Side Elevation

- Refer to Photograph 18
- Single storey height to line of front slope of pitched roof; exposed externally forward of side elevation of third party two storey barn of similar type stone faced
- Stone, different types; wide mortar beds; possible modern repointing
- Adjacent ground mix of hard landscaped and covered by timber decking
- No basal cracks
- No openings down rear corner
- Open mortar beds
- Wall profile tilts over to right at top 15-20/1000; slightly distorted
- Front corner vertical
- Wall profile serviceable

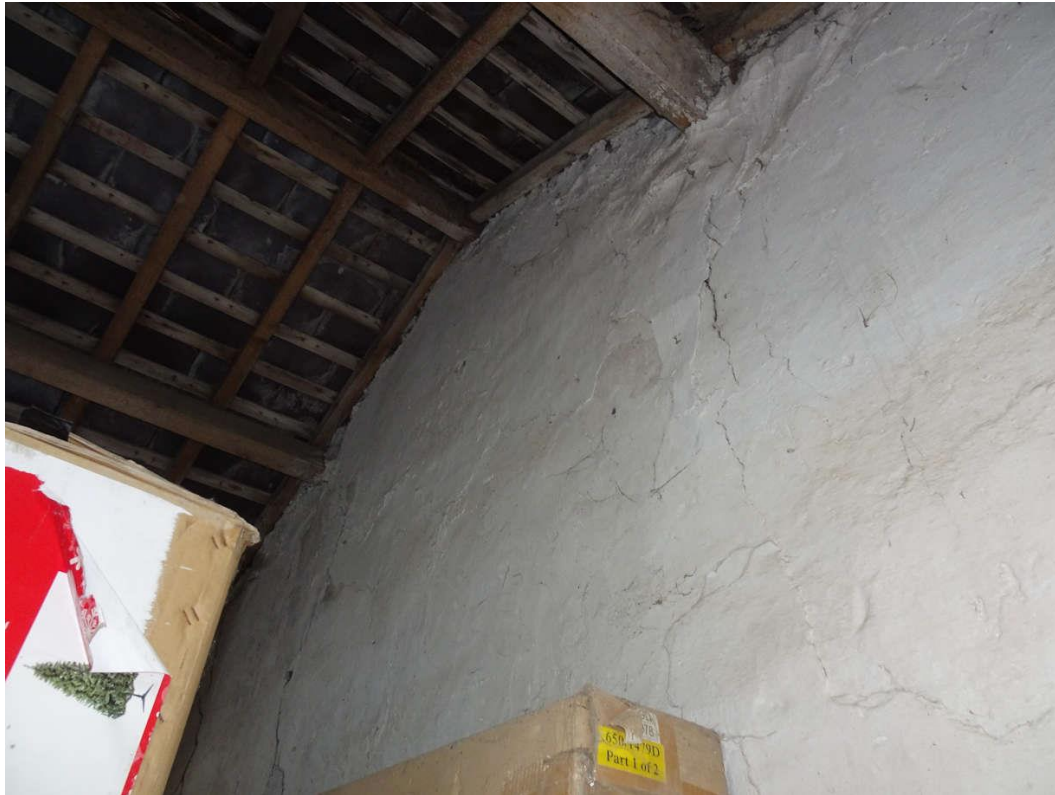
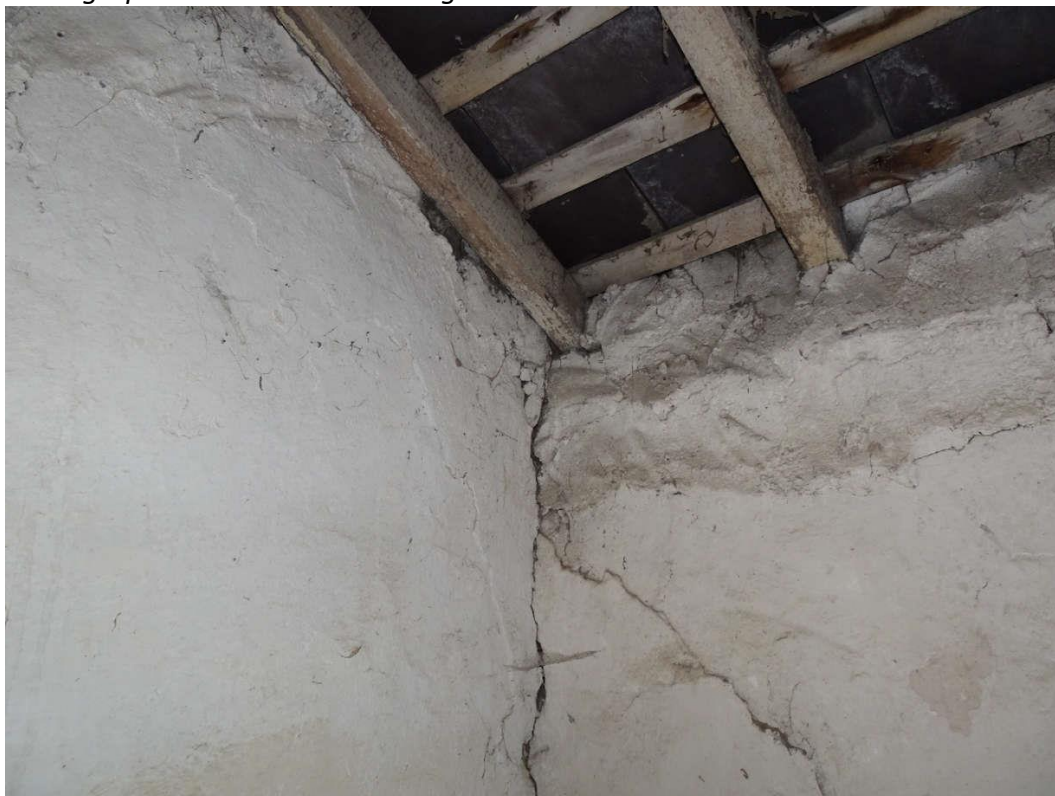
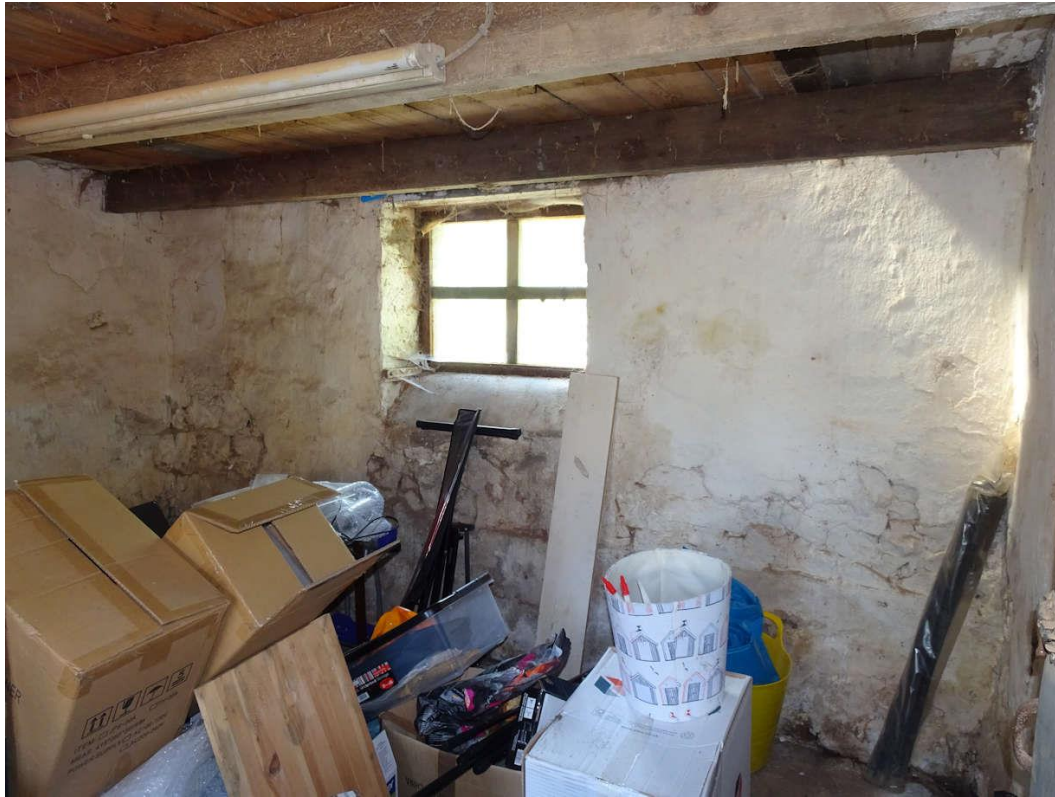
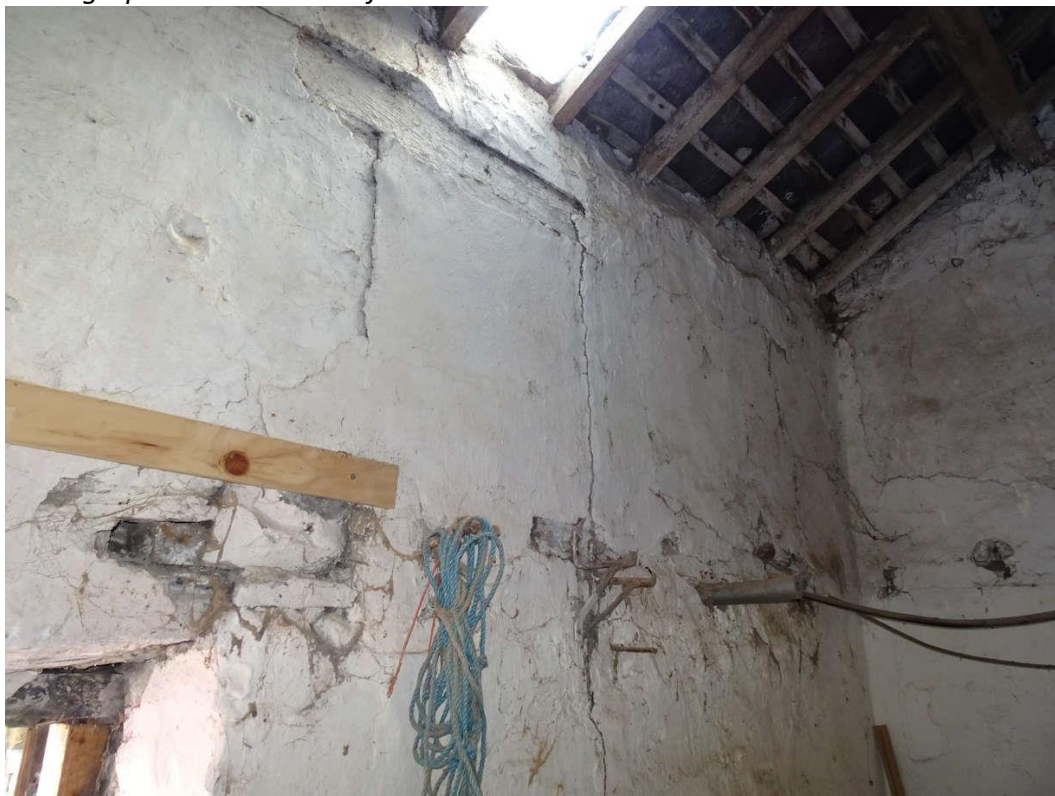
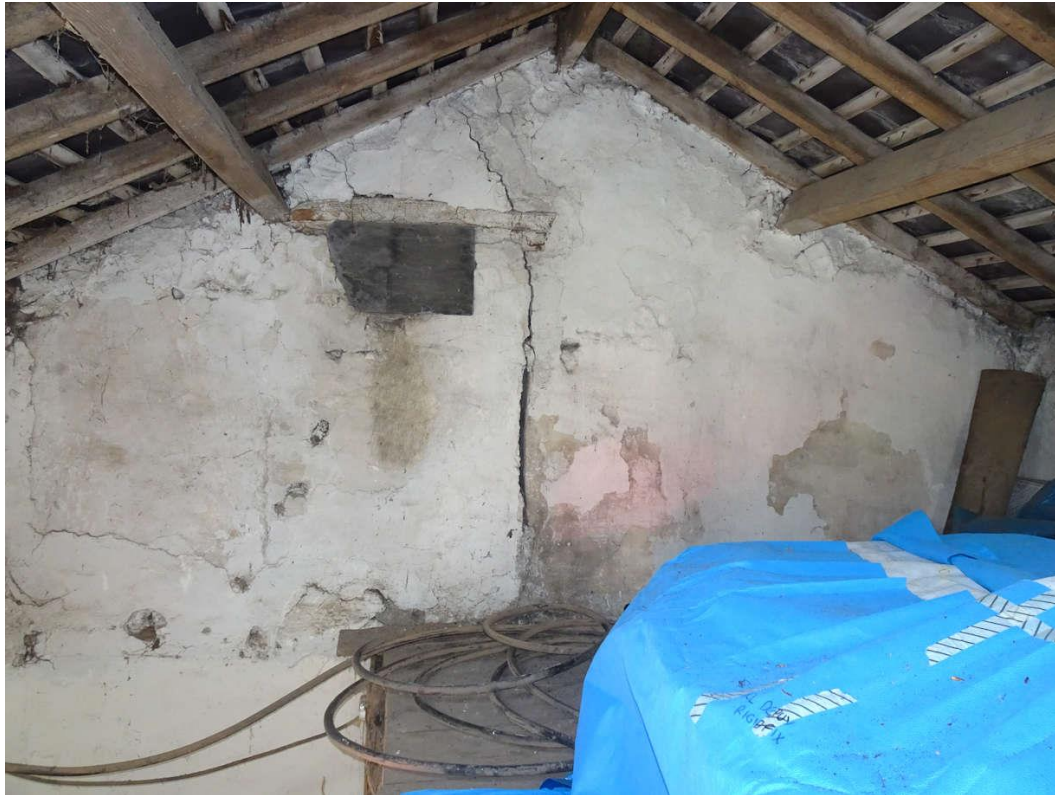
- Refer to Photographs 23 to 27
- Door stone step cracked
- Extensive stored goods
- Solid floor, old concrete surface, stepped up slightly beyond some one and half metres from left edge of room; on visible areas no marked floor cracks noted

- Wall faces mainly thinly rendered and white painted; appears long standing
- Front gable, multiple faint vertical cracks; profile distorted inwards at centre 25/1000 and vertical at left; wider cracking at apex right edge, below right of centre and below left purlin; opening in left corner; below right purlin crack some 10mm width; vertical crack near right corner

- Right elevation with window; not painted above level of mezzanine timber floor; badly disintegrated sandstone lintel above window; several vertical cracks to rear and above window, 5-10mm widths; below mezzanine floor, forward of window, wall profile tilts over to right at top 10/1000; some fallen patches of thin render

- Rear gable elevation (partition wall with proposed D dressing room); central stepped out panel; no door opening; central vertical crack extends over full height of wall, widest at top, width estimated at some 30mm, appears long standing; at mid-wall height cracking tracks to left as faint cracking and continues down to stored goods covered wall area

- Left elevation wall and at rear end wall forming partition with dining room; central full height vertical crack up to 8mm width; profile uneven but verticality serviceable

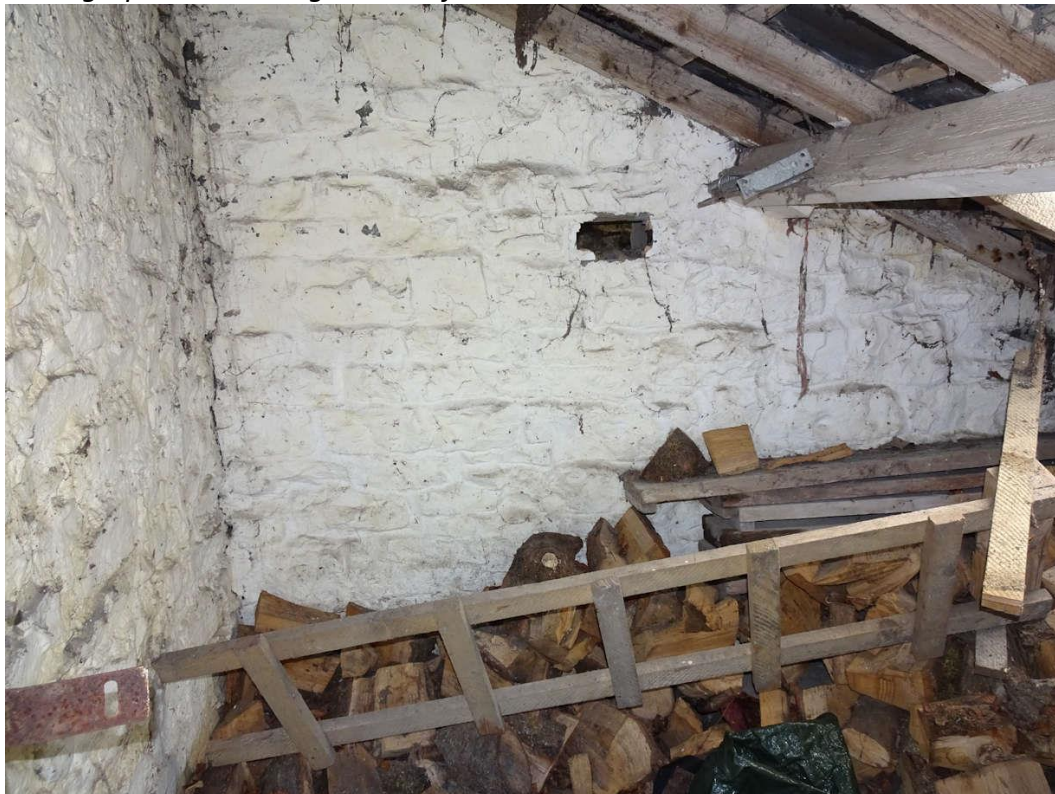
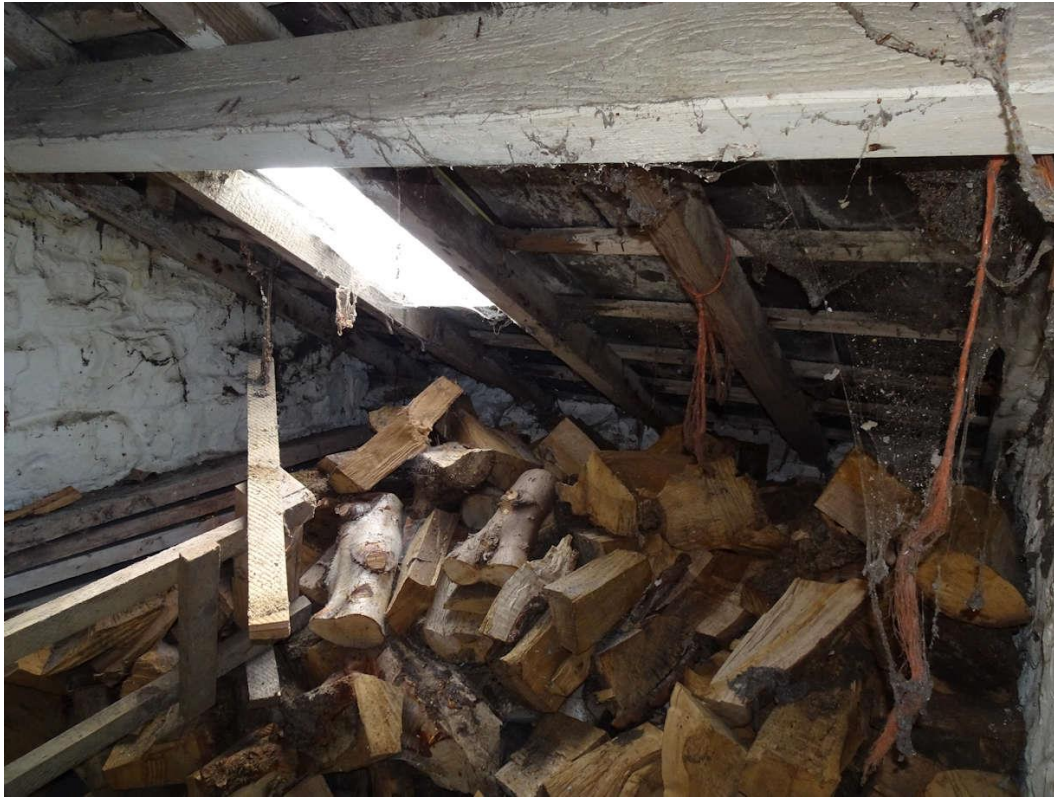
- Refer to Photographs 28 and 29
- Currently used as wood store; tall pile of stored logs; apparent hard packed ground at floor; white painted walls
- Front partition wall formed from bedroom barn rear gable; no door opening; wall profile tilts over to rear at top 20/1000; no cracks; profile serviceable

- Right elevation wall with door; partly covered by stored logs; wall thickness measured at door 350mm; white painted surface; profile tilts over to right at top 20/1000; cracking at rear end, including diagonal crack down to front to base; filled and further faint openings in front corner; cracking above and below door lintel

- Rear elevation wall, extensively covered by stored logs
- Left wall, regular stone; (to divide off bathroom); gap in front corner; vertical cracks 8mm and 2mm widths; profile vertical

- Open to roof canopy; timber purlin at front and centre; five timber rafters at spacing 400mm; timber battens; timber deterioration; loose slates, no felt or torching
