Structural Report Concerning:
Outbuildings
Crow Trees Barn
Crow Trees Brow
Chatburn, Clitheroe
BB7 4AA

Our Ref: 2122173 / Crow Trees Barn, Clitheroe (Baker)

Report of Structural Inspection Concerning

Outbuildings (as per LMP Architects Provisional 05/05/22 Plan Sheet 22/018/E01)
Crow Trees Barn
Crow Trees Brow
Chatburn, Clitheroe
BB7 4AA

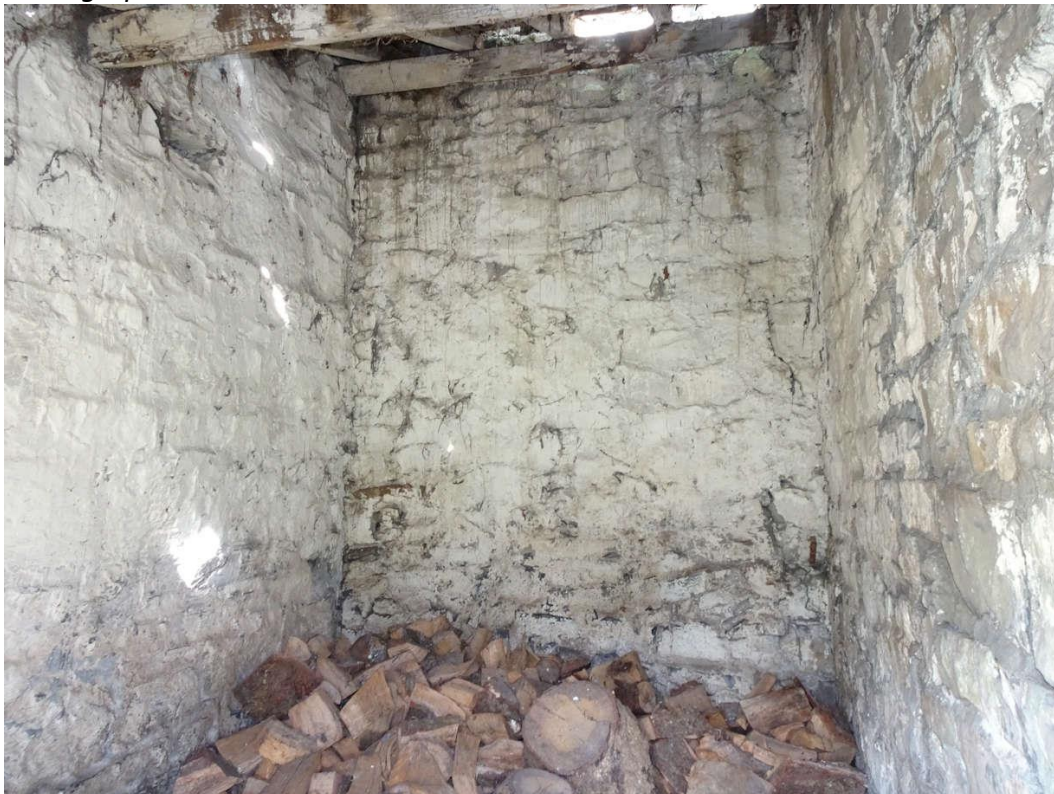
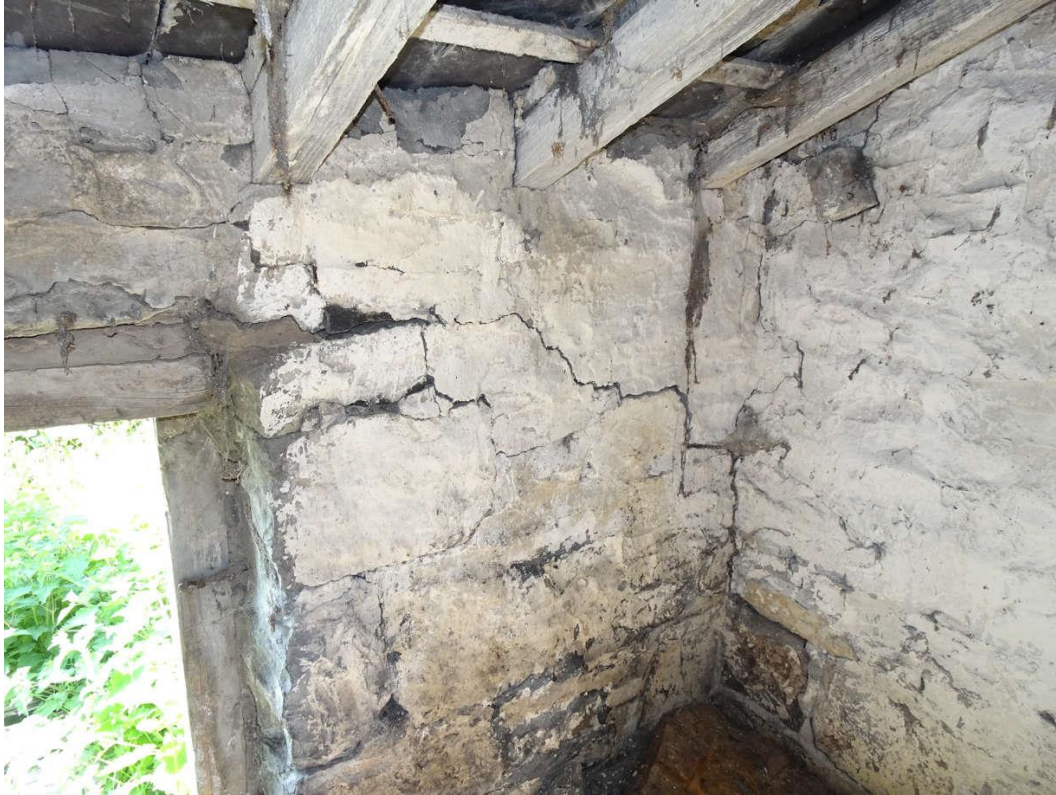
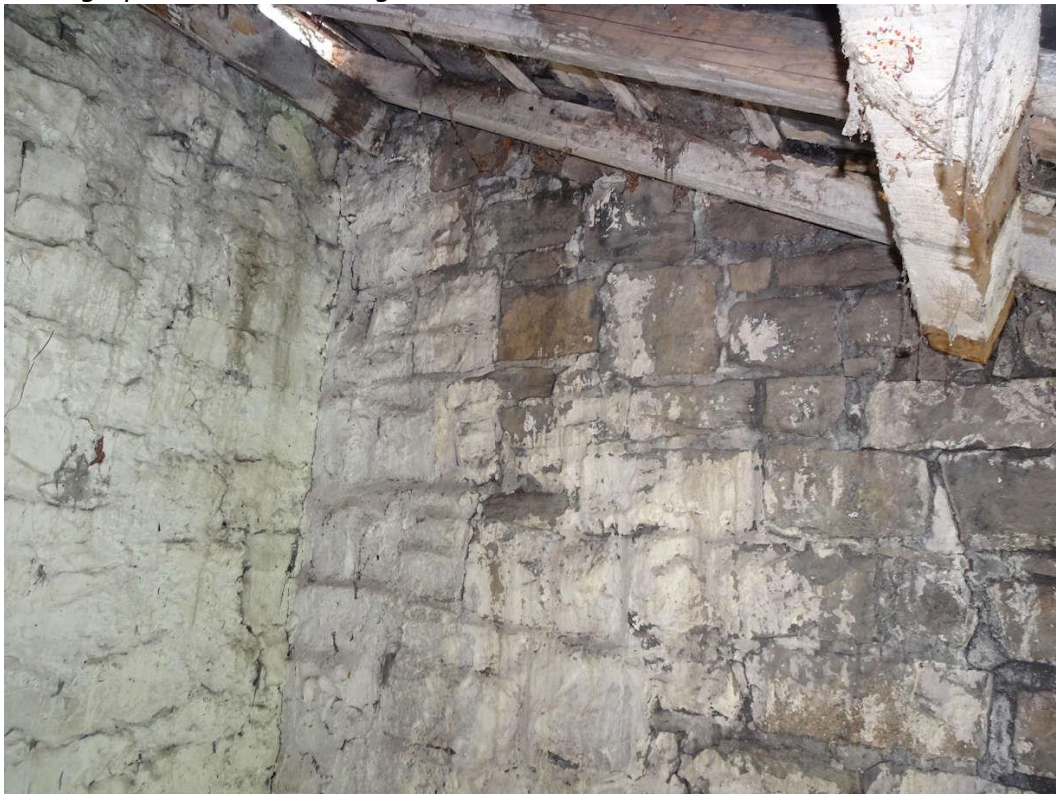
- Refer to Photographs 30 to 32
- Access off third party land to rear of outbuildings; old stored logs in room
- Appears to be hard packed ground for floor; no marked surface disturbances
- Wall faces white painted, appears long standing
- Rear wall with door; wall thickness at door measured 340mm; short crack at base of wall to right of door; lintel at wall inner face not effective as has no bearing white painted; tilts over to rear at top 15/1000; diagonal crack across full width of wall to right of door, width 8mm, joins to right wall cracking
- Left wall, partition wall with sitting/dining room and taken to be original elevation of this block; vertical crack near front end and at rear end below purlin; cracking of width 8mm, centre crack 2mm
- Right wall separates off dressing room
- Open to roof canopy; purlins and rafters as in (D); exposed slates

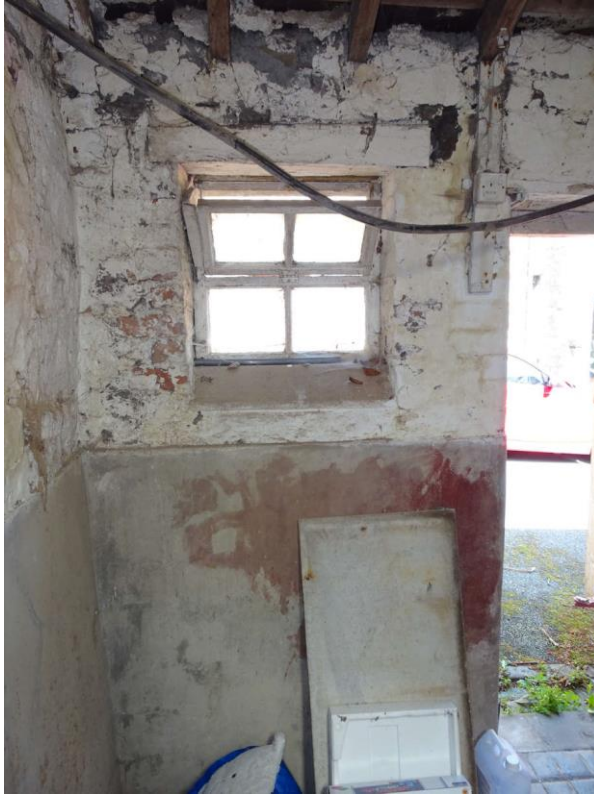
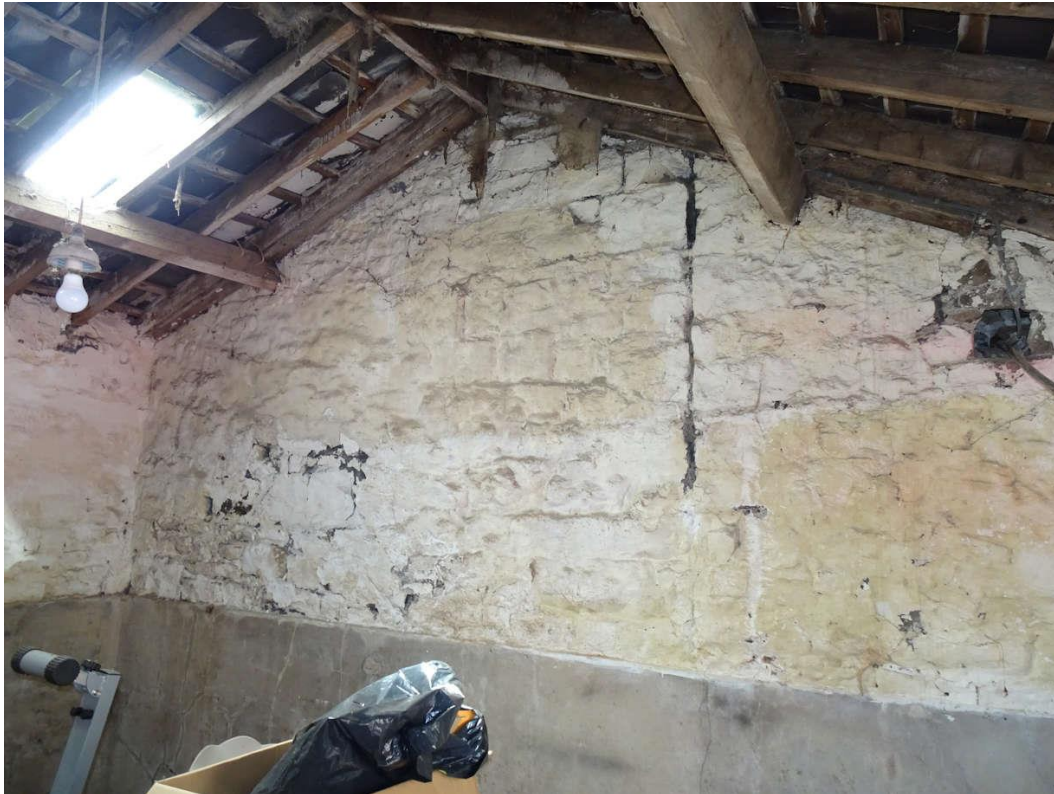
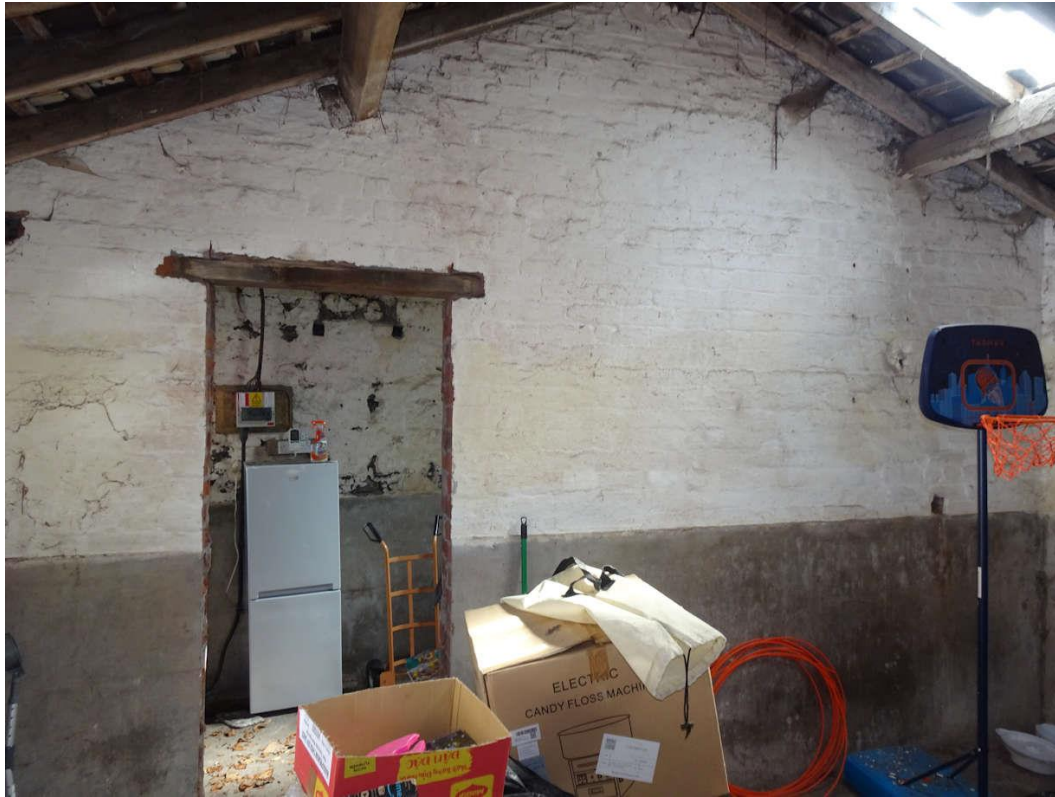
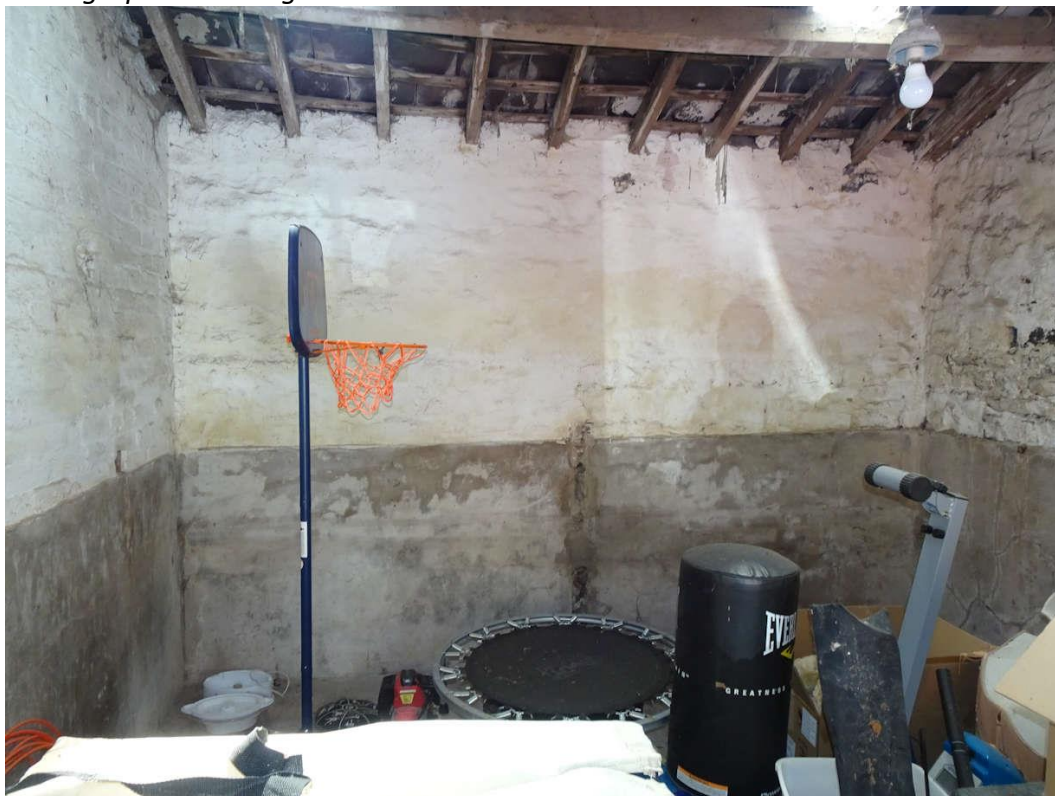
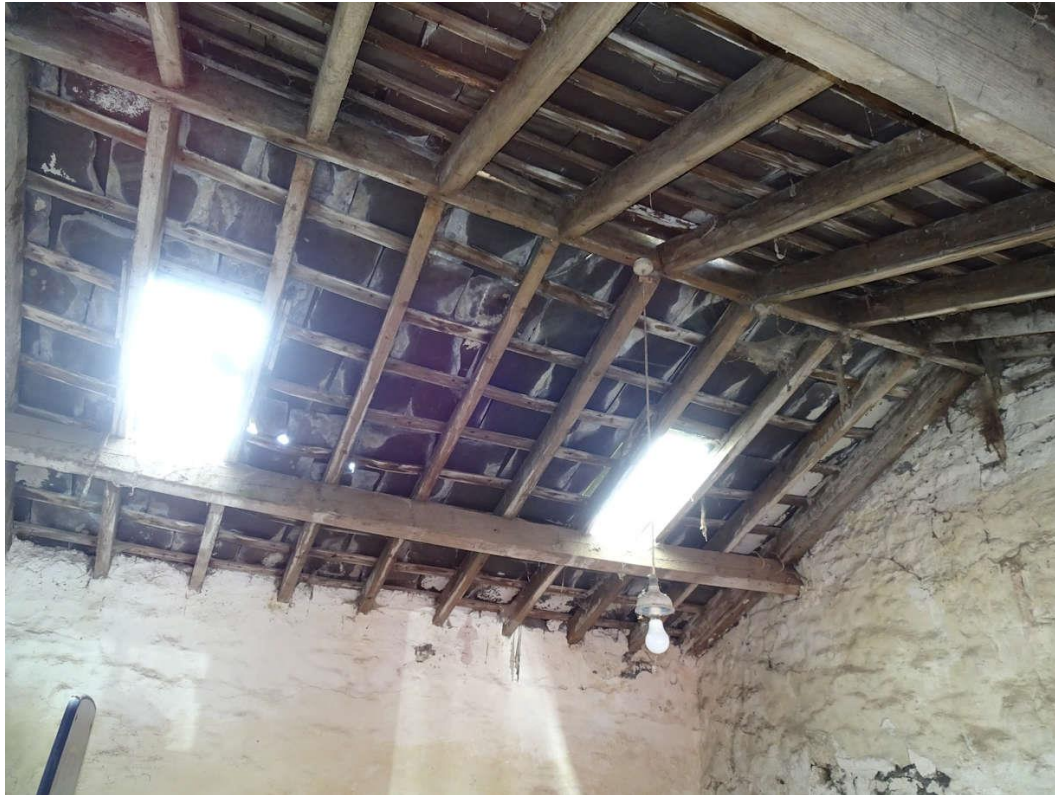
- Refer to Photographs 33 to 37
- Extensive stored goods
- Sett covered and stepped concrete floor surfaces; no visible surface cracks
- Wall surfaces cement rendered over basal height of some one metre and white painted above
- Front elevation with central door and two windows; timber lintels deteriorated; rendered base face tilts out at top 3-4/1000; wall profile serviceable

- Right wall; at line of bedroom rear elevation gap in stonework with hair cracking in basal render; render wall face tilts over to right at top 15/1000; gap appears long standing; multiple hair cracks
- Rear elevation; profile vertical at top and base tilts over to rear 20/1000; hair horizontal cracking positioned some 400mm down from top of wall
- Left partition wall; single solid common brick (nine inch) construction with door opening near front end; brick courses level; no cracks; no openings in corners; profile serviceable
- Roof with one timber purlin on each slope, appear undersized for long span, bowed and distorted; ridge sagging; long rafters, some distorted
