ADDENDUM TO ENVIROTECH REPORT DATED
MAY 21 AND CHADKIRK CONSULTING POND
REPAIR WORK & MAINTENANCE REPORT

KIRK MILL POND OFF MALT KILN BROW,
CHIPPING

Oct 2022, rev A

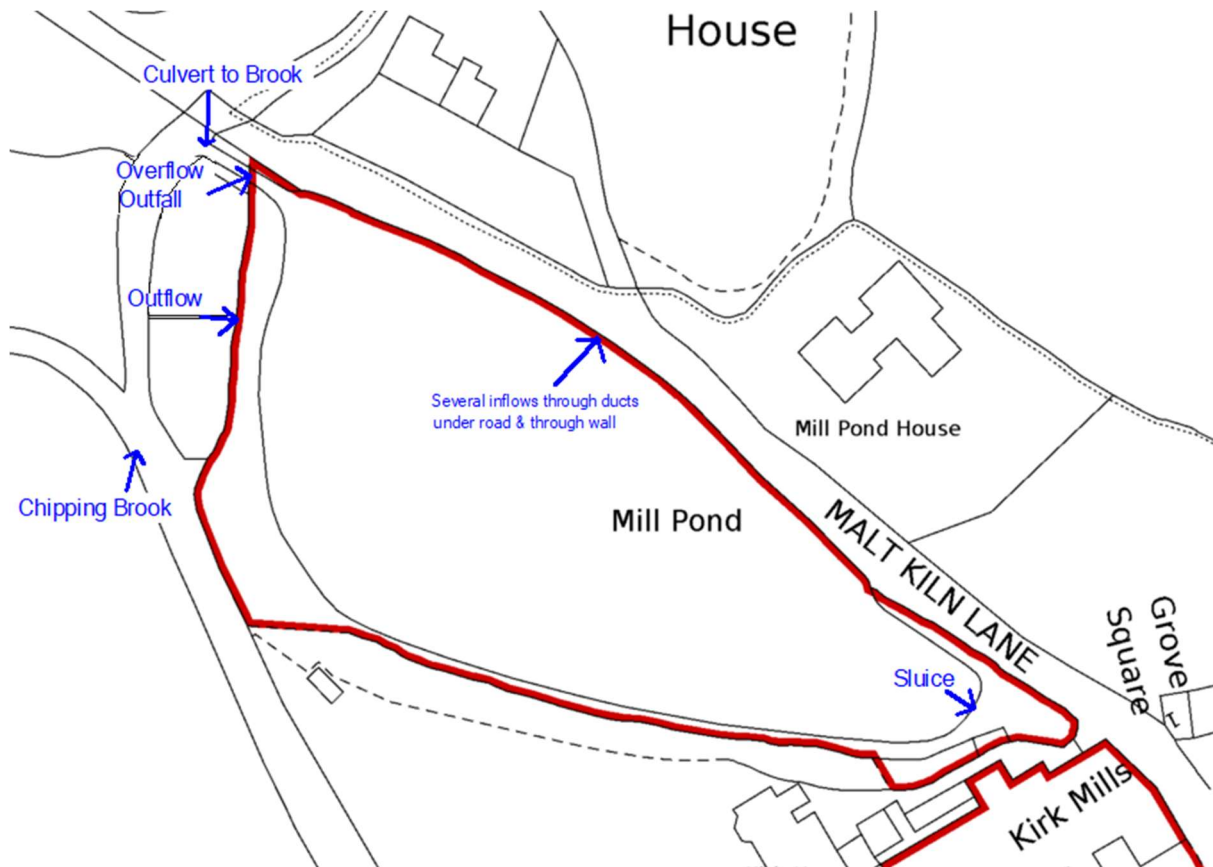
The following denoted emergency work has already been carried out as identified in Chadkirk Consulting Report. Following completion of the emergency repair work, flooding of adjacent areas has been prevented and the pond levels are relatively self-maintaining at present. The outlet for the pond has been rebuilt, providing a mechanism for maintenance and greater control of the water levels. Details as shown below:

- Retaining wall:- Mortar repair works were carried out
- Outfall:- Brickwork rebuilt & grate added
- Overflow outfall:- grate added
