## **STRUCTURAL REPORT**

**PEWTER HOUSE FARM,  
CARR LANE, BALDERSTONE,  
RIBBLE VALLEY BB2 7LN**

**CLIENT:** Pewter House Developments Ltd  
**PROJECT TITLE:** Pewter House Farm, Carr Lane, Balderstone  
**REPORT TITLE:** Structural Survey Report (Class Q Application)  
**PROJECT REFERENCE:** 22111

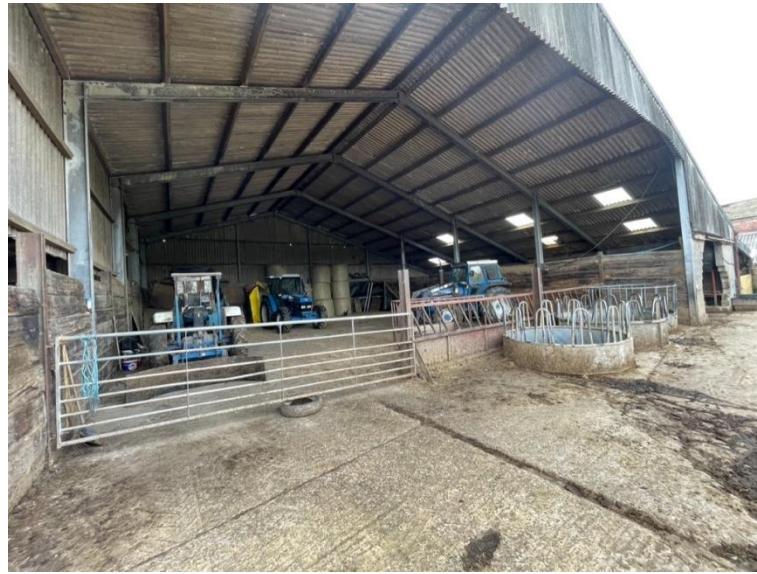
The barns consist of three duo-pitched steel portal frame structures which adjoin each other and are partially sheeted. Each structure consists of four bays (see photograph 1).

**1. Portal frames – concrete hardstanding, timber purlins, 4 bays**

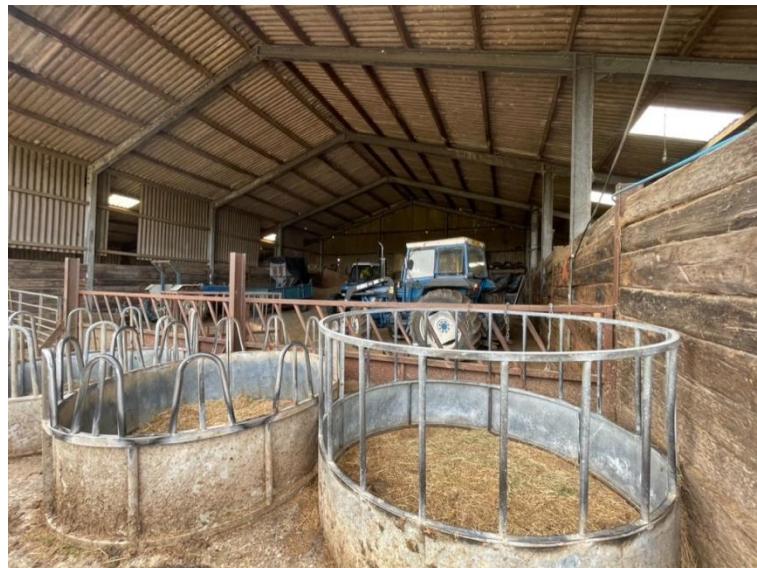
**2. Portal frame – mid structure, timber infill between columns**

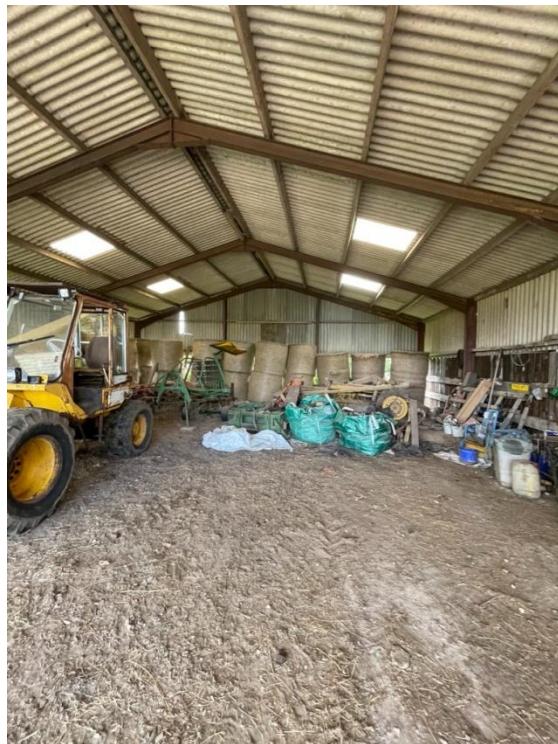
Foundations are unknown and at ground level the covering is mainly concrete hardstanding (depth and make-up unknown) and raised plinths with some areas unfinished (see photograph 3).

**3. Portal frame – unfinished ground**

Foundations will need to be investigated and, depending on the final form, some improvement works may need to be considered.

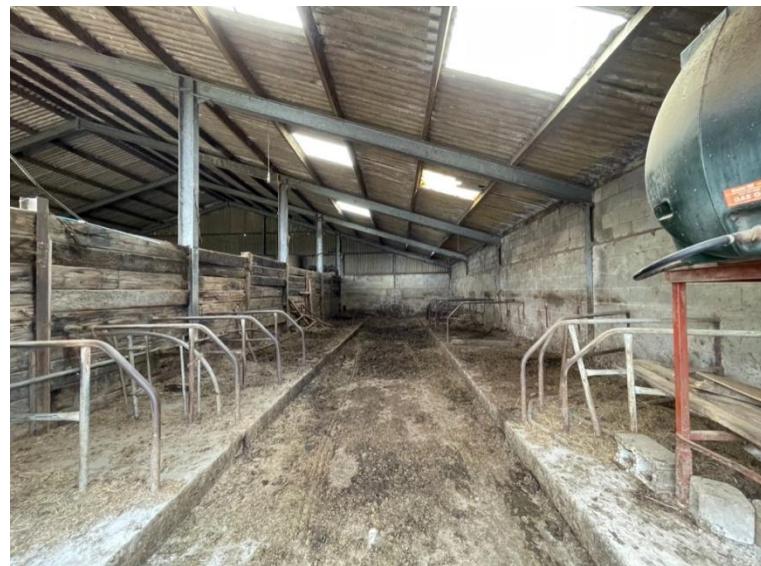
There is some blockwork and some timber infill between columns at lower level (see photograph 4) and in the absence of vertical bracing, it is considered that this is providing some longitudinal stability.

The structure currently relies on infill panels, sheeting and connections for stability. It is considered that the proposed conversion work will have a positive effect and enhance stability further.

**4. Infill between columns longitudinally – timber sleepers and blockwork**
