## Structural Inspection Report

### Crow Trees Farm, Chatburn, Clitheroe

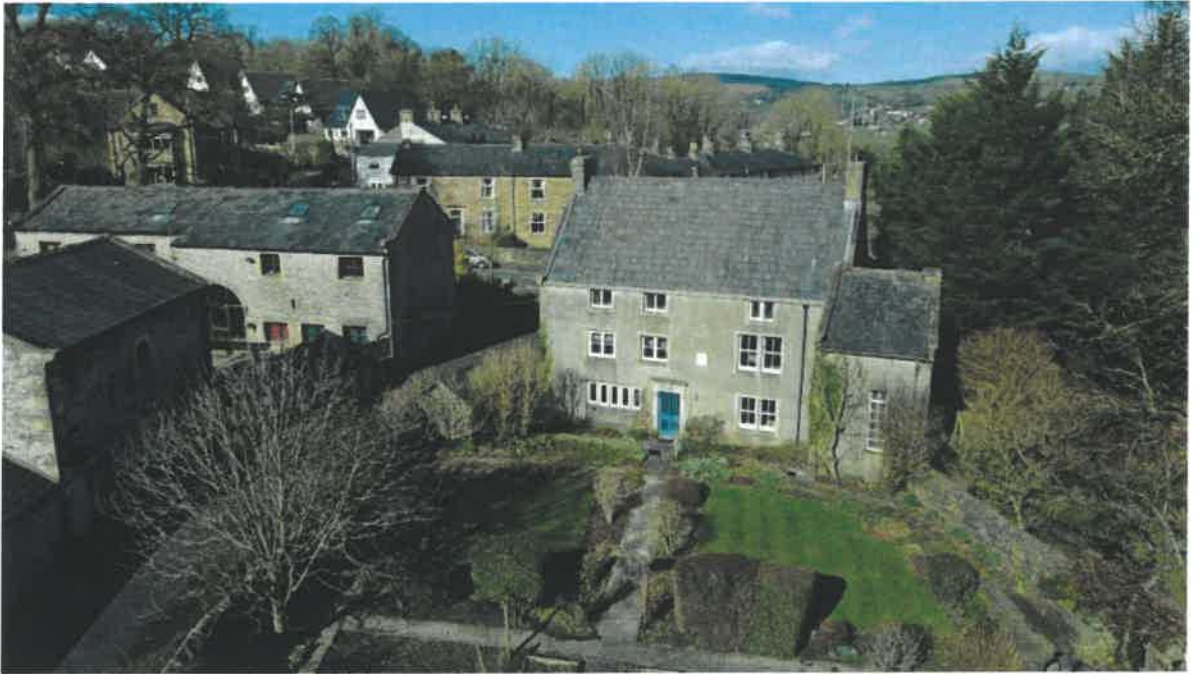
*Figure 6.1.1: Ariel view of the farmhouse (south & rear), cheese room, coal house, with main barn and workshop to the west*

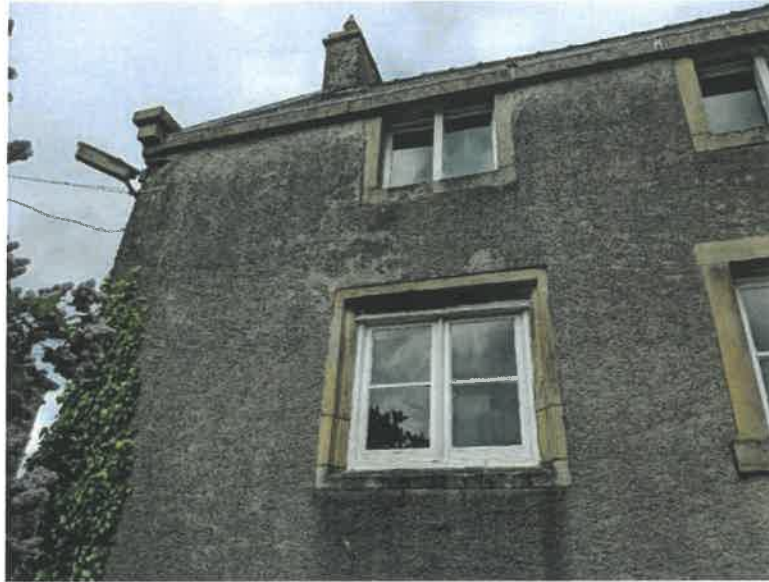
*Figure 7.1.2: Render cracking between windows*

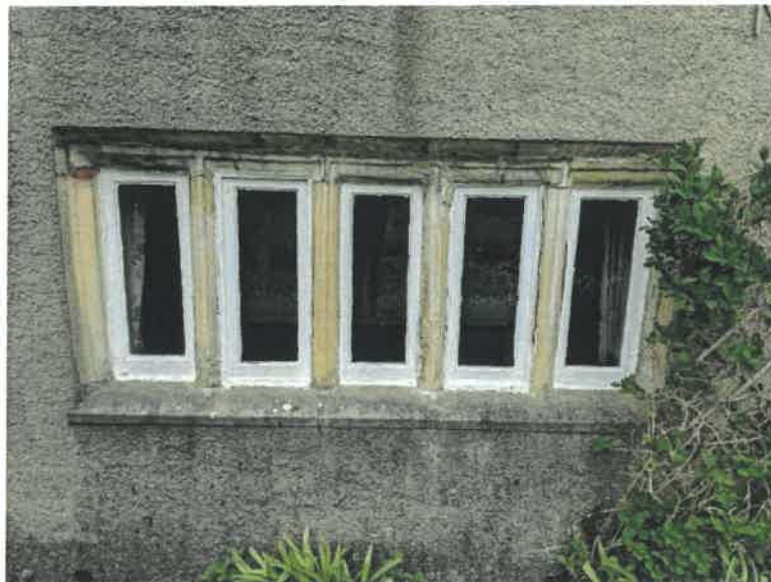
*Figure 7.1.3: 5-panel window with heavily weathered stone surrounds*

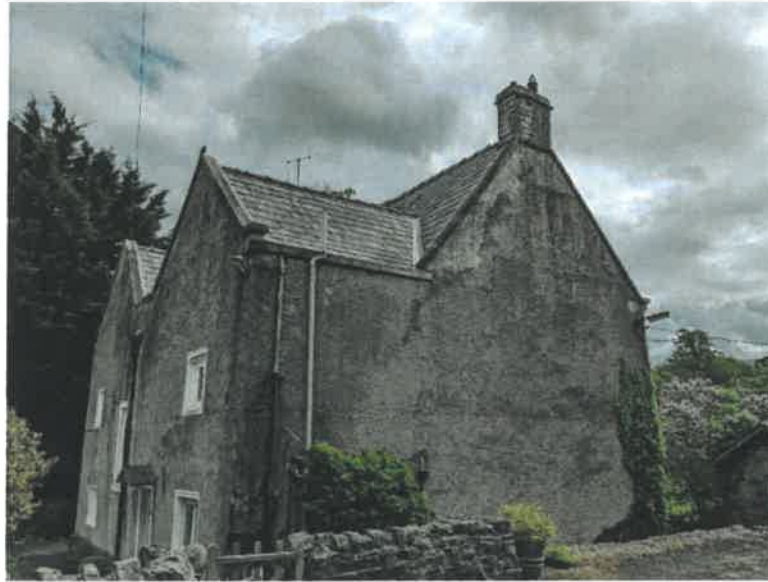
*Figure 7.2.1: Side, west elevation. Northern wings to the left*

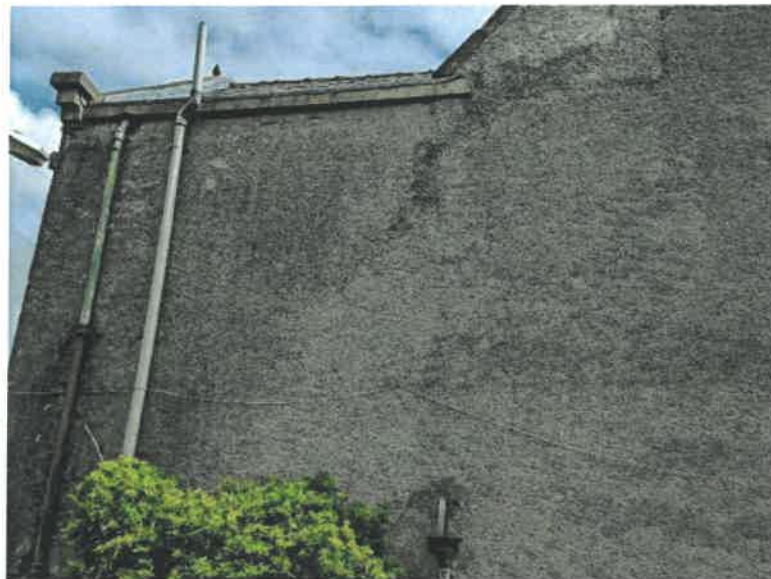
*Figure 7.2.2: Vertical cracking in the render at wall / roof junctions*

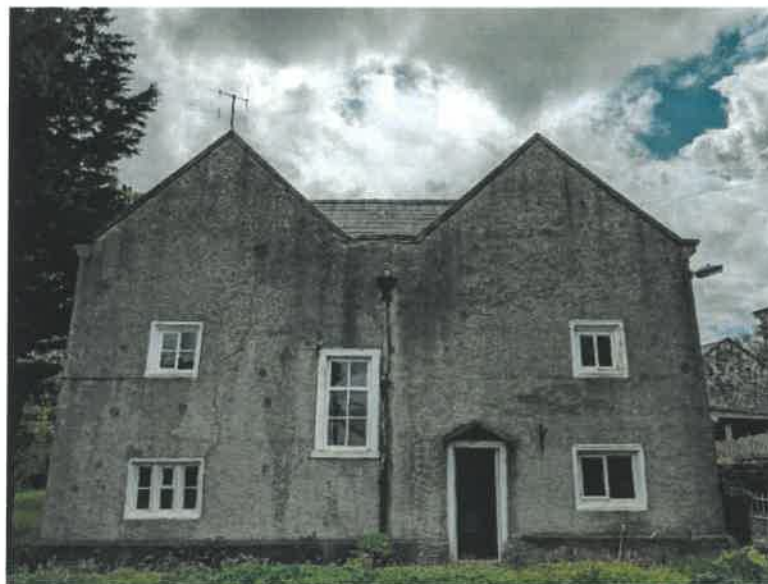
*Figure 7.3.1: Front, north elevation. Twin northern wings, with central valley gutter and downpipe*

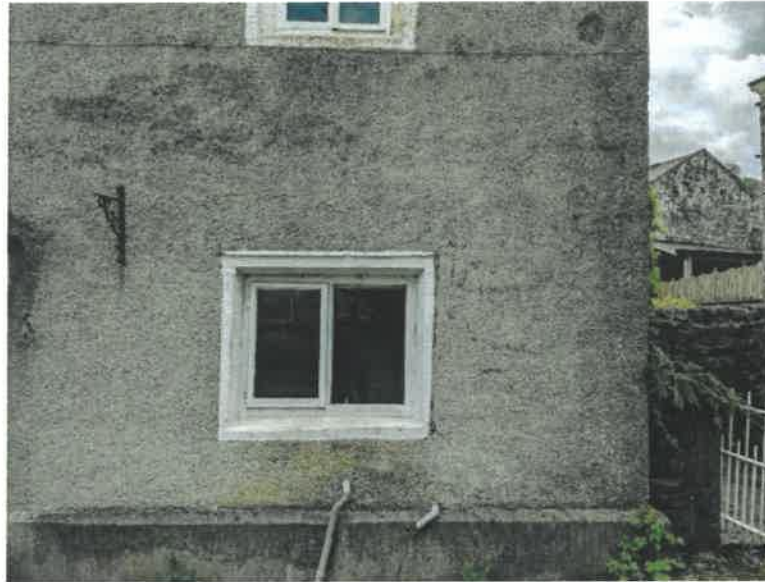
*Figure 7.3.2: Render cracking between windows*

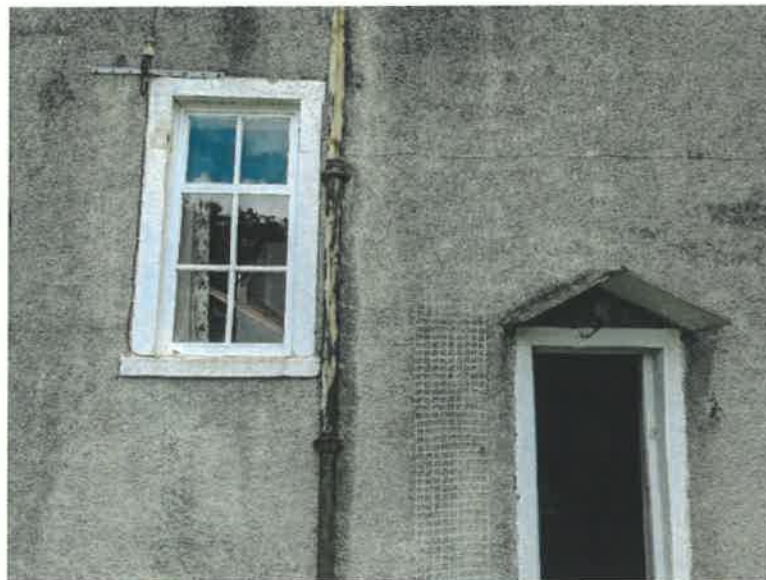
*Figure 7.3.3: Render cracking between door and window*

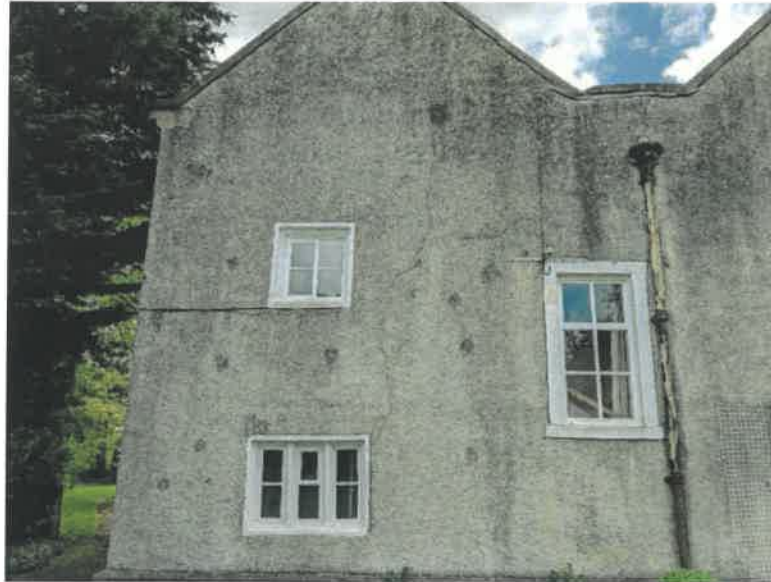
*Figure 7.3.4: Large vertical crack to the eastern wing*

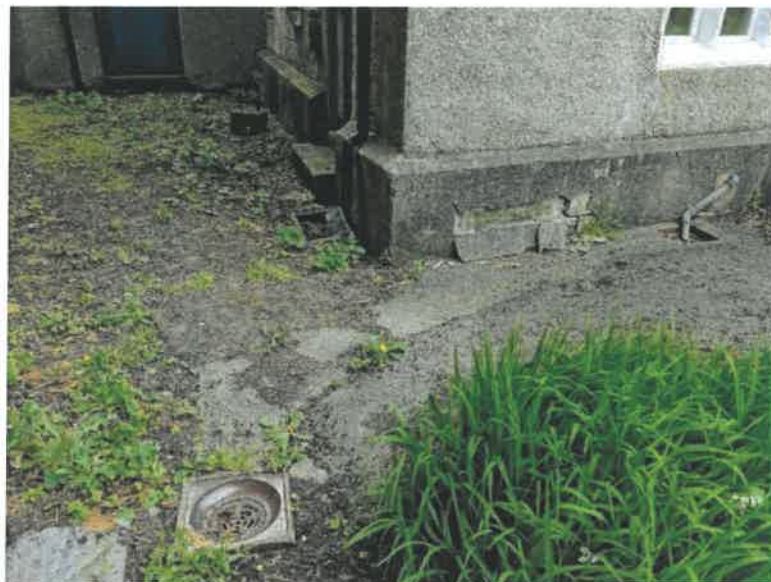
*Figure 7.3.5: Numerous drainage elements in close vicinity to the north-east corner*

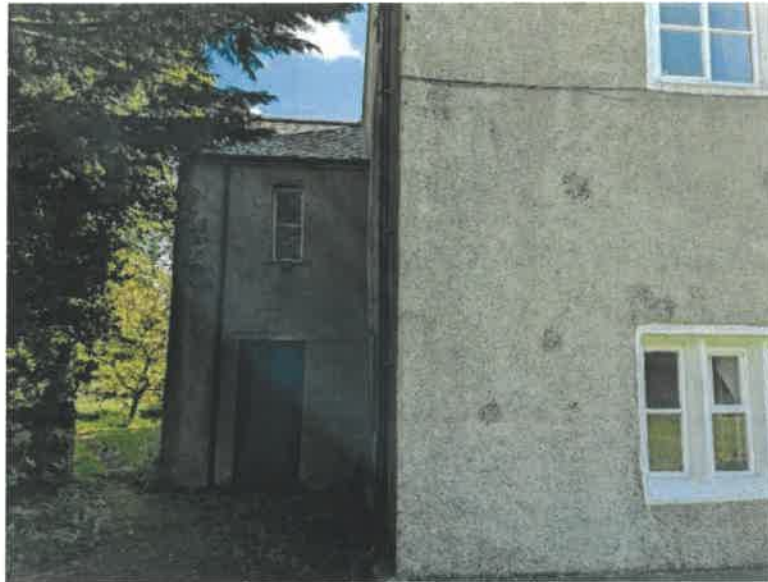
*Figure 7.4.1: Bulge to the east wing wall*

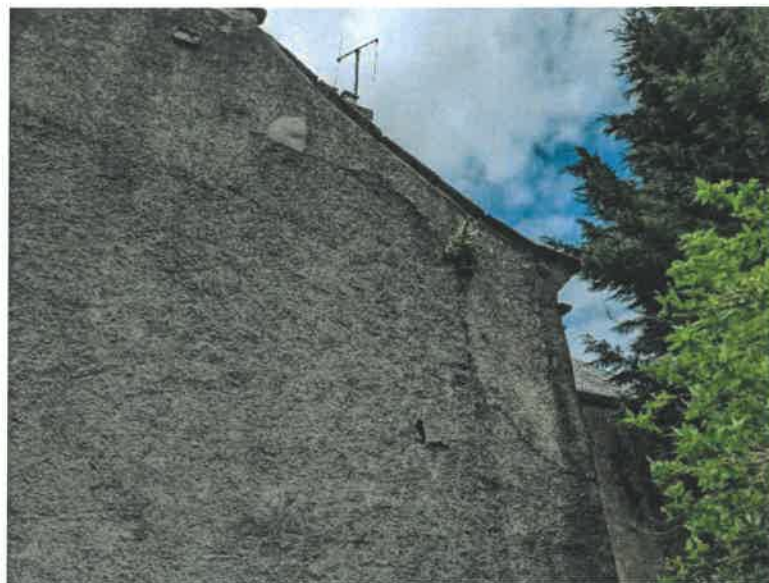
*Figure 7.4.2: Cracked and spalled render to the cheese press gable*

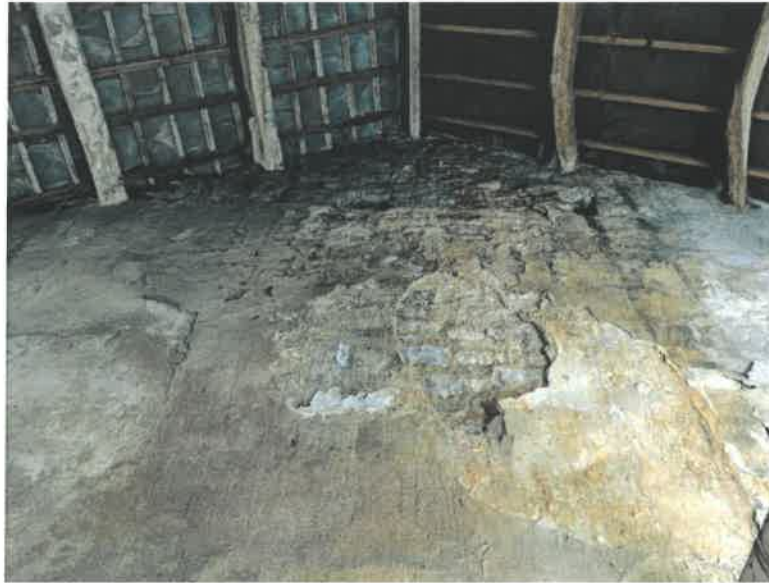
*Figure 7.5.1: Cheese press external gable wall*

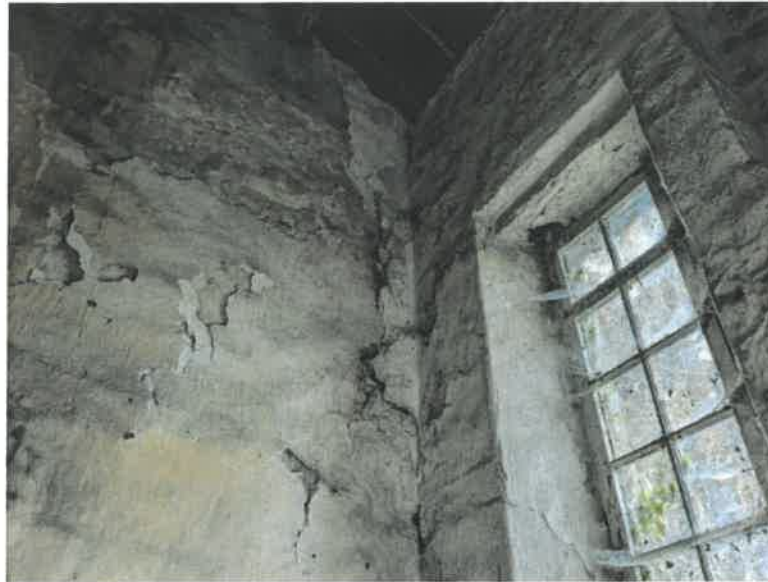
*Figure 7.5.2: Cheese press south east wall corner with lack of tie in*

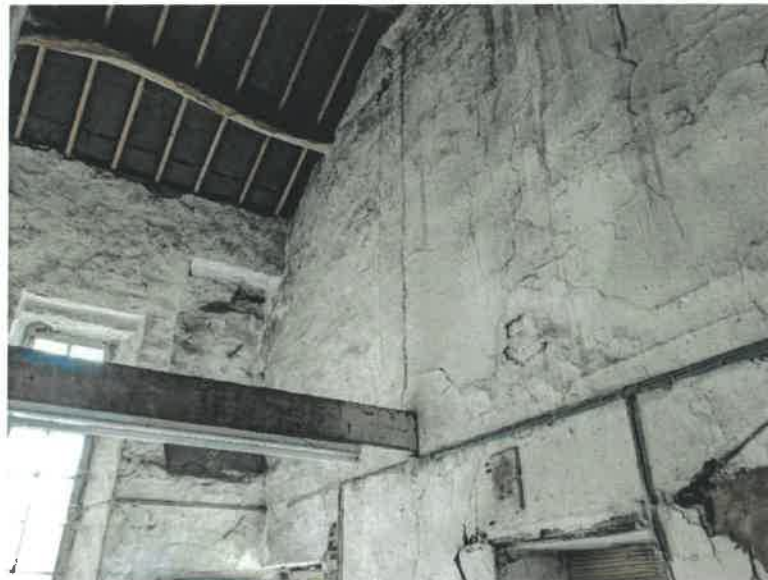
*Figure 7.5.3: Cheese press to farmhouse wall vertical cracking*

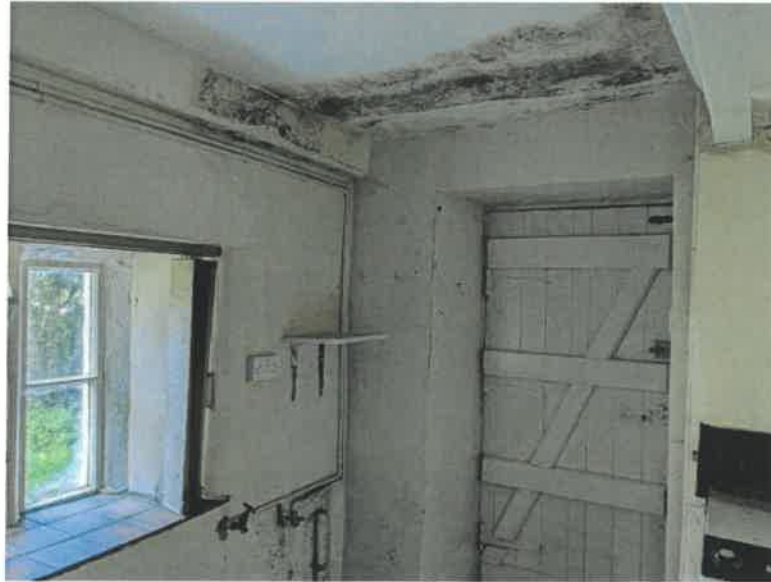
*Figure 7.6.1: North east wing, ground floor bathroom water ingress*

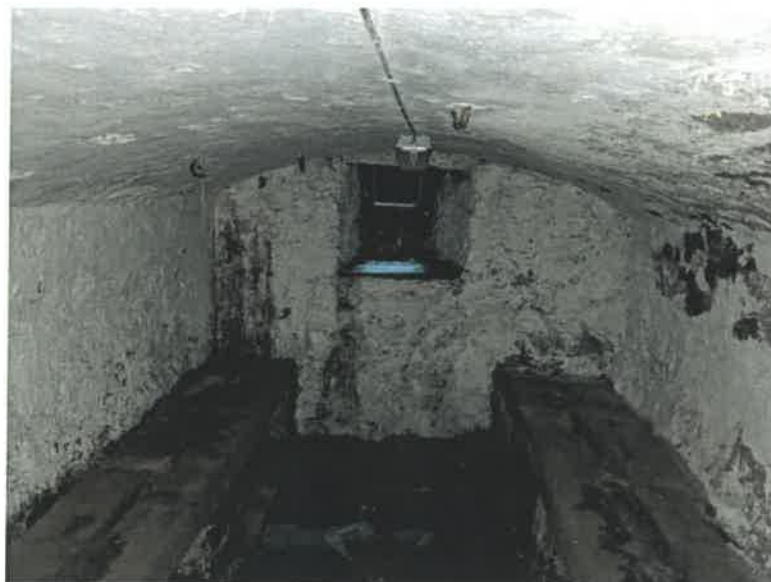
*Figure 7.6.2: Basement cellar with stone arch ceiling*

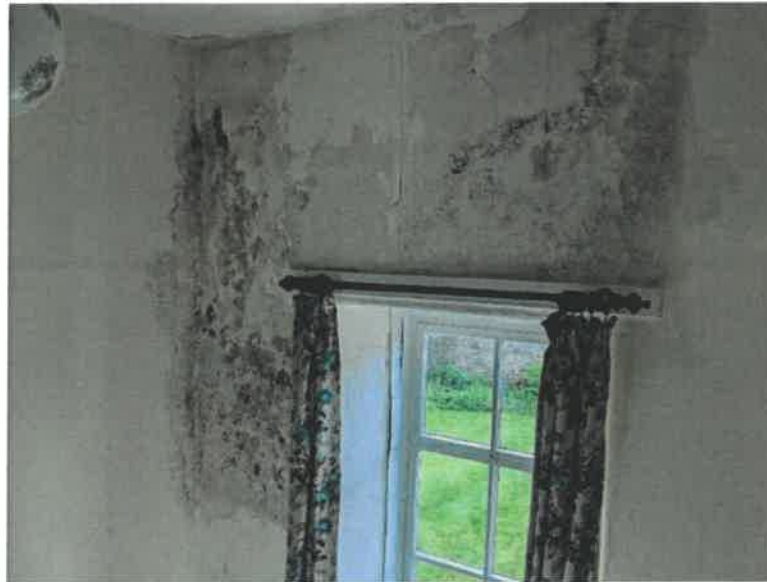
*Figure 7.6.3: North east wing, water ingress at half landing level*

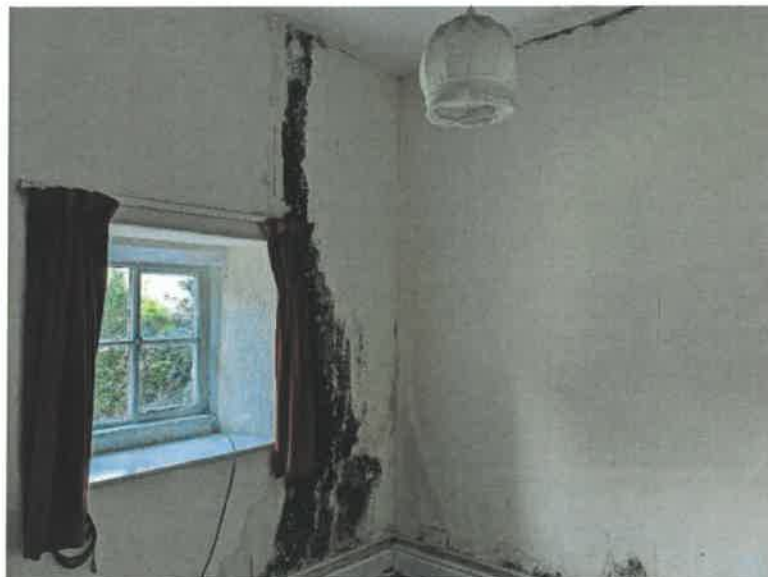
*Figure 7.7.1: North east wing, first floor water ingress*

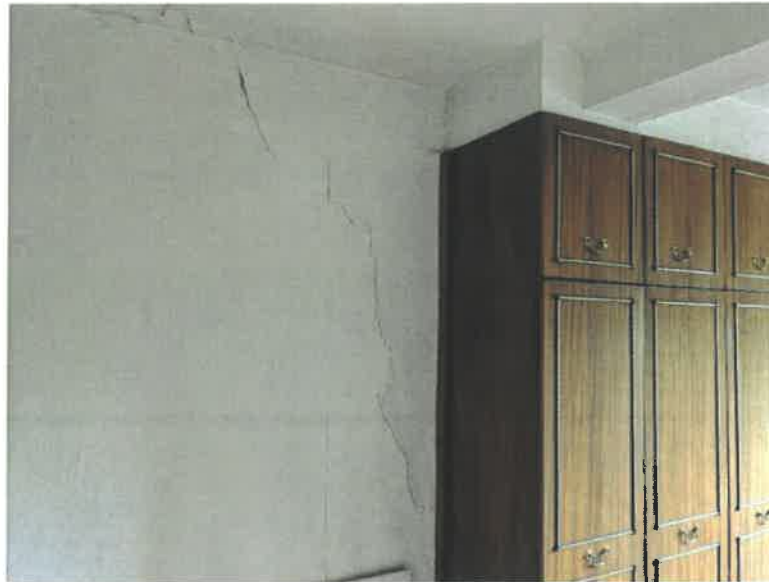
*Figure 7.7.3: East gable wall cracking*

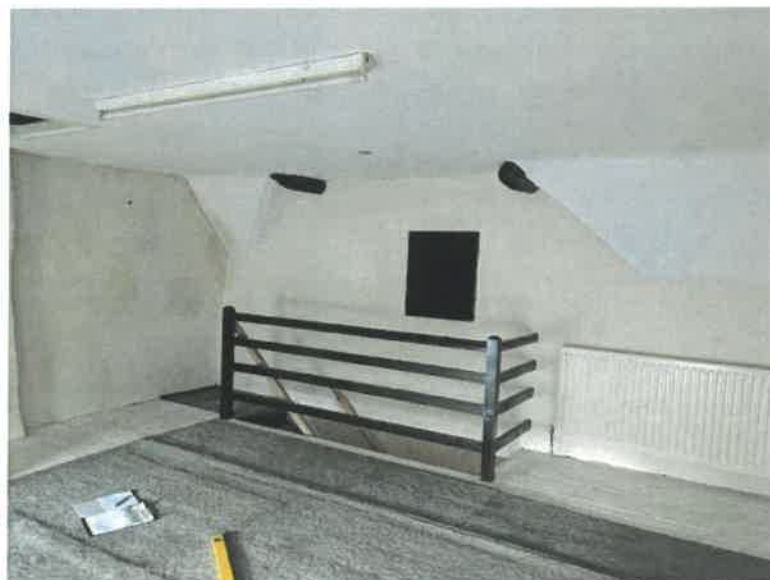
*Figure 7.8.1: Western room ceilings and staining at valley connection*

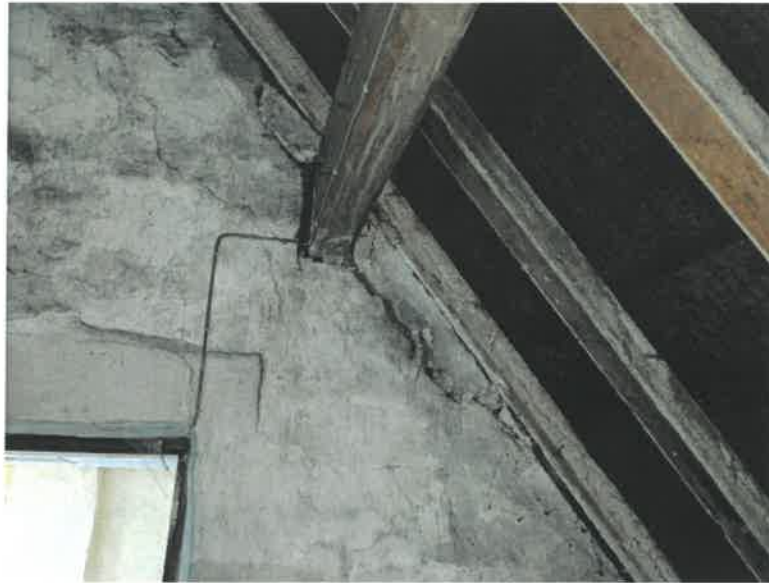
*Figure 7.8.2: Eastern room cracking at purlin bearing*

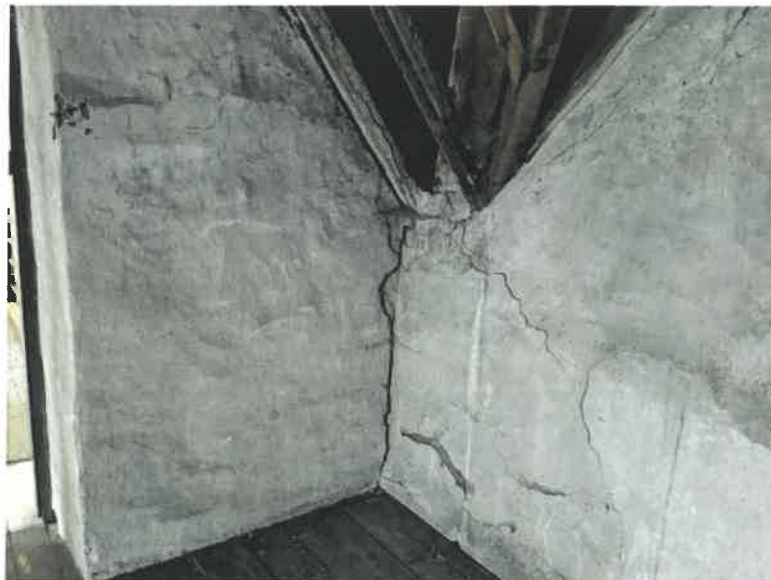
*Figure 7.8.3: Eastern room wall corner separation*

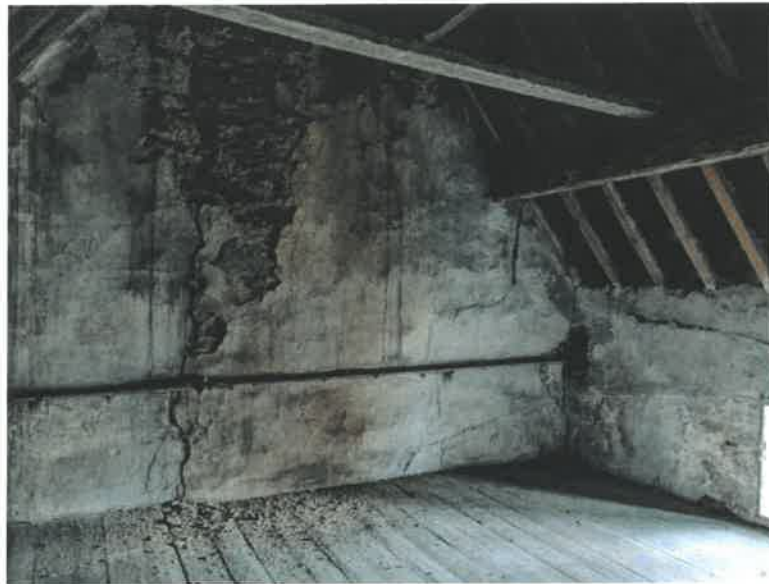
*Figure 7.8.4: Eastern room water ingress below chimney and wall cracking*

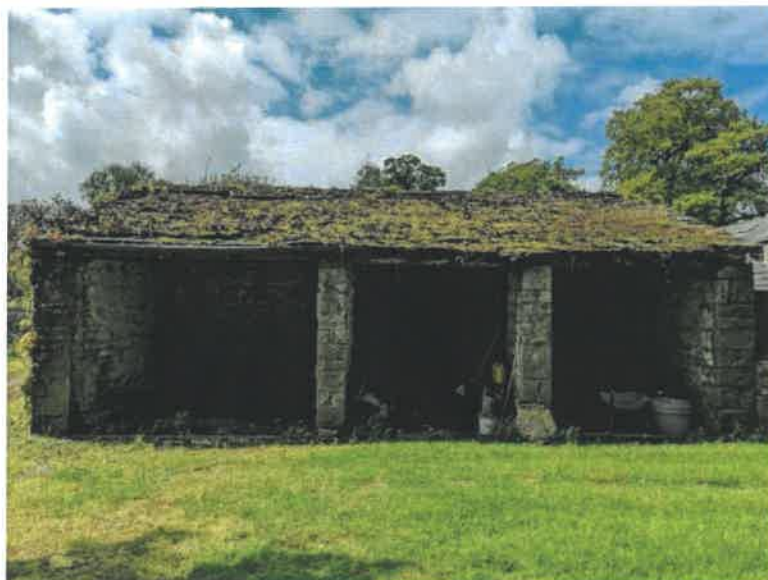
*Figure 8.1.1: Open fronted stone garages*

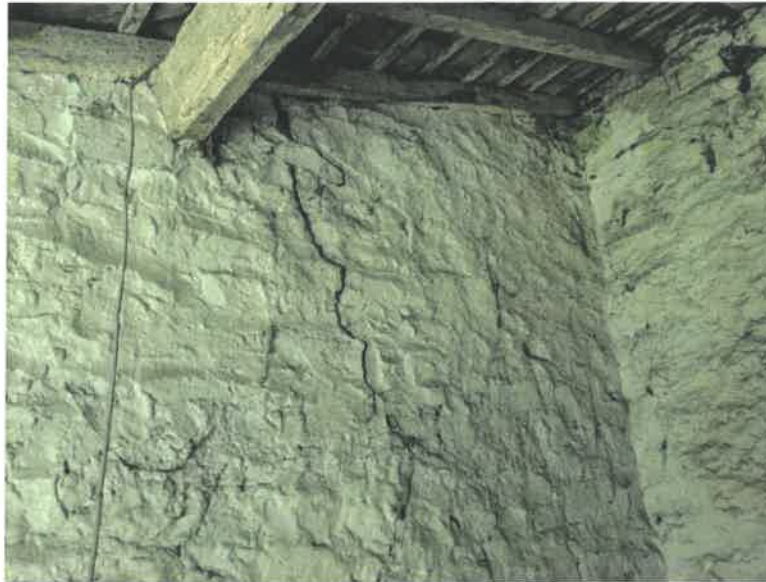
*Figure 8.1.2: Cracking at purlin bearings*

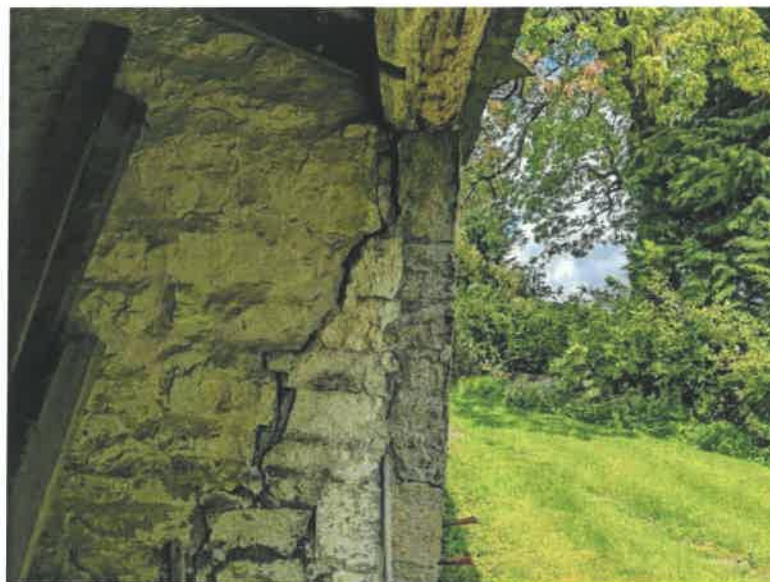
*Figure 8.1.3: Wall settlement / cracking to front side*

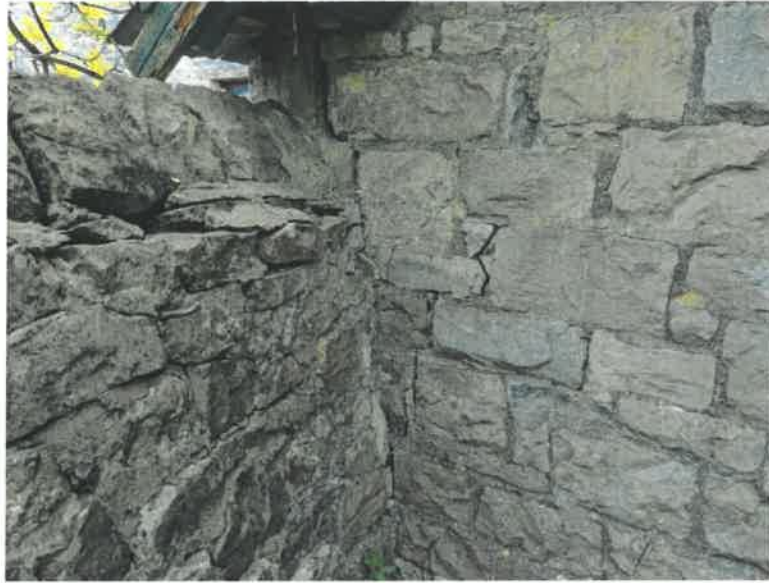
*Figure 9.1.1: Coal store rear wall cracking*

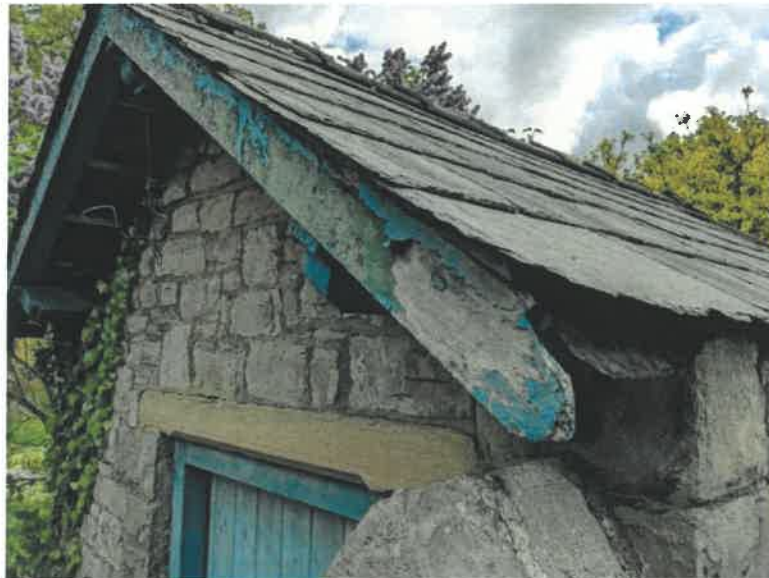
*Figure 9.1.2: Deteriorated timber sections*

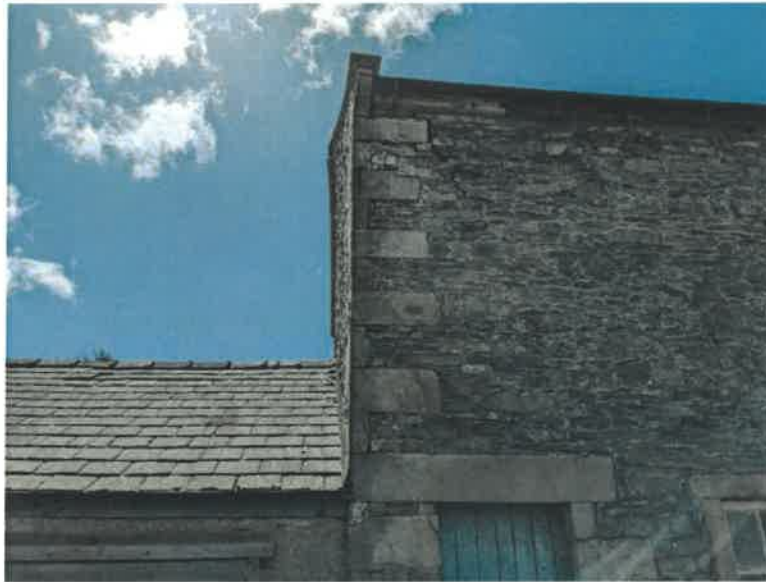
*Figure 10.1.3: Southern gable with a twist to the upper storey*

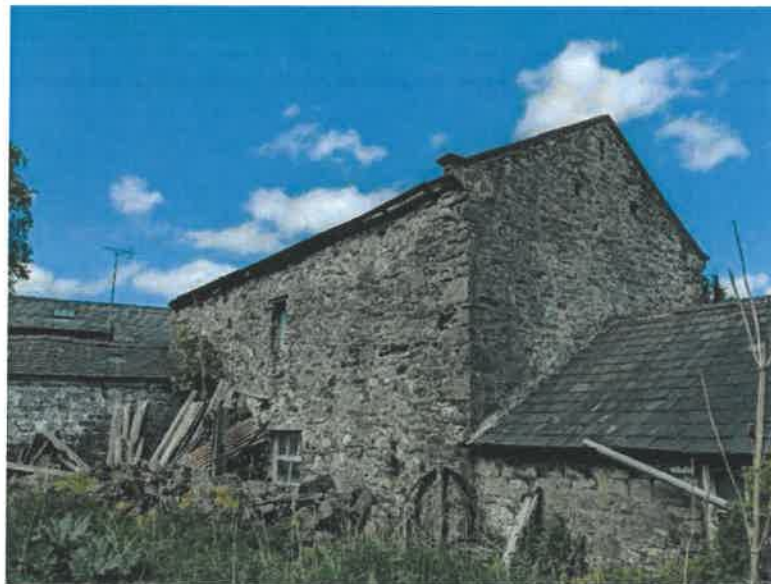
*Figure 10.1.5: Rear elevation*

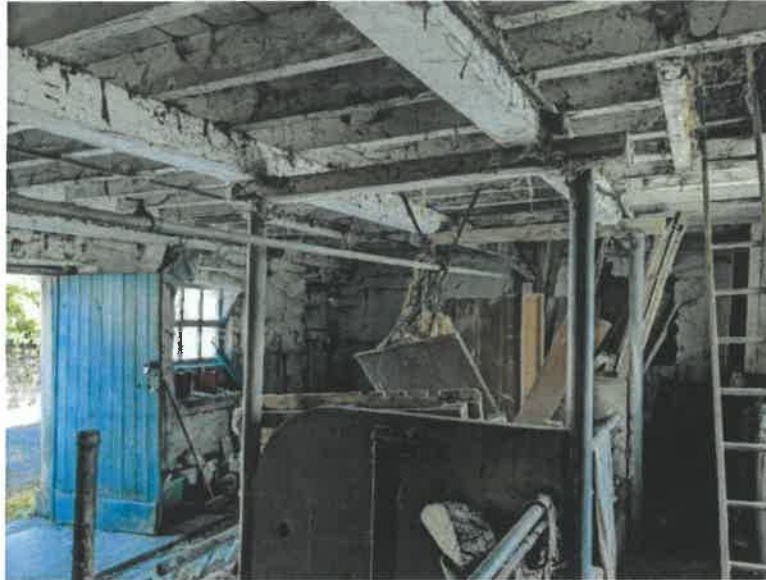
*Figure 10.2.1: Propped timber floor structure*

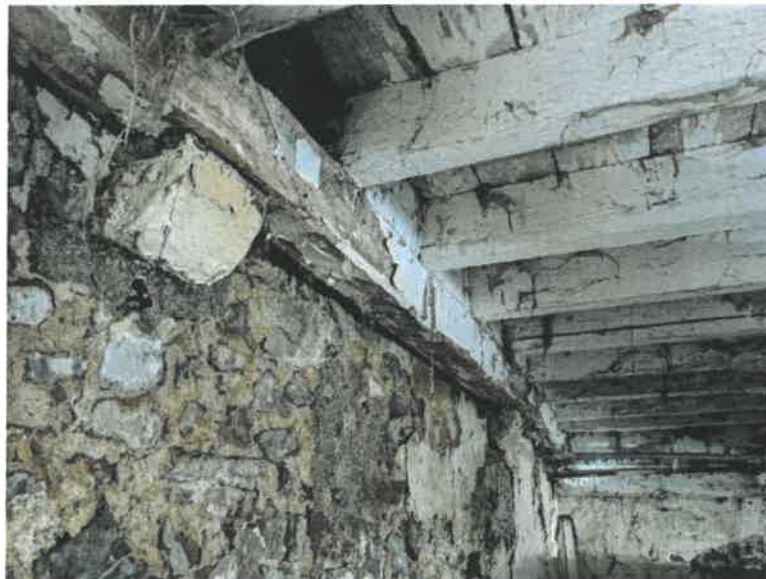
*Figure 10.2.2: Front elevation wall corbel stones separated from the floor structure*

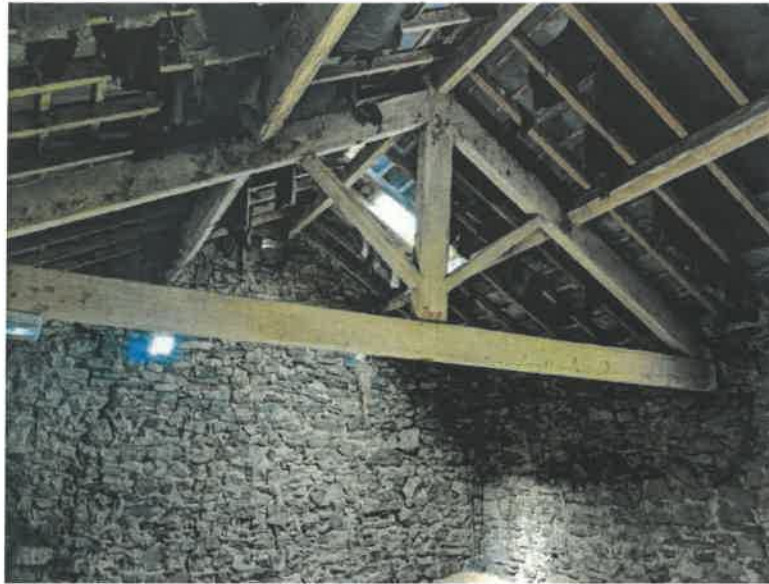
*Figure 10.2.3: Northern gable with cracking to the side of the inwards bow*

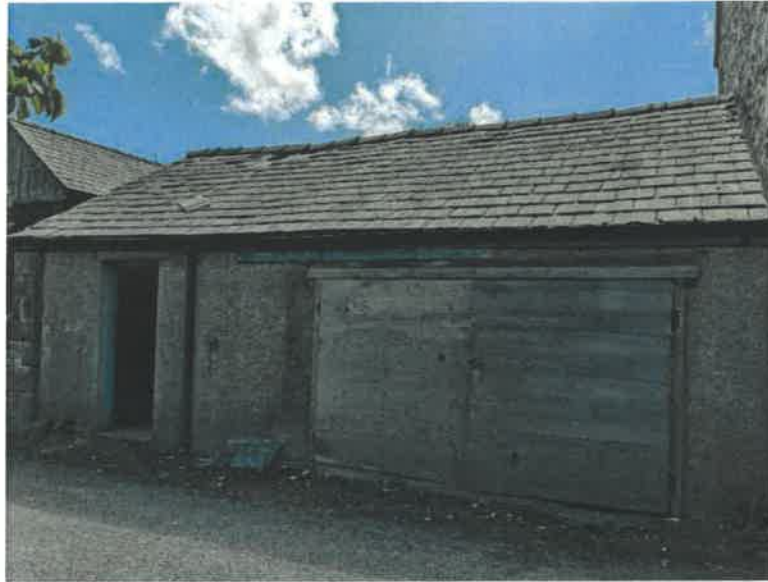
*Figure 11.1.1: Workshop front elevation*

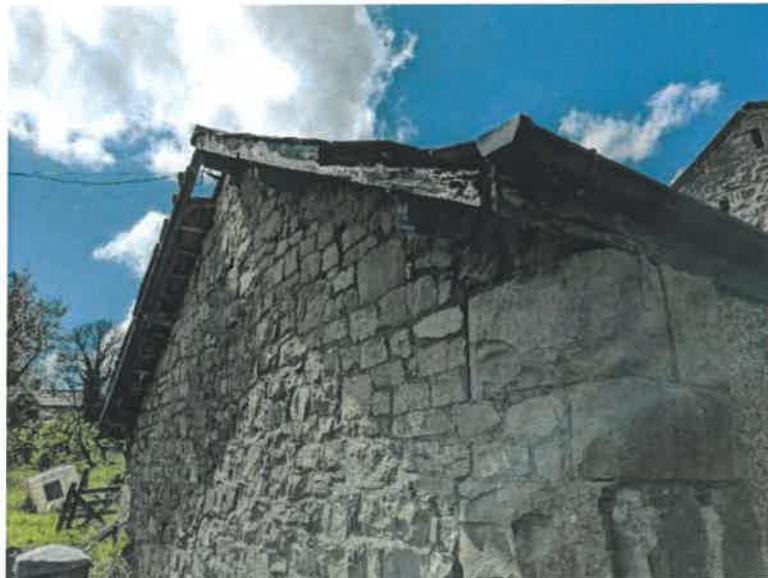
*Figure 11.1.2: Deteriorated timber sections*

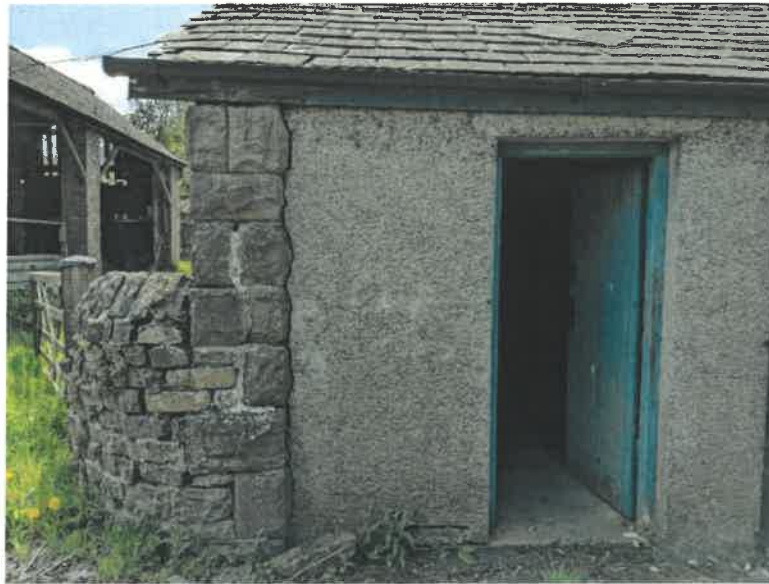
*Figure 11.1.3: Wall / render cracking to corner quoin stones*

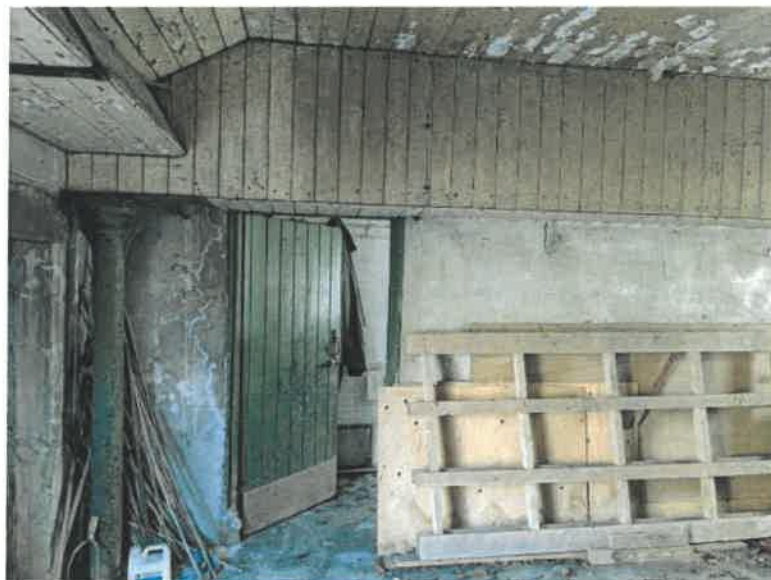
*Figure 11.2.1: Internal view with ceilings present*

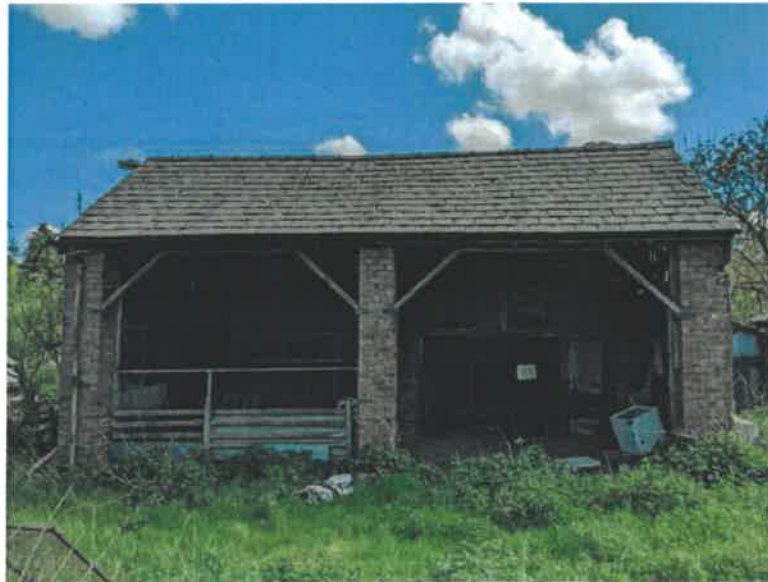
*Figure 12.1.1: Open sided hay barn with brick piers and knee braced timber eaves structure*

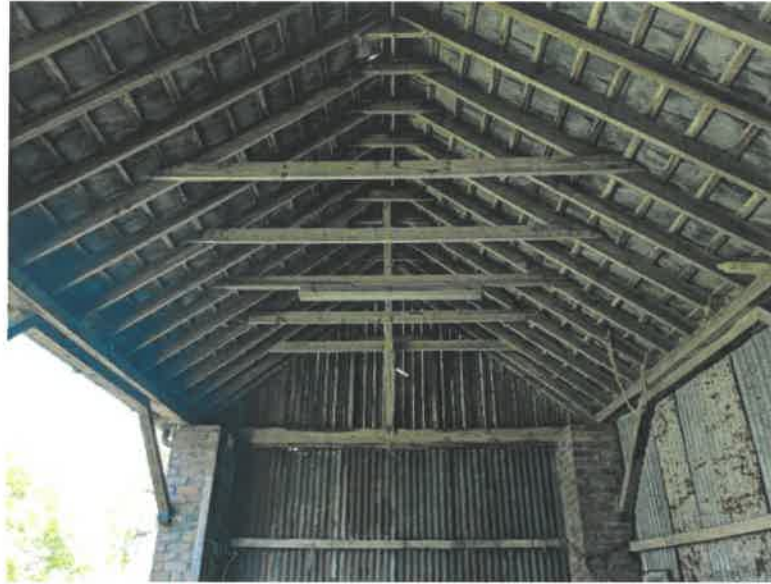
*Figure 12.1.2: Tied roof structure*
