DAYTIME BAT SURVEY

83 MELLOR BROW, MELLOR,
BLACKBURN

NOVEMBER 2022

**RACHEL
HACKING
ECOLOGY**

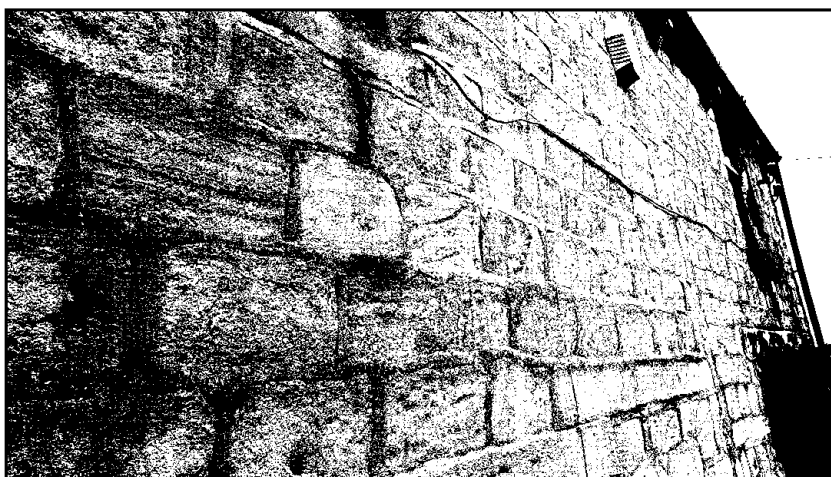
- 3.2 The external stonework on the front elevation is in excellent condition with no evidence of crumbling mortar or crevices for bats to exploit (see Photograph 1). The render on the gable and rear elevation is in moderate condition with a large area of missing render on the rear elevation. The missing render does not lead to any cavities which are exploitable by bats, however (see Photograph 2).

Photograph 1 showing the stonework

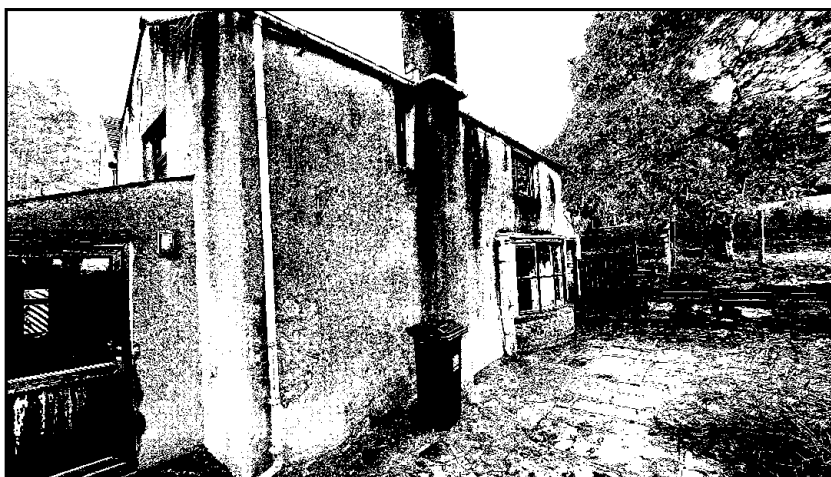
Photograph 2 showing the render with missing section

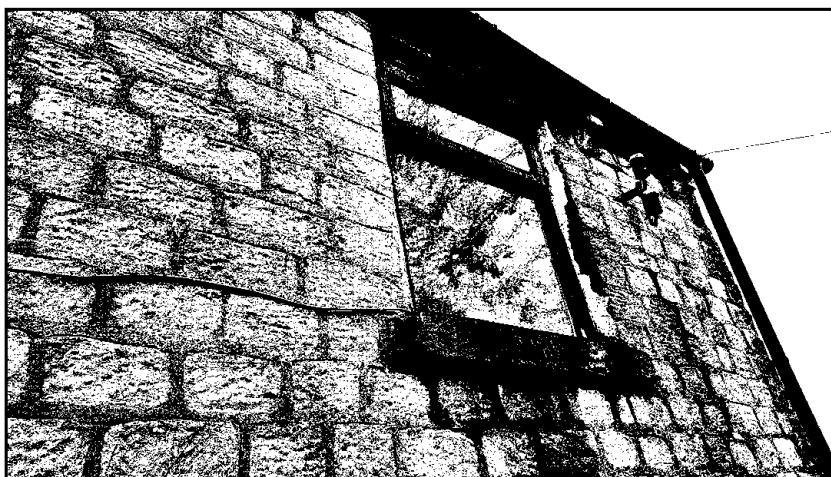
- 3.3 The wooden framed windows and doors are in good condition and fitted tight to the surrounding masonry (see Photograph 3). The slate tiled double pitched roof appears to be in good condition with no missing or slipped tiles or exploitable spaces between them (see Photograph 4). The ridge tiles on the roof appear to be in good condition, with no missing or slipped tiles (visible in Photograph 4 below). The roof of the single-story extension is constructed from slate tiles (see Photograph 5). The roof of the extension is in good condition and provides no exploitable spaces for bats. Lead flashing is present around the edge of the extension (visible in Photograph 5 below) and at the roof valleys and base of the chimney stack (see Photograph 6). This is intact and well-sealed to the surrounding tiling/render.

Photograph 3 showing a window

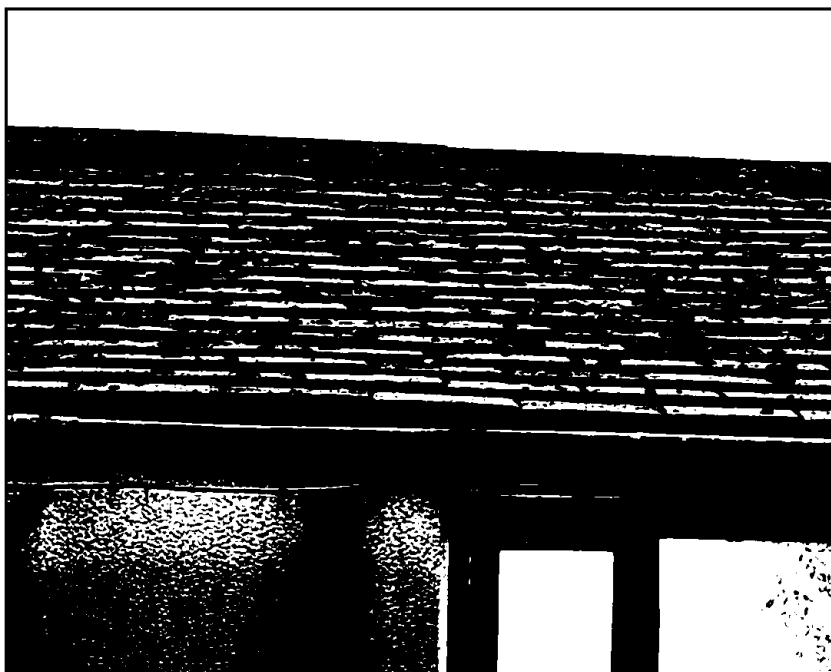
Photograph 4 showing a section of the roof

- 4.3 It should be noted that bat absence is very difficult to prove definitively due to their mobility and size, and single or small numbers of bats are able to roost in extremely small spaces, such as in gaps between roof tiles. Care should be taken during the roof strip, with tiles lifted off rather than dragged.

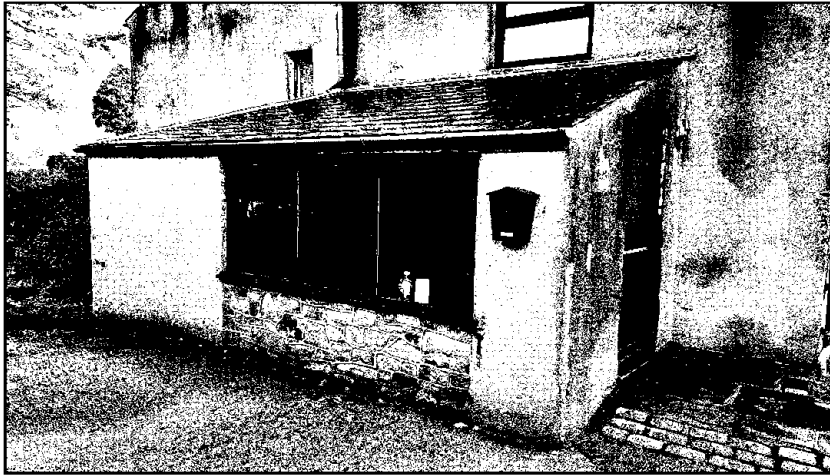
Photograph 5 showing the single-storey extension

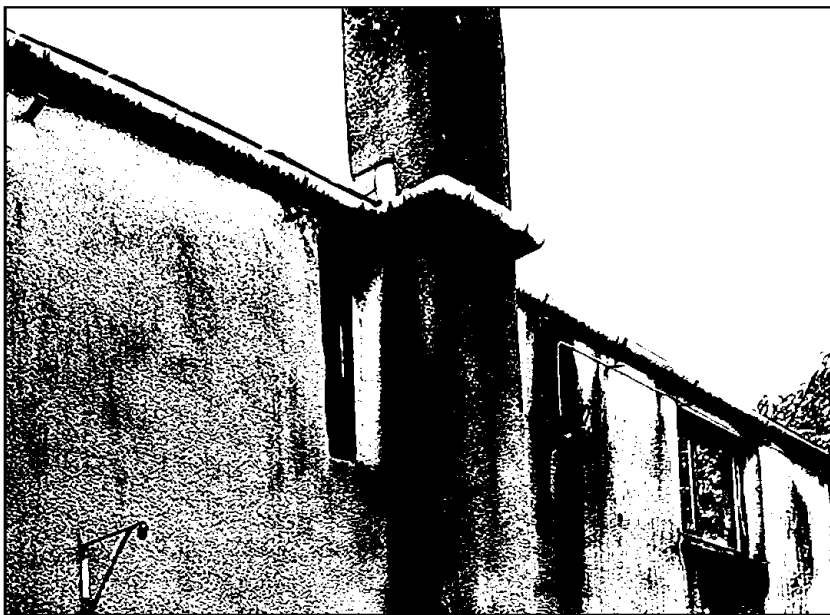
Photograph 6 showing the lead flashing at the base of the chimney stack

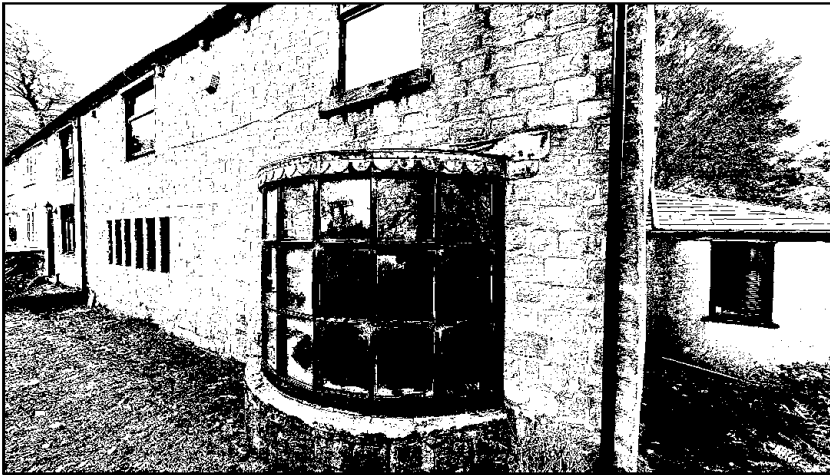
- 3.5 Bay windows are present on the front and rear elevations of the dwelling (see Photograph 8). The window frames of the bay windows are well-sealed to the surrounding masonry and render. Lead flashing is present at the top of the bay windows and masonry/render. This is in moderate condition but does not offer exploitable spaces for bats (see Photograph 9).

Photograph 8 showing a bay window

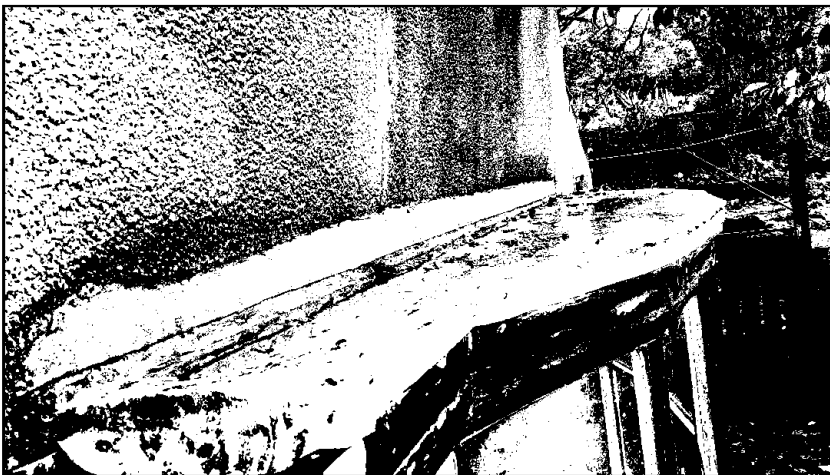
Photograph 9 showing the lead flashing on the rear bay window

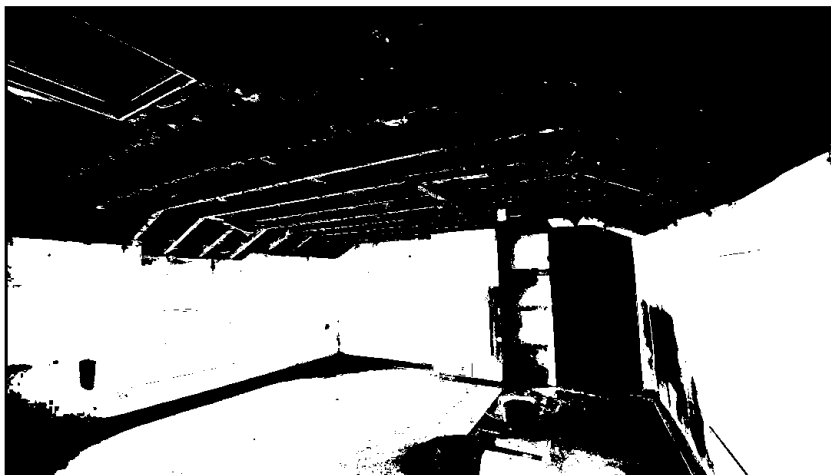
- 3.6 The interior of the dwelling contains well-lit, unfinished spaces, with stripped-out ceilings and walls (see Photograph 10). The stripped-out ceilings offer direct access to the property for bats. No evidence of bat use in the property was found. The unfinished nature of the property provides an airy and cold space unfavoured by roosting bats. The ceiling joists are in good condition with no cracks present exploitable by bats (visible in Photograph 10 below).

Photograph 10 showing the stripped-out ceilings

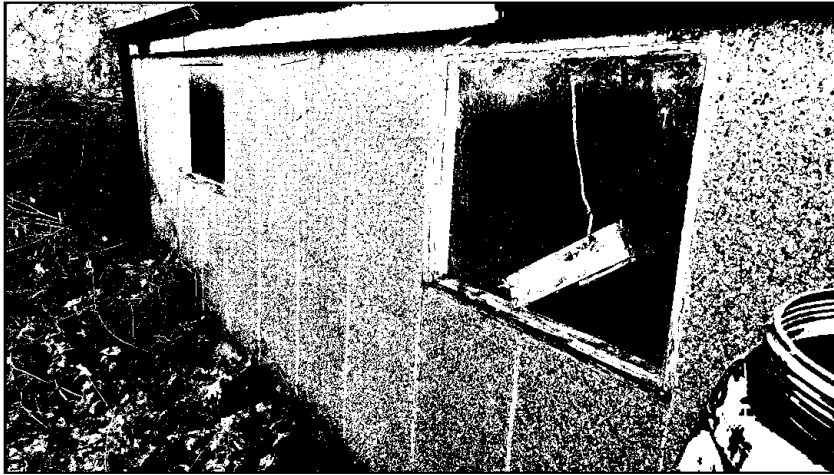
- 3.8 The pebble dashed exterior render of the garage is in good condition with no missing render or crevices for bats to exploit (see Photograph 14). The flat roof is lined with felt and covered in bryophytes (see Photograph 15). The coverage of bryophytes is not considered dense enough for a bat roost.

Photograph 14 showing the exterior of the garage

- 3.9 The wooden framed windows are in moderate condition with paint peeling on some areas of the frame (visible in Photograph 14 above). The frames are flush to the surrounding render however, offering no potential access for bats. The garage door is similarly in good condition and is flush to the surrounding render (see Photograph 16).

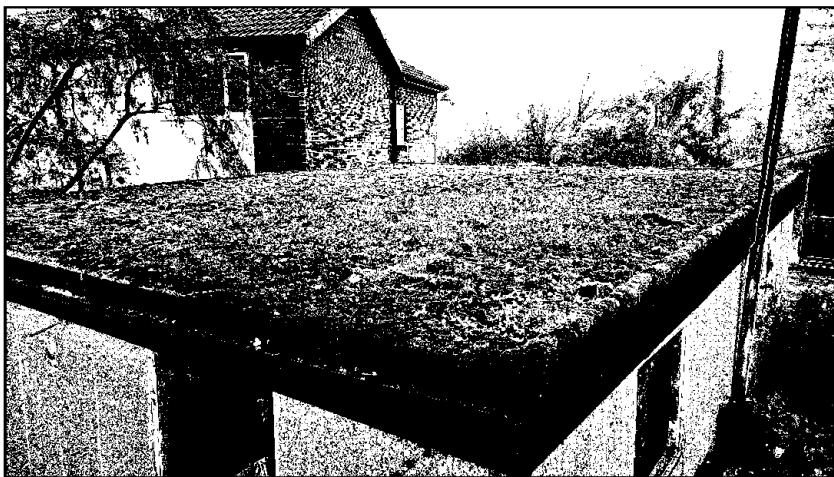
Photograph 15 showing the roof of the garage

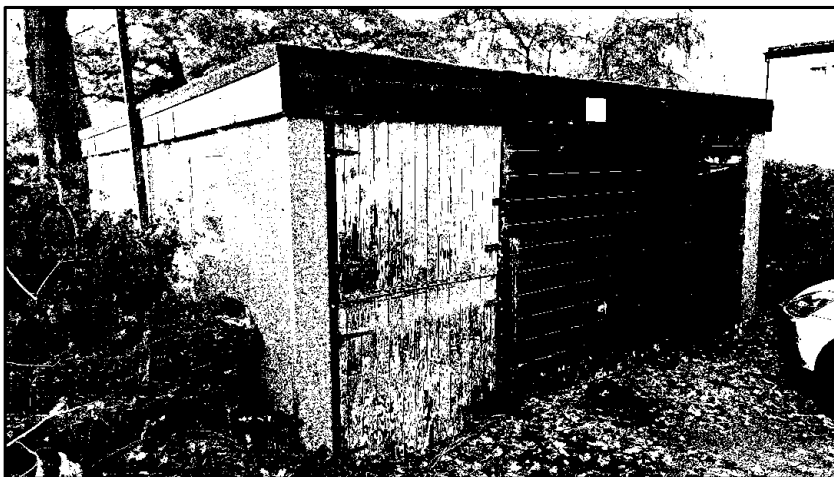
Photograph 16 showing the garage doors

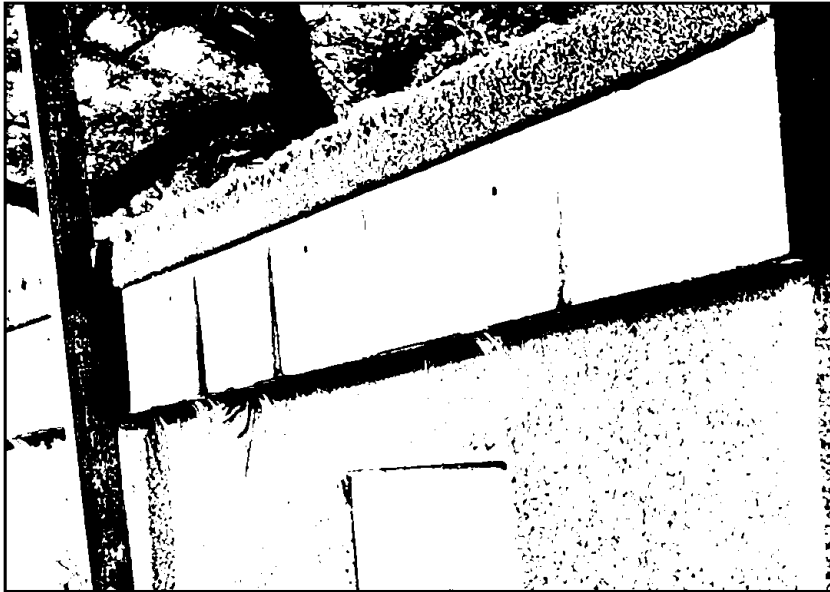
- 3.10 Bargeboards are present around the roof edges and lie flush to the roofing felt (visible in Photograph 16 above). Small exploitable spaces are present between the bargeboards and external rendering (see Photograph 17). These areas were inspected, and no evidence of bat use was found.

Photograph 17 showing the space under the bargeboards
