CONDITION AND TREE RISK INSPECTION OF TREES AT 1 HELLIFIELD RD BOLTON BY BOWLAND

Client: Mr and Mrs J Caswell. Resident Owners.

Date of Tree Inspection: 22.11.22

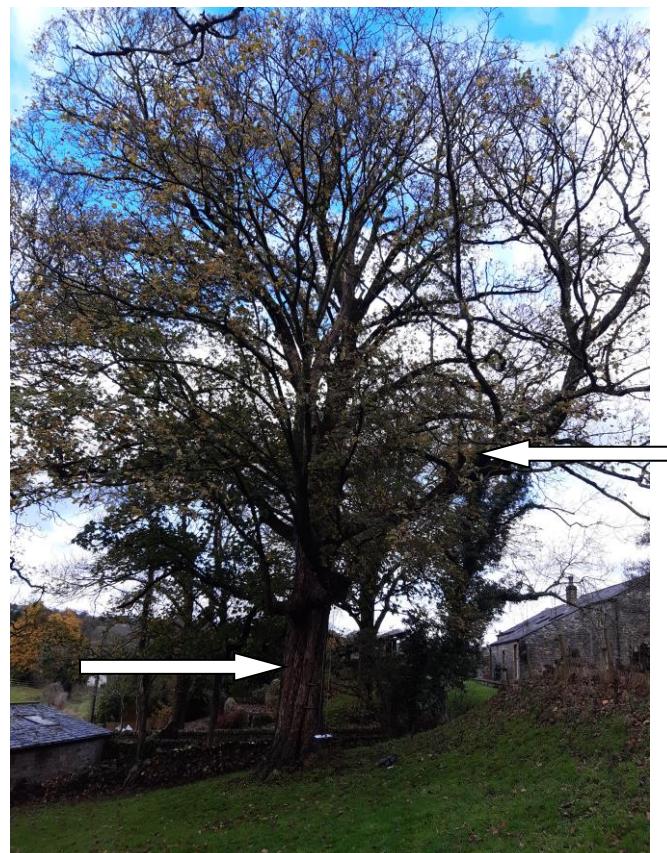
T1

Lower arrow showing decay cavity

Upper arrow showing over dominant lower lateral limb

- The buttress roots appear sound with an open cavity on the south side at ground level. The cavity with a width of 400mm extends from ground level to the lower crown of the tree. No Fruiting bodies are visible from the cambium and there is no evidence of bark canker or stem dysfunctions. Tests suggest a sound butt wall thickness of 200-250mm

We would rate the tree condition to be fair to good and subject to completion of the removal of heavy deadwood and an upper canopy reduction of 3m and the weight reduction of a lower major limb consistent with the standards of BS 3998, we would regard the tree as having a low risk of main stem failure and a low risk of harm in the future Review 2025

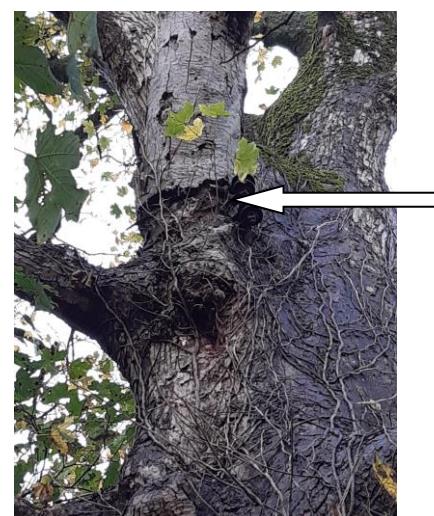
- A single 350mm diameter limb has died because it was girdled by a Utility Company fixing bracket. (See photo) The limb needs to be removed as failure would present risks to the Client and collateral damage to the tree
