DESIGN AND ACCESS STATEMENT

ALMSHOUSES
Flat 4
STYDD LANE
RIBCHESTER
LANCASHIRE
PR3 3YQ

FOR
YOUR HOUSING GROUP
ASTON EVENUE
RISLEY
WARRINGTON
WA3 6ZN

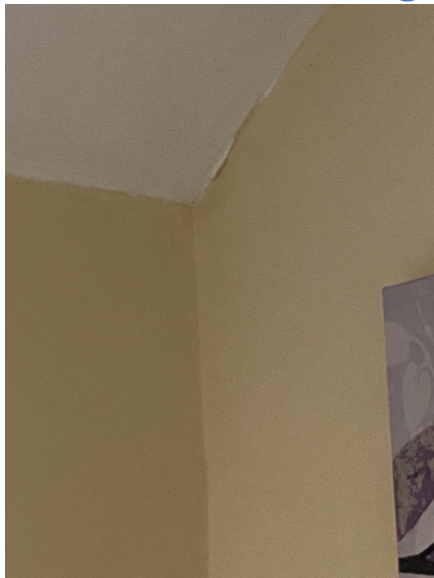
Decoration staining area 1

Photograph 1: Rear bedroom gable/ external elevation at ceiling junction

-There is damp evident at rear/ right hand gable wall/ ceiling junction as marked in red on photograph above.

1.1 Rear down pipe and gutters:

Gutters and downpipes are in cast iron painted black

It is likely that gutter capacity is reduced, and joints could be leaking.

It is proposed to undertake the following:

- a) Provide suitable access and undertake detailed inspection at close quarters
- b) Clean out gutters to ensure free flowing and minimise the chance of rainwater surcharging the gutter

- c) Undertake a water test of gutter and rainwater pipe to ensure that rainwater pipe and gutter do not have any leaks. To extent that leaks are identified they will be repaired in accordance with cast iron rainwater goods manufacturers recommendations. Any decoration is to be made good using black gloss paint.

Once external remedial works are completed undertake the following works:

- Undertake hammer test, hack off any damp, friable or de-bonded plaster to expose brickwork, ensure wall is dry.
- Repoint any defective or open mortar joints using lime mortar as appendix D
- Apply lime plaster to all affected areas as Appendix E
- Apply breathable wall paint to gable wall and chimney breast wall complete and to any other effected areas (ensuring paint taken to a natural stop so as not to look patchy, as Appendix F

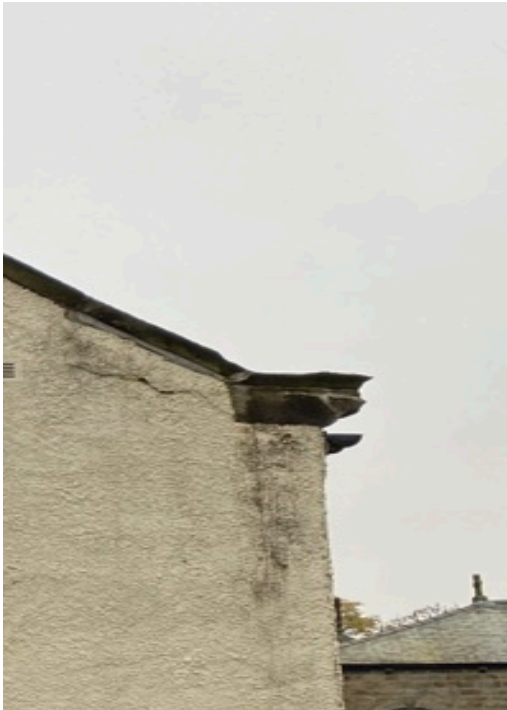
1.2 Cracking to gable elevation:

Photograph 2: Gable/ external elevation junction at verge

- There is evidence of a previous mortar repair to underside of coping extending up from rear elevation Kneeler stone approximately 1m.
- It is noted that there is no overhang or capillary drip to verge stone coping.
- There is bulging and cracking to render below mortar repair.
- Ideally stone coping should incorporate an overhang and capillary groove to prevent water tracking behind render. Given the historic nature of the property this is not possible.

Given the above we propose the following:

- a) Provide suitable access and undertake detailed inspection at close quarters
- b) Carefully remove existing stone copings, set aside and protect to re-fit on completion.
- c) Lay code 4 lead sheet under coping 100mm. lap top over bottom and return down to gable elevation covering and protecting top edge of render. Apply patination oil. As detail 1
- d) Fit stainless steel angles to support upper edge of copings, fixed with resin bolts to wall. Refit stone copings and re-point in lime mortar. As detail 1

- e) Allow for stone repair to coping using stone restoration method colour matched to existing stone as detailed in appendix A ensuring a true square edge
- f) Undertake hammer test, remove loose friable and de-bonded render.
- g) Ensure wall is dry and sound, apply pebble dash render to effected areas (refer to appendix B), provide stainless steel bead to form a hard edge to stone coping

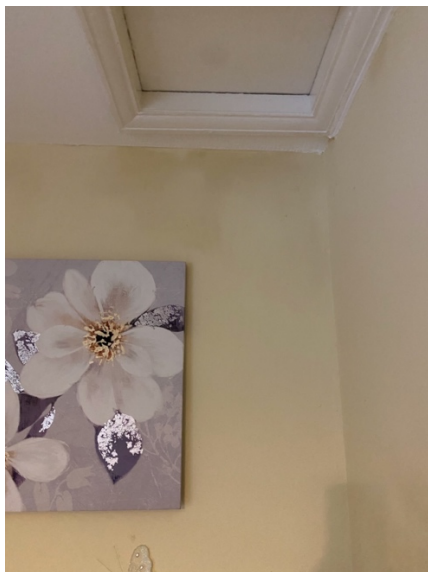
Decoration staining area 2:

Photograph 3: Rear bedroom gable/ chimney breast inner wall at ceiling junction

-There is damp evident at gable external wall. This is approximately 630x350mm in size

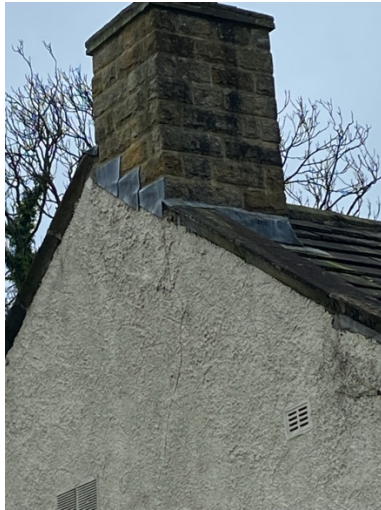
Photograph 4: Gable elevation at chimney breast viewed from rear bedroom

Issues identified:

- Verge coping stops short of chimney; this could allow water to track into structure.
- There is a lead step and apron flashing but this does not extend down over render.
- Verge stone coping has insufficient overhang and no capillary groove
- There is cracking evident to render extending from chimney breast/ verge coping junction extending down to within approximately 1m of first floor level. Some areas of render are bulging

Given the above we propose the following:

- a) Provide suitable access and undertake detailed inspection at close quarters
- b) Undertake hammer test, remove loose friable and de-bonded render.
- c) Ensure wall is dry and sound and apply pebble dash render to effected areas.
Provide stainless steel bead to form hard edge between render and stone verge coping (refer to appendix B)
- d) Provide Code 4 lead flashings to chimney to lead sheet associations recommendations ensuring suitable upstand and cover top edge of render. Lead to be rebated into mortar joint and lead clipped to upper edge as appropriate.
Apply patination oil

Once external remedial works are completed undertake the following works:

- Undertake hammer test, hack off any damp, friable or de-bonded plaster to expose brickwork, ensure wall is dry.
- Repoint any defective or open mortar joints using lime mortar as appendix D
- Apply lime plaster to all effected areas as Appendix E
- Apply breathable wall paint to gable wall and chimney breast wall complete and to any other effected areas (ensuring paint taken to a natural stop so as not to look patchy, as Appendix F

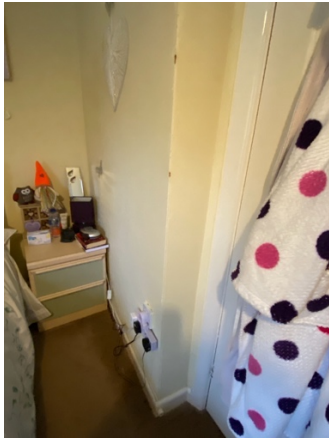
Decoration staining area 3:

Photograph 5: Chimney breast viewed from rear bedroom

There is staining of the wall approximately 400x450mm in size , set approximately 250mm in from external wall/ chimney breast corner at a height of approximately 1050mm above finished floor.

There is also rusting of plaster corner bead to chimney breast near door. It is understood this is most likely to be contamination of plaster due to historic use of chimney as an open fire.

Internally

- a) Carefully hack off defective plaster and carefully remove rusting corner bead
- b) Fit new galvanised corner bead and apply lime plaster system to effected areas as Appendix E
- c) Make good decoration to full walls complete using breathable paint system as Appendix F

Externally

- d) Rectify defects as indicated in photograph 4
- e) Check to ensure that chimney pot is capped to prevent water ingress

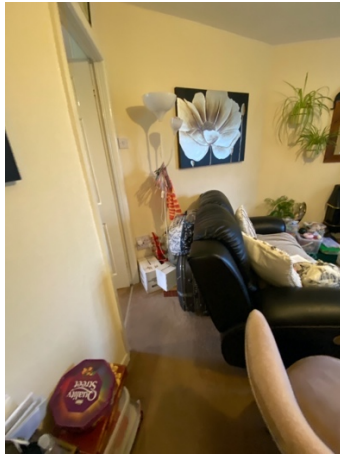
Decoration staining area 4:

Photograph 5: View onto chimney breast within Livingroom

-A specialist damp survey was commissioned by Your Housing Group to chimney breast, this identified that there was high moisture readings to chimney breast wall and identified the cause as being contaminated plaster arising out of historic use of chimney for open fire.

Recommendation is to replace plaster

Given the above we propose to undertake the following works:

- a) Carefully remove existing wall coverings, taking care to form a straight edge to chimney breast, carefully hack off plaster to chimney breast wall
- b) Replaster chimney breast wall using lime plaster as appendix E
- c) Consult with resident and either paint chimney breast wall using breathable paint as Appendix F or apply embossed wall paper and paint to match existing.

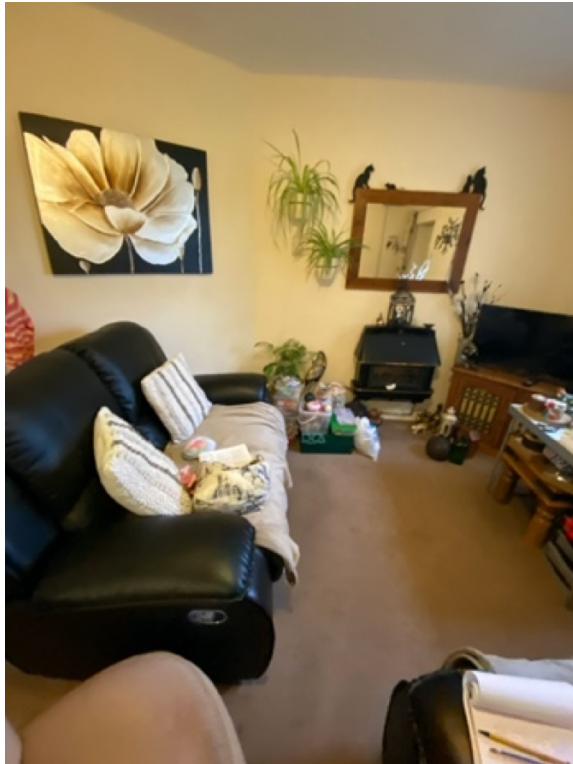
Decoration staining area 5:

Photograph 5: View onto gas fire, on external gable wall

There is evidence of finishes discolouration below the gas fire to external wall. The gas fire is vented direct to external air via a fan assisted flue in gable wall.

Given the above we propose:

Internally:

- a) There is no wall paper to this area
- b) Carefully remove plaster to effected area
- c) Replace plaster with a lime plaster to Appendix E
- d) Make good decoration to match existing, painted embossed wall paper

Externally

- e) Provide access to flue
- f) A gas safe engineer and site manager is to inspect external flue to ensure that there is a suitable seal between render and flue pipe to prevent water ingress.
- g) Make good as required.

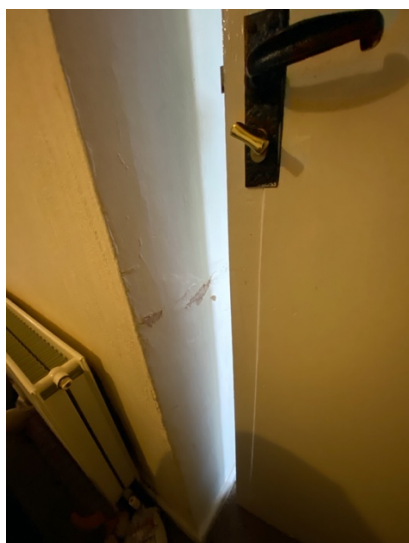
Decoration staining area 6:

Photograph 6: View onto front door reveal
There is evidence of chalking to plaster and paint finish

We propose the following:

Internally

- a) Carefully cut back any wall paper locally to a neat edge to expose effected area
- b) Carefully remove plaster to effected area, review condition of plaster bead
- c) Replace plaster with a lime plaster to Appendix E, replace galvanised plaster bead if necessary
- d) Make good decoration to match existing, painted embossed wall paper
Make good as required.

Externally

Replace chimney flashings to lead sheet associations recommendations ensuring suitable upstand. Apply patination oil.
