CONDITION REPORT

FOR PROPOSED DEMOLITION OF OUTBUILDING AT:
CHERRY HALL,
MAIN STREET,
GRINDLETON,
BB7 4QT

Job No. 6753
December 2022
Version 1.0

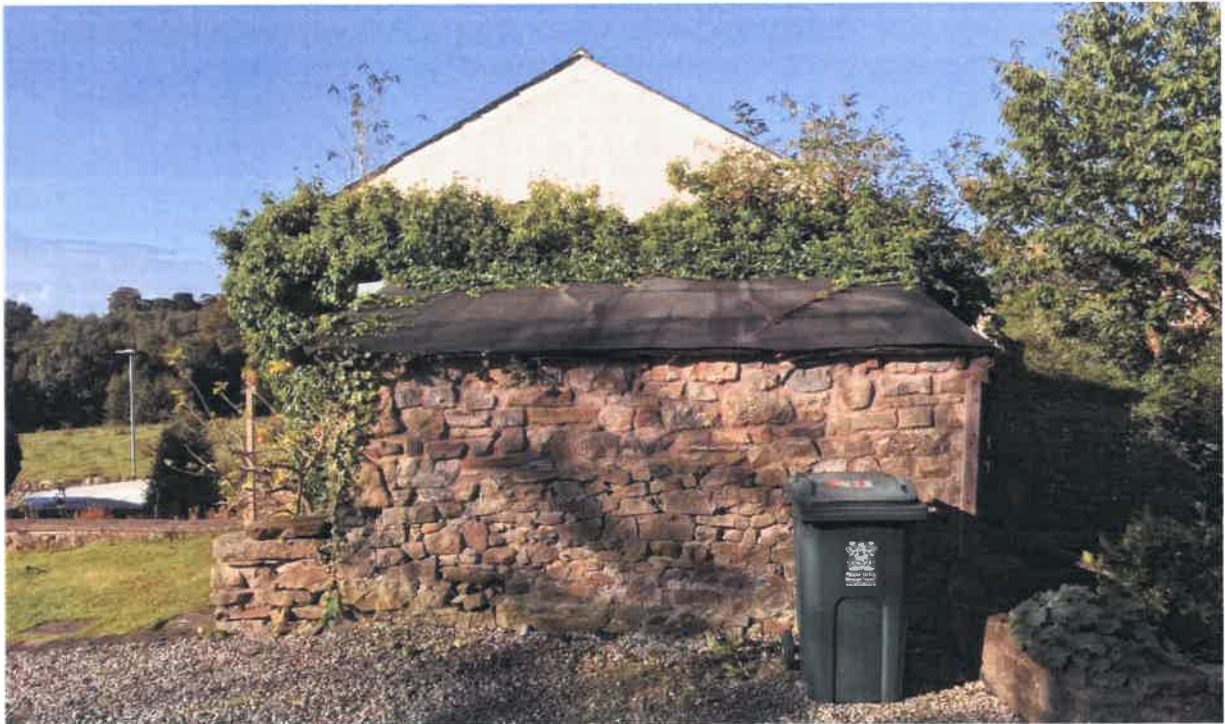
PL02 - Photograph of the existing east elevation of the outbuilding

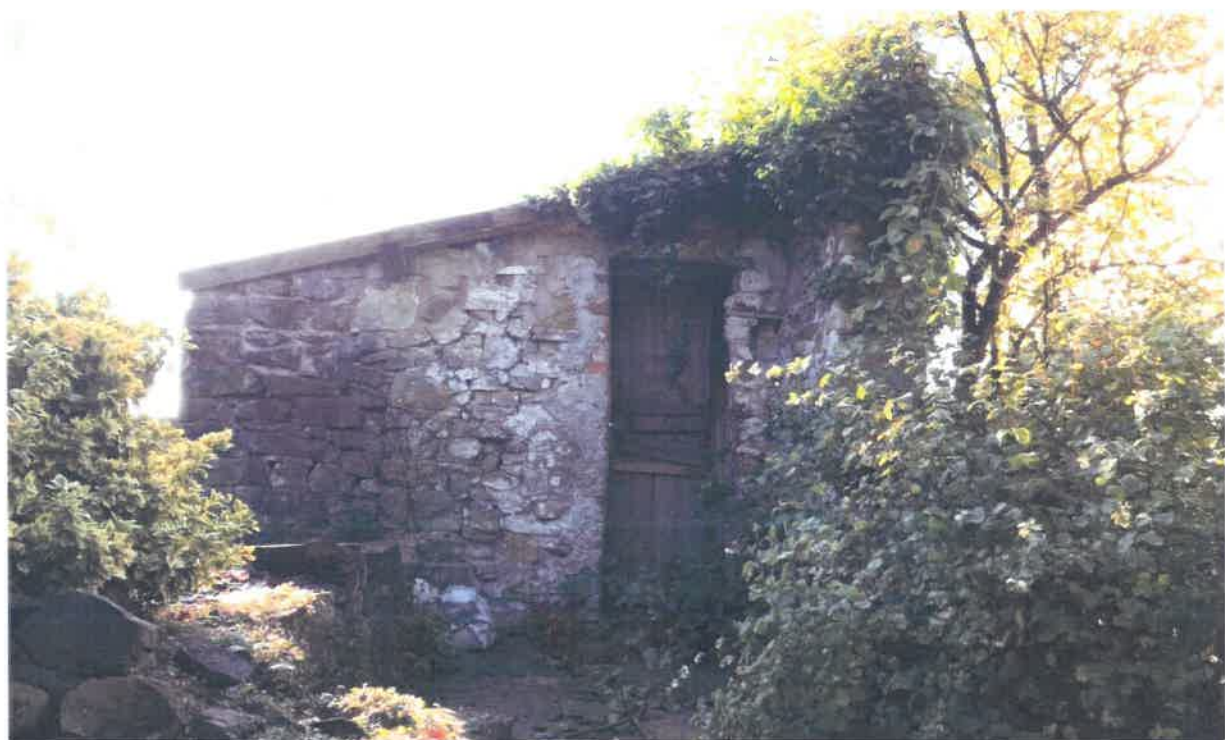
PL03 - Photograph of the existing north elevation of the outbuilding

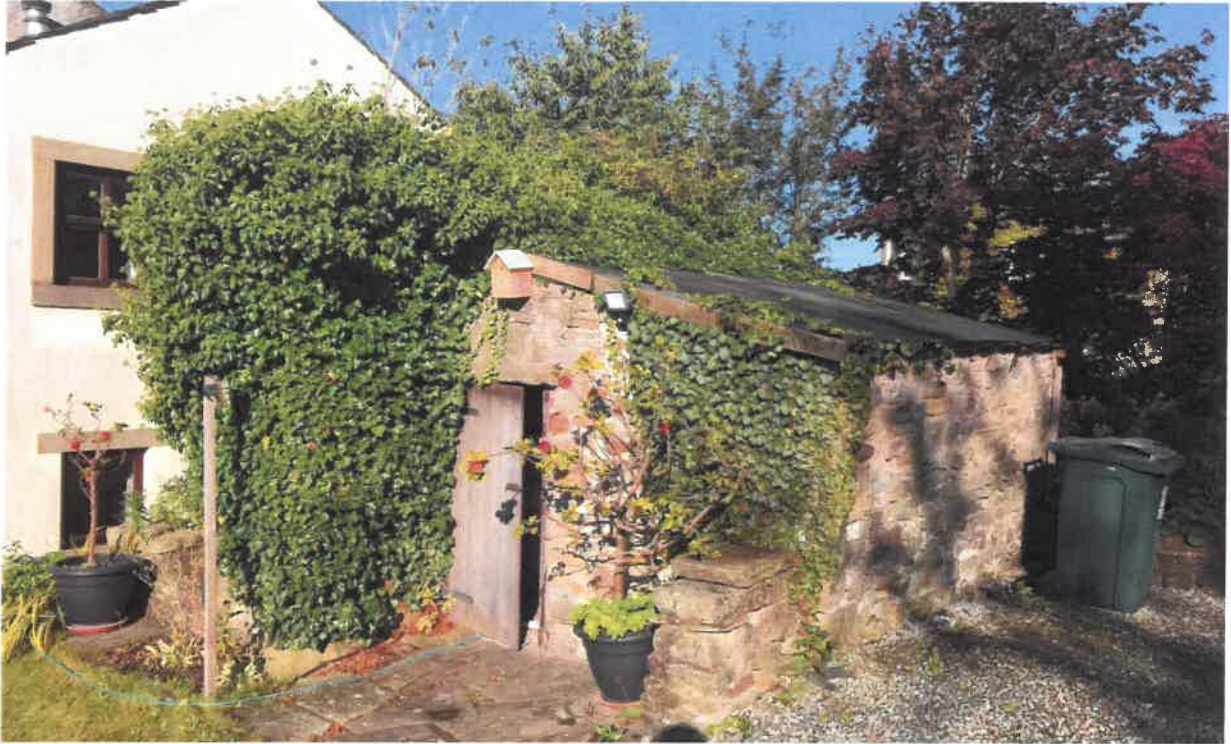
PL04 - Photograph of the existing south elevation of the outbuilding

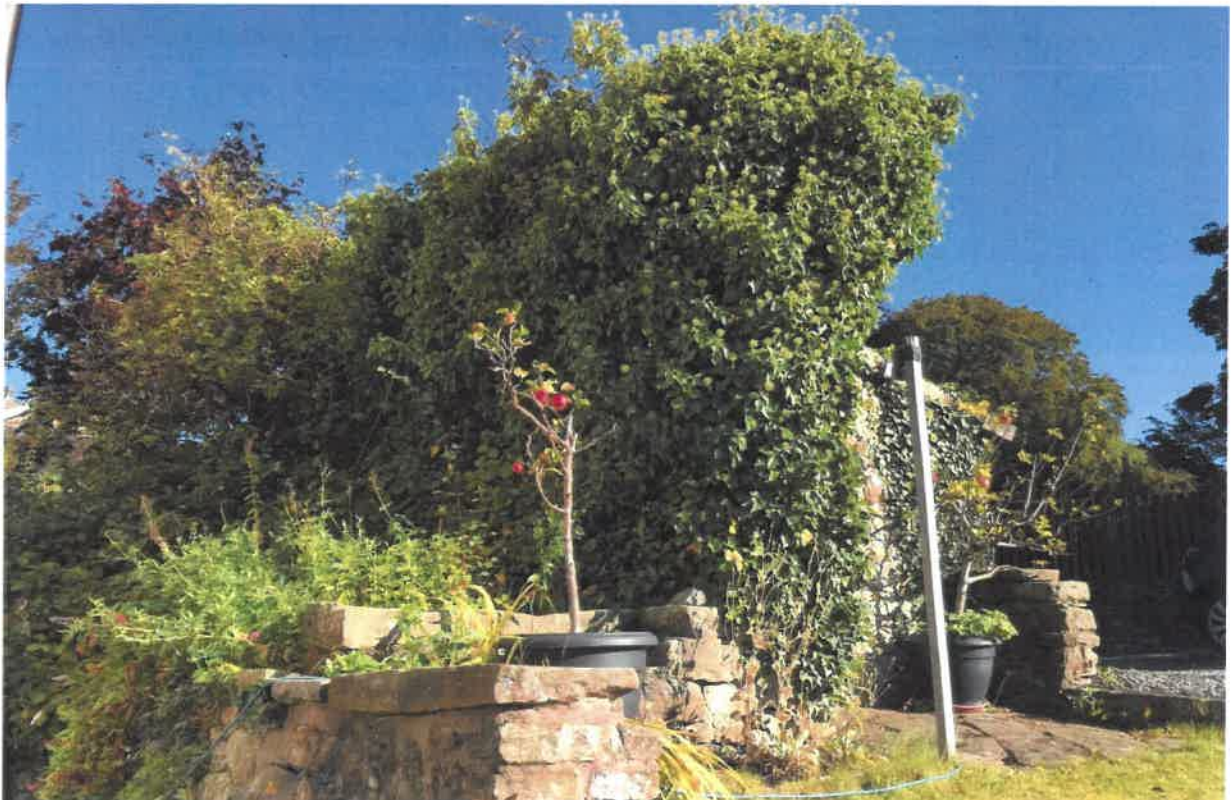
PL05 - Photograph of the existing south/east elevations of the outbuilding

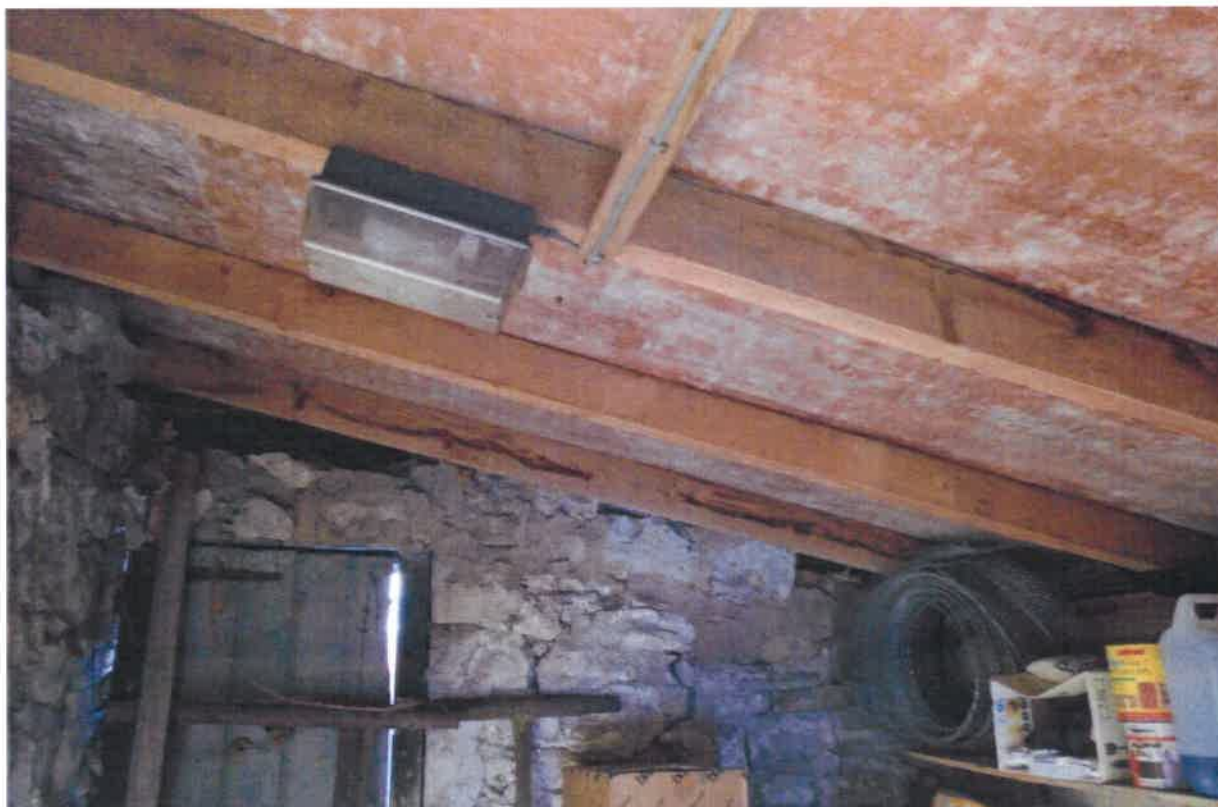
PL06 - Photograph inside the outbuilding, showing the modern roof structure.

- 4.1 The existing roof structure is mono pitched, consisting of modern timber rafters with plywood and felt roof finish over. No rain water goods are present. The roof appears to be a modern refurbishment attempt, using finishes of poor quality.
- 4.2 The roof is also subject to damage by the ivy plant growing up the west wall, compromising its integrity.

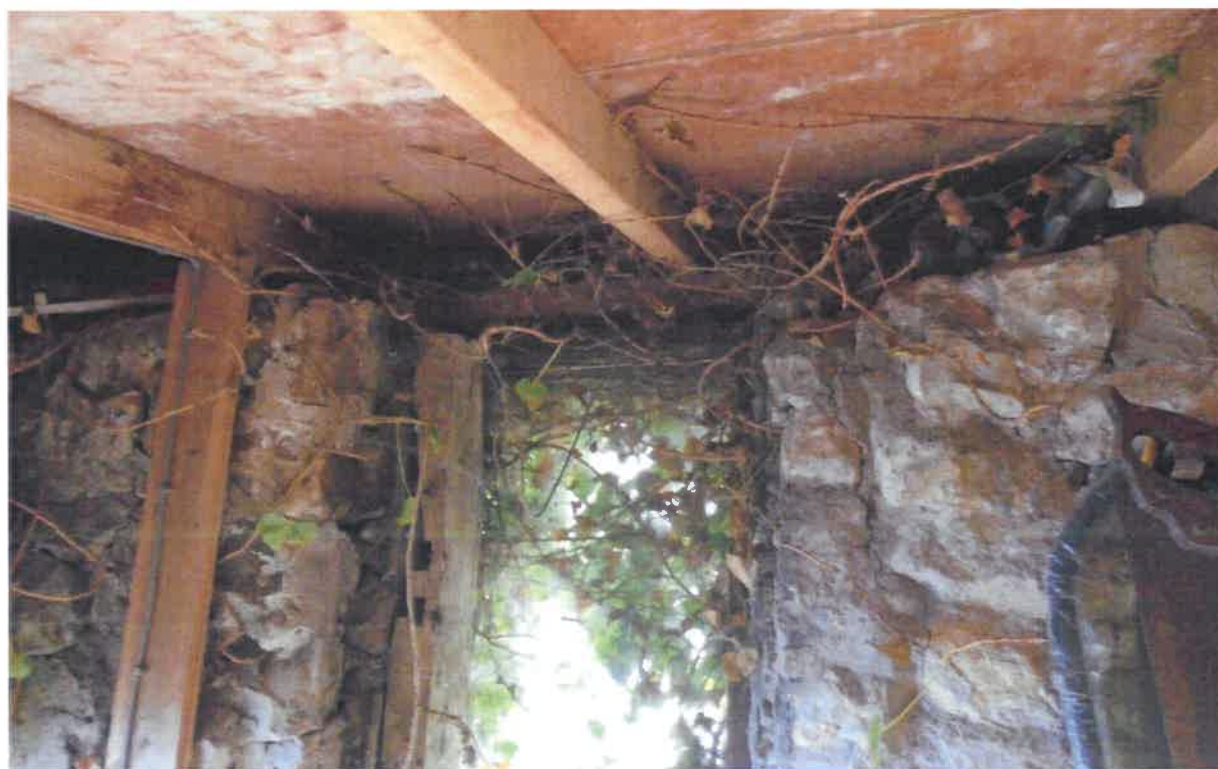
PL07 - Photograph inside the outbuilding, showing the ivy penetration internally.
