**Structural Appraisal
of
Mill Building at
Chipping, Lancashire
for 53N**

Date: October 2013

Job Number 12-155

**KIRK MILL
CHIPPING
NR PRESTON**

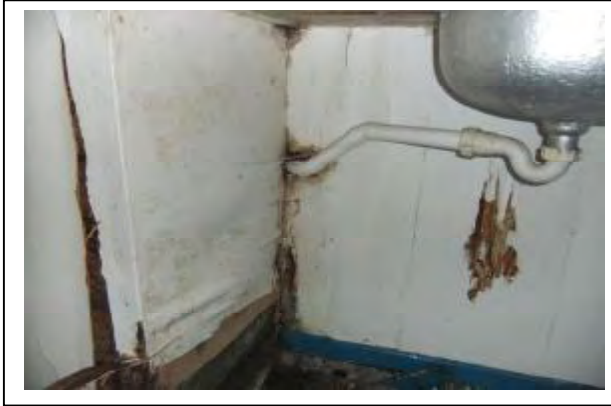
Large fruiting body indicating the presence of the True Dry Rot Fungus (*Serpula lacrymans*) was noted to the base of the kitchen sink unit, extending to floor boarding and timber panelling to the front elevation wall. Large strands of mycelium were noted to the exposed wall surfaces behind the sections of panelling removed.

Dry Rot noted to the panelling affixed to the front elevation of the third floor former showroom

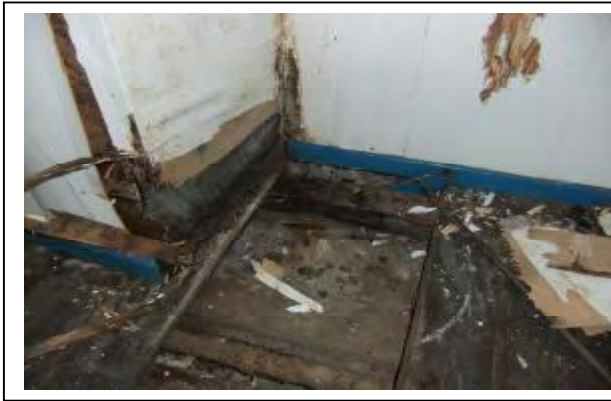
Further exposure works to the panelling and floor boards within the alcoves forming the front elevation

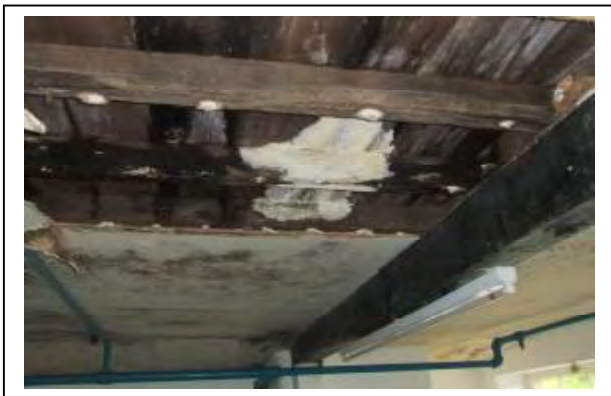
Further Dry Rot Decay in the form of sheet mycelium growth was evident to the mezzanine floor level above the former showroom area, extending to affect floor boarding and floor joists below. This outbreak was directly below a section of defective roof slating.

Sheet Mycelium growth to the underside of the mezzanine floor above the former showroom

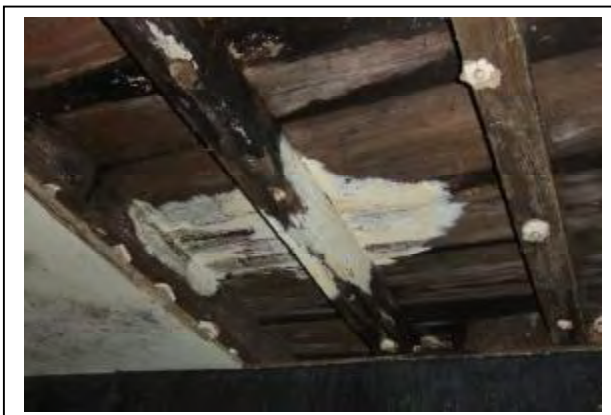
Closer view of Dry rot outbreak. Cut out and treat adjoining timbers as detailed within the report

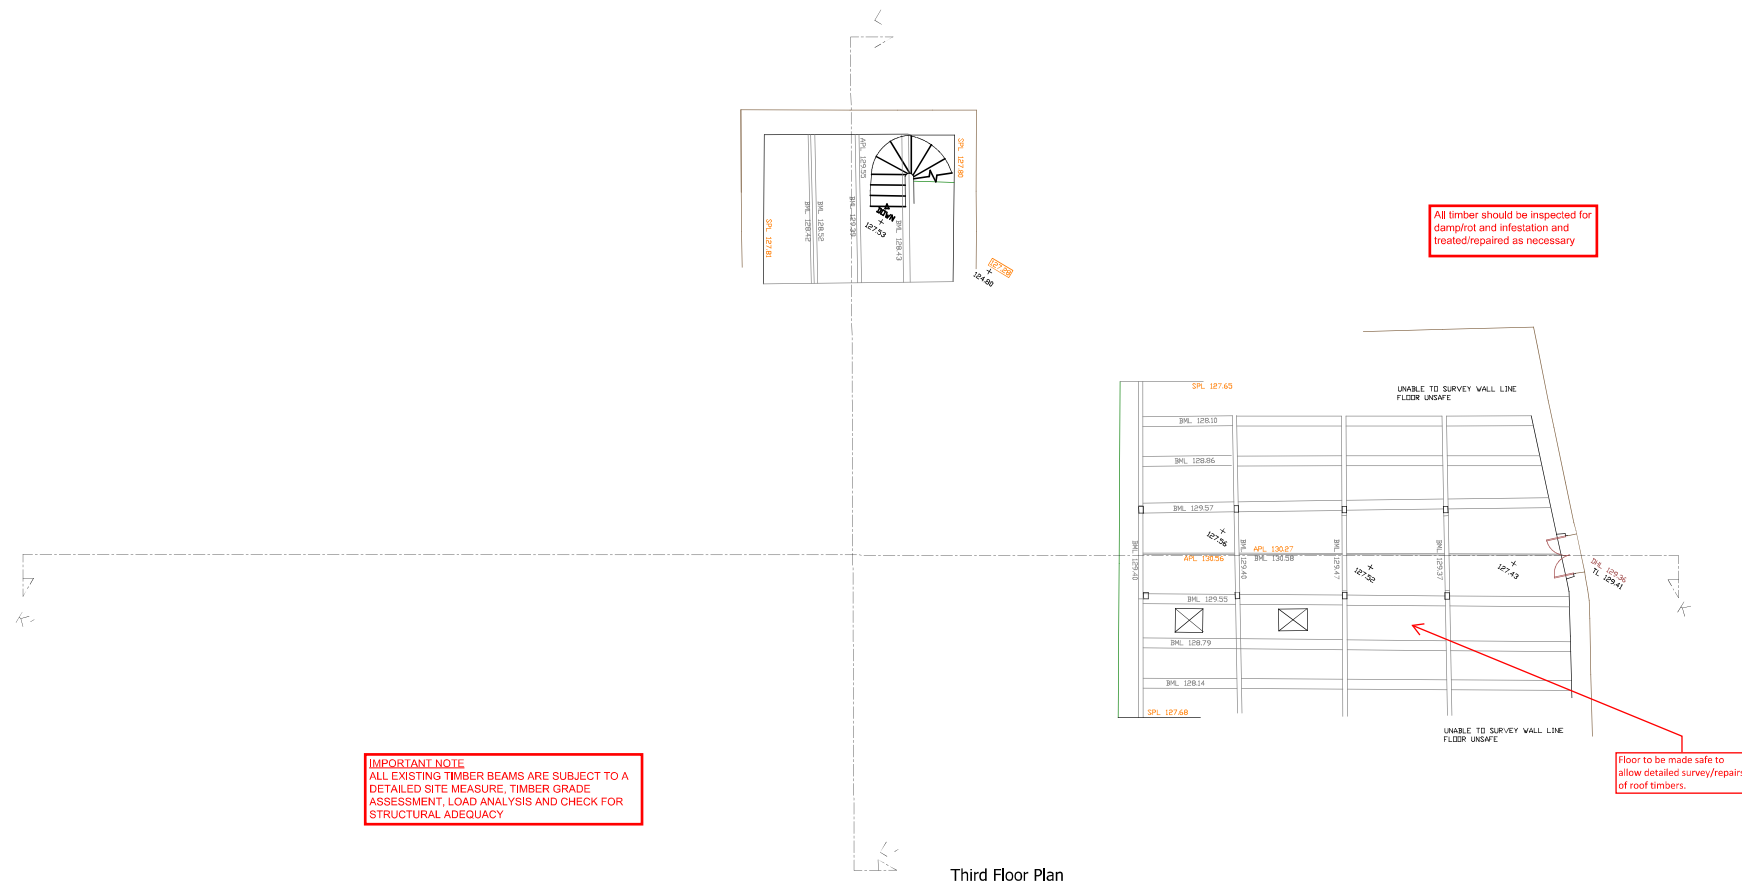
Third Floor Plan

Floor to be made safe to allow detailed survey/repairs of roof timbers.

IMPORTANT NOTE
ALL EXISTING TIMBER BEAMS ARE SUBJECT TO A DETAILED SITE MEASURE, TIMBER GRADE ASSESSMENT, LOAD ANALYSIS AND CHECK FOR STRUCTURAL ADEQUACY

All timber should be inspected for damp/rot and infestation and treated/repairs as necessary
