STRUCTURAL APPRAISAL REPORT

Phynis Farm, Slaidburn

Barn A

Job No.14619

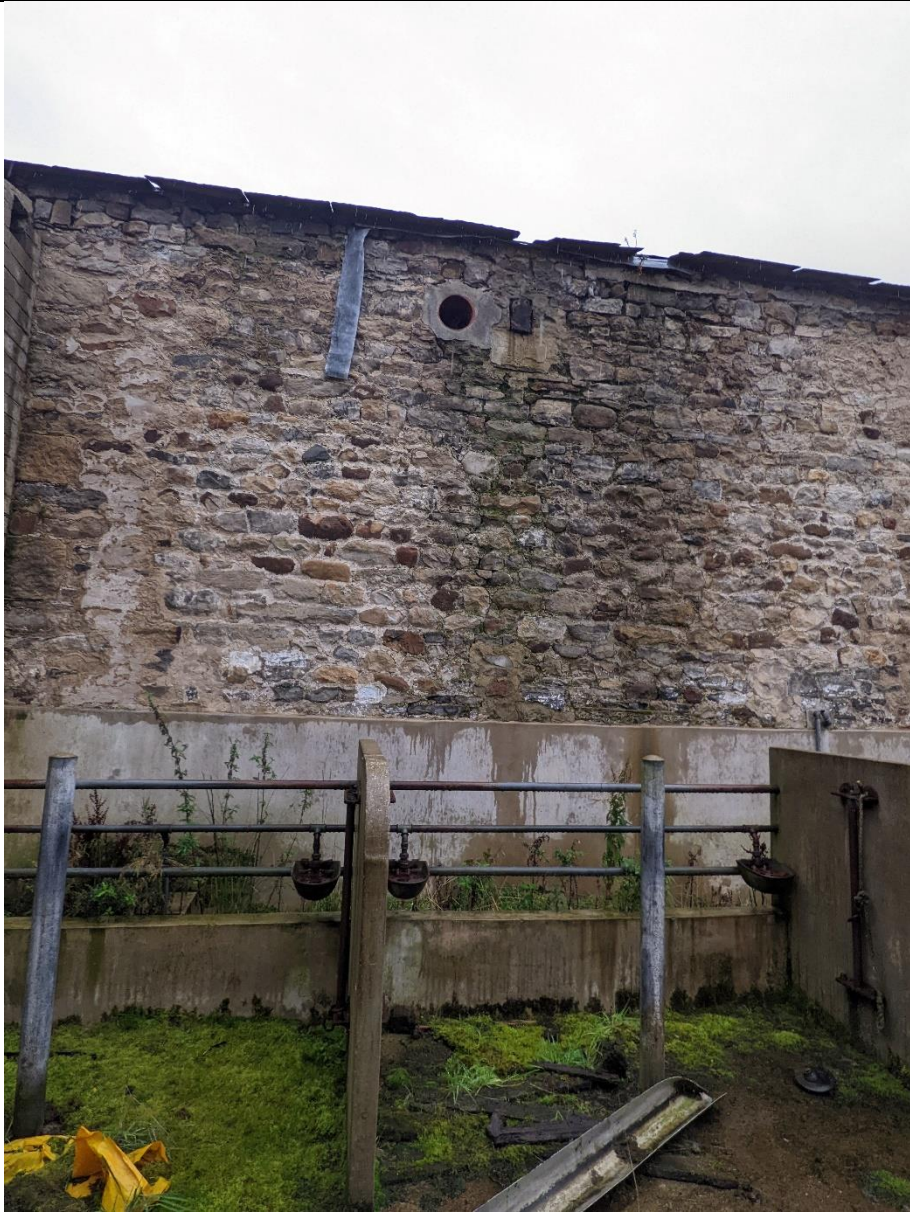
Gutters and rainwater pipes are missing in several places.

There are some slipped and missing tiles and these are allowing water ingress.

Rear elevation, missing tiles at eaves and gutters, allowing water to run down the wall. Pointing is in reasonable condition.

- The building should be inspected by a specialist in rot and infestation. Recommendations arising from that inspection should be actioned.
- Rainwater pipes and gutters are missing in places. All waterproofing and rainwater goods require replacement to protect the building fabric.

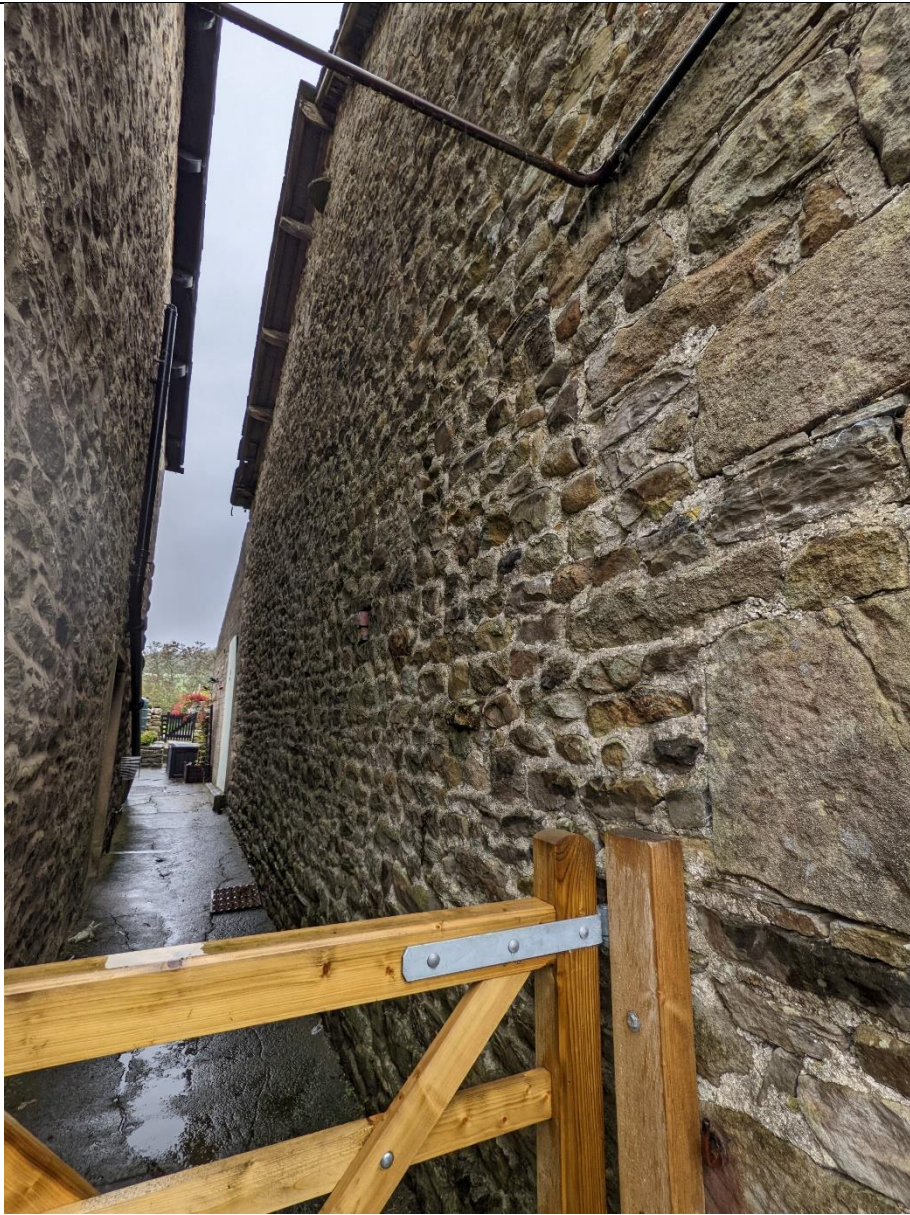
Gable Wall, adjacent to farmhouse, pointing in good condition

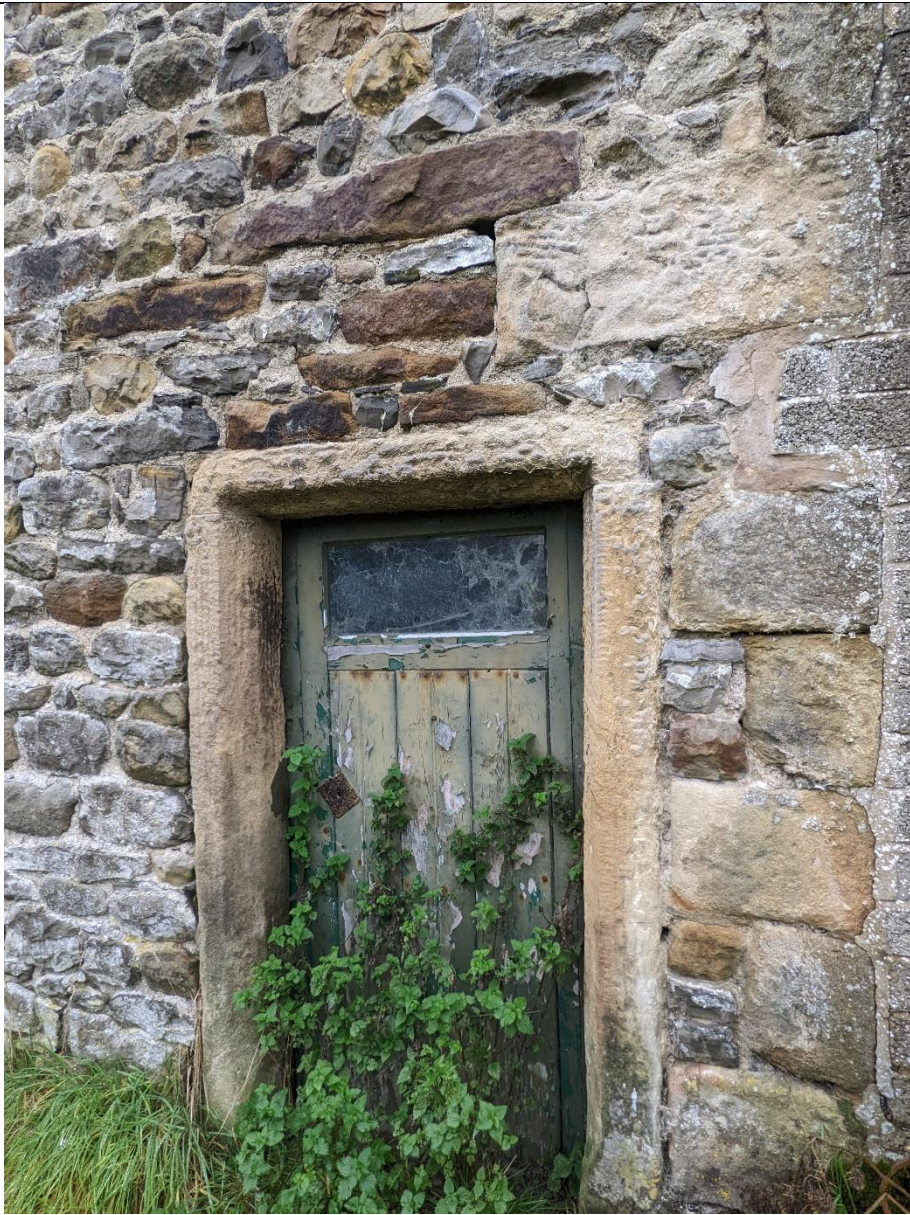
Gale wall, sandstone door surround is weathered, but not structurally significant. Blockwork to shipon block bonded into stone coins.

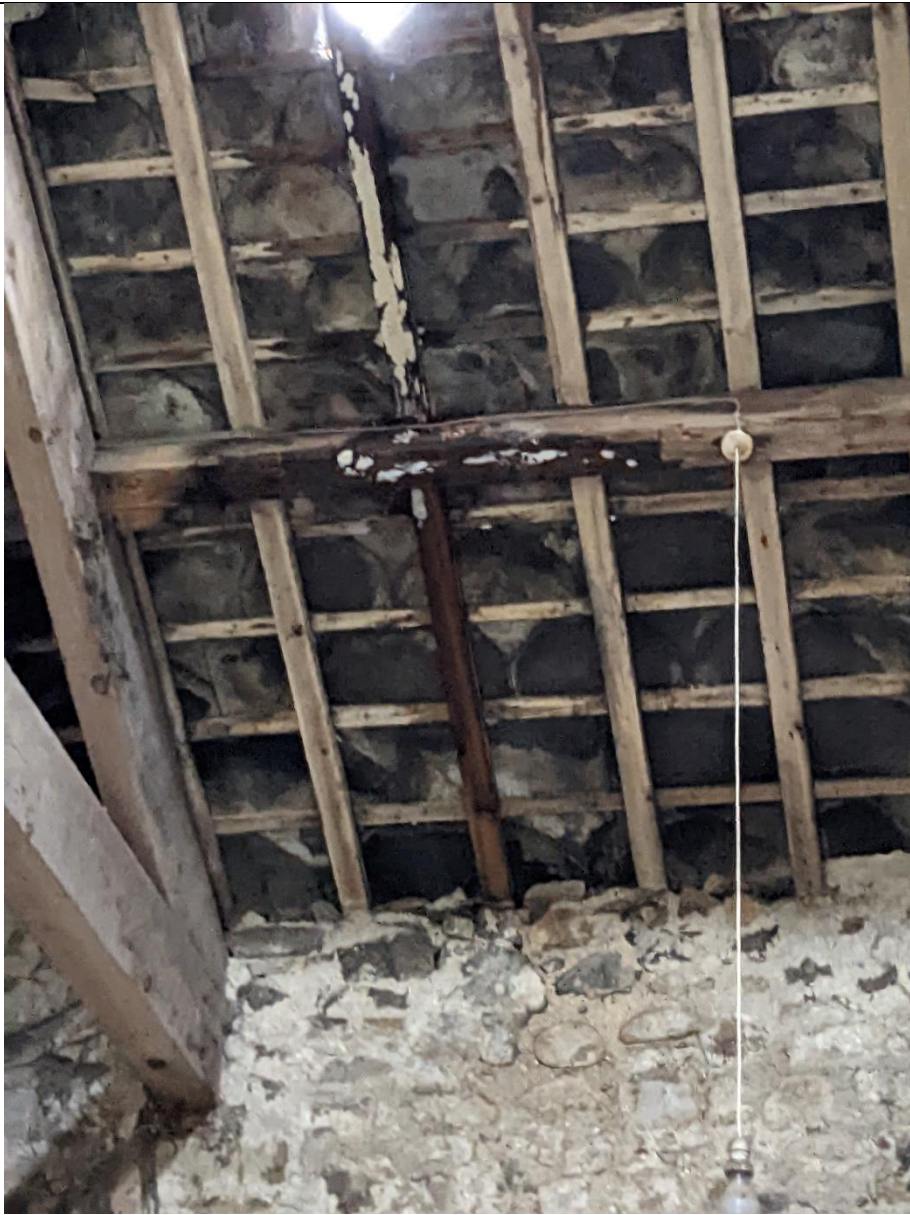
The ridge of the pitched roof is acceptably straight, although there is a noticeable belly on the south east pitch which may be indicative of a local timber failure.

As a result of water ingress there are indications of rot to some roof timbers, most noticeable to the purlins and rafters on the South East pitch towards the middle of the roof.

Suspected rot in purlin and rafter due to water ingress.

- There is partial sarking felt below the stone tiles on the pitched roofs. This should be repaired/replaced/installed during the conversion works.
- There is local evidence of rot to some roof timbers. It is clear that water ingress has occurred.

- These truss ends must be inspected by a specialist as these are bearing into the masonry walls, and as we note, the guttering is in poor condition.
- There is evidence of woodwork infestation to the hayloft supporting timbers. It is possible that this also applies to the roof timbers. These should be inspected by the specialist and treated as appropriate. It is unlikely that the hayloft structure would be retained as part of the conversion due to the low head height.

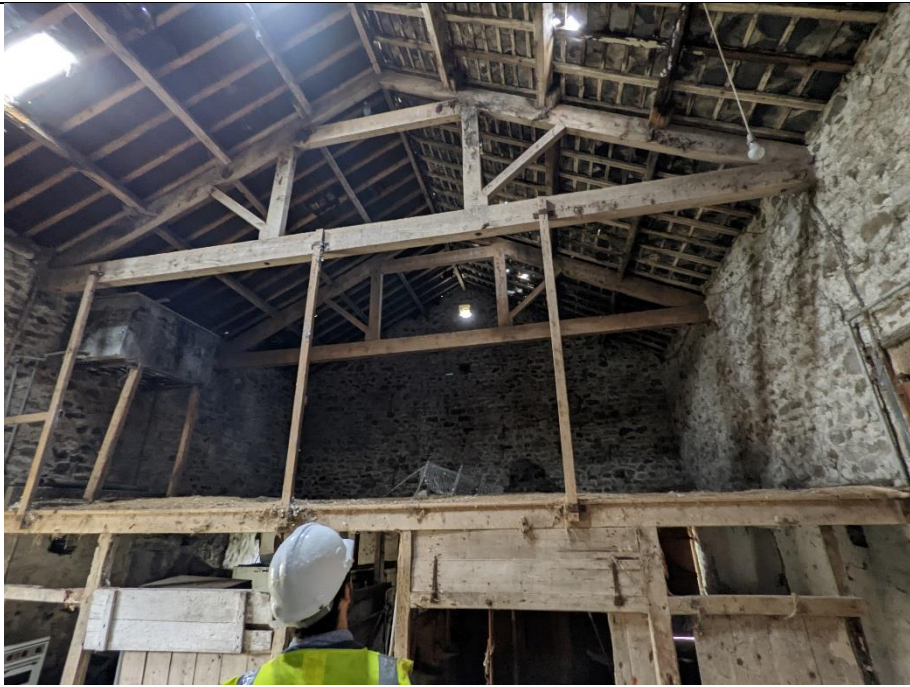
The primary roof trusses are substantial, with the ties being a single piece of timber for the full span of the barn. For the most part the trusses seem to be dry and not showing excessive deflections' trusses bear into the walls and their ends could not be inspected.

The northern pitch seems to have been re-roofed at some time in the recent past with a roofing felt between the rafters and battens. In some places the felt is torn, and the sky can be seen through the holes. This is not the case for the southern pitch.

Interior view showing trusses, and hayloft. Note holes in roof.

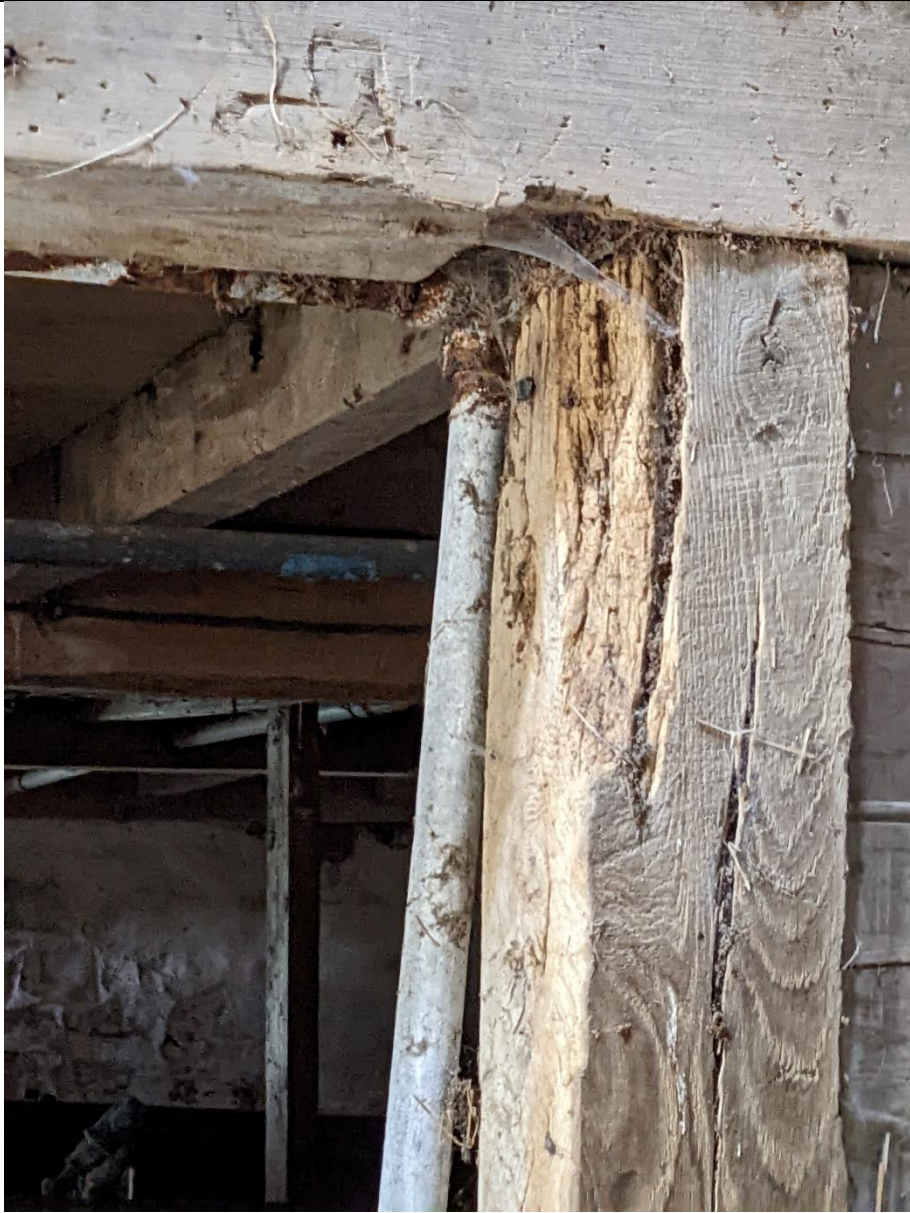
Timbers supporting the loft have been affected by woodworm.

Woodwork affected timber in stalls
