## **STRUCTURAL APPRAISAL REPORT**

**Phynis Farm, Slaidburn**

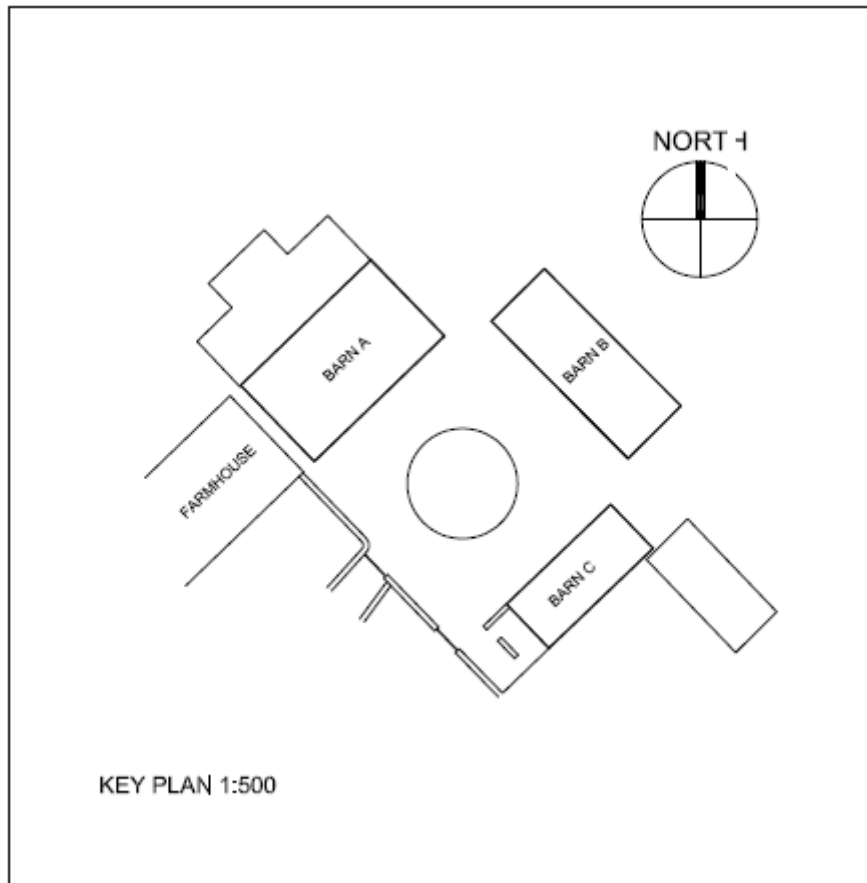
FIGURE 1 SITE AERIAL VIEW

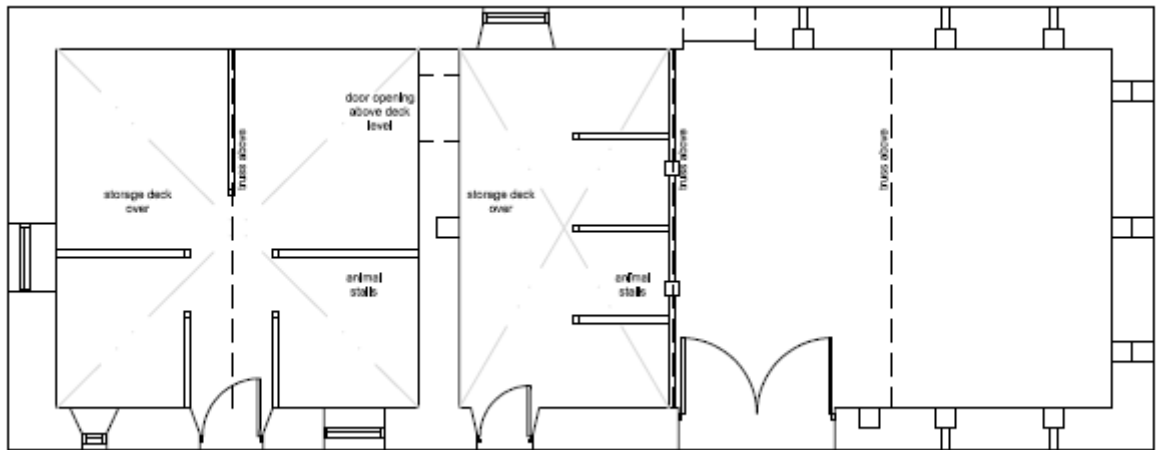
FIGURE 3 GROUND FLOOR PLAN

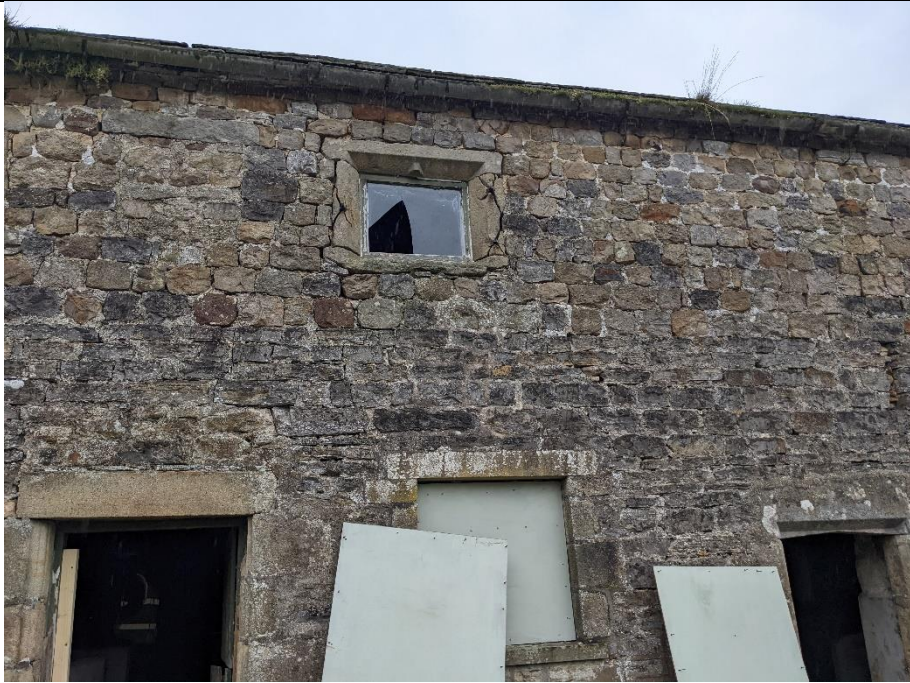
Front elevation, broken stone jambs to first floor window

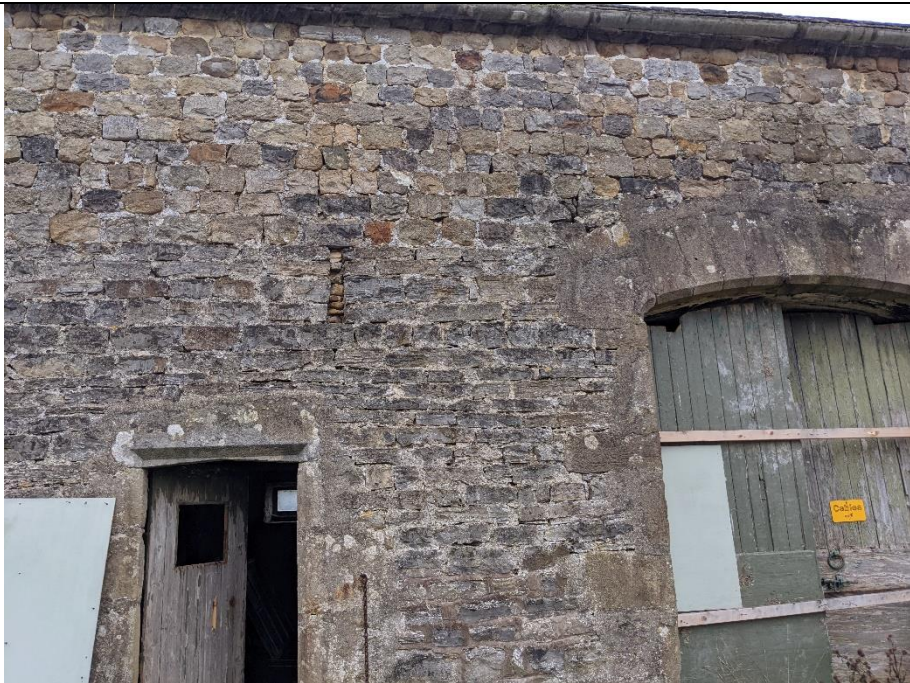
Front elevation, middle. Different masonry colouration and coursing above level of arch springing. Possibly historic re-construction.

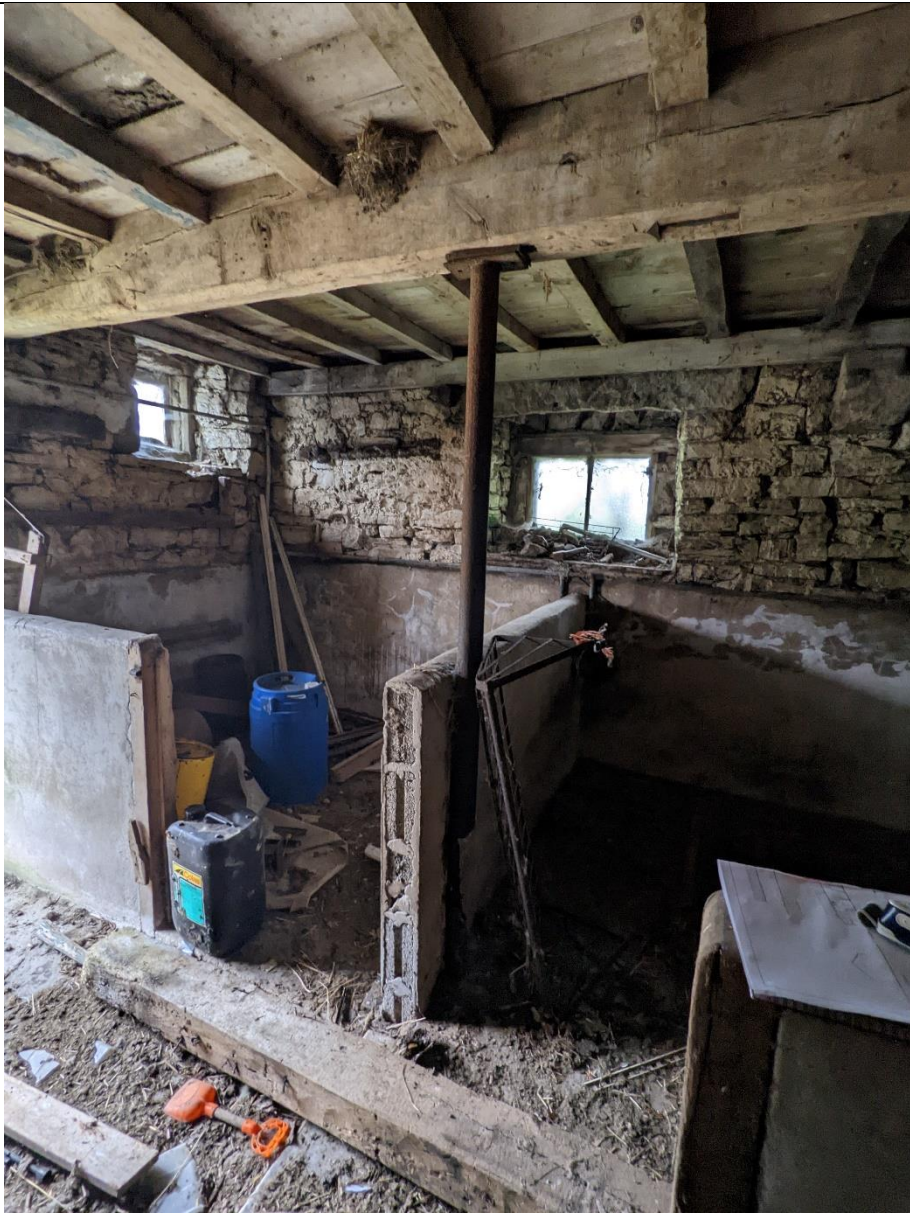
Steel prop installed under timber beam. Note bottom 1/3<sup>rd</sup> of prop is missing due to corrosion..

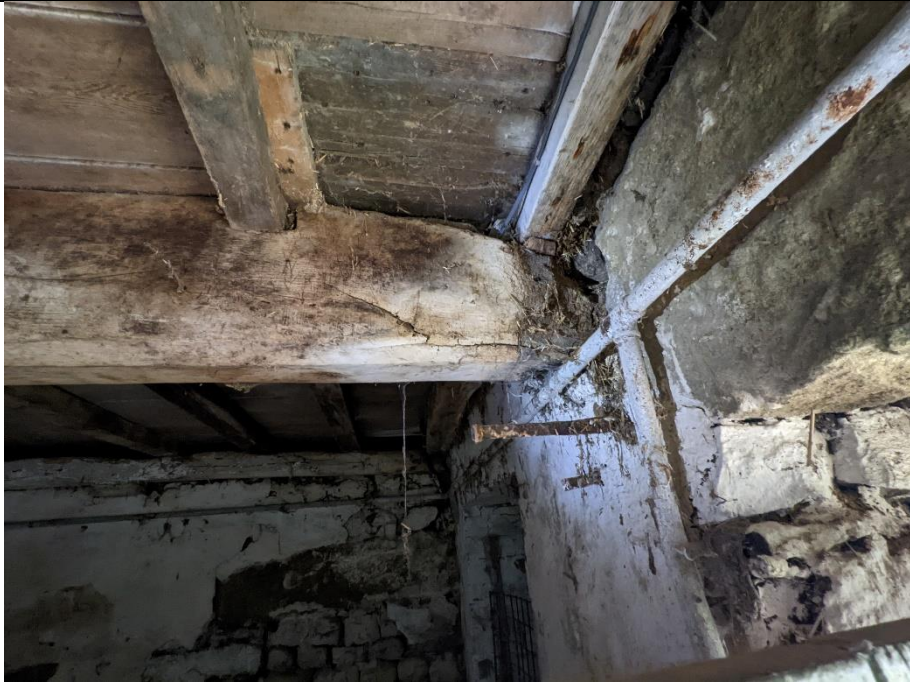
Timber beam supporting loft in left hand room, loss of section from rot at bearing in front wall.

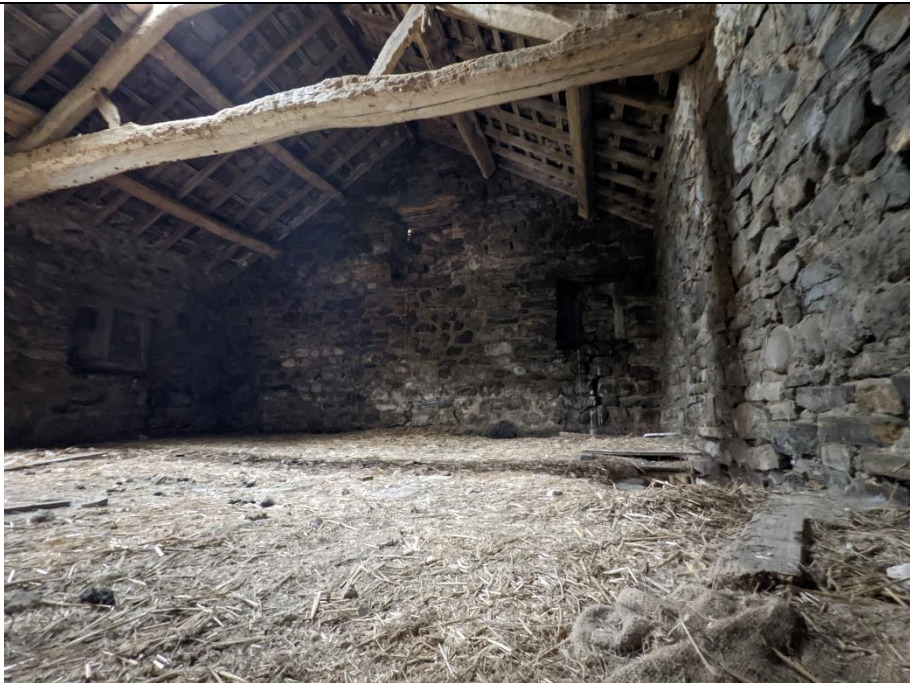
View into loft from hatch. Floor is uneven. Roof appears intact. Rustic truss appears affected by woodworm. Floor is uneven. Not entered, due to condition of timbers viewed from below.

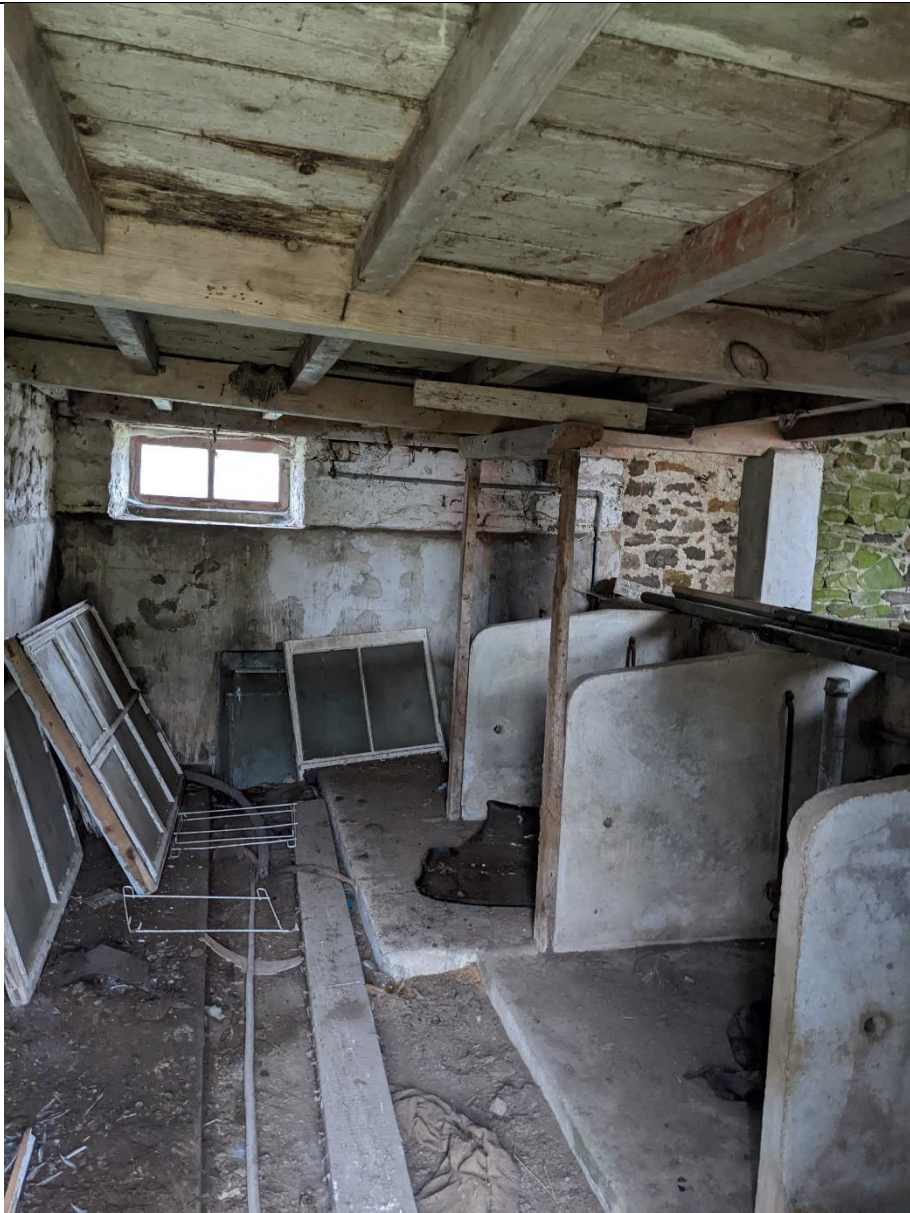
View into stalls in middle portion of barn. Timbers to loft over appear in reasonable condition, not original.

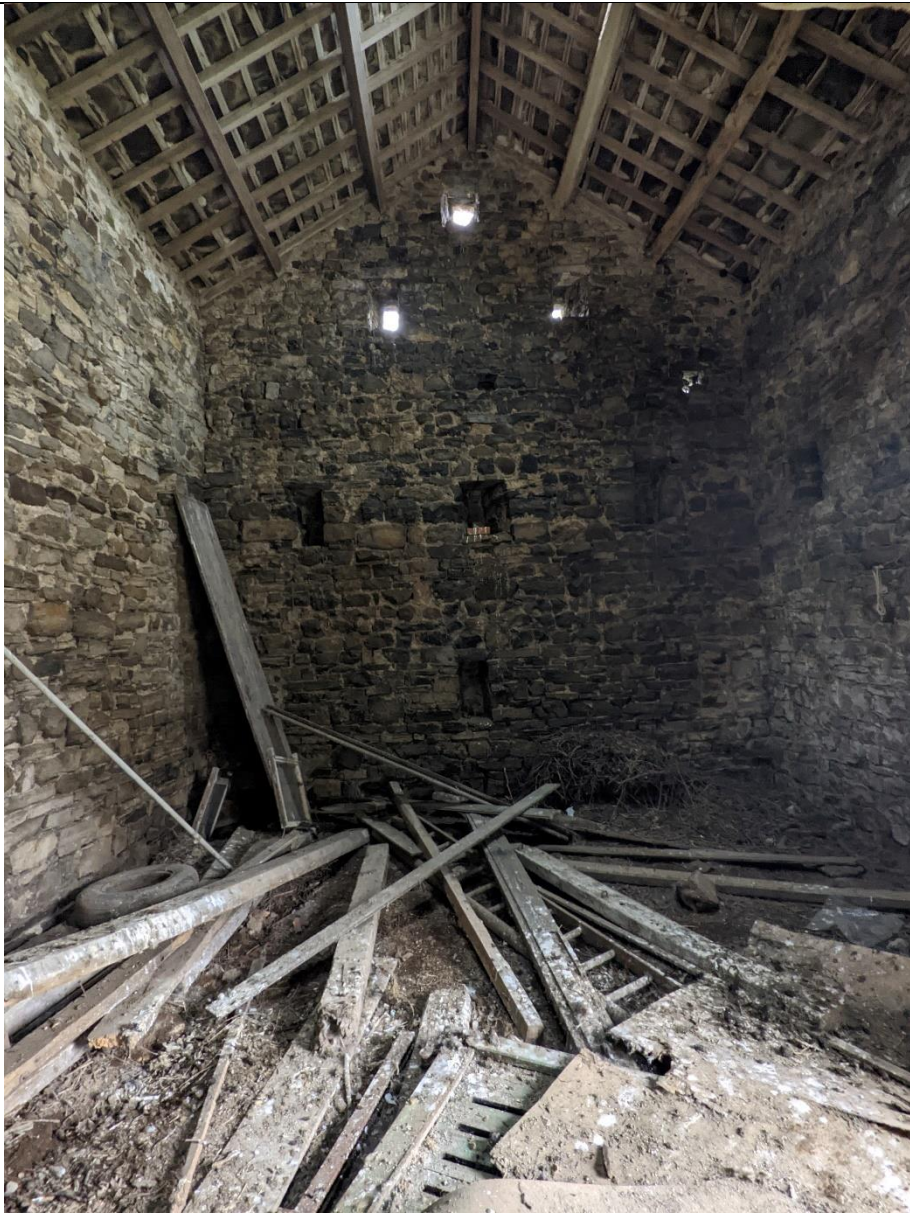
View in main barn. Roof timbers appear in reasonable condition. Top of walls appear to have been recently re-pointed, possibly at the time of ree-roofing. No sarking felt.

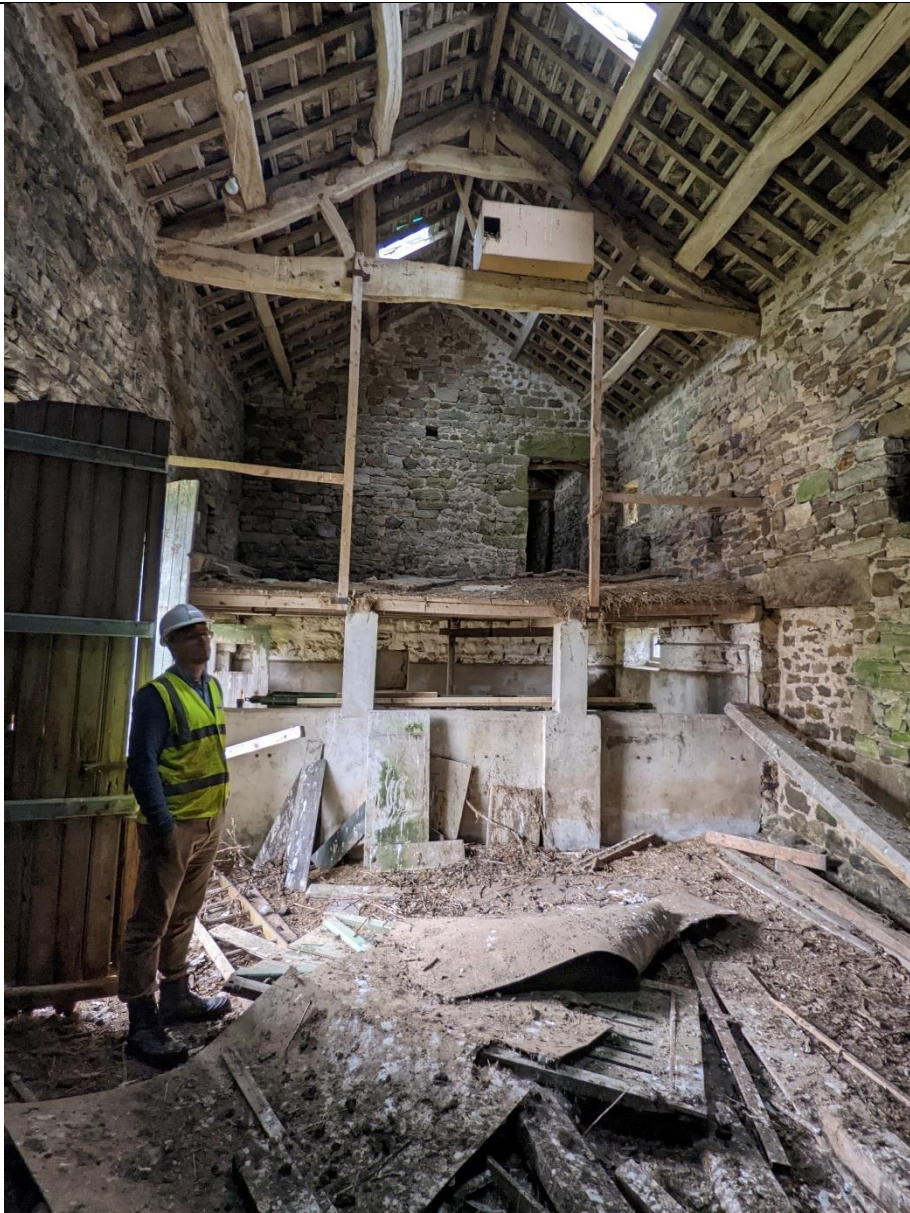
View back to the loft in the main barn. Some purlins seem original hewn beams. Walls reasonably plumb.

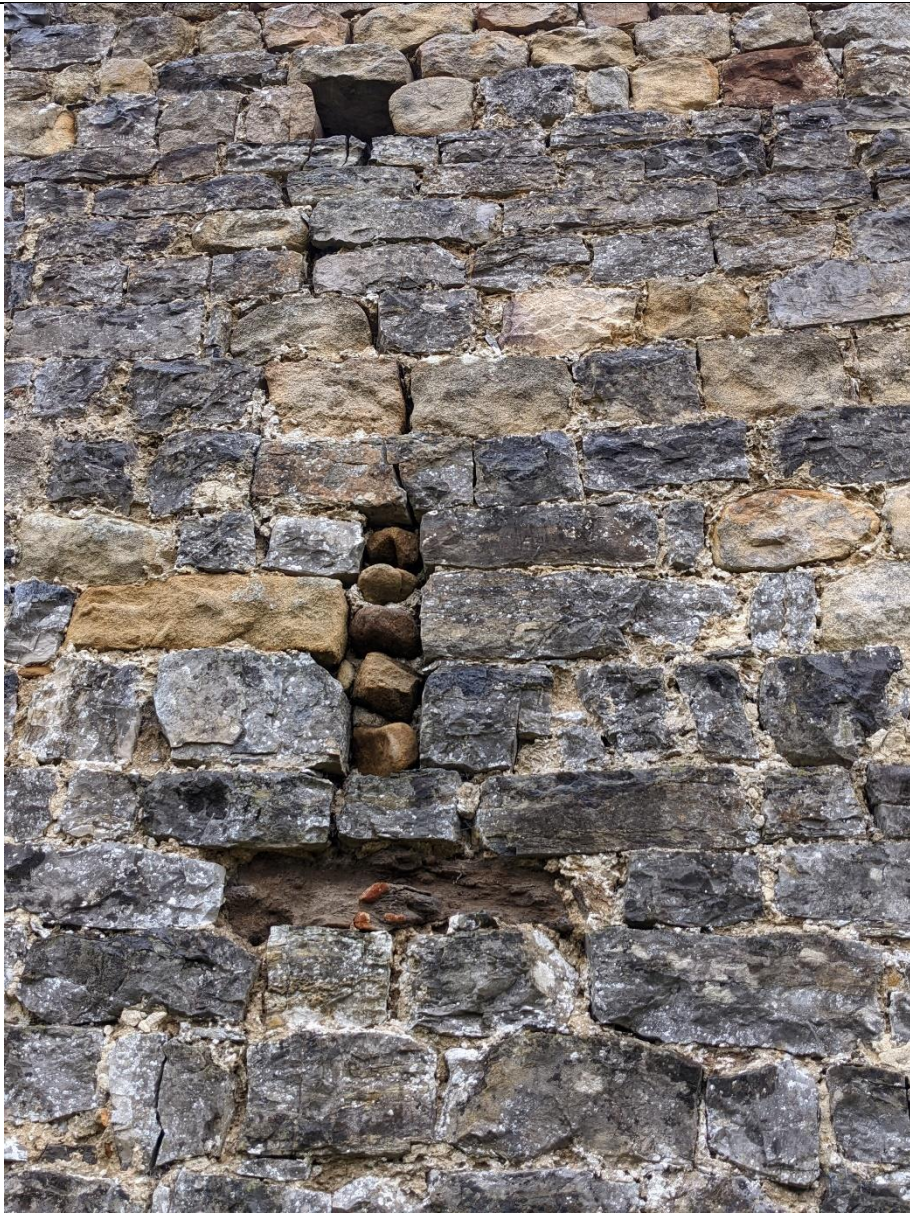
Vertical crack in middle of east gable, stone block over infilled slot has cracked. Possible settlement in foundation causing hogging in the wall. Appears long standing.

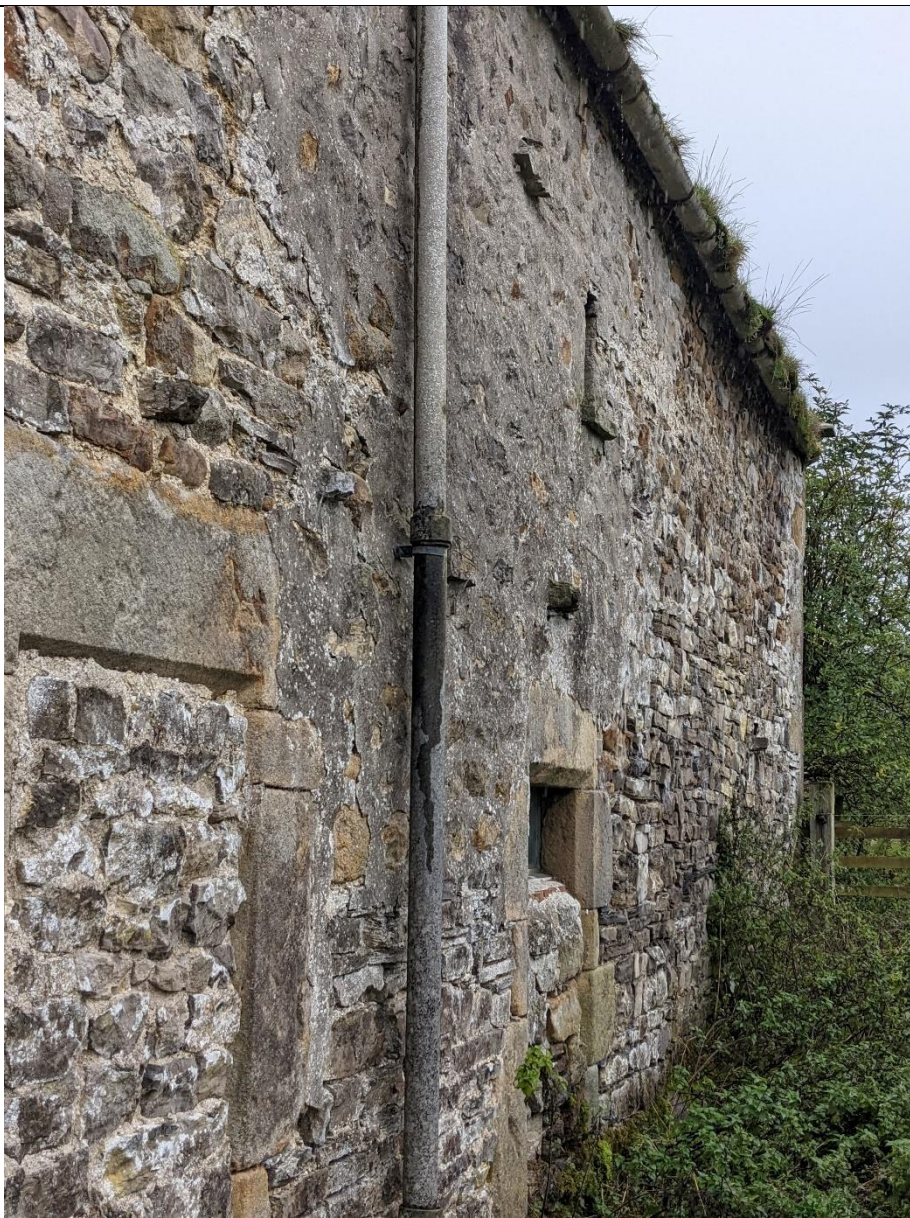
Rear elevation- vegetaion in gutters to be cleared and downpipe repaired.

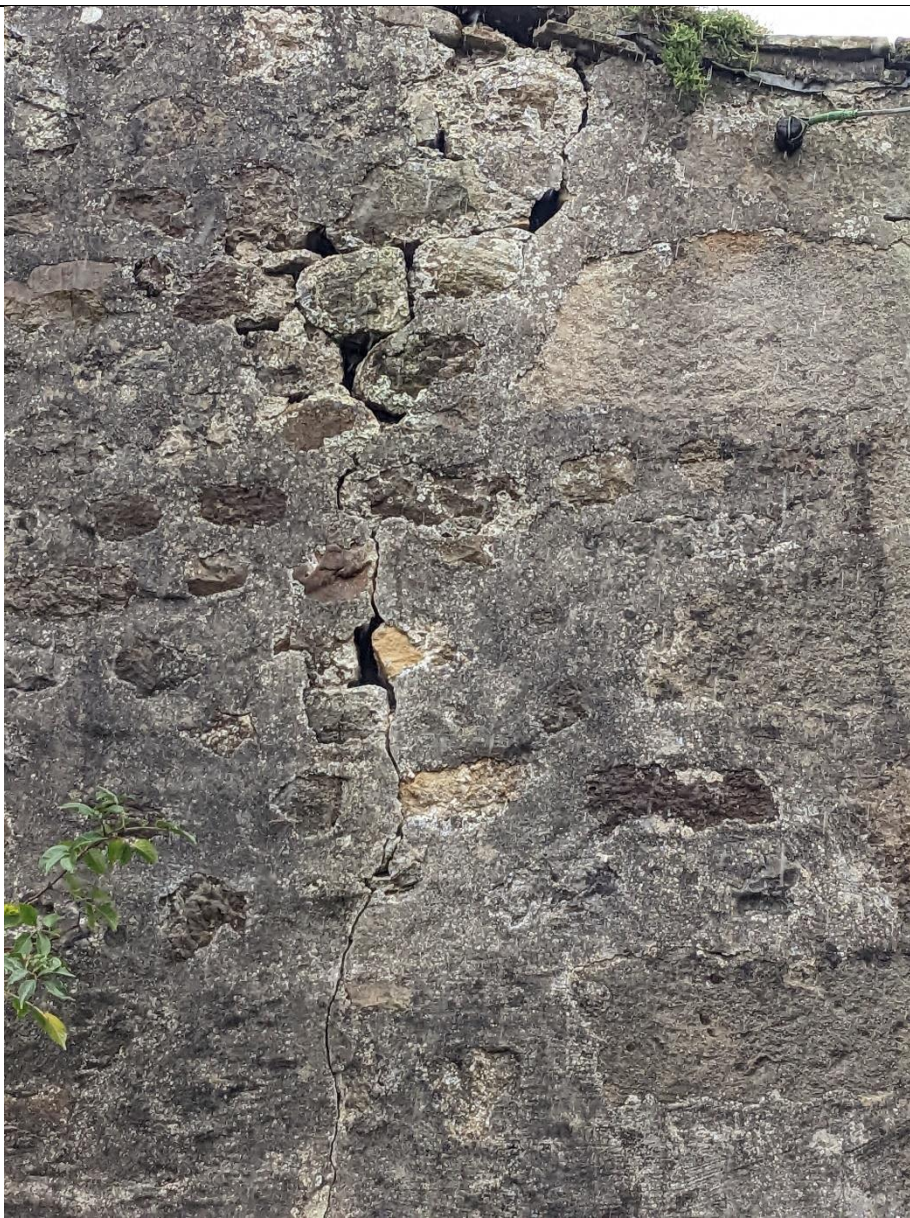
Crack in west gable at verge near south kneeler stone.
