## **STRUCTURAL APPRAISAL REPORT**

**Phynis Farm, Slaidburn**

**Barn C**

**Job No.14619**

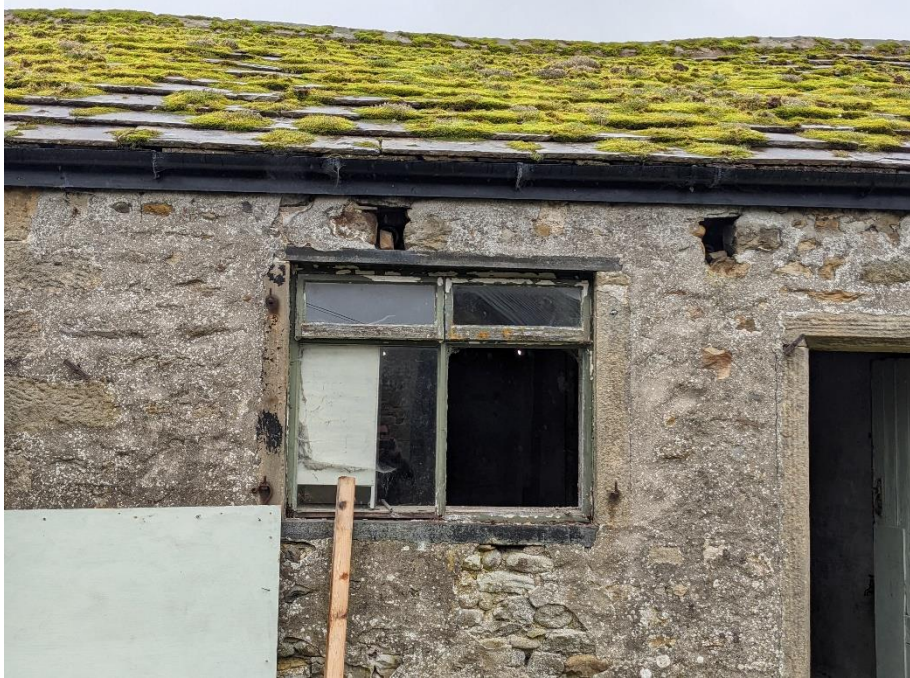
External lintels over doorways and windows are stone, with one timber lintel to the front window and there is a timber lintel over what was originally a wide opening. These are generally sound with no obvious significant movement.

Close up on front window with timber lintel, which may be considered for replacement

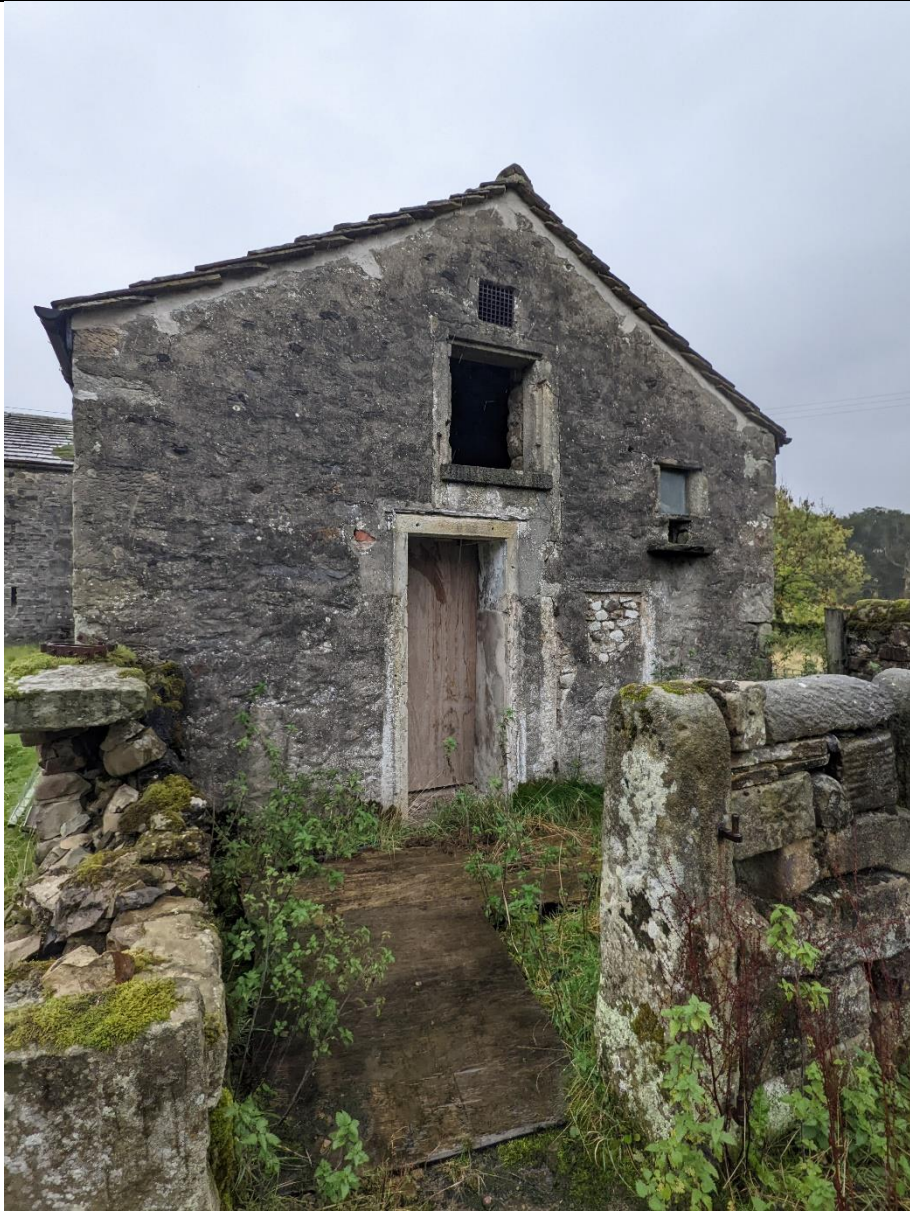
Right hand gable

There are openings in the right gable, with minor cracking between the stone mullions and lintels and masonry.

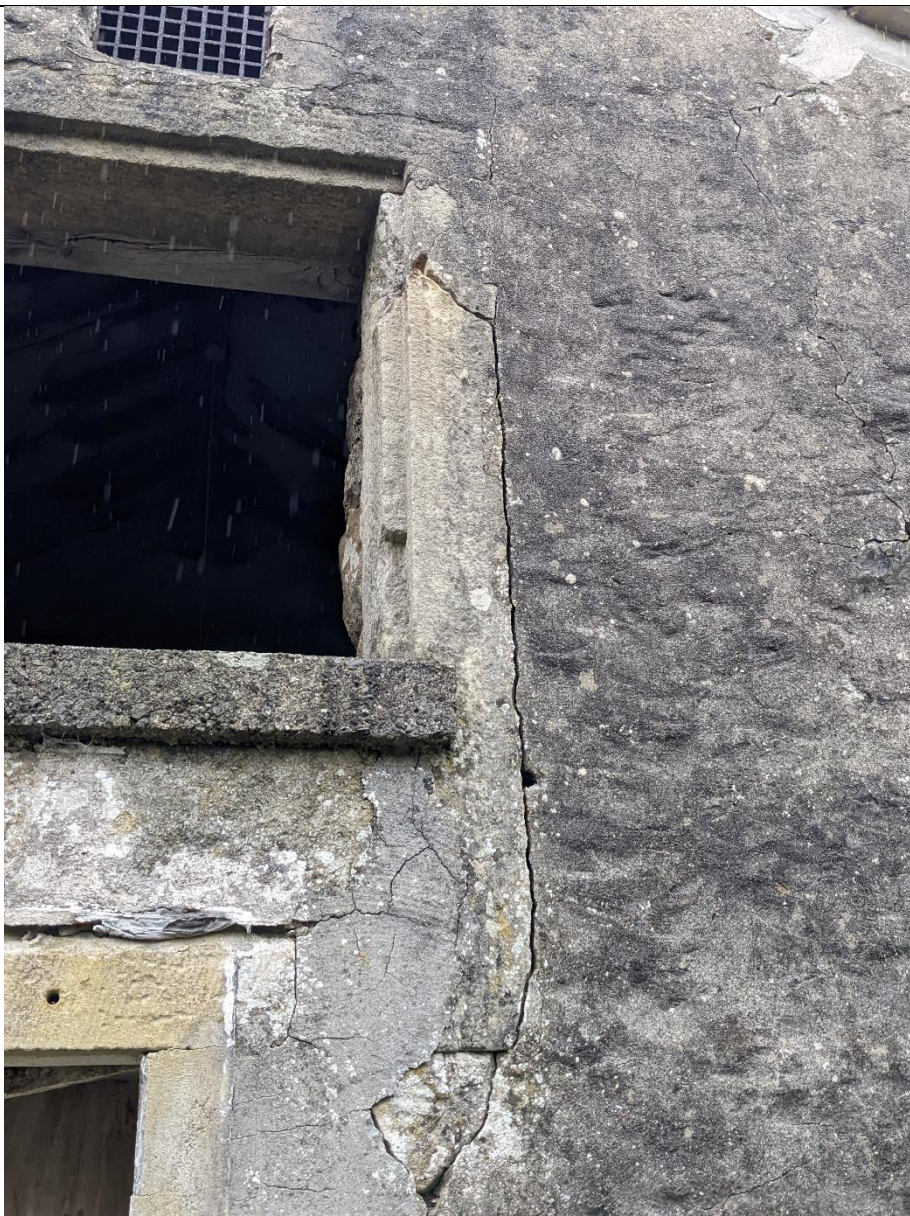
There are openings in the right-hand gable, where there is cracking between the stone Jambes and lintels and the masonry. These are indicative of some movement in the foundations but appear long standing.

Crack in right hand gable between RH stone jamb and masonry.

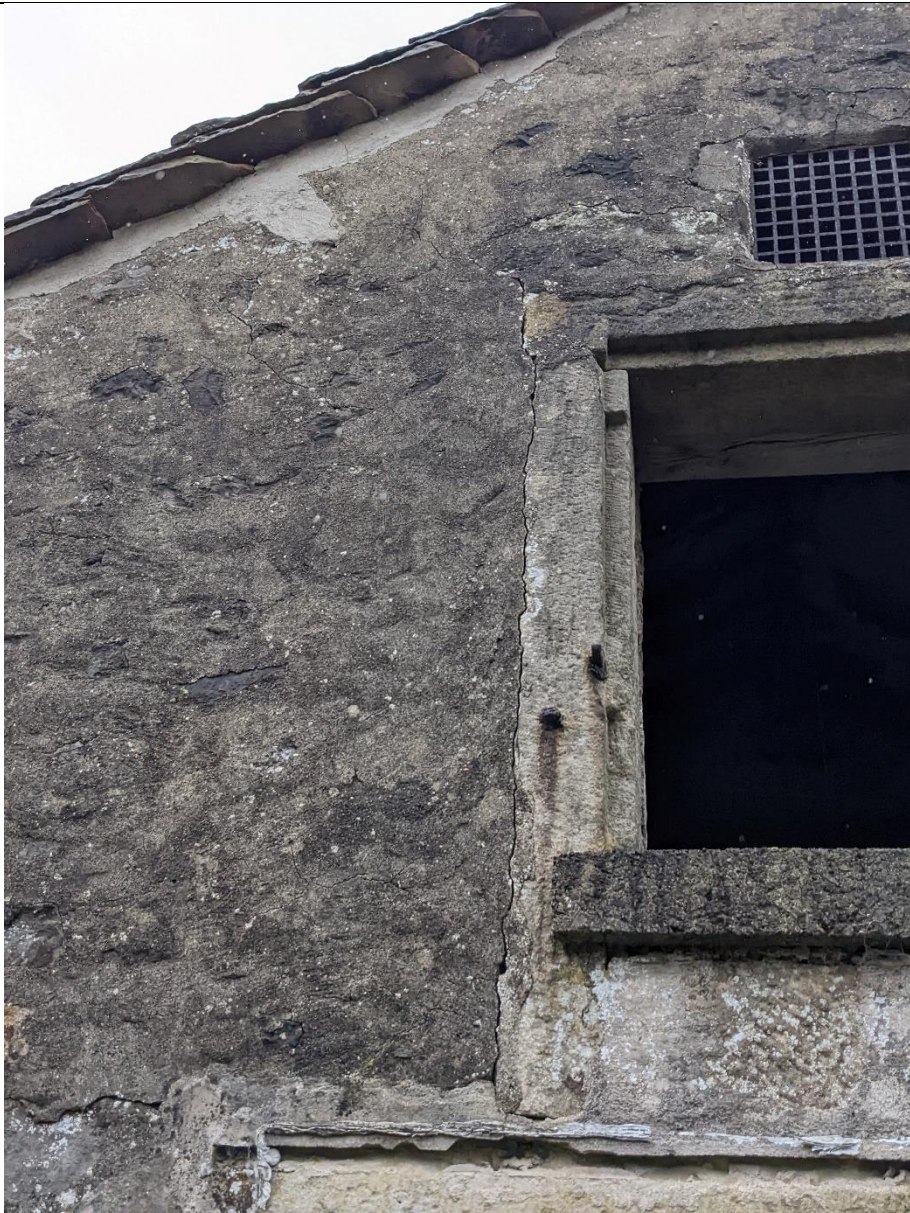
Crack in right hand gable between LH stone jamb and masonry.

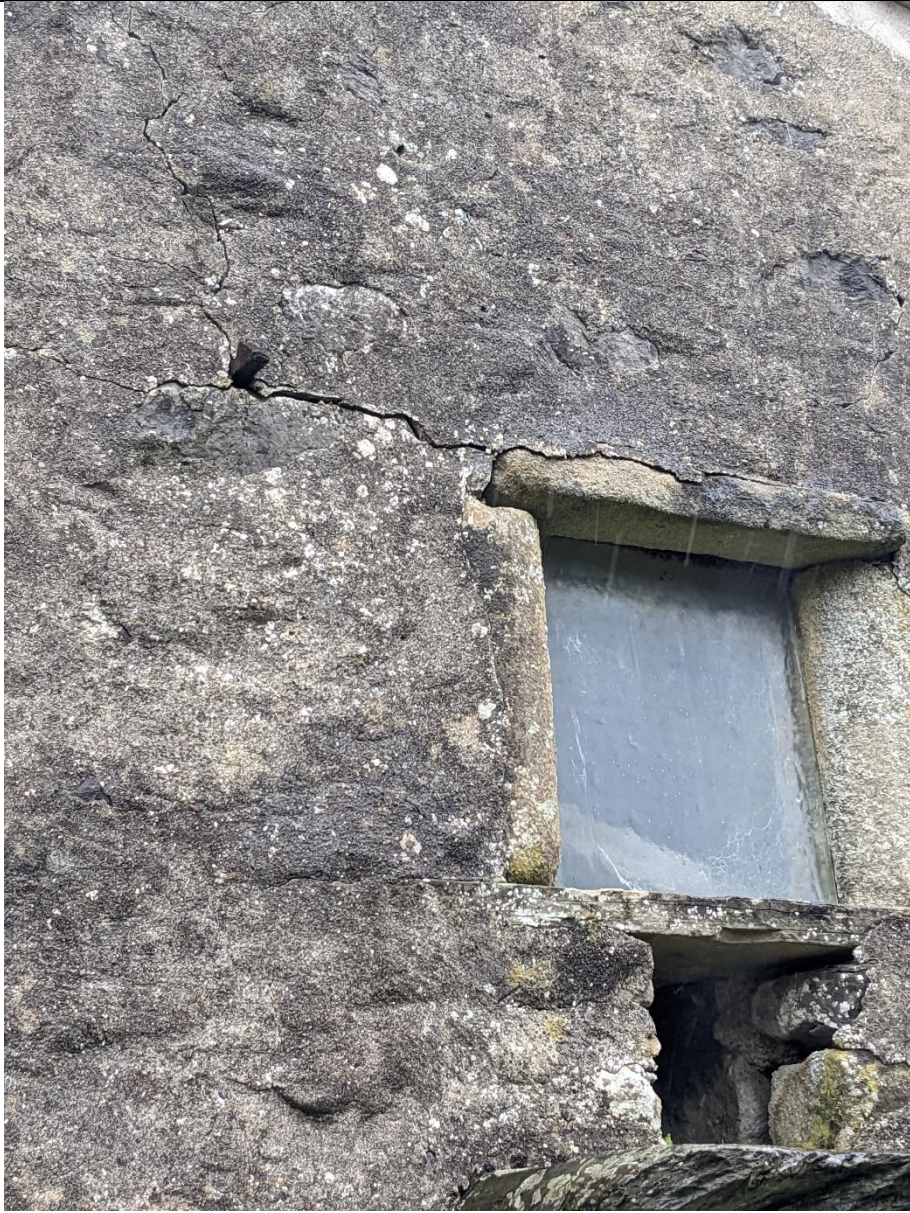
Crack in RH gable wall between stone lintel and masonry wall.

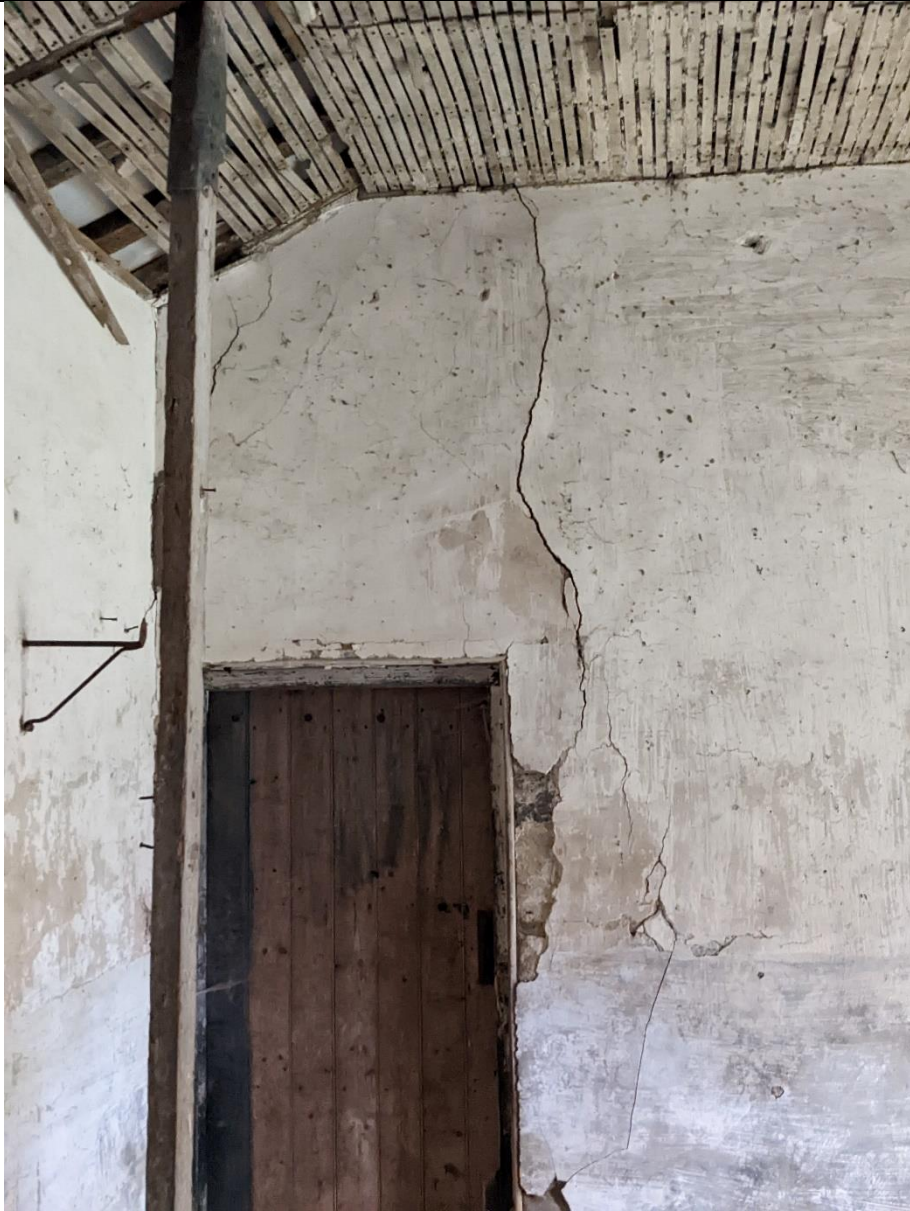
There are significant cracks in the left gable and the middle cross wall, emanating downwards from the purlin bearings. In the left room the purlins seem modern regular timber, and cut ends of older hewn timbers are visible in the wall adjacent.

This suggests that the roof has at some time collapsed and been repaired. If this was the case, the outwards thrust from the collapsed roof could explain the vertical cracks and irregularity of the ridge. As the roof has been repaired, the cause of the cracking has also been mitigated. These cracks should be repaired by stitch tying and repointing.

Interior view showing crack in cross wall, emanating from purlin bearing

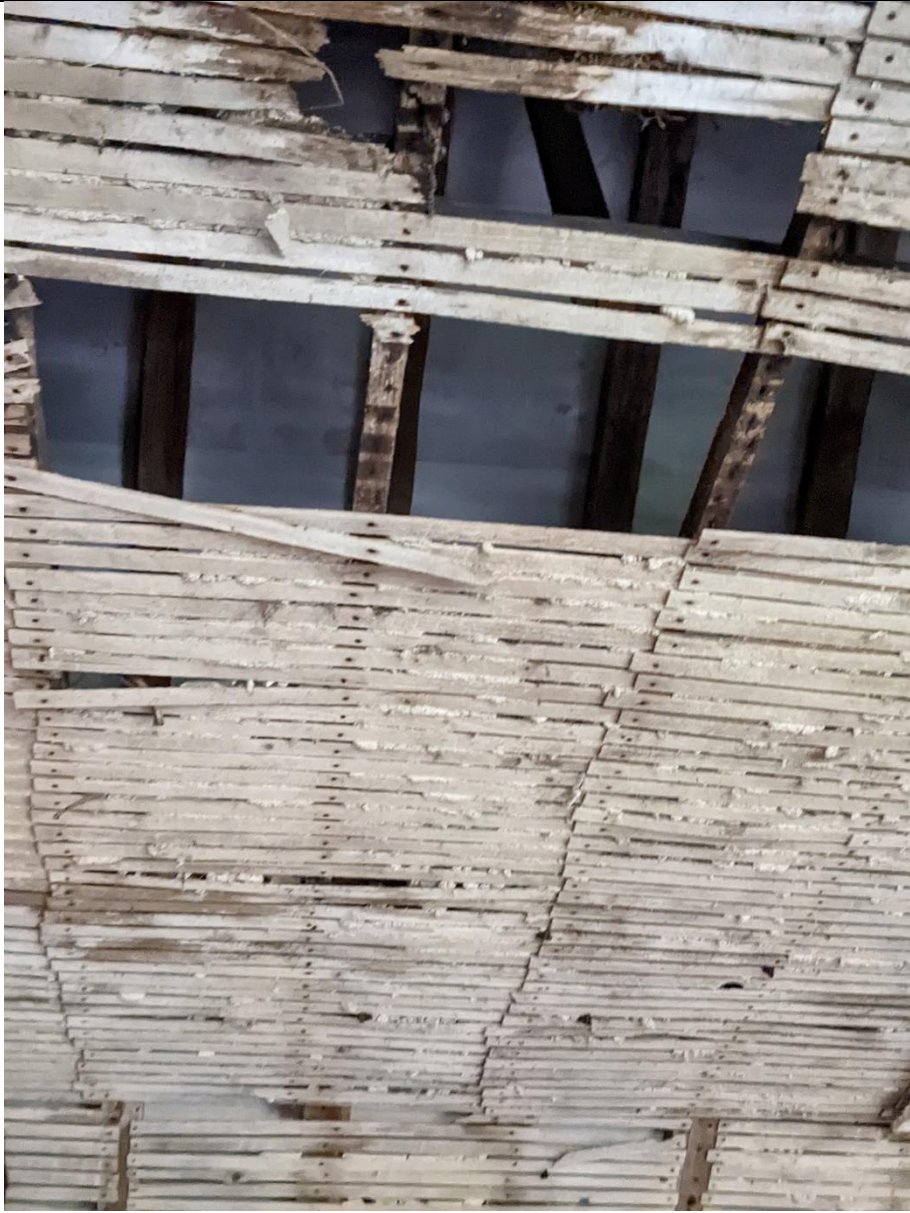
It is thought that the building has been recently re-roofed and as a result the interior appears dry.

Roof space, showing modern breather membrane over rafters

We could not see all the roof timbers due to the ceiling; we would recommend that these are inspected by a timber specialist for rot and infestation.

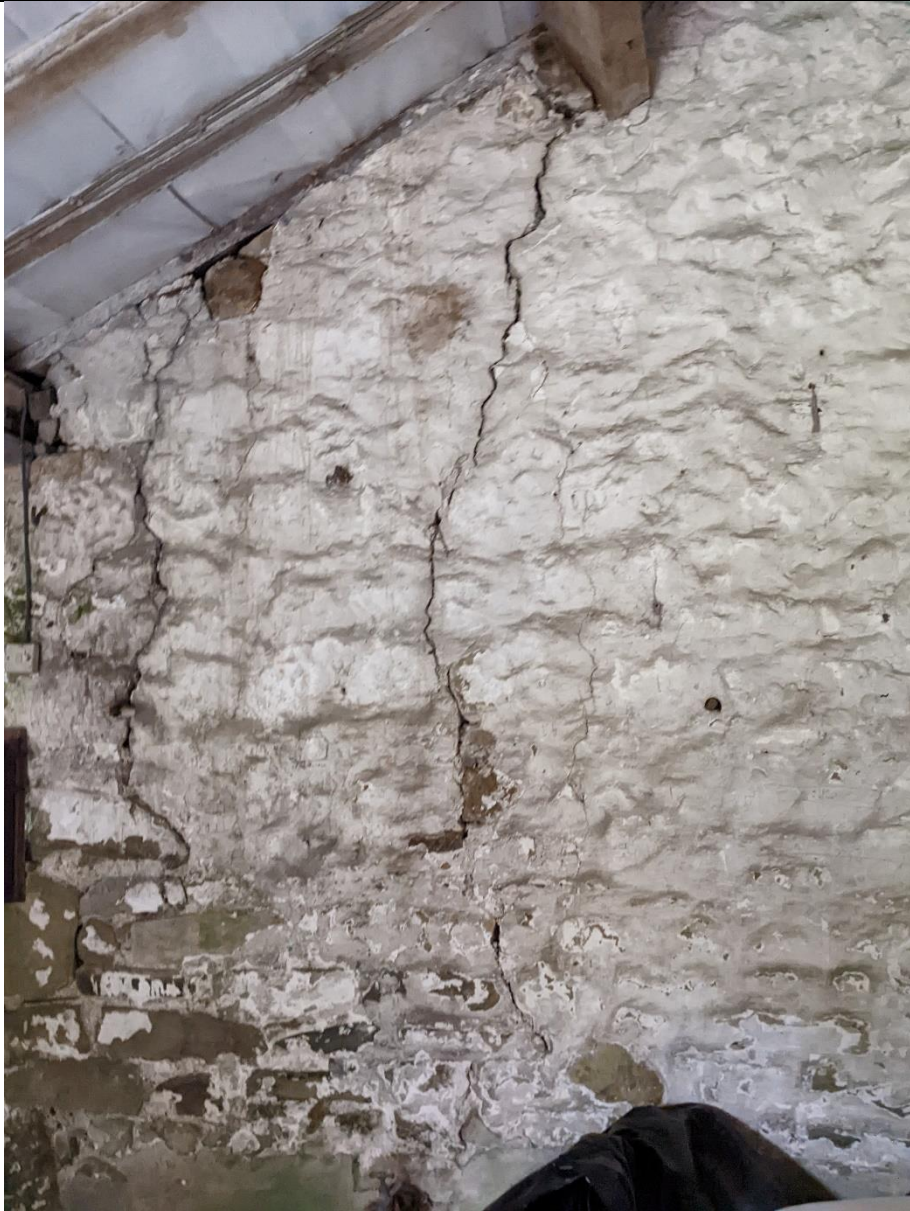
Internal wall, vertical cracks emanating from purlin bearings

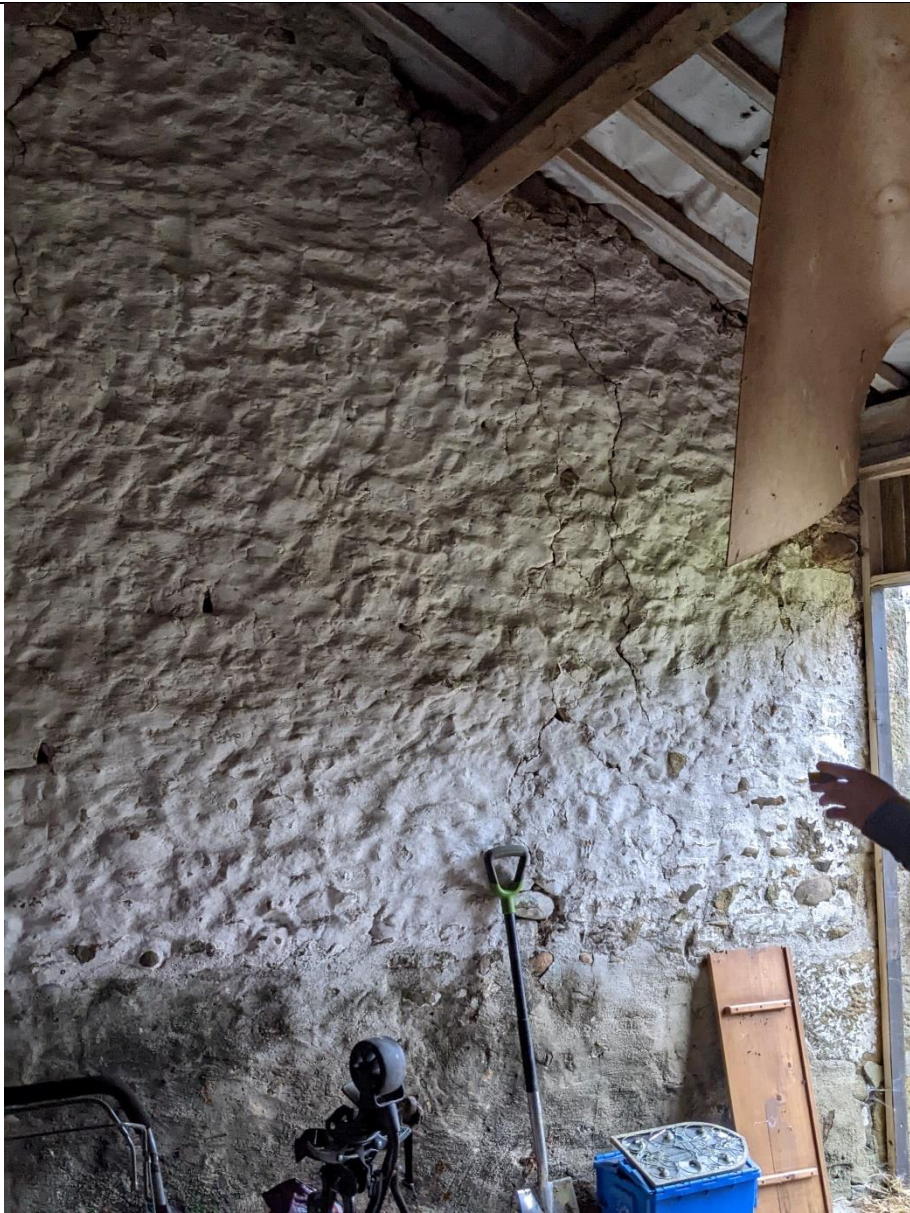
Vertical cracks in cross wall to front, emanating from purlin bearings

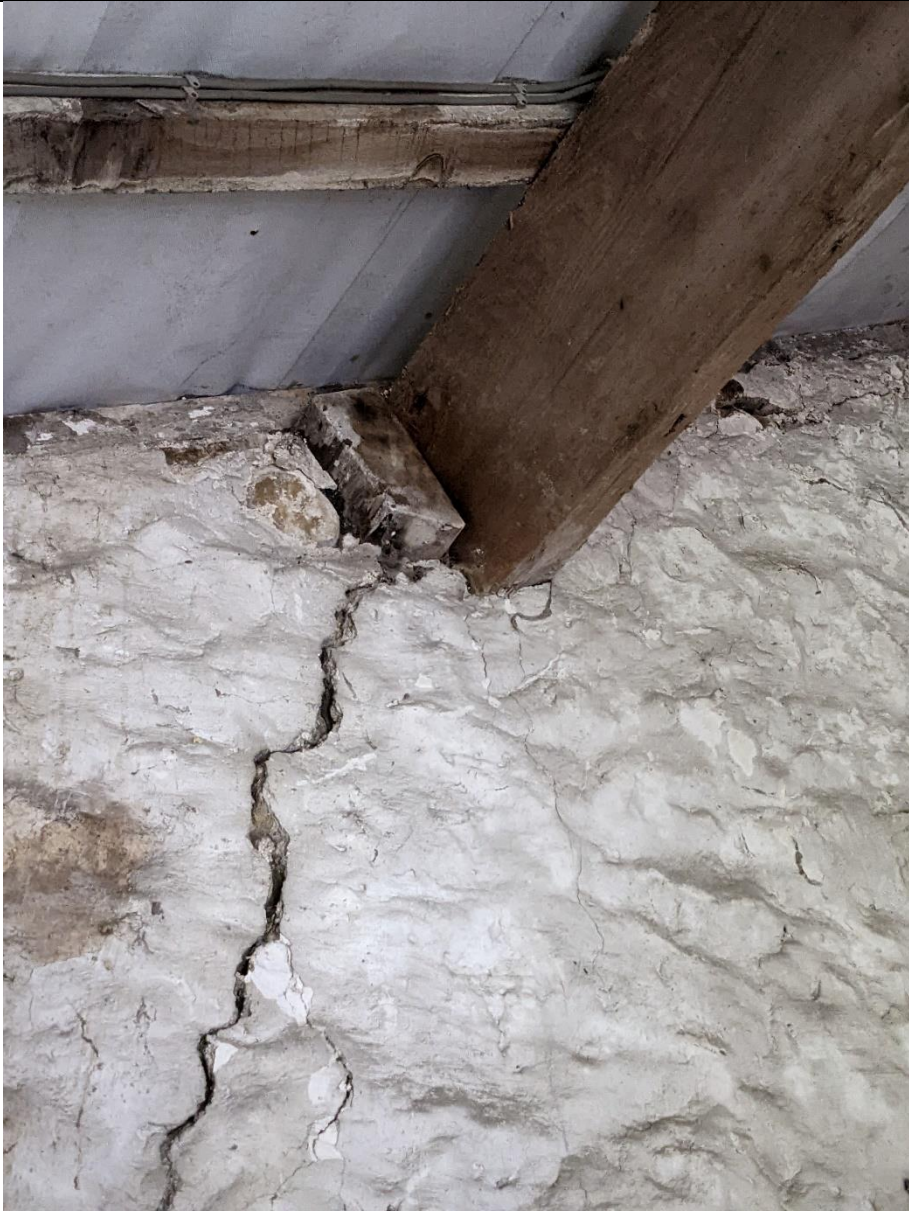
Close up on purlin bearing, showin vistige of old purlin cut end.

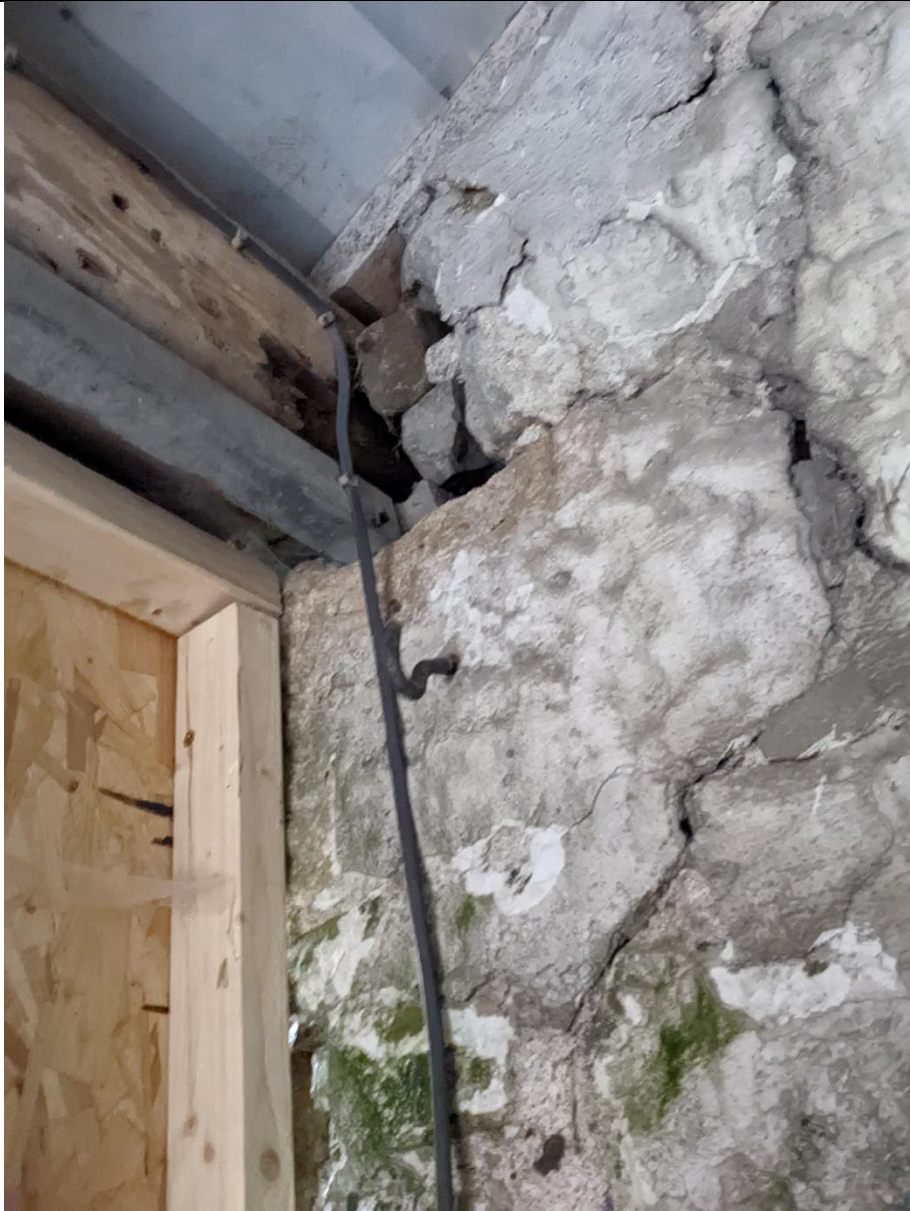
Detail on end of timber lintel at left hand side of wide opening, with timber infill

- The building should be inspected by a specialist in rot and infestation. Recommendations arising from that inspection should be actioned.
- Rainwater pipes and gutters are missing in places. All waterproofing and rainwater goods require replacement to protect the building fabric.
- There are cracks observed in the gables and cross walls. These should be repaired by stitch tying and repointed.
- The lintel over the wide opening should be assessed and possibly replaced with a larger beam capable of spanning the width of the opening un propped as part of a conversion.
