# Tree Condition Report

Higher Woodcock Farm,  
Whinney Lane,  
Langho,  
BB6 8DQ.

18/09/2020

Job Ref: 1483

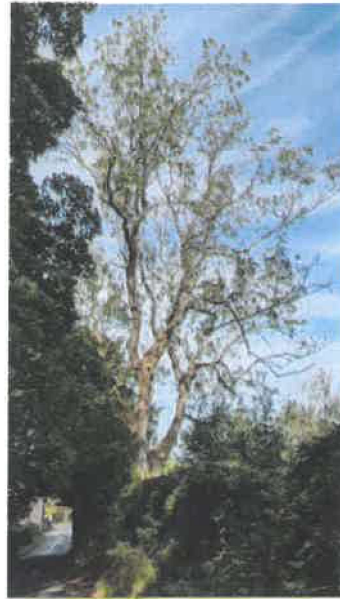
T291 – The Ash Tree located next to public highway has got significant dieback within the canopy with large amounts of dead wood present, there is epicormic growth growing on the structural branches which is a good indicator of stress. This tree has symptoms consistent with Ash Dieback and removal is recommended within the next 6 months the tree can be reduced to a monolith at the first main fork union of the stem. Removal of all timber and arisings will need to comply with government guidance, see attached notes.

T291 – tree needing removal due to Ash Dieback

| Job Ref: | 1483 | | | Survey Date: | | 18 September 2020 | | Surveyor: | | Gary Marsden | | Site Address: | | Higher Woodcock Farm, Whinney Lane, Lango | | | | Tel: 077 6166 7384<br>www.gmtreiconsultants.co.uk | | VTA TREE SURVEY DATA | | |
|---|---|---|---|---|---|---|---|---|---|---|---|---|---|---|---|---|---|---|---|---|---|---|
| T | 291 | Ash | 1 | 1000 | 20 | 16+ | Mature | Poor | Fair | <10 | 3 | - No significant<br>visual root<br>defects | - No significant<br>visual stem<br>defects | - Epithemic<br>growth / stress<br>indicator | - Dying+<br>Moderate<br>deadwood 25-<br>100mm dia +<br>Crown dieback+<br>Crown thinning | - Dying+<br>Abnormal foliage<br>density+<br>Abnormal foliage<br>size+<br>Defoliation+<br>Tip<br>dieback+<br>Disease /<br>infection - Ash<br>Dieback | - No fungi<br>visible at time<br>of inspection | - Road+<br>Footpath - Public<br>highways+ Open<br>Space | NO | - Remove for sound<br>arboricultural<br>management reasons+<br>Reduce to monolith -<br>can be retained up to<br>first main limb union<br>from ground level | 6mths | Not<br>Applicable |

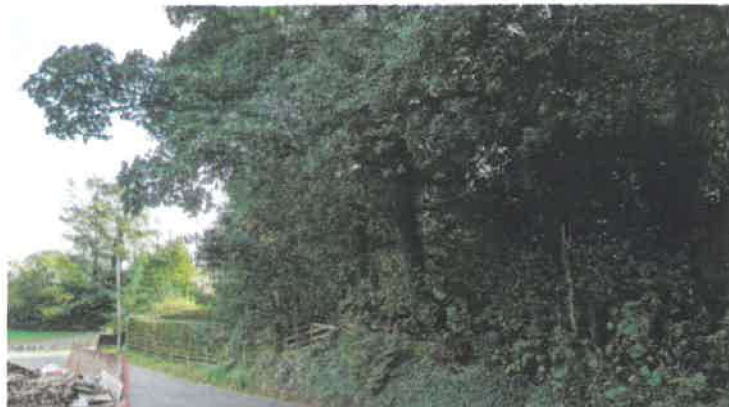
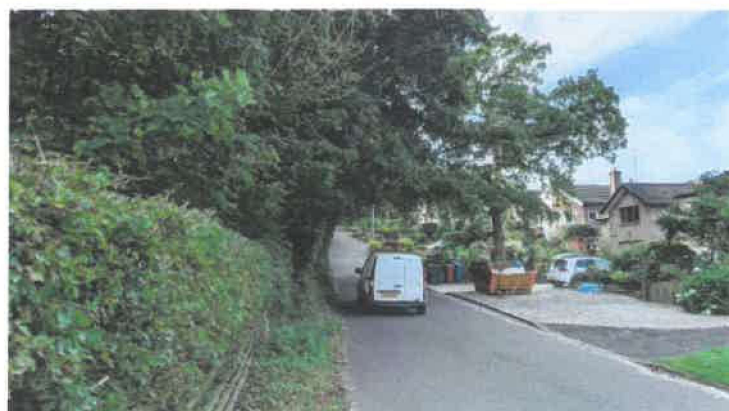
Road area needing low branches removing to give 5m clearance over the road

T290 - The Sycamore is in good condition with only remedial pruning needed of small branches over the public highway to give 5m clearance.

(There are some smaller self-seeded trees along the roadside near T289 and T290, these should also be crown lifted to give clearance over the road to 5m).
