## 6 Lodge View, Longridge.

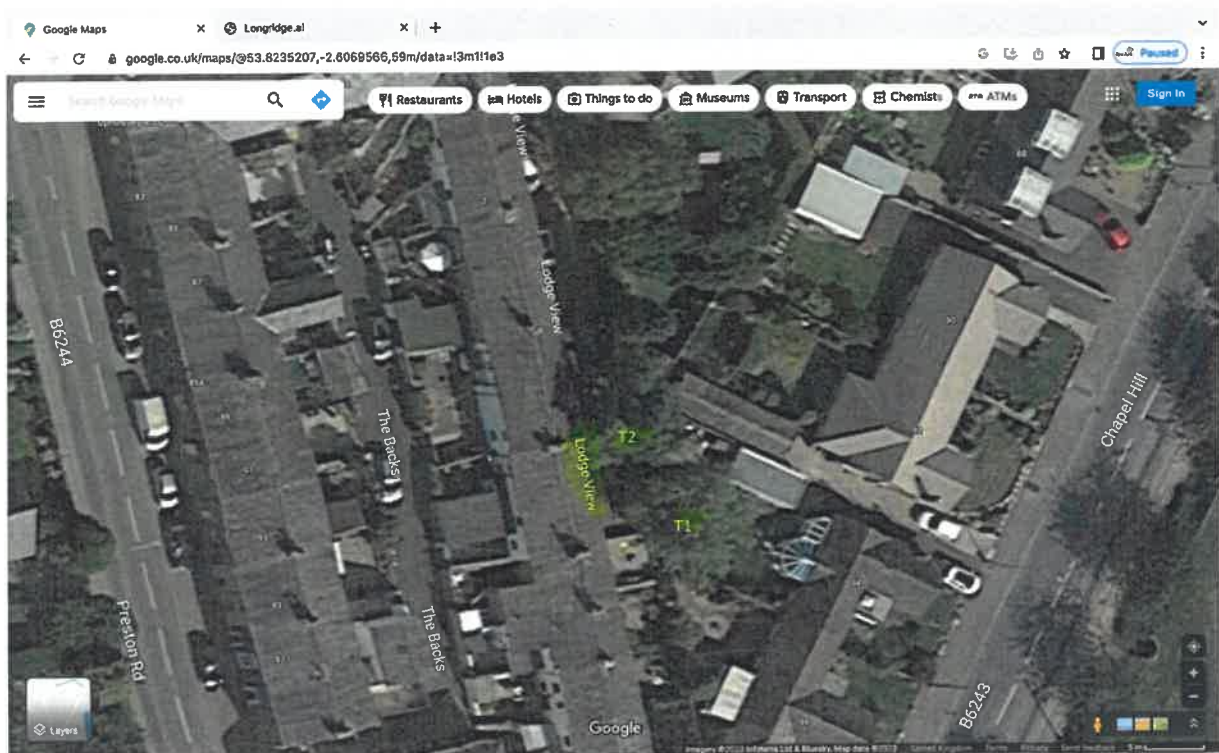
Tree has server bark damage from previous ivy removal, large cavity where top has failed.

Backside of tree previously removed. Tree is in bad form heavily weighted towards property with mechanically weak limbs extending over property.

15% Crown Reduction, old stub cuts and rips removed, crown cleaned of any dead wood.

Removal down to 4m habitat pole.
