Our Ref: Abbey Gardens/BB7 4LE/2022  
Date: 28 November 2022

**ABBAY GARDENS, SAWLEY, CLITHEROE, BB7 4LE**  
**PRELIMINARY RISK ASSESSMENT (DESK STUDY)**

**ABBAY GARDENS, SAWLEY, CLITHEROE, BB7 4LE**

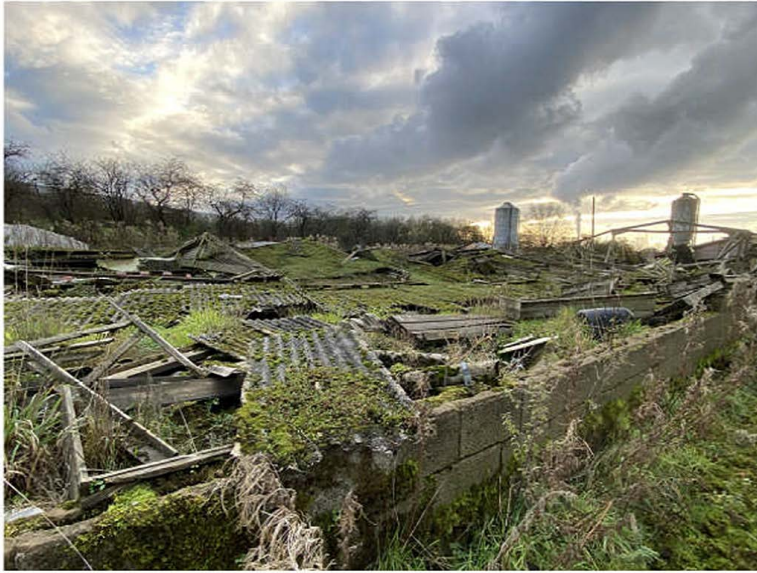
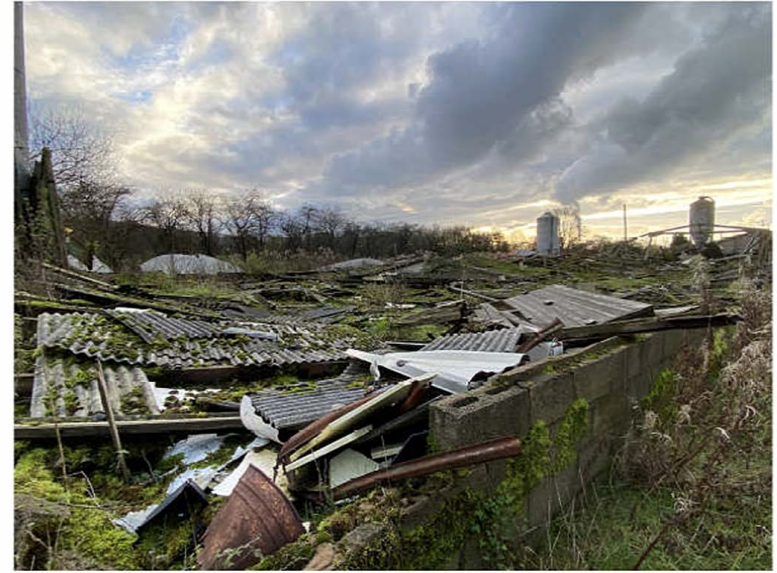
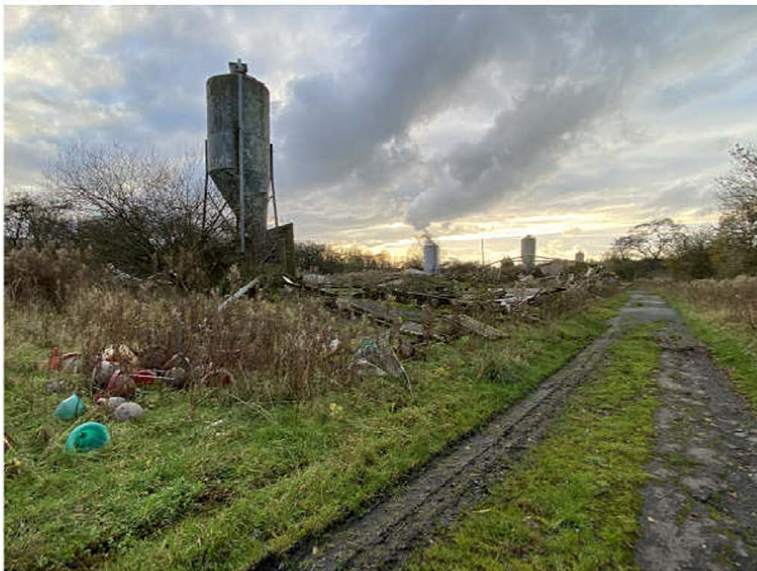
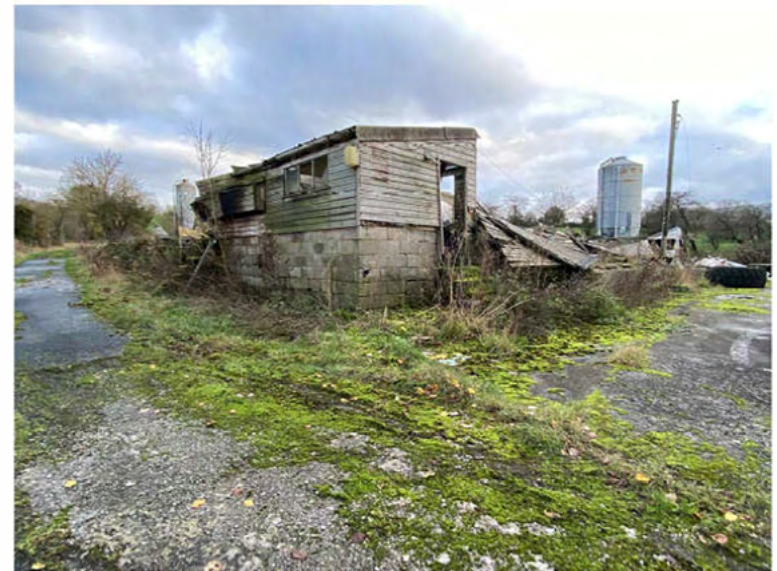
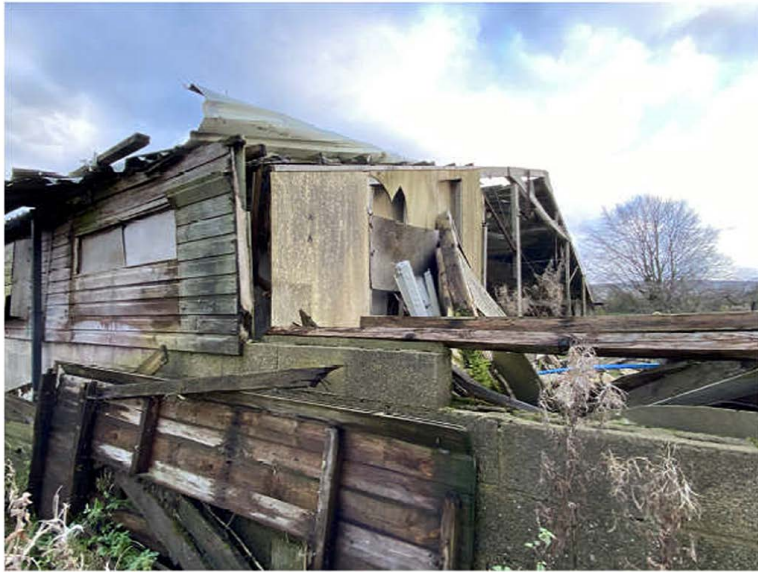
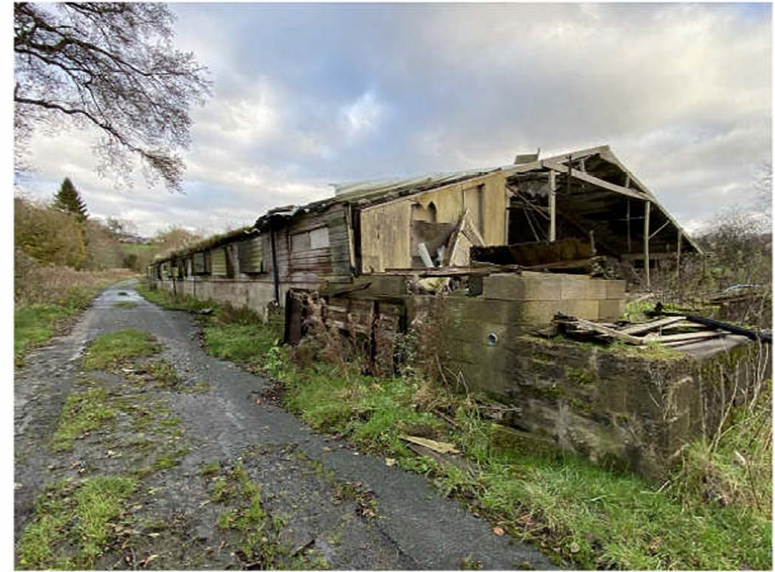
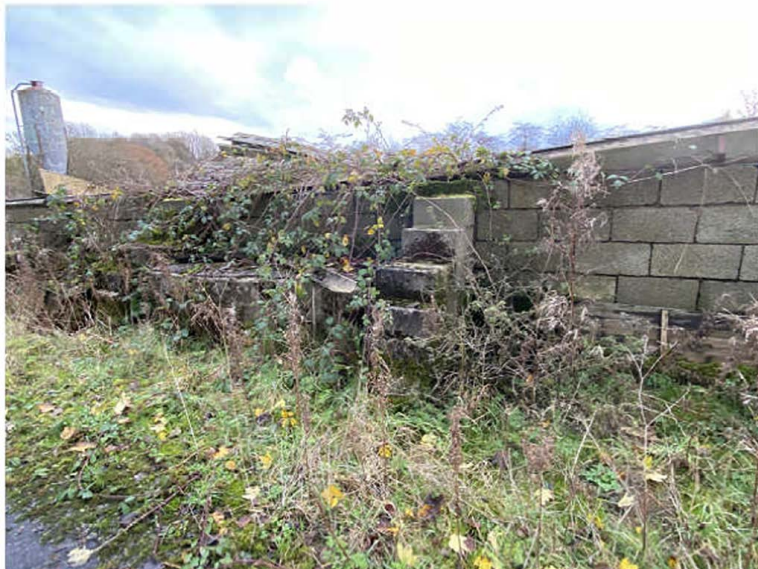
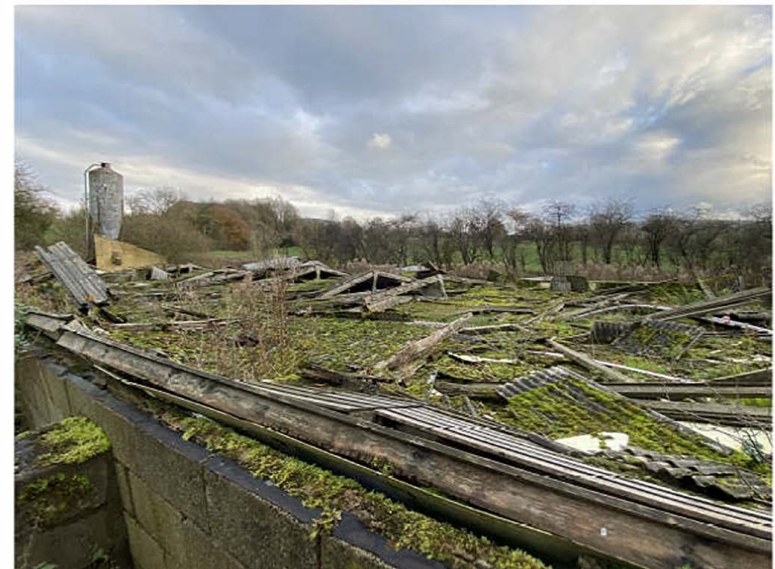
19/11/22  
Building 4

On the northeast of the site are two former chicken sheds (building 3 at the northeast corner, building 4 the southeast corner), both are collapsed with building 4 having previously suffered from a fire. This has left building material, including suspected ACM strewn across the northeast of the site.

A fire at the northeast has created potential for low levels of PAHs to be generated on site (exceeding residential thresholds). These may be present in shallow soils on the northeast of the site and, if water was used to extinguish the fire this can spread shallow contaminants further around the site.

There is probable ACM strewn around the northeast of the site and scattered around the buildings. This should be cleared, and the buildings demolished, prior to investigations being carried out.

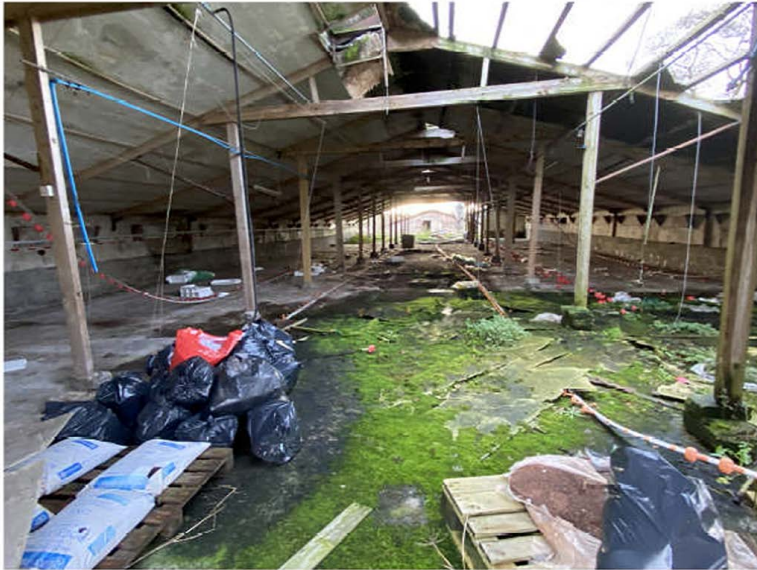
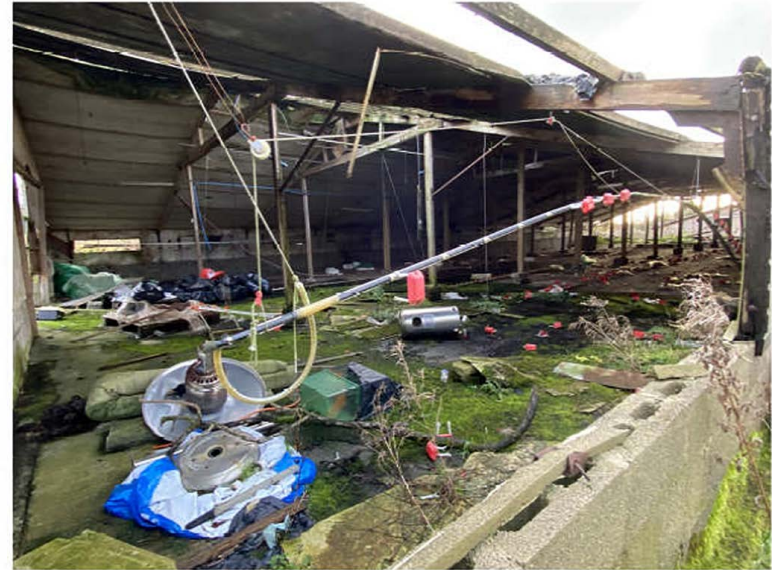
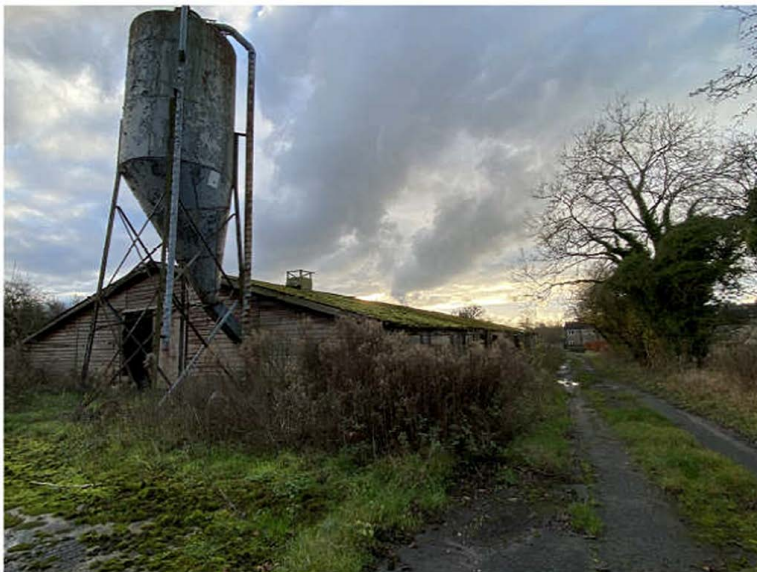
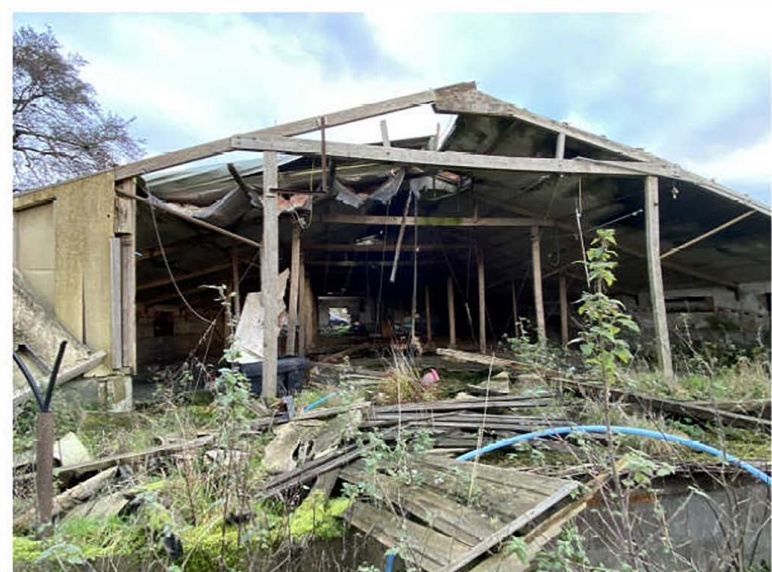
Building 2

A heating oil tank is on a concrete apron at the rear of building 2, the original location is not known.

A heating oil tank has been placed to the rear of building 2, the original location is not known, suggesting TPHs may be present in places.

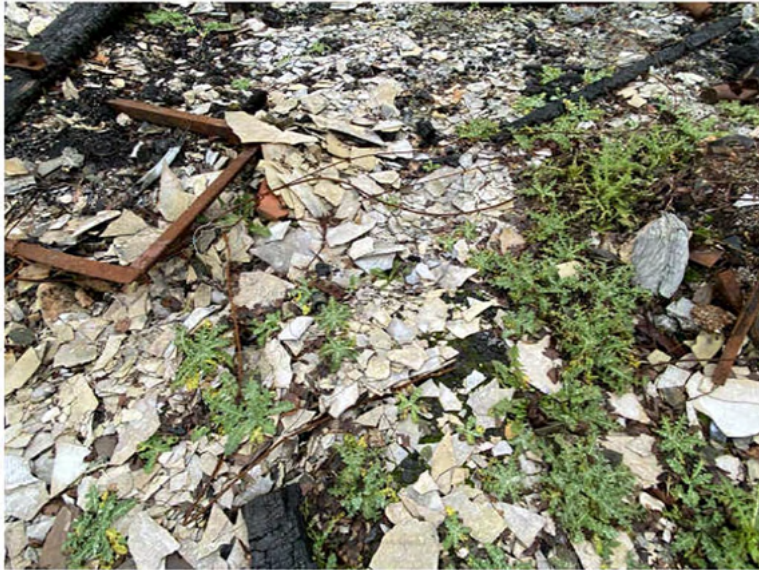
Building 3

Suspected Asbestos

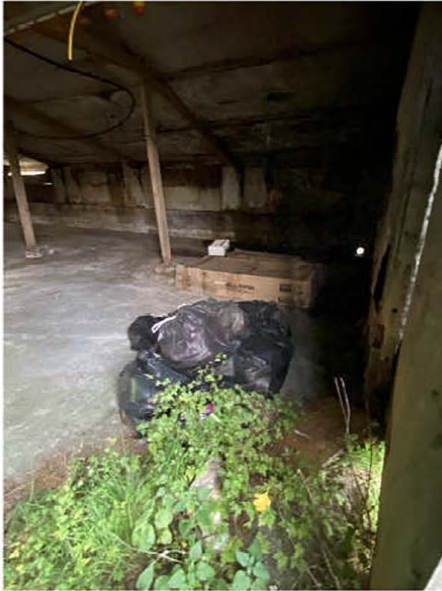
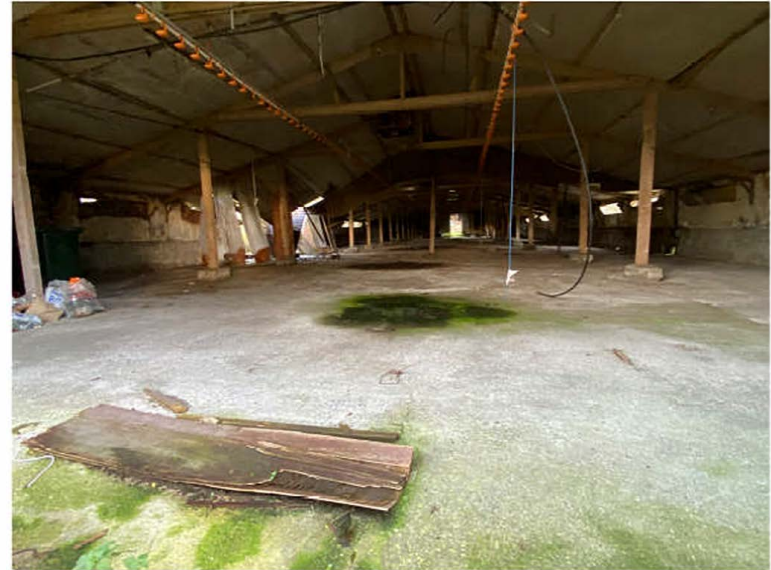
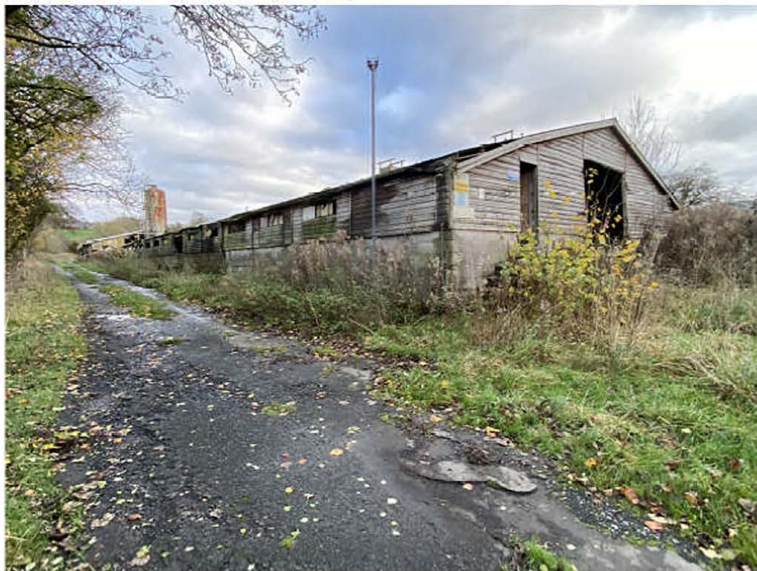
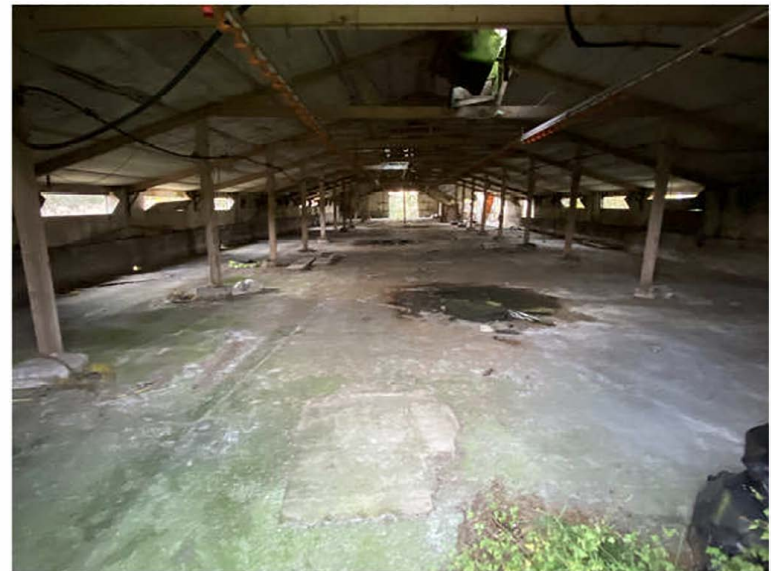
Building 1

The site is rectangular, 170 x 45m, located to the northeast of Sawley, in Sawley, Clitheroe, and at OS Grid Reference 377744, 446 175. Inspected on 19/11/22 by Mr D Lord, there are two derelict chicken sheds, one at the northwest (building 1) and one at the north middle (building 2), these have concrete floor slabs, concrete block dwarf walls and wood cladding above, with suspected asbestos containing material (ACM) in various places (sheet cement roof, rainwater pipes and cladding inside the building). There is building material, including probable ACM, on the ground around the buildings perimeter.
