**STRUCTURAL CONDITION SURVEY
FOR THE
OUTBUILDING
ADJACENT TO TWIN BROOKS FARM
UPBROOKS
CLITHEROE
FOR Mr Thornburn**

Date: 24th Feb 2023
(amended)

Our job Ref : 5765

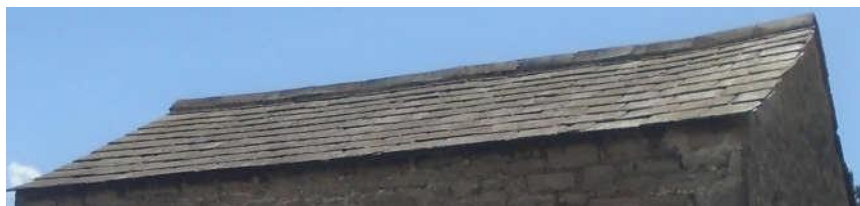
The roof over the 2 storey stone building is covered with blue slate it appears to have been re-roofed and is in good condition, there are no slates out of place the timbers and felt are in good condition with no signs of rot.

The ridge tiles are in excellent condition and well pointed. Gutters are absent from the eaves.

photograph (1) - North pitch of 2 storey stone outbuilding

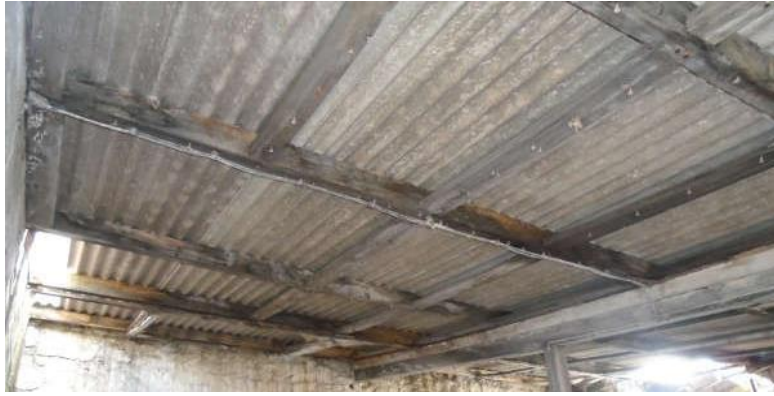
The lean-to has corrugated fibre cement sheet covering, it is in poor condition with a section missing adjacent to the main building at the south east corner. The timber structure of purlins and rafters has an ad hoc appearance. The timbers have suffered some water ingress and are stained although there were no significant signs of rot. Some sections of the rafters supporting the sheet laps are missing.

Photograph (2)- dilapidated roof structure of the lean -to.

The roof timbers and sheets would have to be replaced.

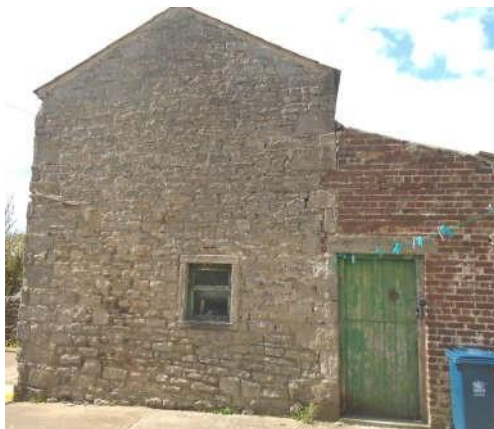
East elevation

The window opening in the stone section of the east elevation has been formed with stone head, sill and jambs. The 2no door openings in the brick lean-to have stone heads. All the stone surrounds are in reasonable condition and could be retained.

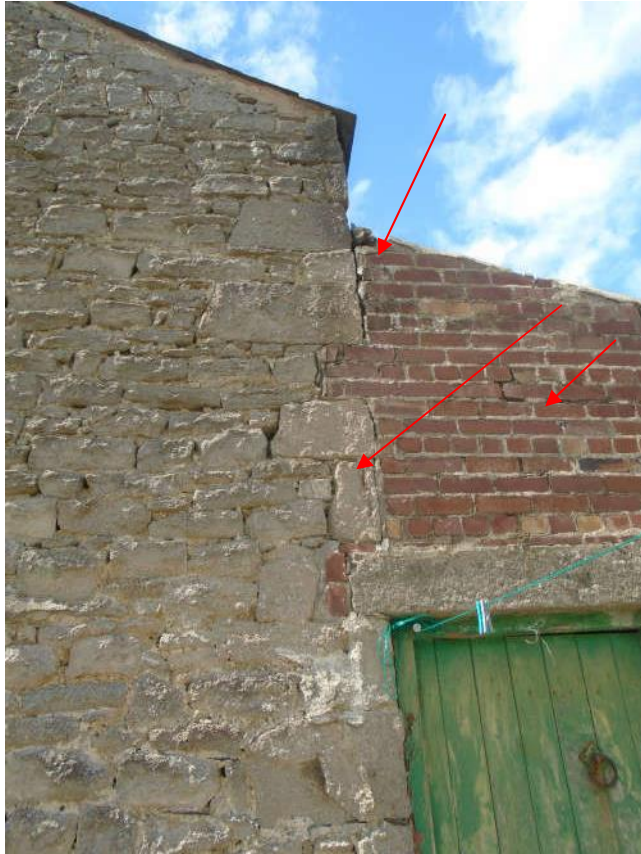
The pointing whilst the majority is in average condition, the stone adjacent to the lean- to roof abutment is in poor condition with some sections missing. All the pointing would need to be raked out and replaced. The lean-to appears to have been constructed to form a buttress support for the stone outbuilding, although it is not tied in towards the top of the wall. The quoins were detached from the stone walls.

Photo (3) – East elevation cracks at lean -to abutment

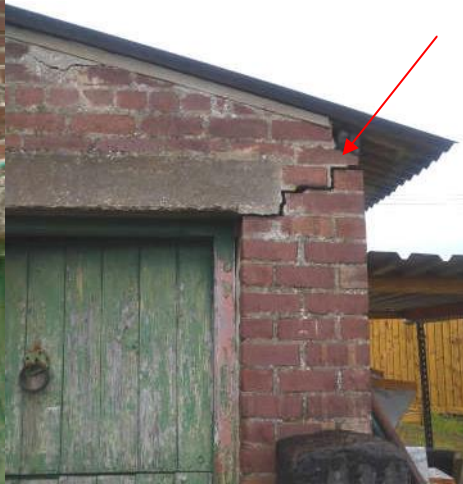
The north east corner of the brick lean -to has a brick missing adjacent to the roof a significant crack has developed towards the door head, the north elevation of the lean -to is pulling away. See photo 4

Photo (4)- north east corner of lean -to

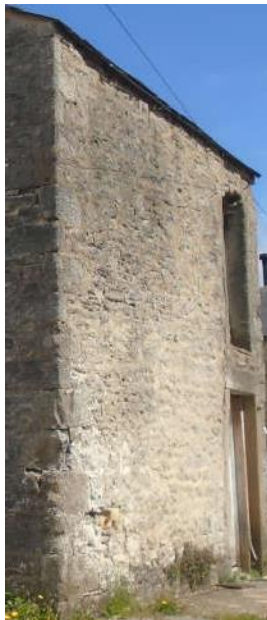
The south elevation is the principle elevation with a door opening formed with stone head and jambs, the jamb to the left is sub standard to the other surrounds it has moved causing a significant crack which extends up the wall separating the render reveal from the stone it is restraining in the first floor window opening. The window has been incorporated retrospectively without stone surrounds, the only supporting

Due to the scale of the elevation and the extent of the re building required it will result in the total re build of this elevation.

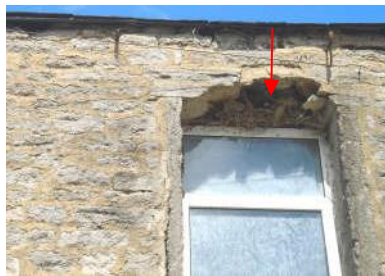
Photo (6)

structure is an interior timber lintel which is in poor condition and needs replacing. See photo 7. The cracks in the lime plaster above the window is the result of historic plant ingress, the remnants of which can be seen on the exterior elevation over the window opening. See photo 6.

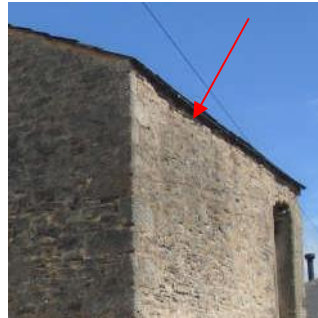
Photo (8)

South elevation is not plumb, the section of wall indicated in photo 8 is significantly leaning in towards the eaves and photo 9 illustrates the significant crack in the south west corner.

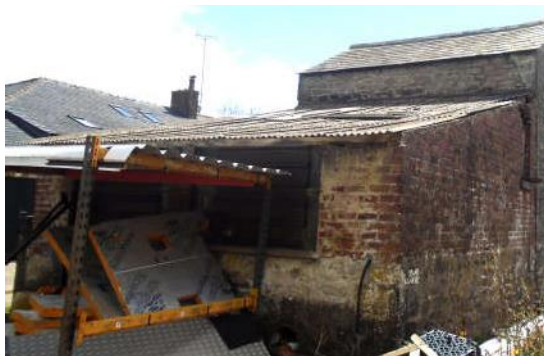
The north elevation of the lean –to has 2no large window openings with narrow piers between, no heads are present, a roof timber spans over but does not form any restraint to the brickwork. Significant restraint is required.

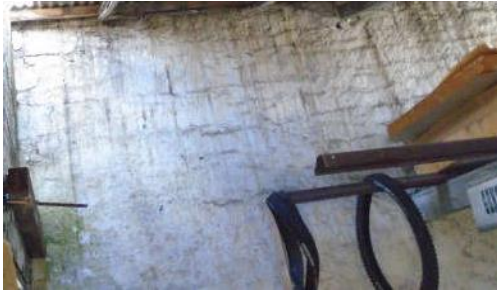
Photograph (10)

The internal/ external (north elevation) stone section of wall within the lean–to and projecting above, is in reasonable condition and generally plumb although movement in the east elevation adjacent was evident. The interior section is illustrated in the photograph (10). Exterior section photo (11).

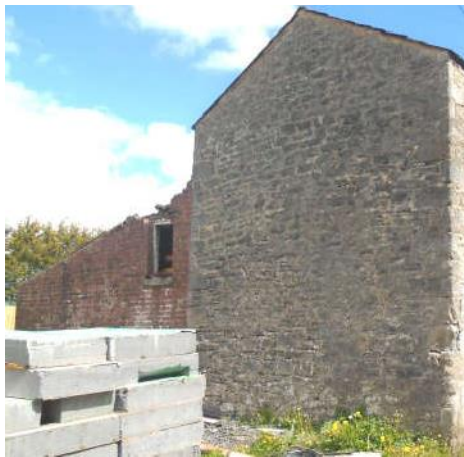
West elevation

The west elevation was plumb and no significant cracks although the pointing is failing as on the other elevations. The stone wall requires re pointing.

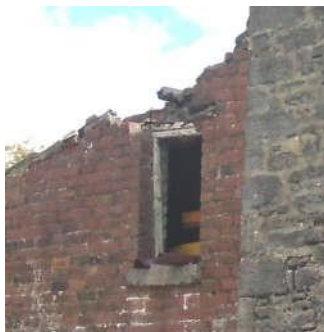
Photograph (12)

The window at high level in the brick section is without a head and a significant number of bricks are missing. See photo (12). The wall requires re building.
