# **Barn at Lane Side, Grindleton, Lancashire:**

## **Heritage assessment to inform a scheme for a replacement dwelling**

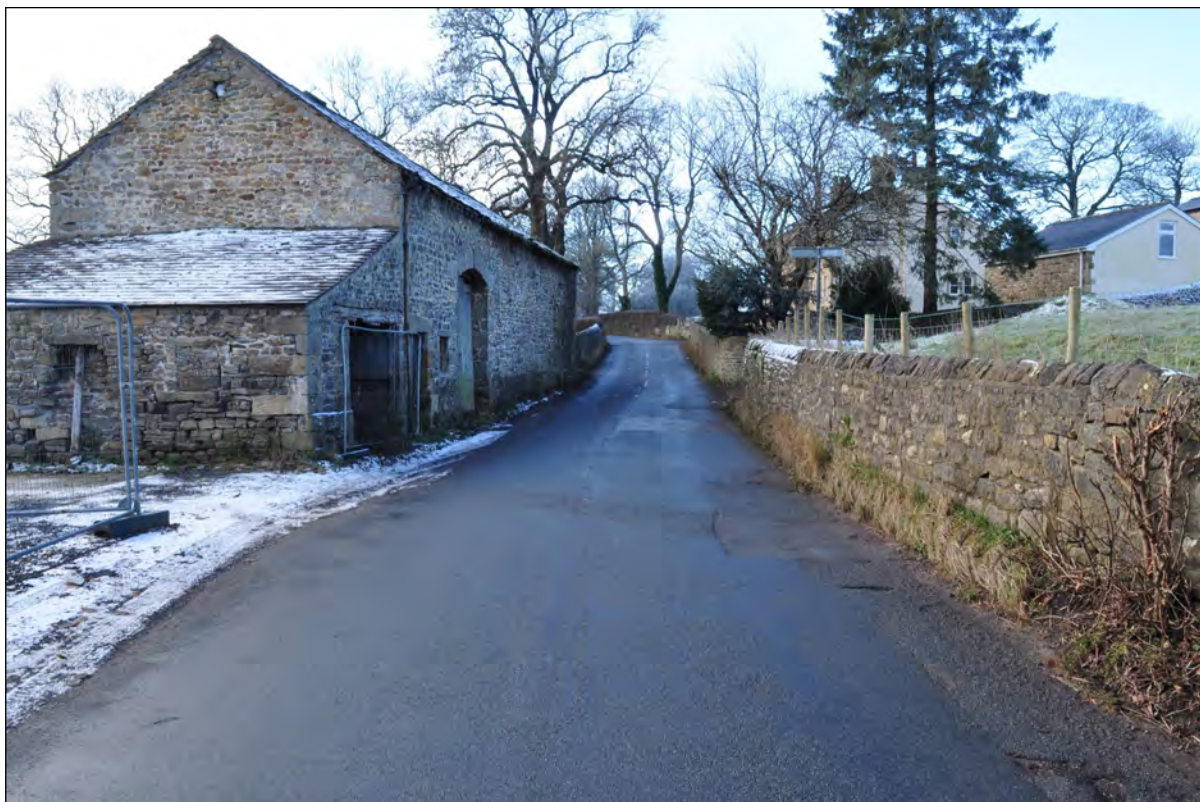
6.2 The north front is very plain, with the cart entrance being the only visual focus; it has a segmental arch with keystone, and much repaired, harr-hung doors (photos 1 to 3 below). There are also two pedestrian doorways (the right-hand one of which has been blocked up), and a modern window opening. A single-storey lean-to has been added at the east gable; it forms a garage, and the opening in its north side formerly occupied its full width. The lean-to's walls are rather poorly built and/or modified, and its interior seems to have been used for housing livestock at some point during its life. It too has a roof covering of modern tiles.

Photo 1: The barn, viewed along Grindleton Road. Lane Side farmhouse to right.

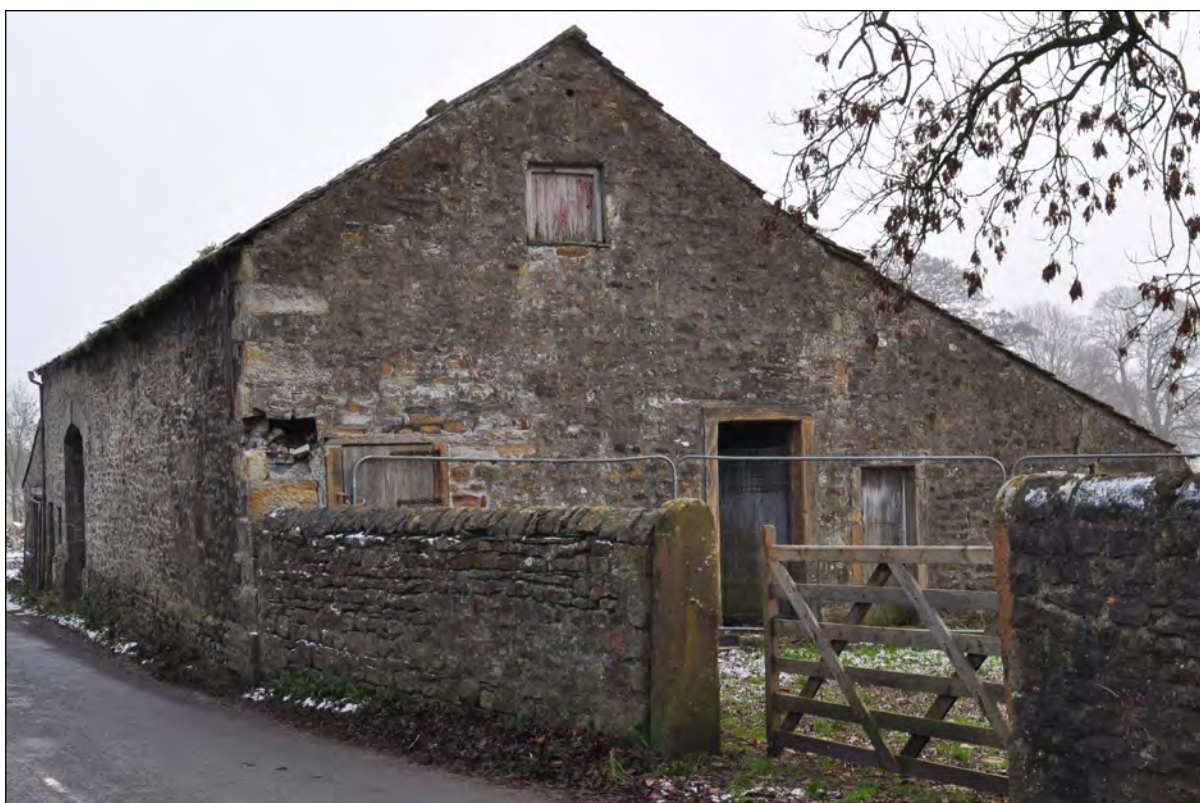
Photo 2: West end of barn, with doorways to stable, and shippon outshut (right)

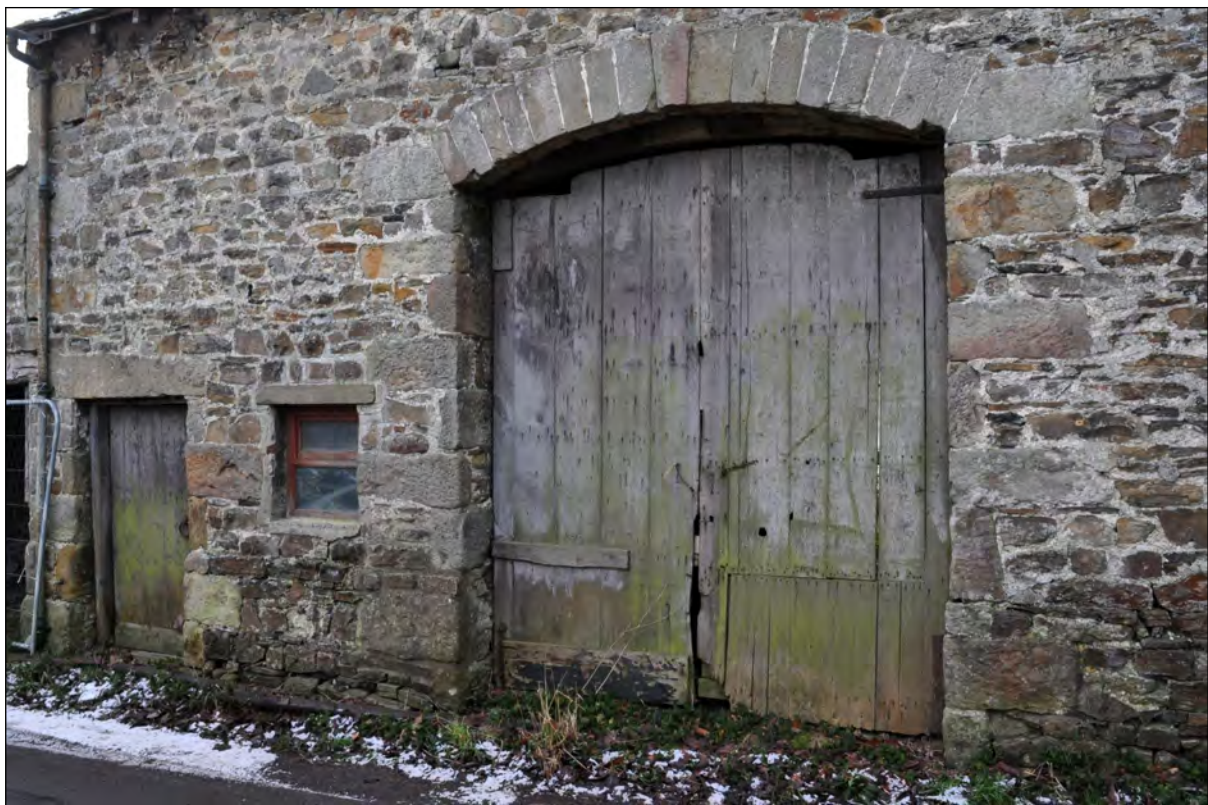
Photo 3: Detail of doorways and modern window opening in north side

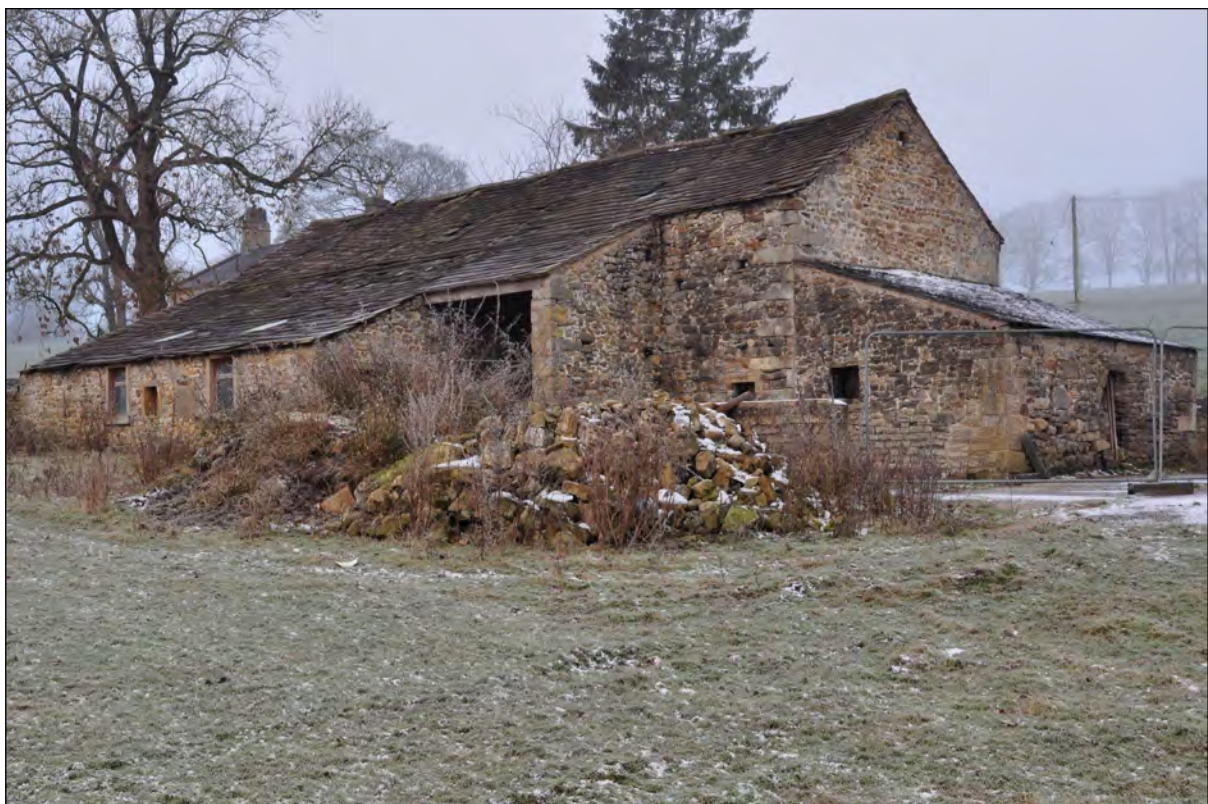
- 6.4 The south side of the barn has a similar cart entrance to that in the north, albeit enclosed within a porch (perhaps added at a later date), and to the west of here is a shippon outshut under a catslide roof, added after the porch, probably in the mid to late nineteenth century (photos 4 and 5). The outshut conceals a number of doorways and slit breathers in the barn's south side, although at least one of the doorways was inserted to communicate with the shippon. The outshut's south wall has an original muck hole as well as two relatively large, twentieth century windows; there are two doorways in the west end, and one in the east.

Photo 4: View from the south-east, with later lean-tos to south and east

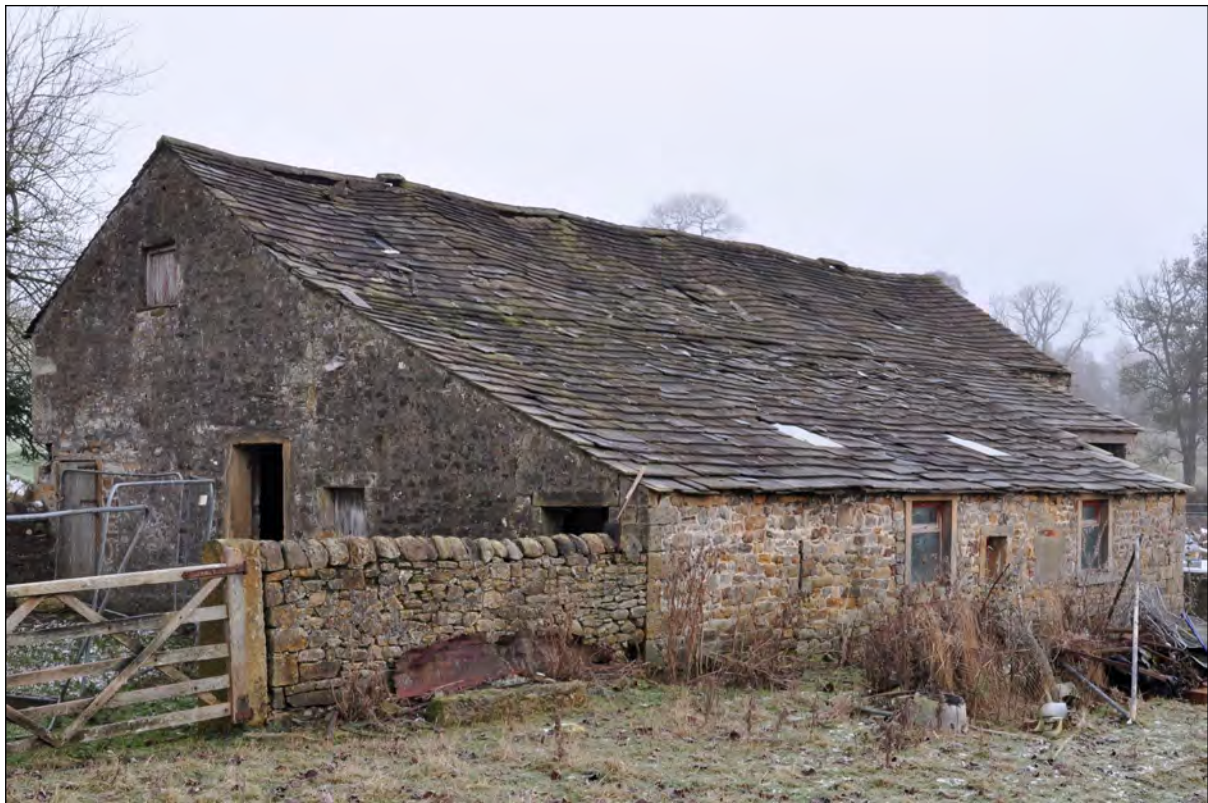
Photo 5: View from south-west, showing later shippon

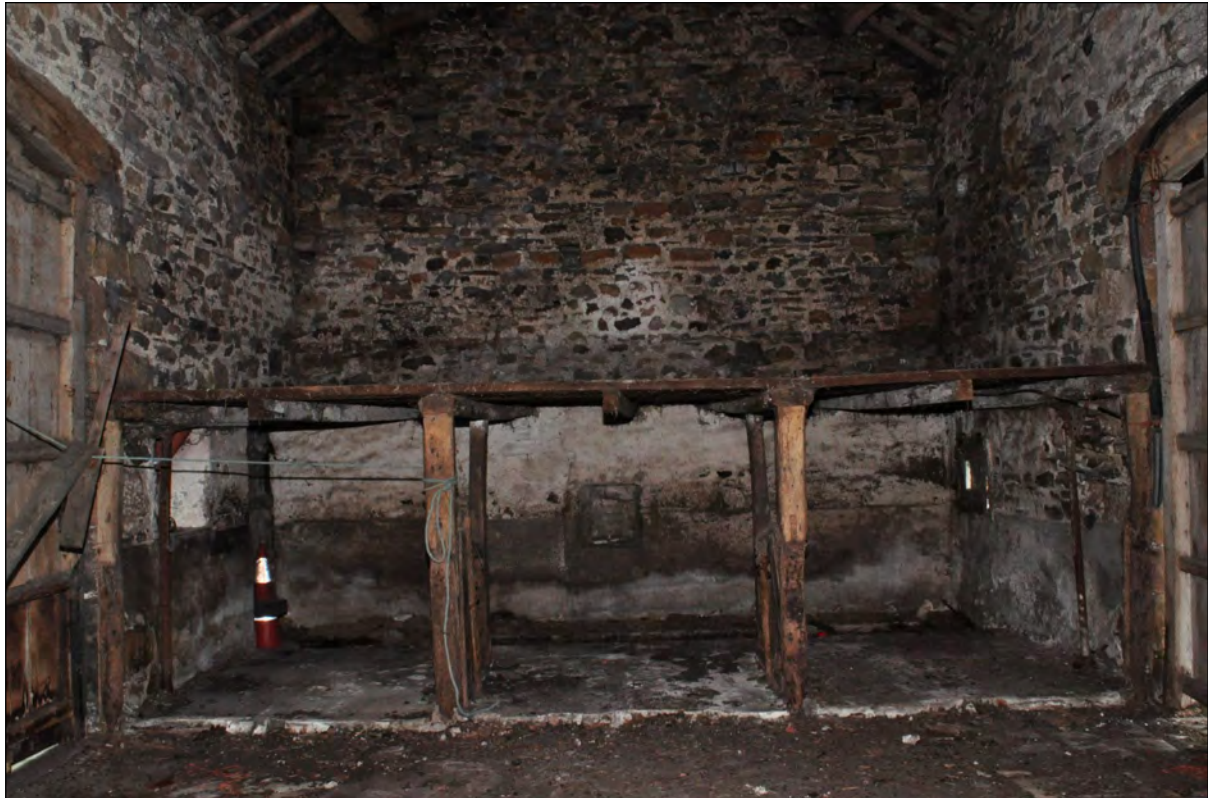
- 6.5 The barn itself is of six bays, five of which form the main space, separated from the stable in the west end by an original cross-wall with doorway through at hayloft level. The east bay contains the remains of a shippon for six animals in characteristic fashion; its timber frame has been much repaired, but it still supports a hayloft (photos 6 and 7). The other four bays in this area are open to the roof and contain the flagged threshing bay. All the roof trusses are of pegged oak and of principal rafter type, with curved collars and raking struts for the most part, though there have been some losses and repairs; they are a reliable indicator of an eighteenth century date for the barn. The majority of the purlins are also oak, and some bear marks of earlier use (photo 8).

Photo 6: Shippon to east of threshing bay, with remains of timber structure

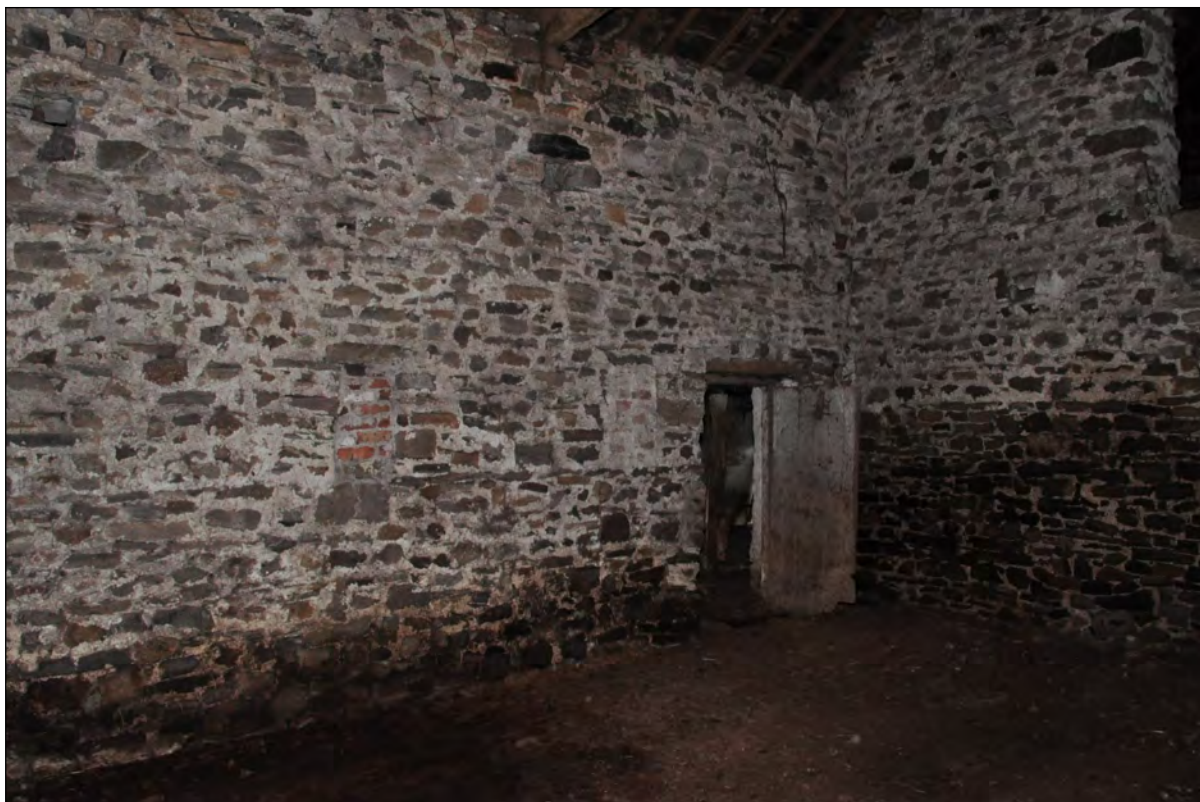
Photo 7: South-west corner of main part of barn, with inserted doorway to later shippon

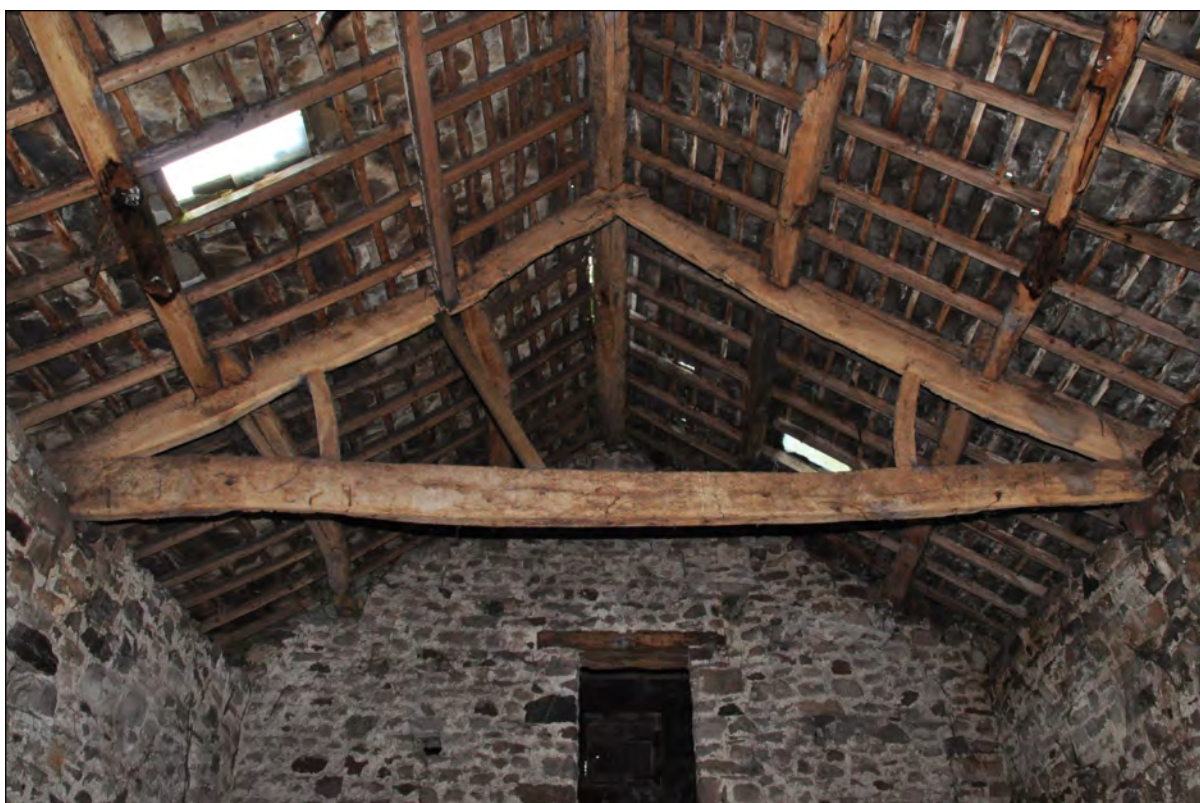
Photo 8: West roof truss. Note that the collar has been removed, and later timbers have been added as repairs.

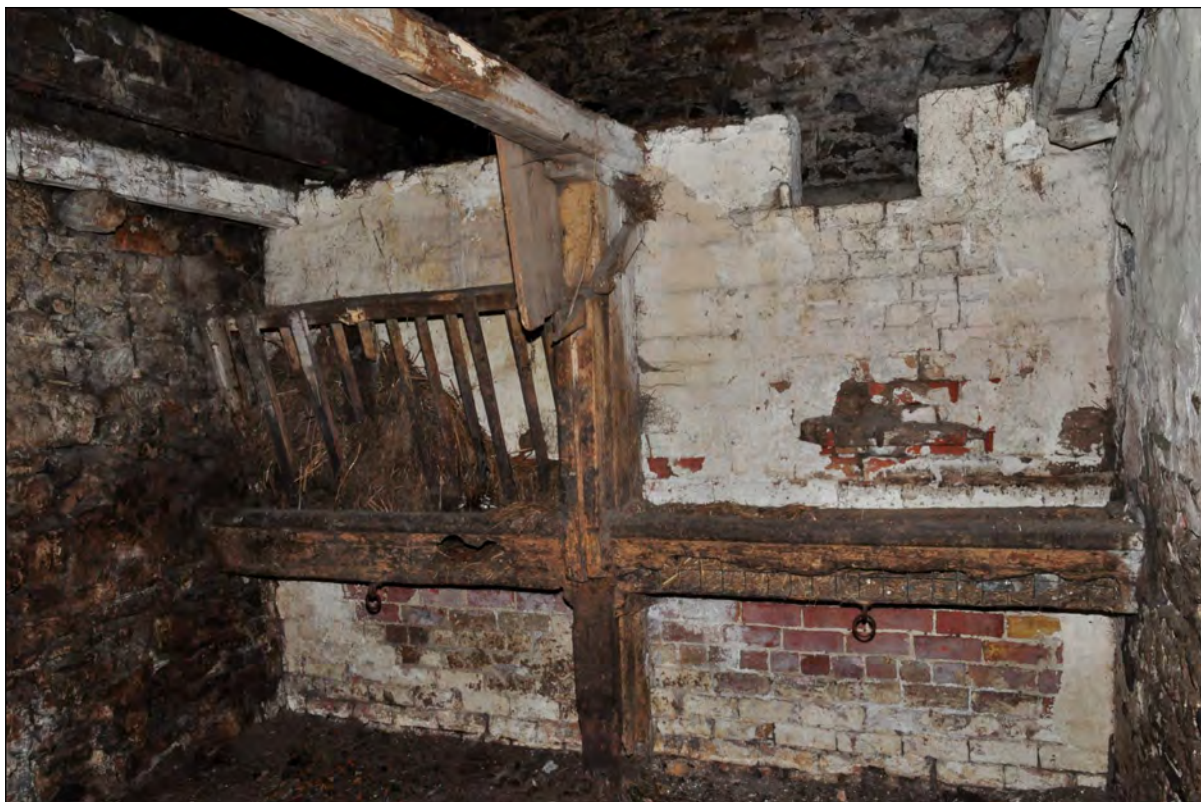
- 6.6 The stable in the west end appears to have been modified in the nineteenth or early twentieth century, and is divided by a brick wall, to the south of which is a pair of stalls for large horses. The stall divider and hayloft over are missing, but there are still mangers, part of the hay rack, and harness pegs to indicate former use (photo 9).

Photo 9: Remains of some of the fittings in the stable, attached to a secondary brick wall

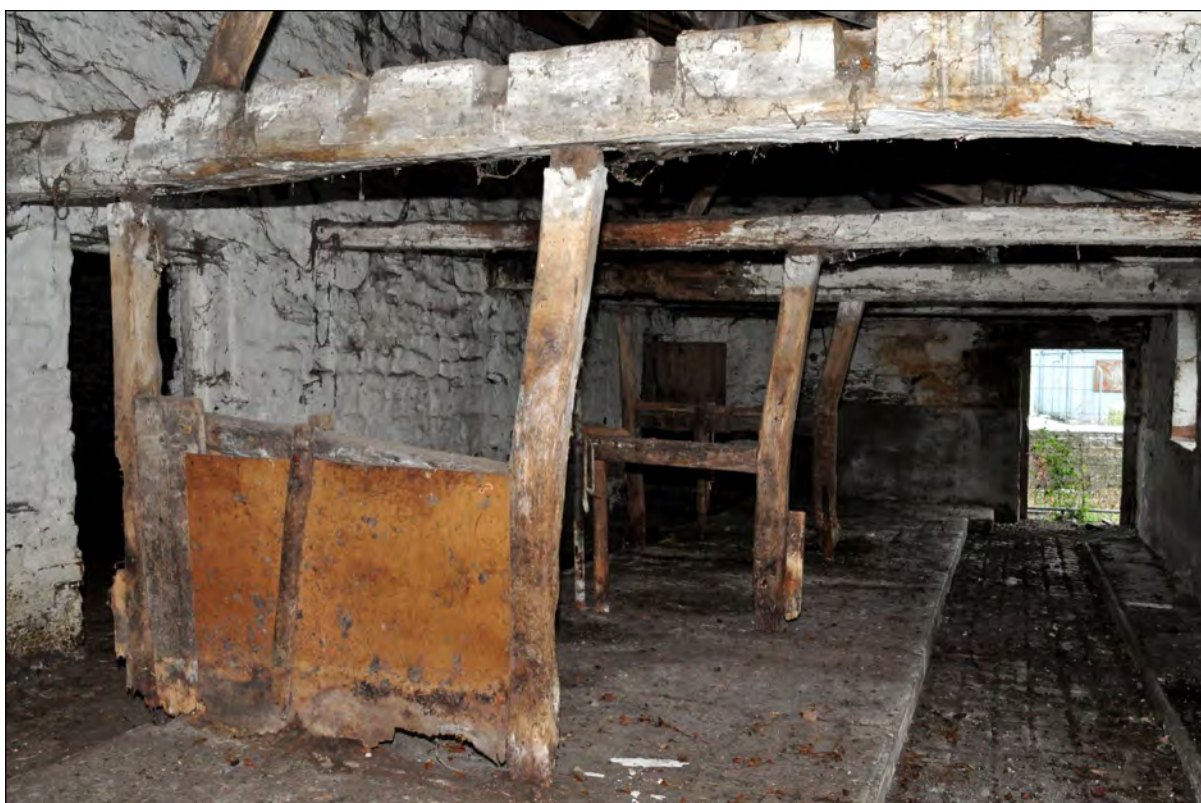
- 6.7 A few internal fixtures survive within the shippon outshut, mainly in the form of timber boskins, arranged in a single row facing north onto a feeding passage, but the floor is entirely concrete. The surviving boskins have elbowed heel-posts, so perhaps were re-used in this building from elsewhere, as this form is not in keeping with the likely date of the outshut (photo 10).

Photo 10: Interior of outshut shippon, looking east
