## Arboricultural Report

Tree survey at 33 Lyndale Avenue, Wilpshire,  
Blackburn, Lancashire

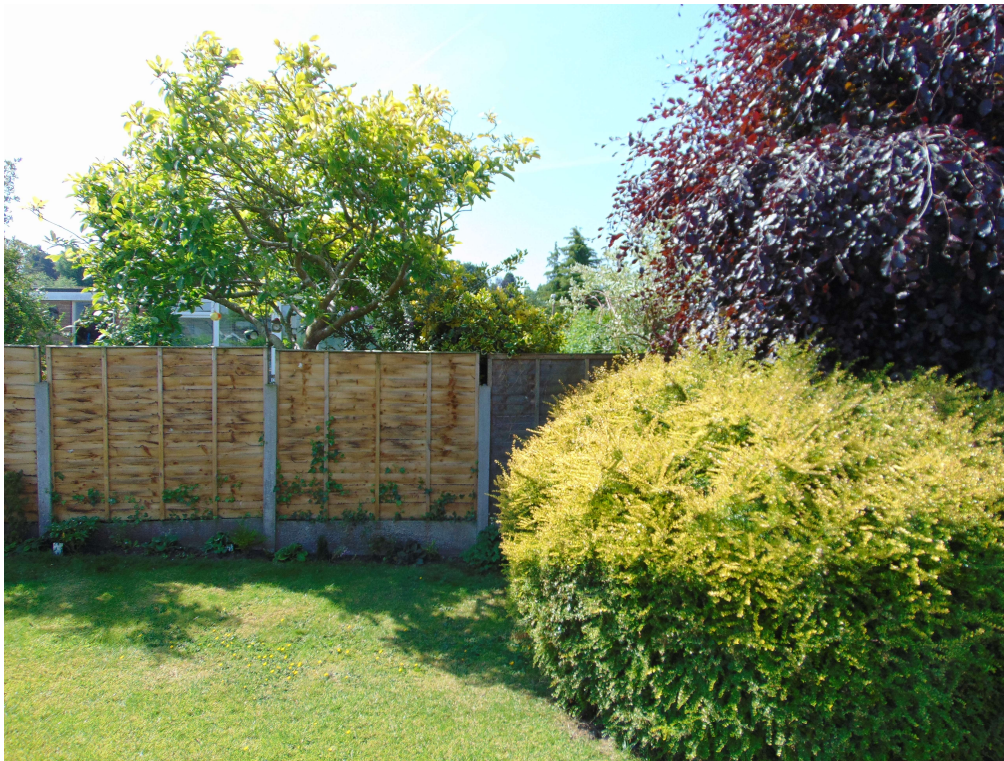
**Figure 2: T1 – magnolia – situated to the rear of a neighbouring garden. This small ornamental tree is situated near to the footprint of the garage and garden room proposed to be sited in the garden of 33 Lyndale Avenue. However, this is a small tree and any associated minor root severance is likely to have no significant impact upon its future growth.**

| Tree or Group No. | Species | Height (metres) | DBH (mm) | Crown Spread (metres) | | | | Age Class | Notes | Life Expectancy (years) | BS5837 Category | RPA radius (metres) |
|---|---|---|---|---|---|---|---|---|---|---|---|---|
| T1 | <i>Magnolia x soulangeana</i> (magnolia) | 3.6 m | 260 mm | 2 | 2 | 2 | 2 | Semi-mature | Growing in the rear garden of an adjacent property. Minor roots may be severed by construction of garage and garden room. Previously pruned away from the garden of No. 33 Lyndale Avenue with some stubs. No actions required. | 40 years+ | C | 3.1 m |

- 4.4 The footprint of the proposed development is also likely to cause minor root loss to the magnolia (T1) that is situated in a neighbouring property (rear garden of No. 22 Durham Road). This is a relatively young specimen and is likely to continue to grow, relatively unaffected by any changes caused by the proposed development. As this tree is not under legal protection, the owner is within their rights to remove any roots from this magnolia that are encroaching into their property (Mynors *et al.*, 2022).

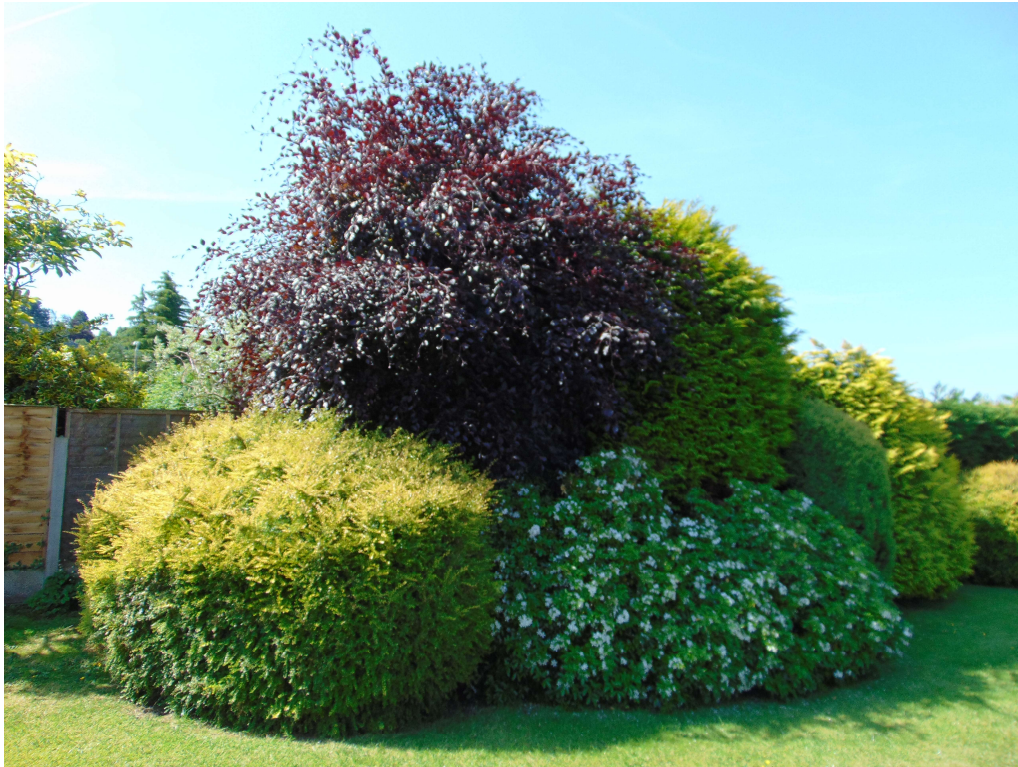
**Figure 3: T2 – copper beech – set within a border of shrubs and topiarized ornamental conifers. This tree has been previously reduced/shaped to stay at approximately 3 metres, which is evident from the lack of a leading shoot to this tree and a view of its internal branch structure. The proposed development would require the removal of the eastern end of this shrub bed, including T2. This loss can be mitigated for within the garden space of 33 Lyndale Avenue.**

| Tree or Group No. | Species | Height (metres) | DBH (mm) | Crown Spread (metres) | | | | Age Class | Notes | Life Expectancy (years) | BS5837 Category | RPA radius (metres) |
|---|---|---|---|---|---|---|---|---|---|---|---|---|
| T2 | <i>Fagus sylvatica Purpurea</i> group (copper beech) | 4.5 m | 230 mm | 2 | 2 | 2 | 2 | Young | Topiarised specimen with no main leading shoot. Would require removal for development proposal. Easily to mitigate this loss. | 40 years+ | C | 2.8 m |

- 4.3 The proposed footprint of the development (garage and garden room) would require the removal of some shrubs, topped conifers and the copper beech tree (T2) (Fig. 3), which has been topiarized in the past to 'shape' it and prevent it developing to a larger size. The impact of these removals will be minor and only very local – and can easily be mitigated.

- 4.6 Mitigation of the lost shrubs, conifers and copper beech tree can be easily accommodated in the garden space. The owner may wish to consider the following garden tree species as suitable for this purpose, if planting one tree in replacement of the removed copper beech tree:

- *Acer griseum* (paperbark maple)
  - *Betula ermanii* (Erman's birch)
  - *Prunus x yedoensis* (Yoshino cherry)

| Tree/Group | Tree works recommended | Work Priority |
|---|---|---|
| <b>T2</b> | <p>To enact the proposed development, this copper beech tree (topiarized) and some neighbouring shrubs and shaped conifers will need to be removed. If so, the owner may wish to consider mitigation by the provision of planting one garden tree suited to the garden space.</p> <p>If the proposed development does not go ahead, regular reductions of this topiarized tree are recommended, given its location and current structure.</p> | Low |

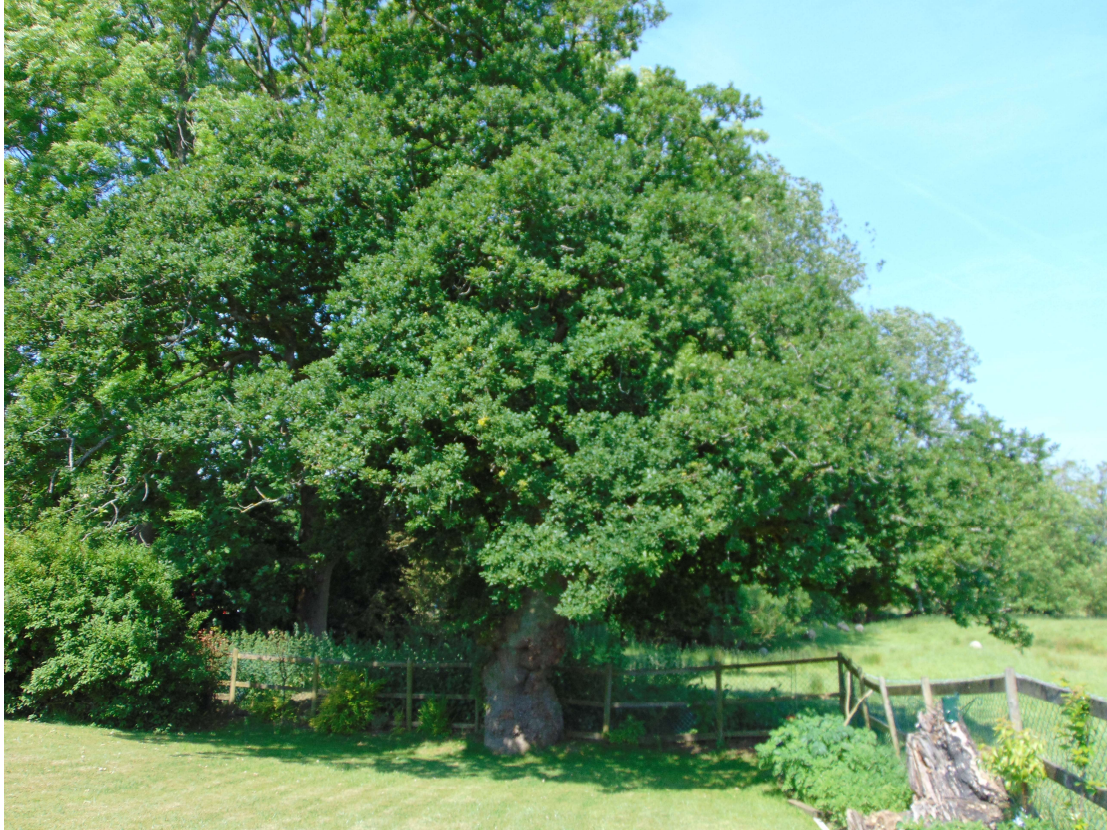
**Figure 4: Veteran oak tree (T3) that predates the property and lies on the northern boundary with adjacent meadow. This agricultural retention is of high amenity and ecological value, and it should be protected from any harm during the construction phase of the proposed development.**

| Tree or Group No. | Species | Height (metres) | DBH (mm) | Crown Spread (metres) | | | | Age Class | Notes | Life Expectancy (years) | BS5837 Category | RPA radius (metres) |
|---|---|---|---|---|---|---|---|---|---|---|---|---|
| T3 | <i>Quercus robur</i> (oak) | 12 m | 960 mm | 6 | 6 | 6 | 5 | Veteran | Oak tree of high value aesthetically, culturally and ecologically. Minor deadwood present. Not near proposed development footprint but should have full RPA on garden side protected during construction work. Monitor – consider mulching. | 40 years+ | A | 11.5 m |

- 4.5 One retained agricultural tree (oak T3) is a substantial arboricultural asset on this site because of its age, structure, ecological and landscape value. It is not situated near the proposed development and thus does not act as a significant constraint to the proposal. However, it will be important to ensure that this tree is fully protected from any construction works and from having construction materials or spoil being stored within its designated root protection area (RPA). Consequently, prior to any development activities, the RPA of this tree, on the garden side of the tree only, should be fenced off at 11.5 metres from the tree's main stem, using braced Heras fencing as recommended within BS5837: 2012. The fencing should remain in place for the whole period when the construction of the garage/garden room is being carried out: pedestrian access to the area for the purposes of gardening and recreation can be put in place. No materials should be stored in this fenced off area and no access should be allowed for construction vehicles into this protected area.

| Tree/Group | Tree works recommended | Work Priority |
|---|---|---|
| <b>T3</b> | <p>Monitor structure and tree health on a regular basis.</p> <p>Consider provision of a mulch circle at the base of the tree, to improve tree health and longevity. Advice on tree mulching is available at: <a href="#">TreesAreGood Consumer Brochures Proper Mulching Techniques</a> (ISA, 2021).</p> | Low |

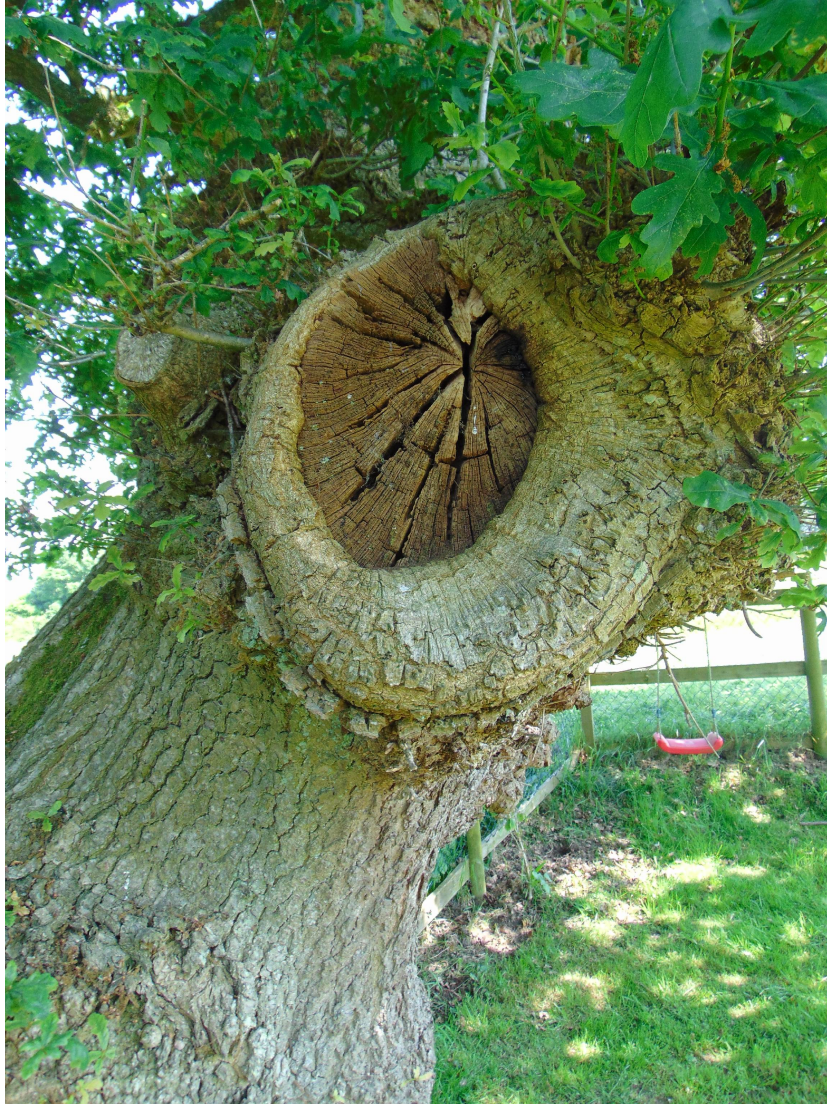
**Figure 5: Old wound due to previous large-diameter limb removal on oak (T3). This tree has several ecological features that makes it more valuable for wildlife, including deadwood and wounds. No works are required upon this tree at this time, and any maintenance work should be minimized.**

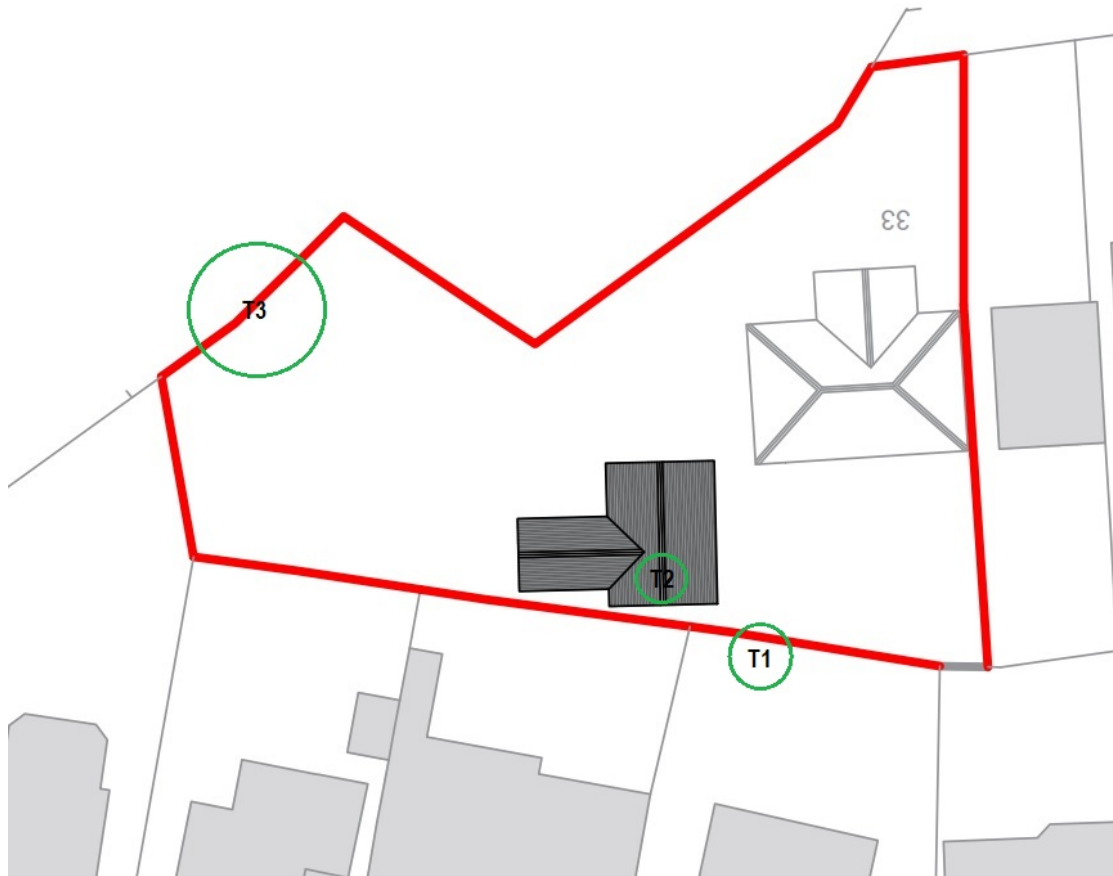
**Figure 6: Outline map of tree locations on land at 33 Lyndale Avenue, Wilpshire, Blackburn, as surveyed on the 8<sup>th</sup> of June 2023. The proposed development of a garage and garden room is printed in dark grey. Copper beech (T2) would need to be removed.**
