### REPORT ON A STRUCTURAL INSPECTION

The Old Barn  
Malt Kiln Brow  
Chipping  
PR3 2GP

Project No. 9645

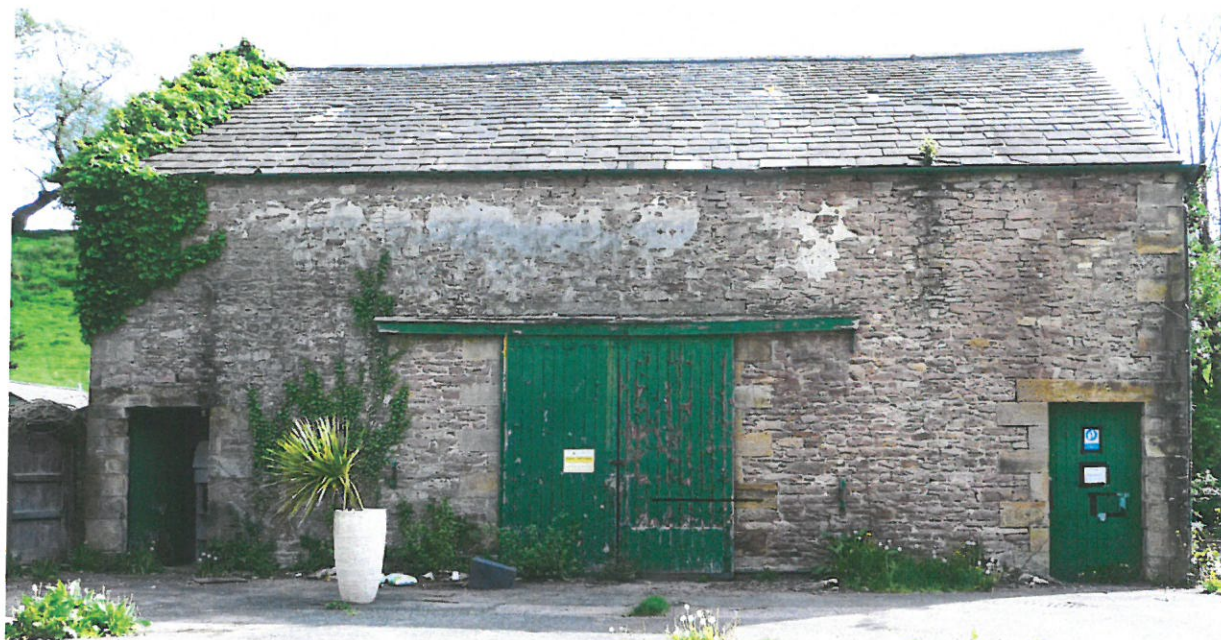
**PHOTOGRAPH 1**

See photograph 1 for details of this elevation. The features of this wall are symmetrical about the central doorway.

Reporting on the front wall of the barn from the right-hand side gable wall. This wall is a stone-built wall in the order of 5m. high. It is constructed from random sandstone built as a solid wall some 400mm thick. There are quoins in the corner of the barn wall and there is a short panel of stone to a doorway. There is a stone lintel over the door and stone quoins to the sides.

At a point 3m. from the gable wall there has been water leaking from the roof and this has discoloured the wall and eroded some of the mortar. Then there is a panel of stone to a large barn door. This has sliding doors to the front and there is a concrete lintel over the doorway. There are quoins to the sides of the opening.

The roof to the barn is a conventional double pitched roof with the ridge running from side to side. The front slope is clad with slates and a number of these have slipped. There are holes mainly to the right side of the roof. There is a slight deflection to the ridge, but this is not excessive. (See photograph 1).

There are holes in the roof and the slates need to be re-positioned.

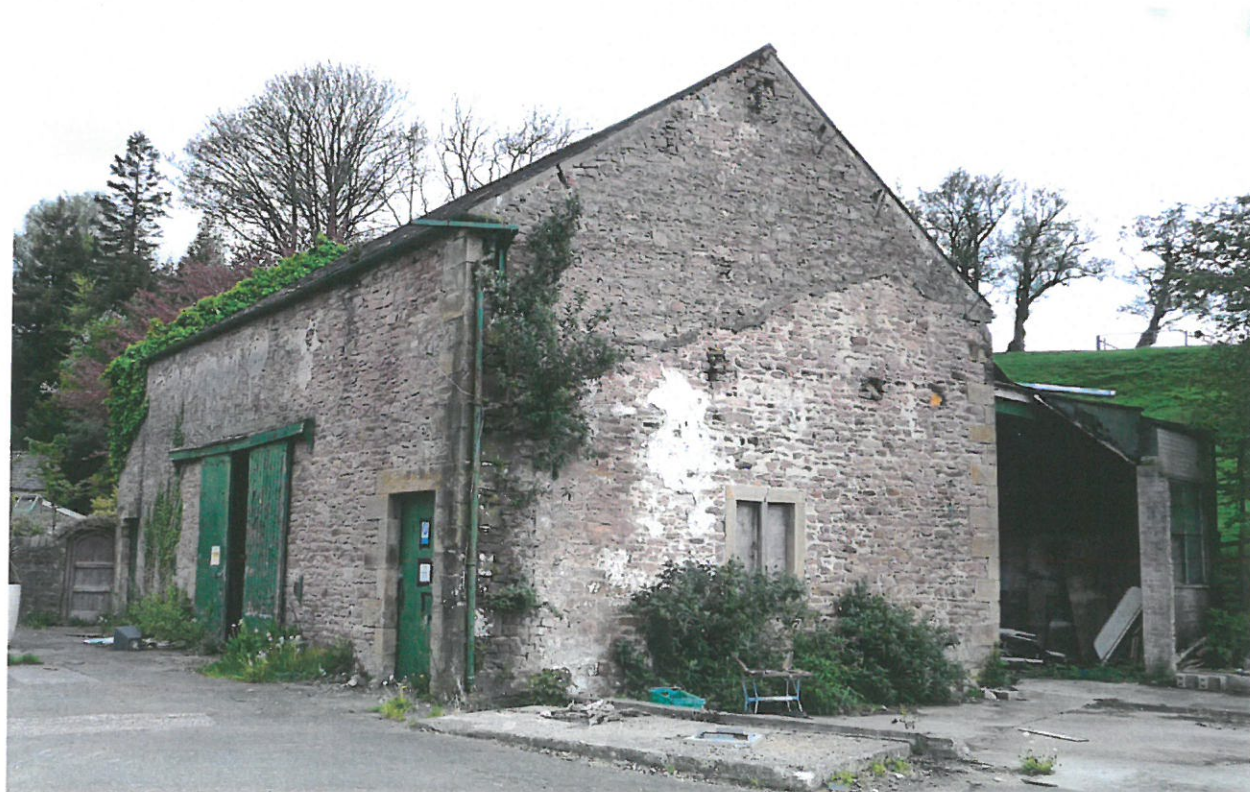
**PHOTOGRAPH 2**

See photograph 2 for details of this elevation. This side gable wall is constructed from random sandstone built as a solid wall some 400mm thick. It would appear that there was a single storey annex built up against this wall. This had an off-centre ridge creating an asymmetrical roof shape. The flashing to this roof has not been fully removed.

The wall has a slight bulge outward to the middle of the wall, in the order of 10mm. However, this is structurally acceptable.

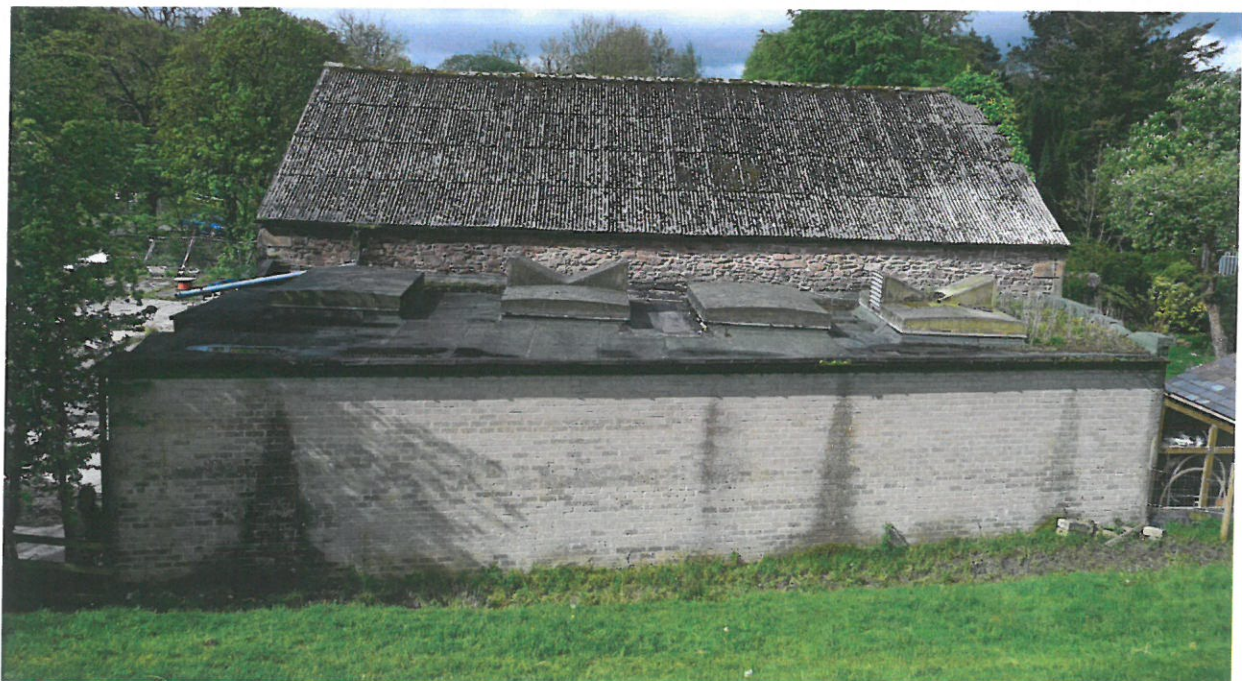
**PHOTOGRAPH 4**

The lower part of the barn is enclosed by the rear annex. However, the upper wall of the barn can be seen in photograph 4. This wall is a stone-built wall constructed from random sandstone built as a solid wall some 400mm thick. There are quoins in the corners of the barn wall. There are no designed openings in this upper wall. There are no signs of any distress. (See photograph 4).

Reporting on the rear wall of the annex. This wall is constructed from a concrete brick, and this is of varying thickness. There are no designed openings to this wall. (See photograph 4). The wall has been water stained because of a leaking gutter. (See photograph 24). There is no cracking in this wall.

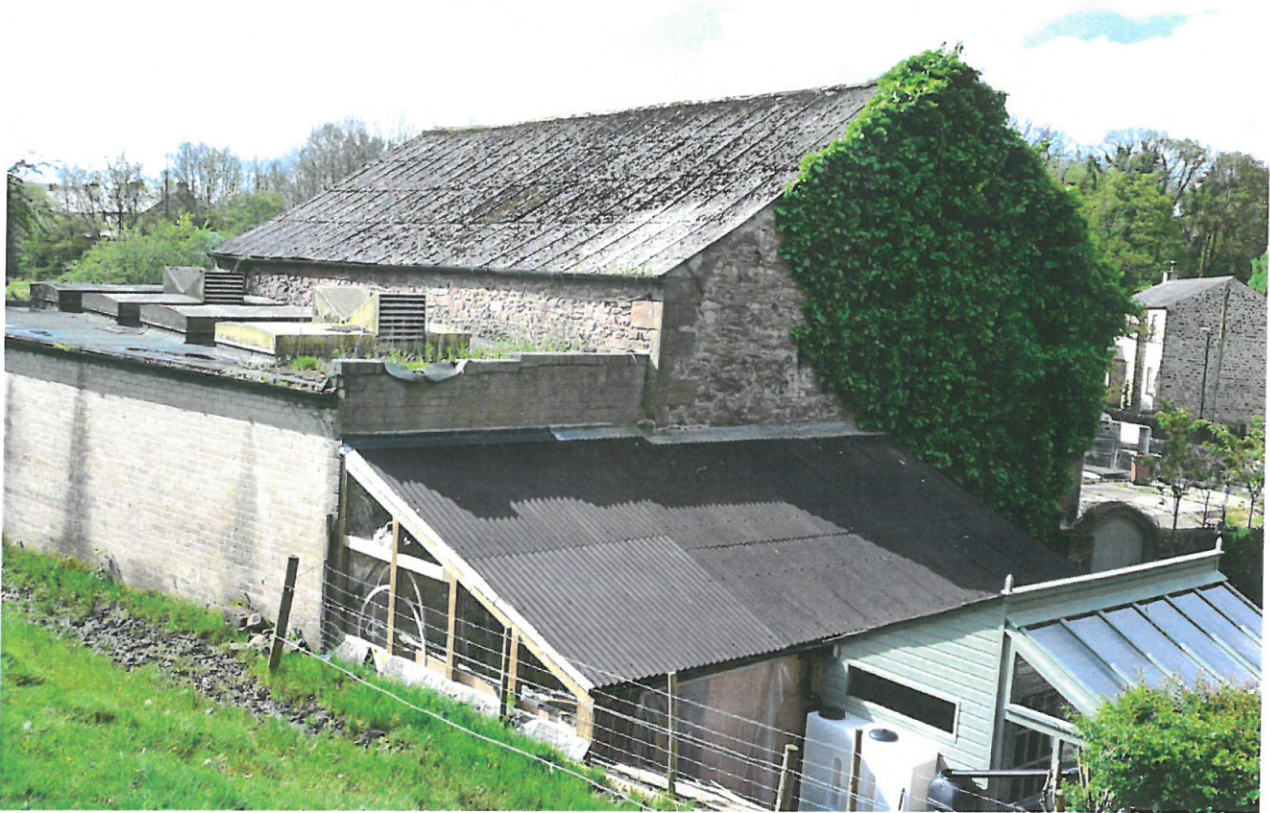
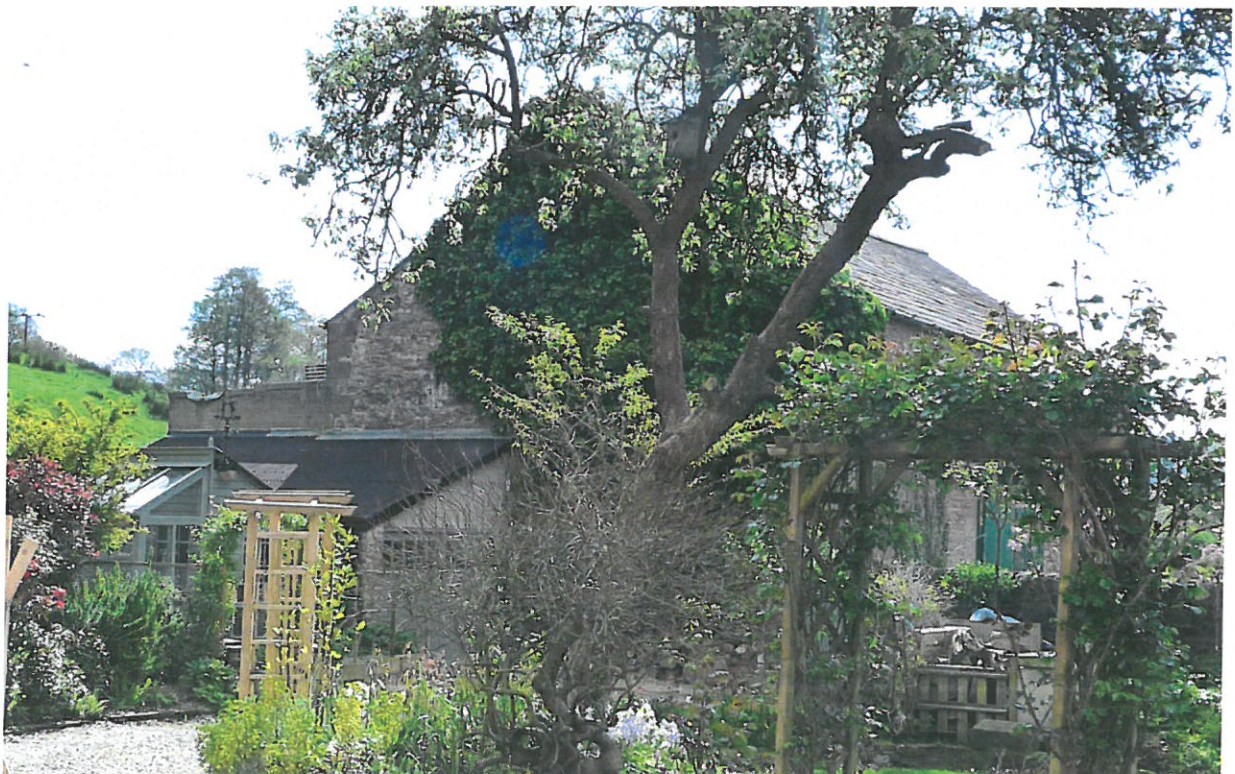
See photographs 5 & 6) for details of this elevation. This side gable wall is constructed from random sandstone built as a solid wall some 400mm thick. There is a single-storey building built up against this wall and this belongs to a neighbour.

Reporting from the rear wall there are quoins to the corner of the wall and there is a panel of stone. For the rest of the wall, we cannot report upon because it is covered in Ivy.

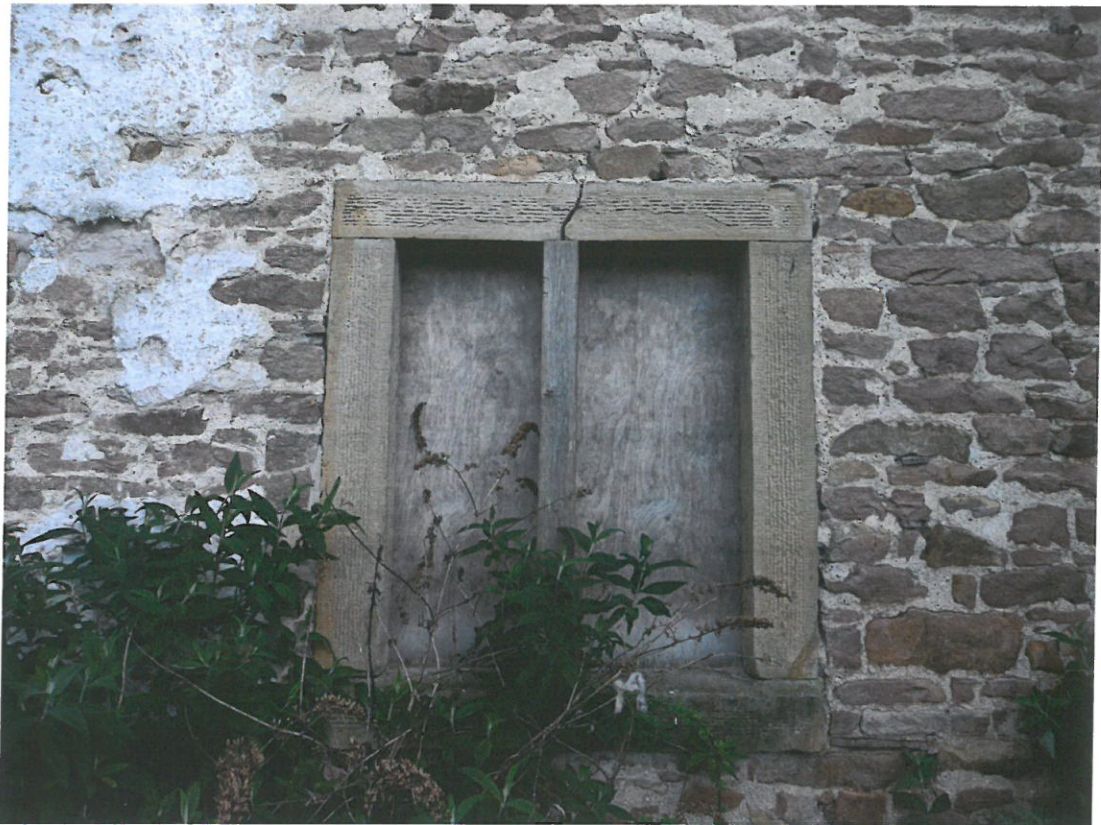
**PHOTOGRAPH 9**

Reporting from the front wall there are quoins to the corner of the wall and then there is a panel of wall up to a ground floor window. This has stone cills and lintel. The stone lintel has cracked and has a timber post supporting the wall above. (See photograph 9). There are three voids in the wall at a height of 3m. and these have been partially filled with expanding foam. There is a void at the top of the wall just down from the ridge.

The intention is to convert this building into a dwelling. The existing building is of stone-built construction, and this appears to be well constructed. There are some voids in the walls, and these will need the stone replaced and then pointed. There are some cracked stone lintels and these need to be replaced with similar stone.

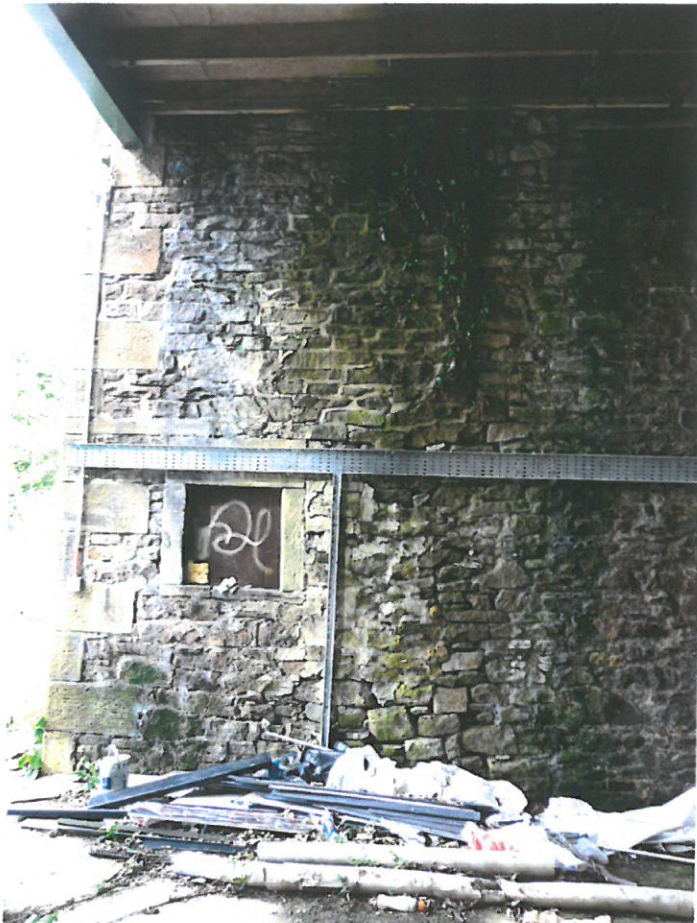
**PHOTOGRAPH  
11**

Reporting now on the rear wall of the Barn which is enclosed by the annex. This wall is a stone-built wall in the order of 5m. high. The wall is constructed from random sandstone built as a solid wall some 400mm thick. Reporting from the left gable wall (as viewed) there are quoins in the corners of the barn wall. (See photograph 10). There is a small ground floor window close to the gable wall. This has stone jambs, cill and lintel. (See photograph 11).

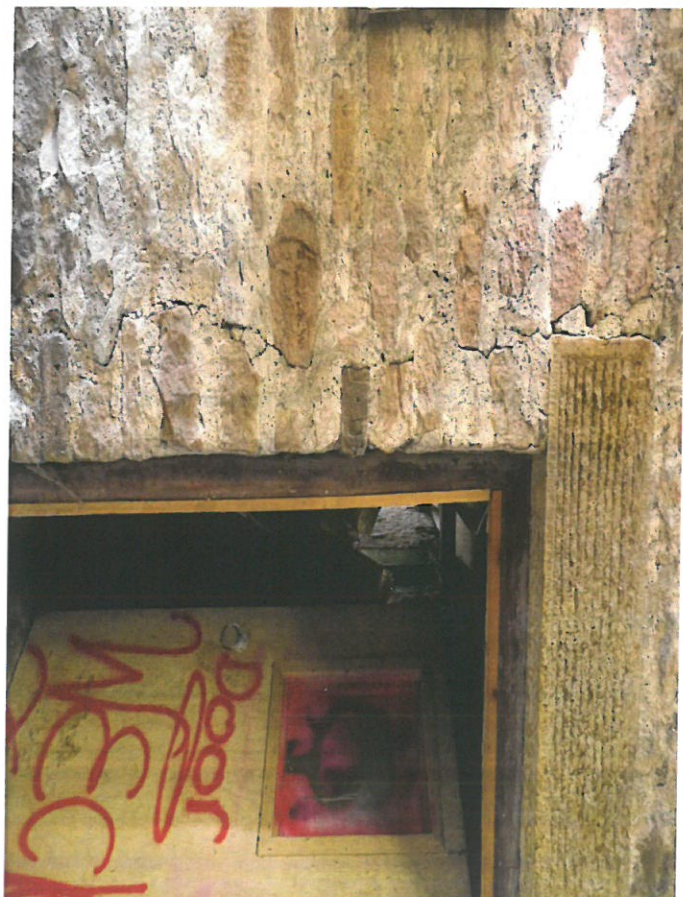
**PHOTOGRAPH  
12**

Then there is a large panel of stone with no designed openings. Close to the far gable wall there is a doorway, and this has a stone lintel. There is a 2mm. wide crack in the rear wall running down from the left side of the lintel for 1.5m. (See photograph 12).

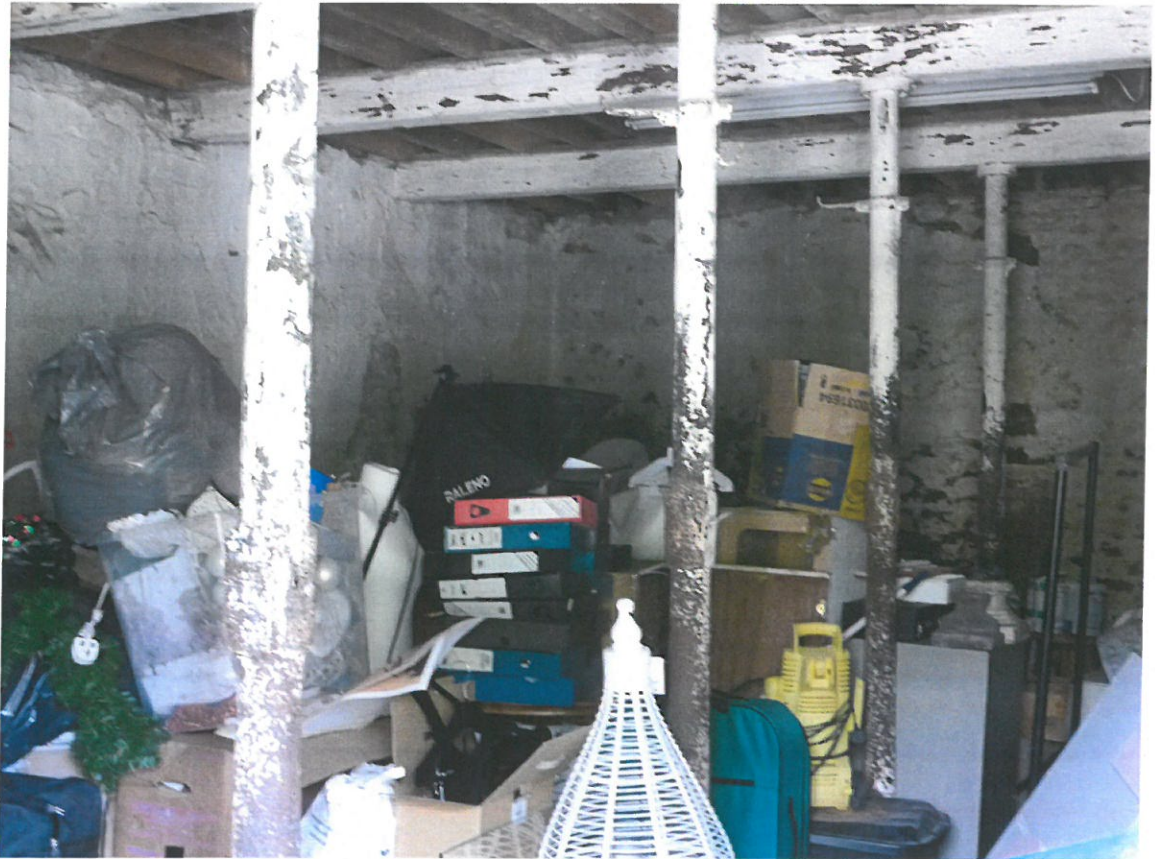
**PHOTOGRAPH 13**

This area is along the right side of the barn and runs full depth. There is a timber first floor over this area. This is supported on a number of cast iron posts supporting timber beams. These are supporting timber joists which form the first floor above. (See photographs 13 & 14).

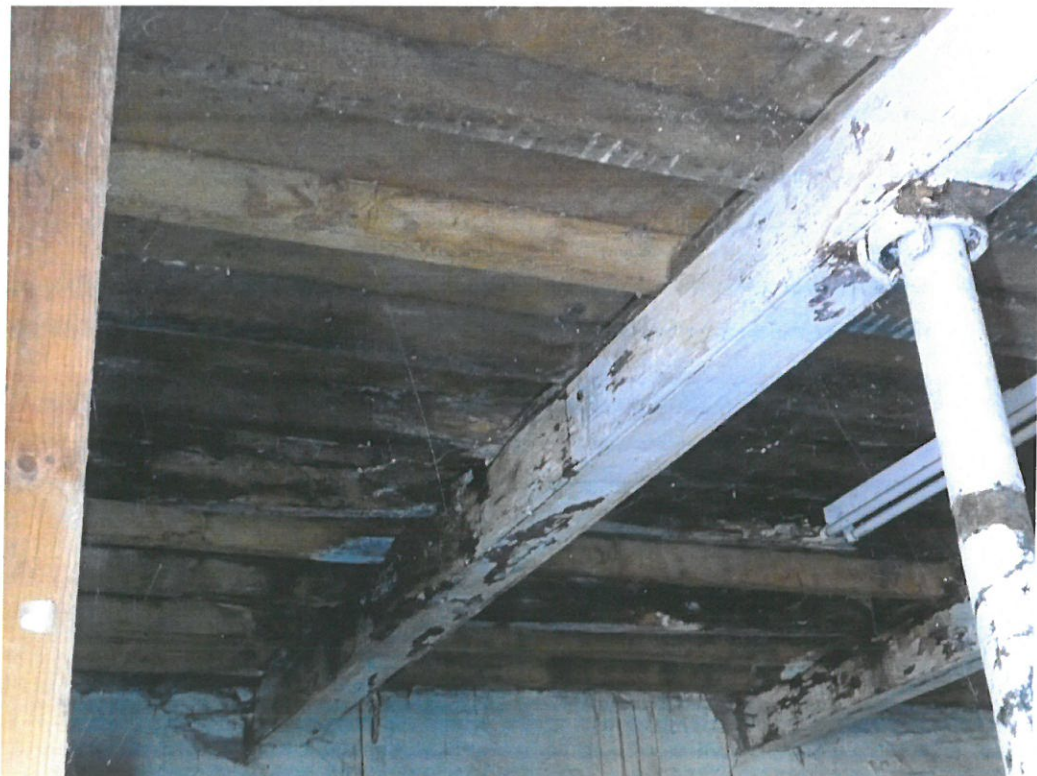
**PHOTOGRAPH 14**

There has been water dropping down from the roof and this has discoloured and allowed rot to form on some joists and a timber support beam. (See photograph 14). The floor boarding to the first floor in this area has rotted making access unsafe.

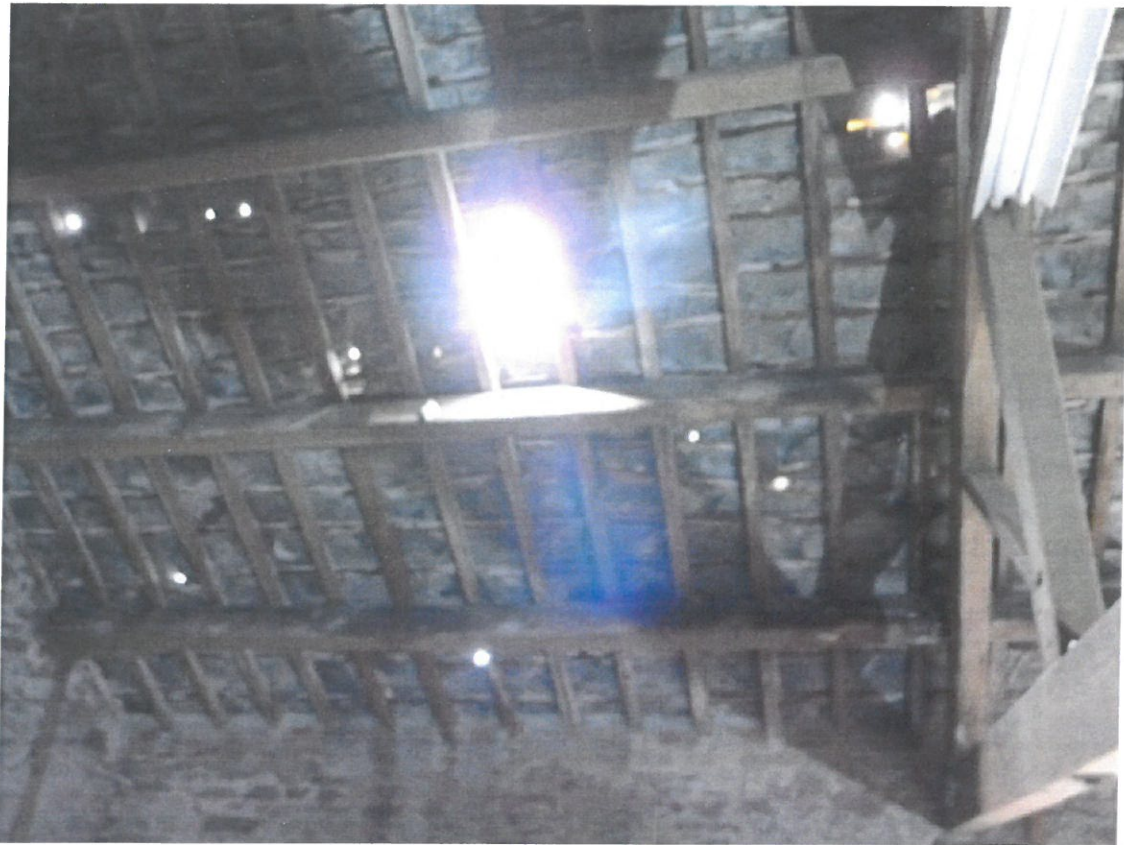
**PHOTOGRAPH 15**

The roof above Area 1 has been leaking causing rot to the first floor structure. (See photograph 15).

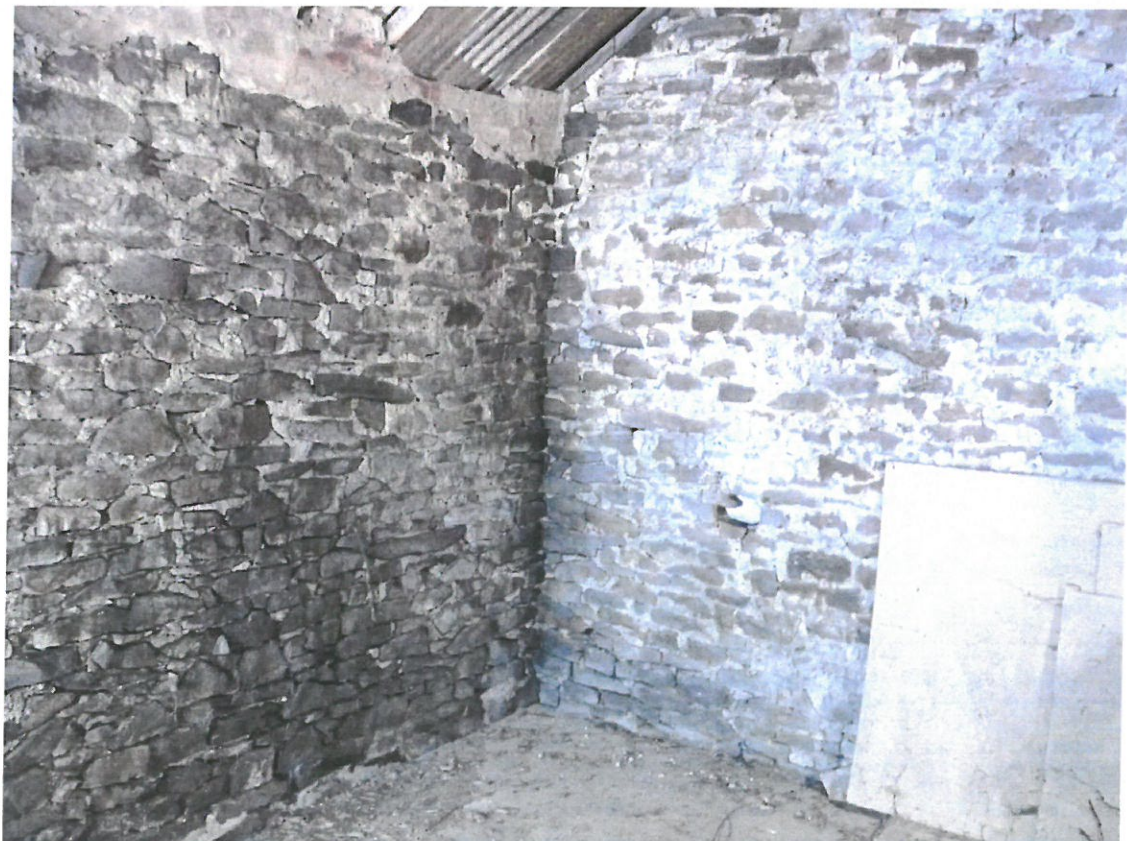
**PHOTOGRAPH 16**

There is a crack/gap running along the corner of the right gable wall and the rear wall. This could be due to there being poor bonding of the stones. (See photograph 16).

The crack in the rear right corner above the first floor is due to poor bonding along the line of the crack. This needs to be improved by adding larger stones across the line of the crack.

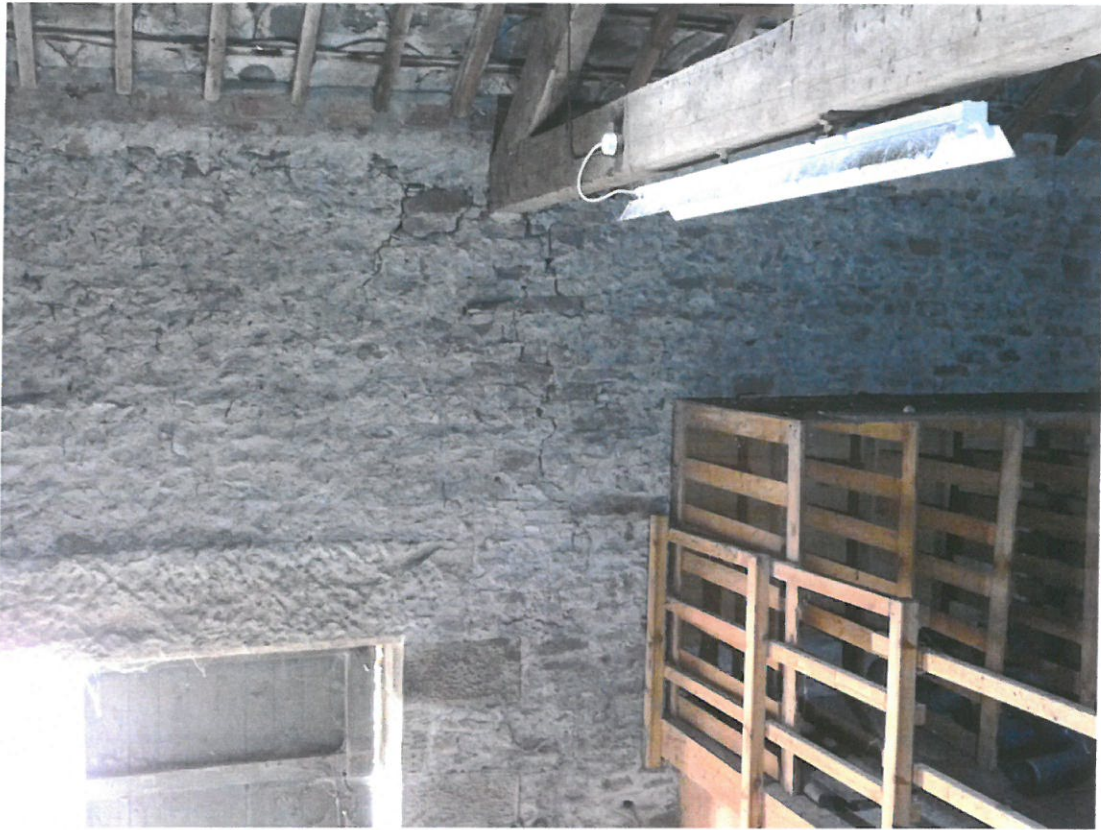
**PHOTOGRAPH 17**

There is a large barn door to the front wall, and this has a stone lintel over. (See photograph 18). There is a vertical crack 2mm. wide running down the front wall from the bearing of one of the roof trusses. This runs for 1.5m. There is a similar diagonal crack running from the same point but this only runs for 700mm. (See photograph 17).

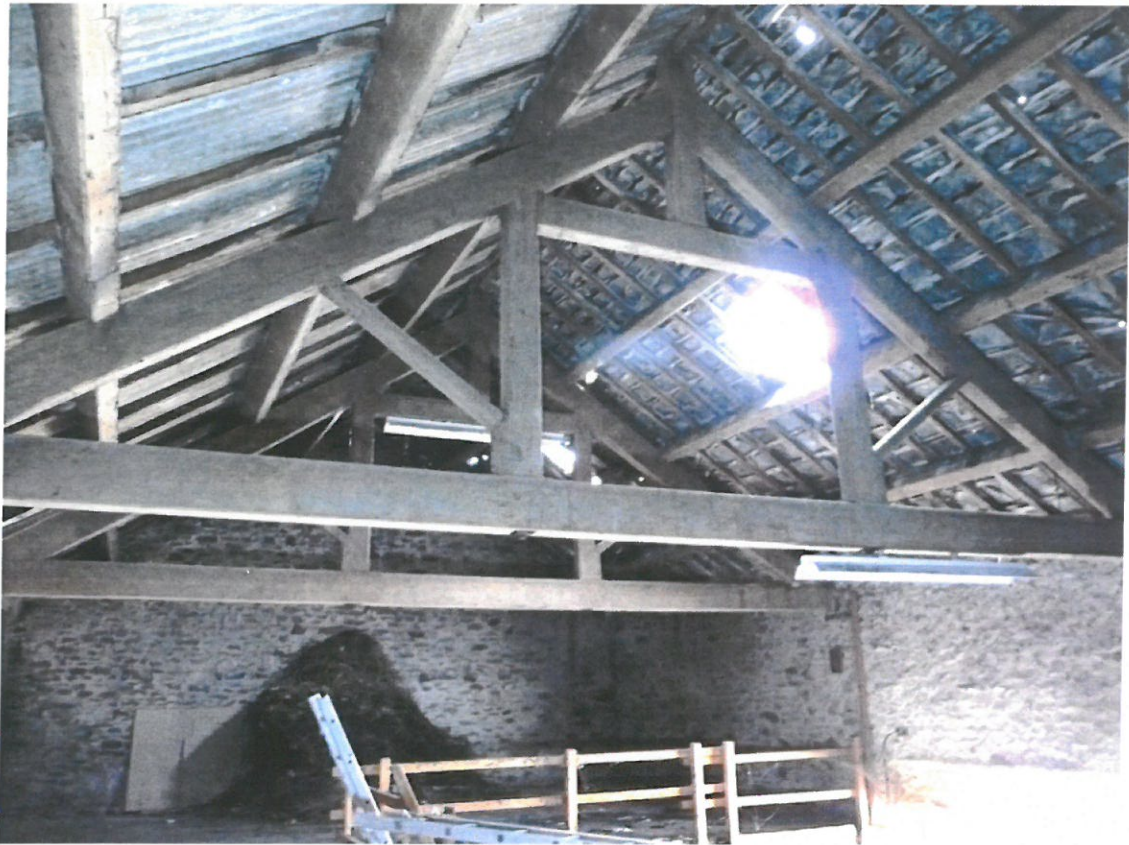
**PHOTOGRAPH 19**

The roof to the barn consists of two main timber roof trusses and these support three timber purlins to each slope. There are no missing members to these trusses. The purlins appear to be of a reasonable section size for the loading and the span.. (See photograph 19).

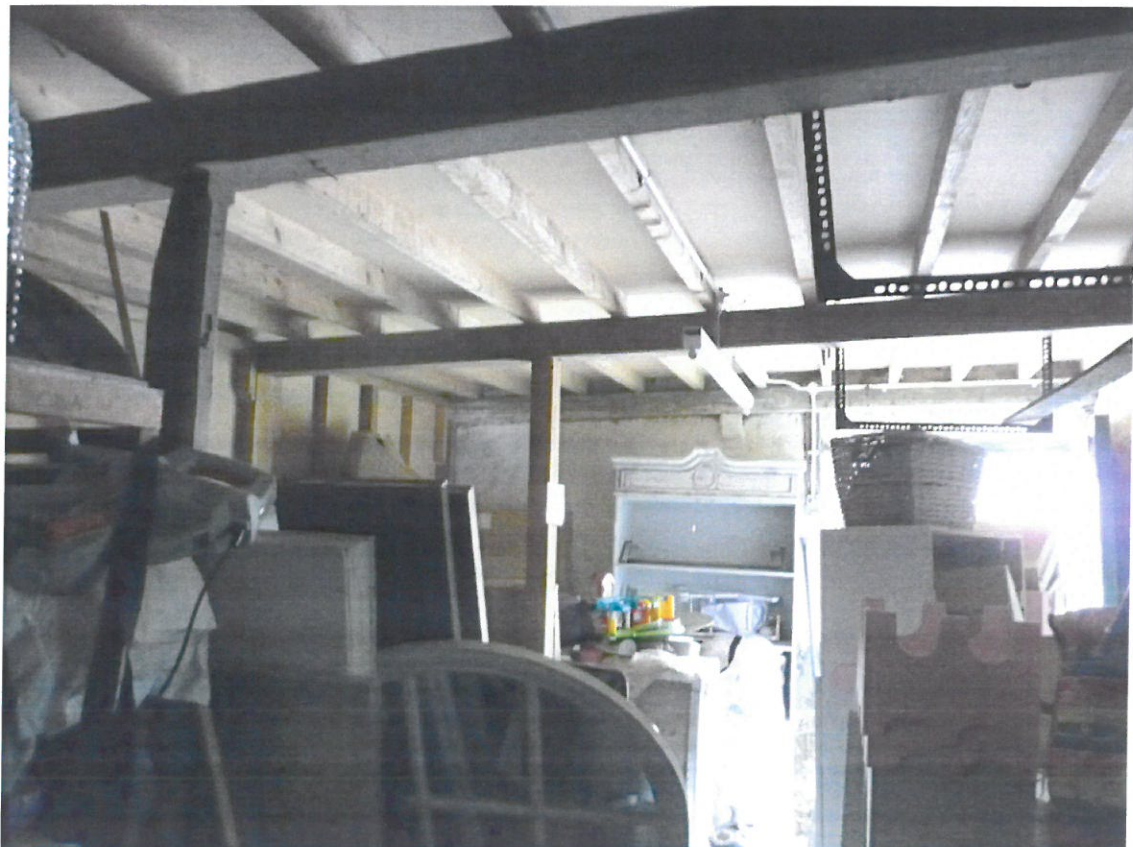
**PHOTOGRAPH 20**

This area is along the left side of the barn and runs the full depth of the barn. There is a timber first floor over this area. This is supported on a number of timber posts supporting timber beams. These are supporting timber joists which form the first floor above. (See photograph 20). The beams and joists appear to be undersized for this floor.

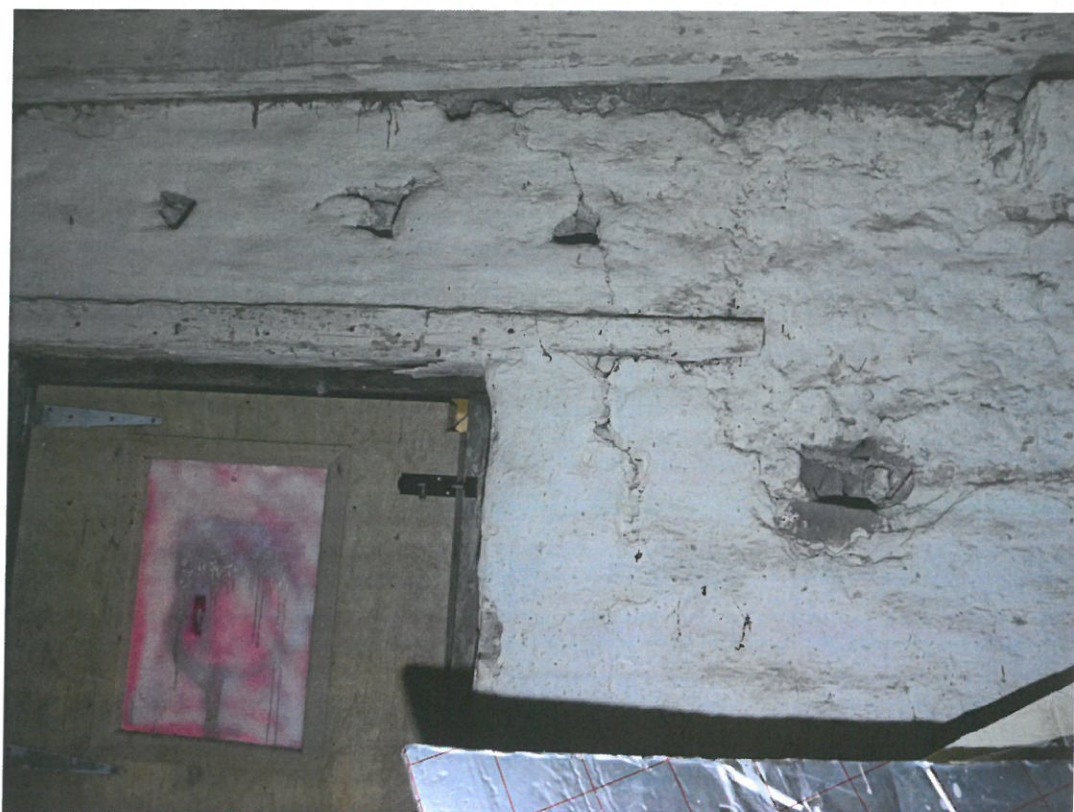
**PHOTOGRAPH 21**

There is a doorway to the rear wall and there is a 2mm. wide vertical crack running down the wall for 1.5m. (See photograph 21).

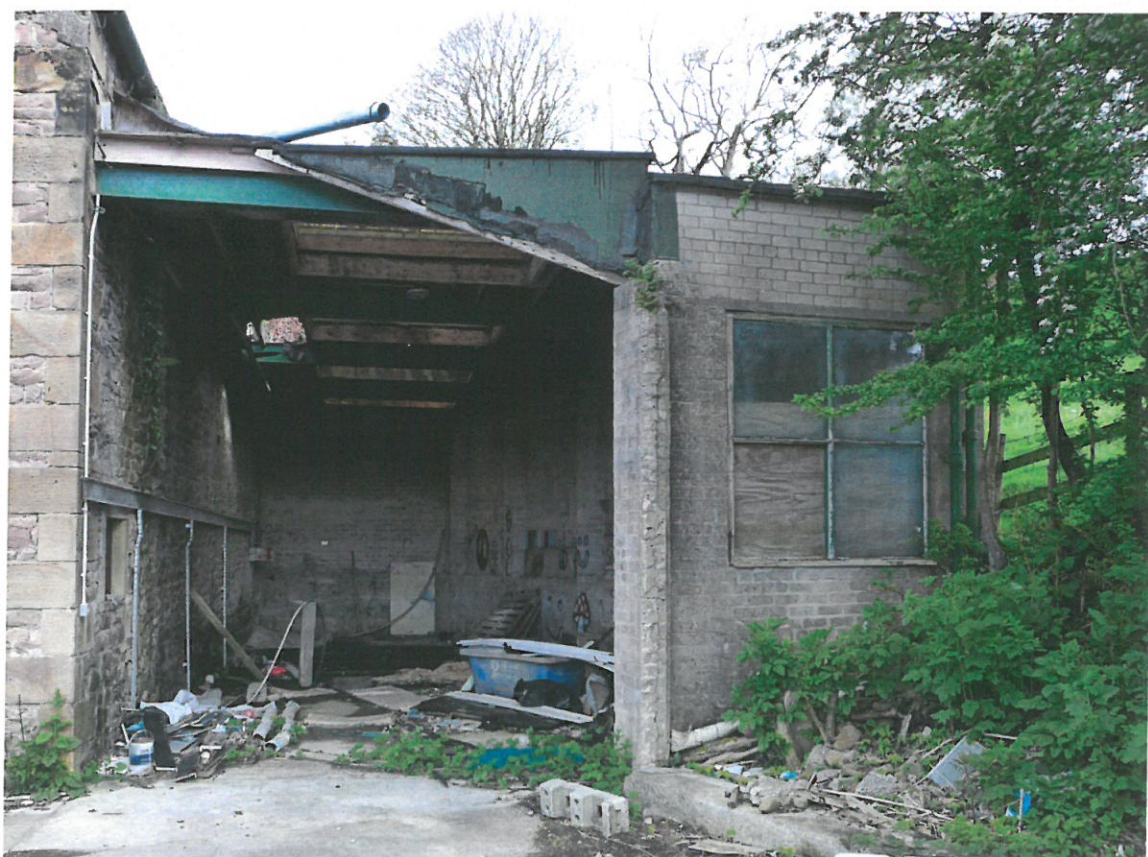
**PHOTOGRAPH 22**

There is a single storey annex built out from the rear corner of this gable wall. (See photograph 22). There is a large opening in the wall approximately 2.8m. wide. Then there is a brick pier, and this is constructed from concrete bricks and is 3.5m. high. To the right of this pier there is a brick wall constructed from concrete bricks and built as a solid wall 230mm. wide. There is a large window on this wall, and this has a concrete lintel over. There is a vertical butt joint in the wall close to the rear wall above the bearing of the lintel. (See photograph 28).

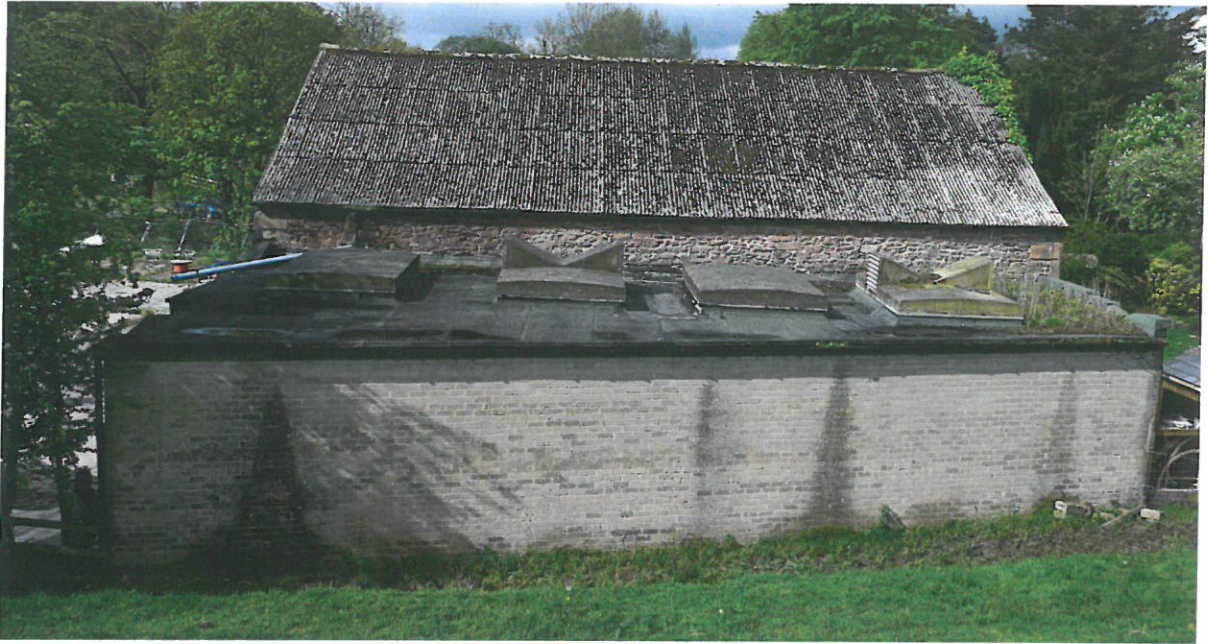
**PHOTOGRAPH 23**

The cladding to the rear roof is corrugated mineral fibre sheeting. (See photograph 23).

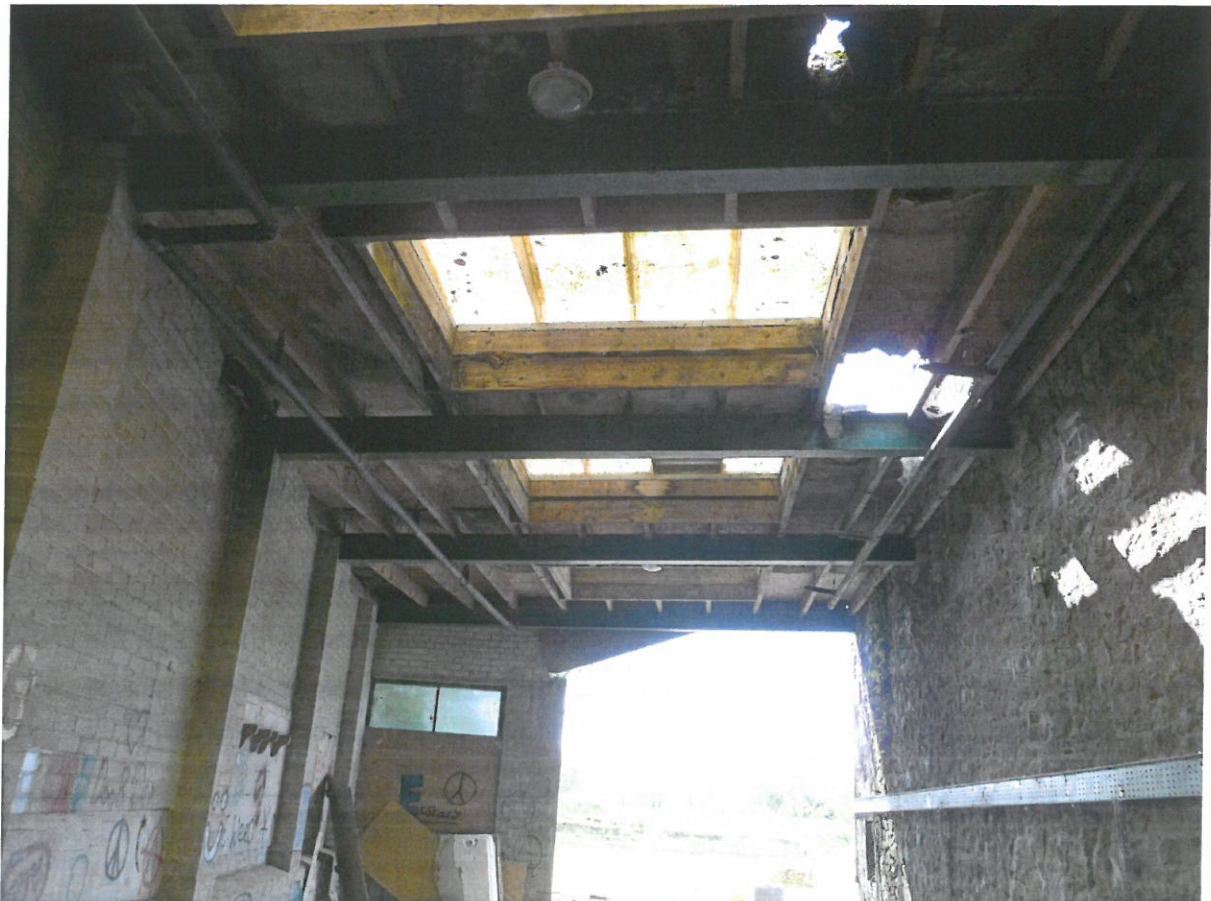
**PHOTOGRAPH 26**

This is one large open area which has a rear wall running at an angle to the rear wall of the barn. This rear wall is a retaining wall and has a dado wall some 1m. high. This wall is likely to be 450mm. wide. From the top of the dado wall there are piers which continue up to the roof and these are supporting steel roof beams. Between the piers the wall is only 230mm. thick built as a solid wall. All of this wall construction is in a concrete brick. There is no sign of any cracking to this wall. (See photograph 26 & 27).

The roof over this annex is a flat roof with timber joists. These are bearing on steel beams spanning from the rear wall of the barn out to the rear wall of the annex. (See photograph 26 & 27).

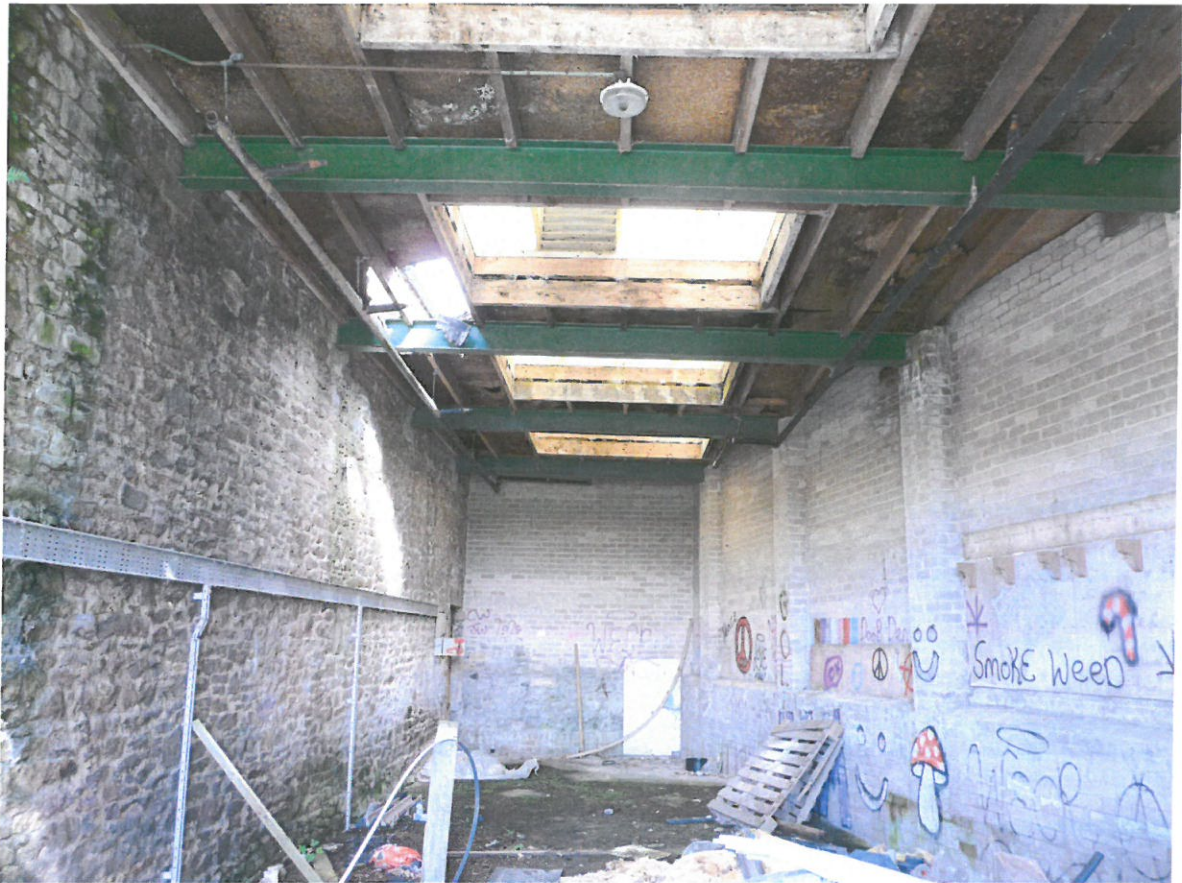
**PHOTOGRAPH 27**

At the far end of the area there is a solid brick wall without there being any designed openings. This appears to be free from any distress. (See photograph 27).

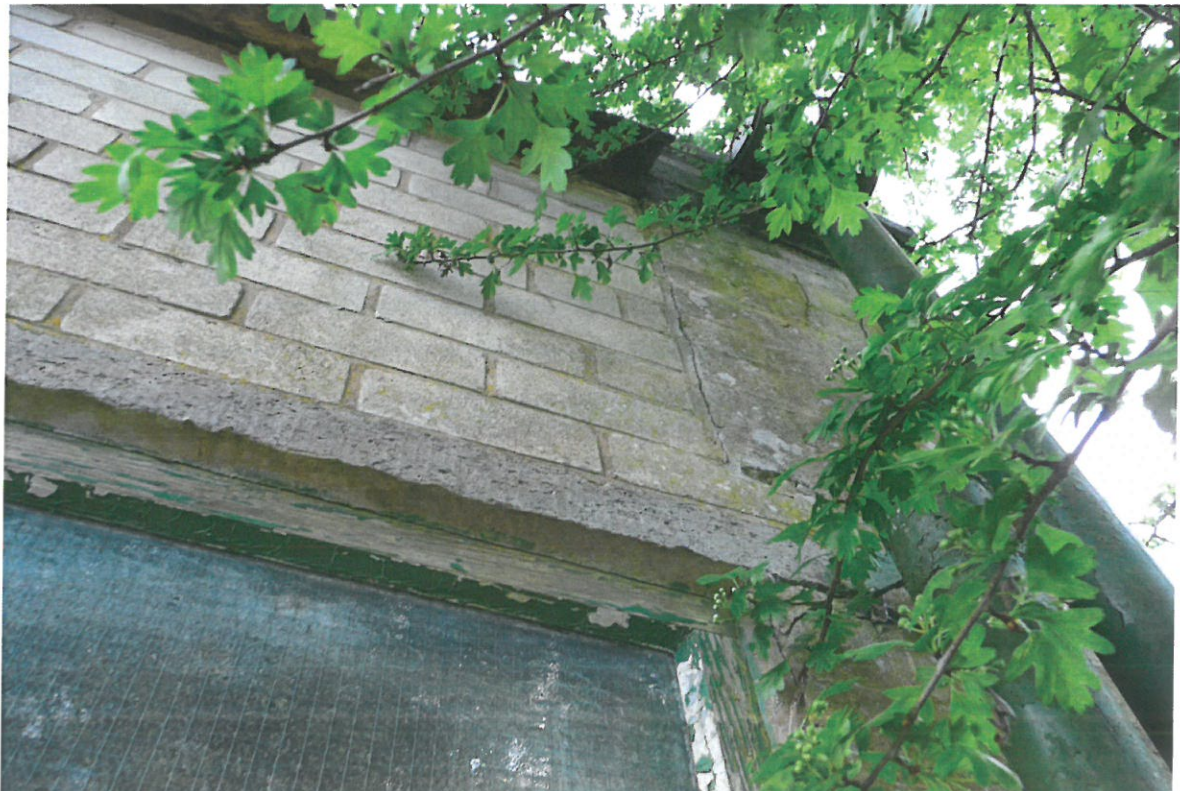
**PHOTOGRAPH 28**

The stone above the doorway has received a coating of render. Then there is a large panel of stone wall to a doorway. This has a stone lintel over the door. The bottom edge of this has been damaged and some stone has been knocked off. (See photograph 28). There are stone quoins to the sides of the doorway. There are quoins to the vertical corner of the barn wall.
