### REPORT ON A STRUCTURAL INSPECTION

The Old Barn  
Malt Kiln Brow  
Chipping  
PR3 2GP

Project No. 9645

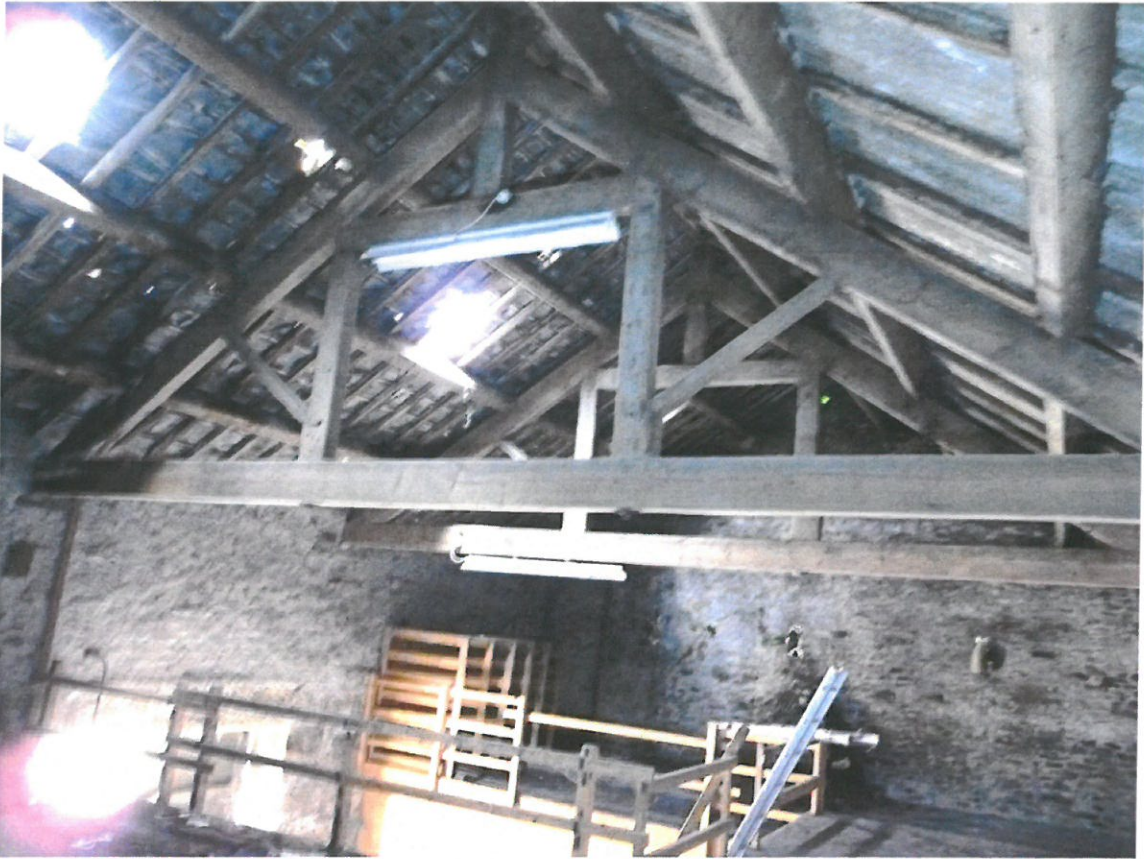
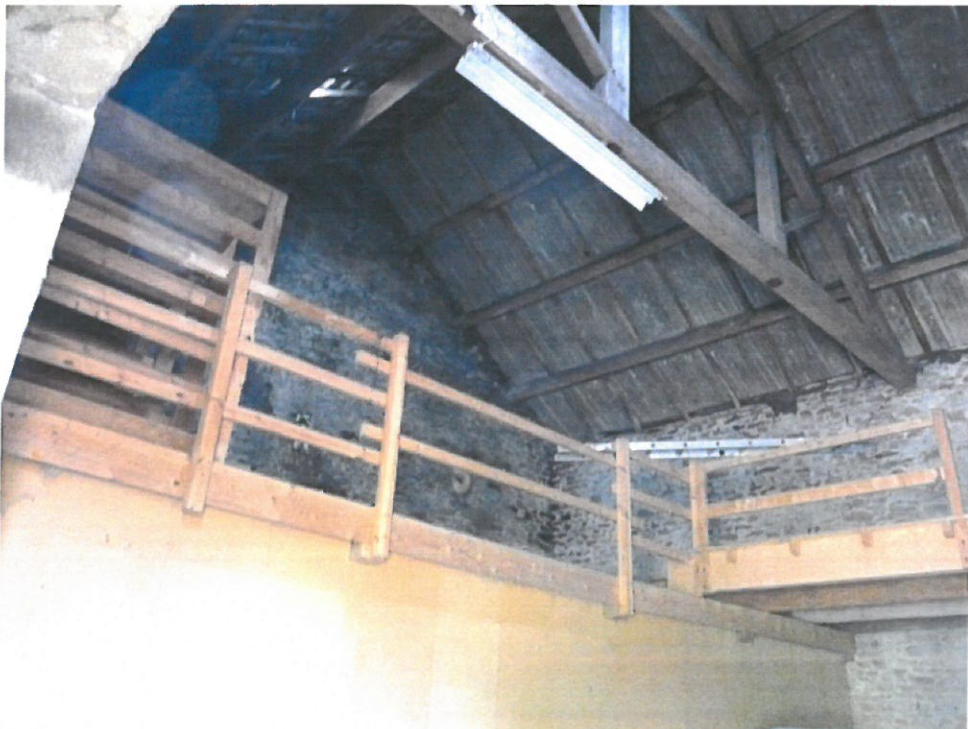
This is the area in the middle of the barn in between the two walled off areas 1 and 2. This area is vaulted up to the roof. There are partition walls to either side and at the rear there is a walkway to provide access to the first floor above areas 1 & 2. (See photographs 29 & 30).

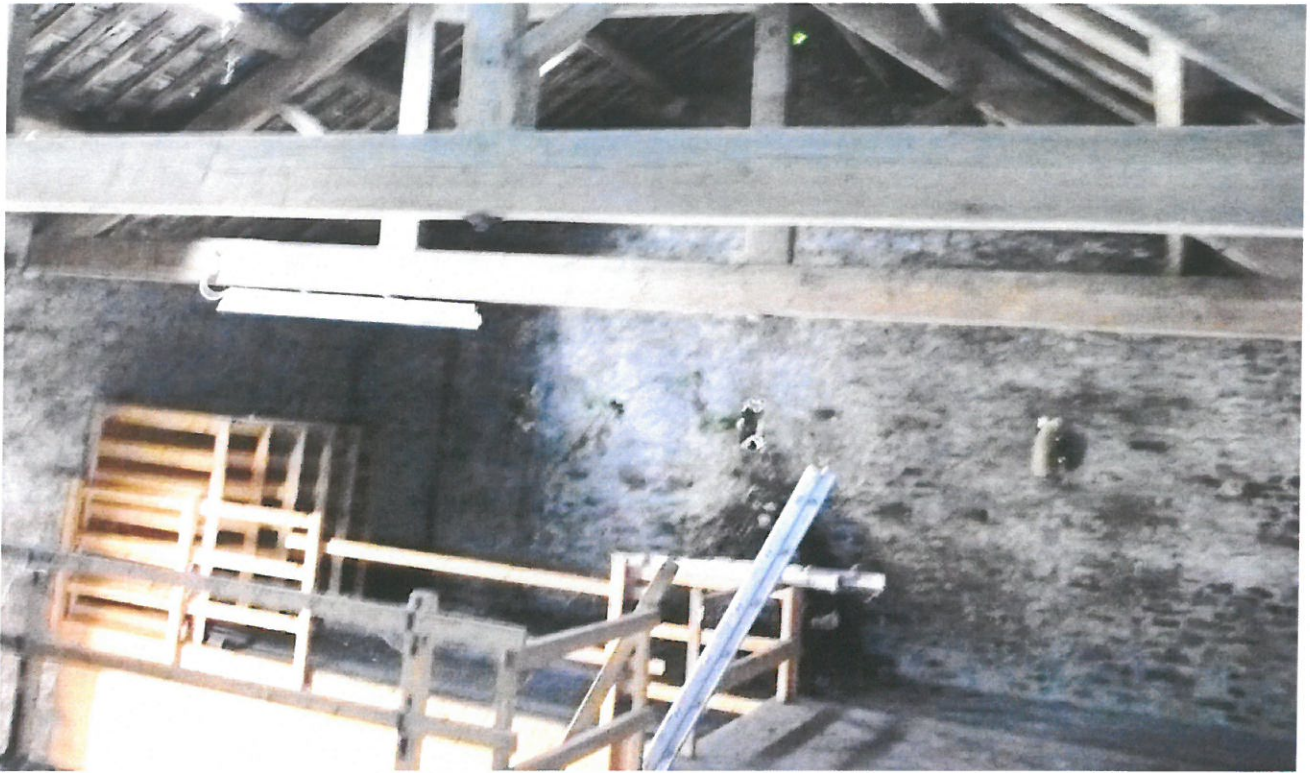
**PHOTOGRAPH 31**

The first floor above the right side of the barn was not walked upon because of the flimsy nature of the floor joists seen in this area from the room below. There are voids to the left gable wall and these need to be infilled with stone. (See photograph 31).

The intention is to convert this building into a dwelling. The existing building is of stone-built construction, and this appears to be well constructed. There are some voids in the walls, and these will need the stone replaced and then pointed. There are some cracked stone lintels and these need to be replaced with similar stone.

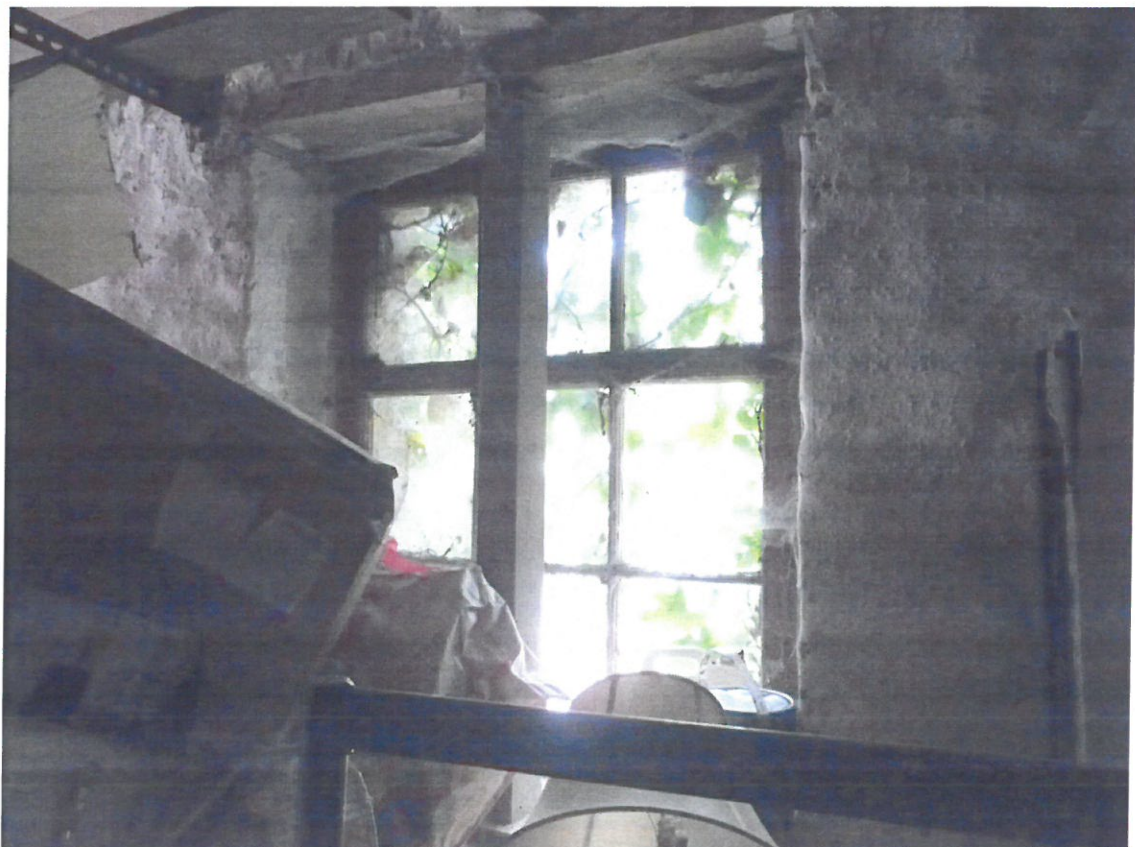
**PHOTOGRAPH 32**

There is a window to the side wall. The lintel is cracked and is supported with a timber post. (See photograph 32).
