## **Structural Inspection Report**

### **Thornley – Knott Farm Barn** **Proposed Conversion to Single Dwelling**

**Ref. 3526-1 : August 2022**

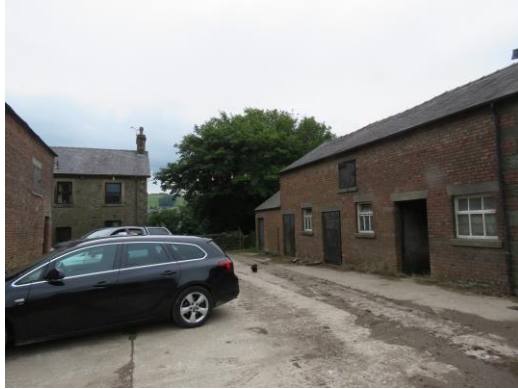
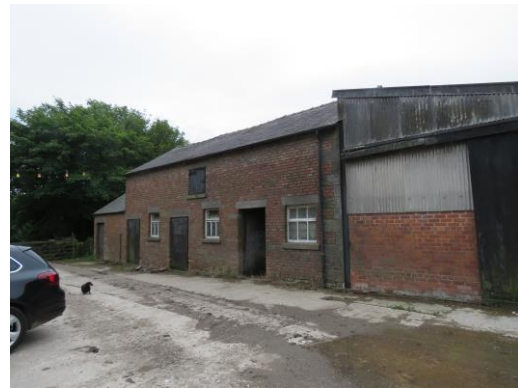
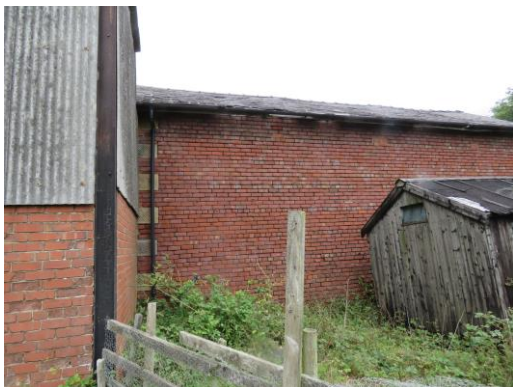
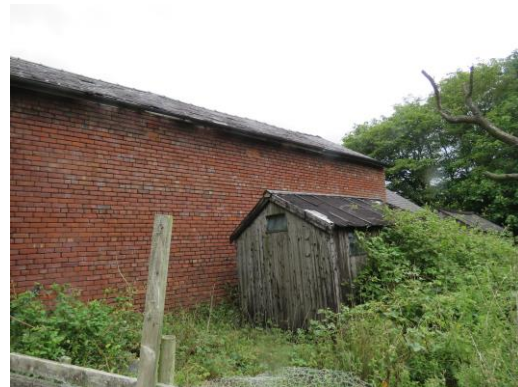
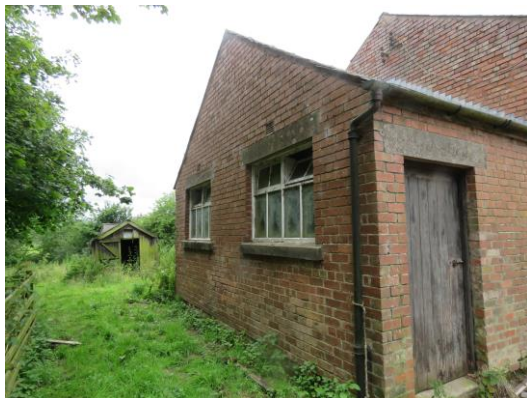
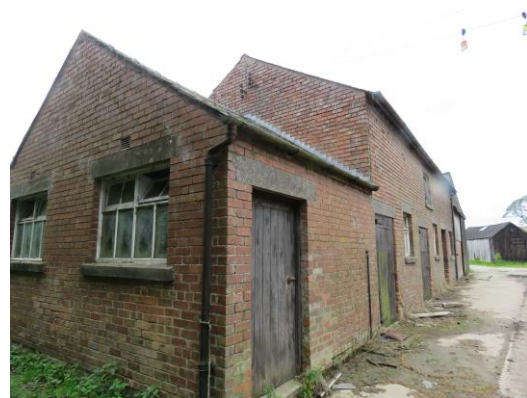
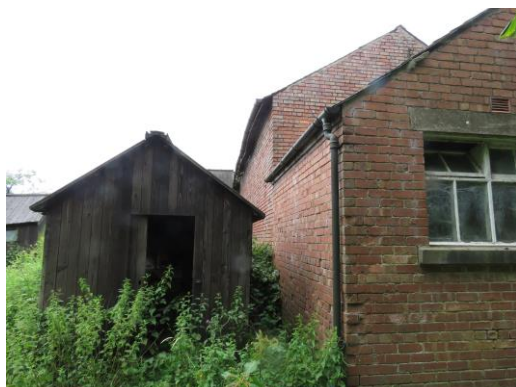
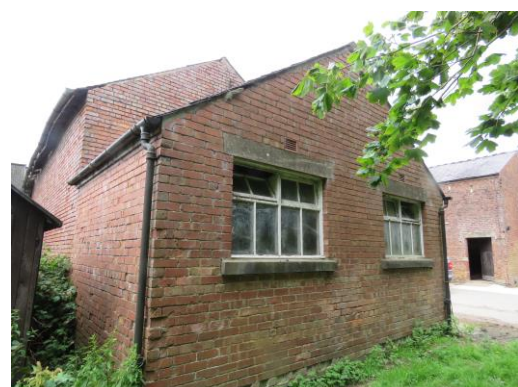
External brickwork walls appear to be reasonably plumb within tolerances normally accepted for buildings of this age, type and character,

*There are very occasional bricks which have spalled due to frost action, or are broken mostly adjacent to openings, and which will require careful cutting out and replacement to match existing adjacent. Volume is estimated at less than 1%*

*Small localised areas of external brickwork have been previously repointed, but pointing generally is in poor to moderate condition and we would advise that all external brickwork elevations are raked out to a depth of at least 20mm and repointed in a suitable lime based mortar with a recessed bag finish to shed water from the face of the brickwork and thereby avoid or minimise future spalling.*

*Some existing precast concrete lintels above openings are showing evidence of structural distress in the form of longitudinal cracking most likely associated with corrosion of embedded steel reinforcement, and we advise installation of suitable temporary propping, removal of all existing concrete lintels and sills and replacement preferably with suitable natural stone lintels and sills, or possibly reconstituted stone, on suitable brickwork bearings.*

*Provide sufficient internal cavity and additional leaf of lightweight thermal blockwork internally with stainless steel cavity wall ties in accordance with BS 5628. Cavity partially infilled with insulation to comply with current Building Regulations Part “L”.*

*Cavity closers around all openings incorporating damp proof course and cavity trays with weep holes through the outer brickwork above all door and window heads.*

*There is no evidence of any effective damp proof course and therefore provision of new damp proof course is required to new inner leaf blockwork walls and to existing remaining external and internal brickwork masonry walls. In addition, installation of vertical damp proof course will be necessary at junctions of external walls and remaining internal walls. All damp proof courses must be continuous with damp proof membranes beneath floors to ensure no water ingress.*

*Incorporate lateral restraints to walls, roof and floors in accordance with British Standard BS 5628; Appendix C and current Building Regulations.*

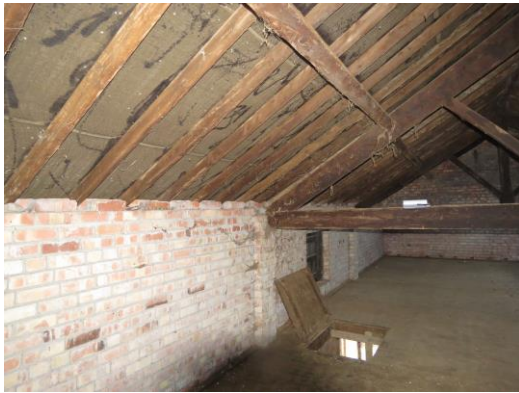
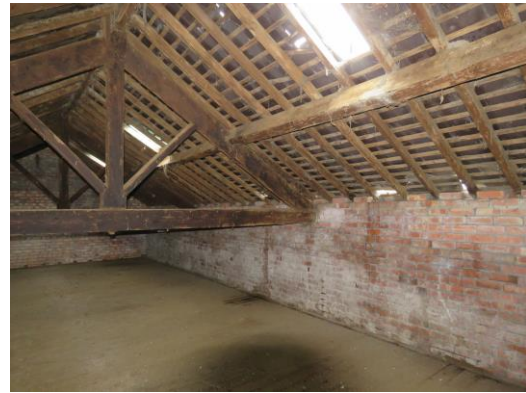
The existing roof is pitched and covered in slate.

The north side pitch has a bitumen based underfelt which is non-breathable.

The south side pitch has no underfelt at all and there are numerous holes through the slate roof covering due to missing, broken or displaced slates.

*Recent water ingress has marked the brickwork walls and first floor boards in the vicinity of holes through the roof coverings and such areas should be investigated during construction for evidence of decay and rot and remedied as necessary.*

*Those parts of the timber roof structure which were readily accessible and visible from the first floor appear to be generally in good condition.*

Purlins are approximately 100x225mm deep. Only minor sag deflection was noted and within tolerances normally accepted for buildings of this age, type and character.

*Timber embedded within damp brickwork or located in the vicinity of holes through the roof would be regarded as susceptible to decay and rot and should be exposed and inspected, and any defective timber should be cut out and replaced with similar section new preservative treated timber.*

*The building will need to be re-roofed to provide a new breatheable roofing felt as secondary means of defence against water ingress, together with insulation and ventilation requirements, all to comply with current Building Regulations Part “L”. From our inspection, we observed no evidence of any significant decay, however the re-roofing works will permit access to all parts of the roof structure and we advise detailed inspection of all structural timber including rafters, purlins, trusses, wallplates, etc. for evidence of decay or other defect and repair or replace with new as necessary.*

*Capacity of purlins to support actual roof loadings should be checked by Structural Engineer and if necessary it would be a relatively simple matter to strengthen purlins using steel flitch plates bolted to the side, or alternatively by doubling up.*

*We advise engagement of timber specialist to inspect all parts of the timberwork within the building, prepare report with recommendations for repair and remedial works, and implement in full including preservative treatment of all existing timberwork within the building.*

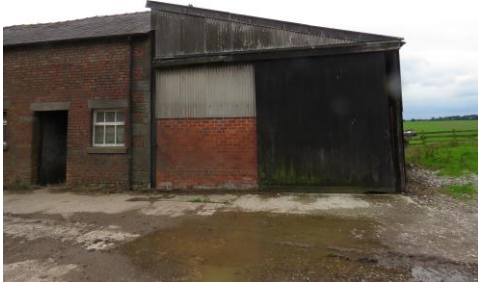
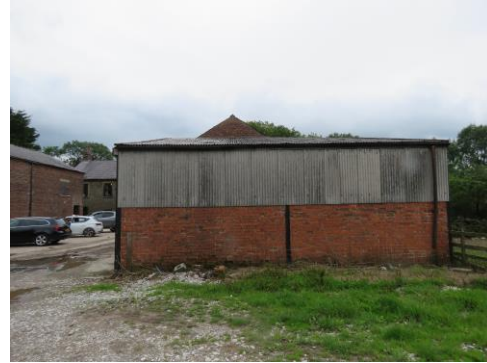
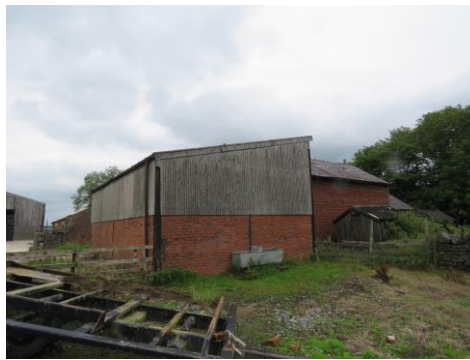
At the north end of the barn there is a more recent extension comprising steel frame with lower stub “9 inch” external brickwork walls, and asbestos sheeting roof supported upon timber purlins and mono pitch trusses.

The steel portal frameworks comprise 178x102 RSJ/UB steel sections. The lower brickwork stub walls are just under 2 metres in height above external ground level, and asbestos cement sheeting extends from there up to the roof eaves.

This extension appears to have been used largely for storage and probably livestock also. Steelwork and brickwork are generally in reasonable condition for buildings of this type and usage.

*The upper walls and monopitch roof are covered in corrugated asbestos cement sheeting and will require very careful removal by a suitably qualified and experienced licensed asbestos removal specialist.*

The remaining steel frameworks and lower brickwork walls could probably be incorporated within the proposed barn conversion if necessary, however, we note that the facing brickwork differs very significantly from that in the adjacent main two storey barn building in terms of colour, texture, age, etc. and it seems most likely that existing foundations may not be adequate to support additional loadings without excessive settlement.

*This more recent extension is of little or no particular architectural or historical merit, and we suggest consideration is given to its demolition and replacement with new extension using more appropriate external materials and design features to match and compatible with the much older parts of the barn adjacent.*
