Arboricultural Report

Tree survey at 3 Grindleton View, Chatburn,
Lancashire

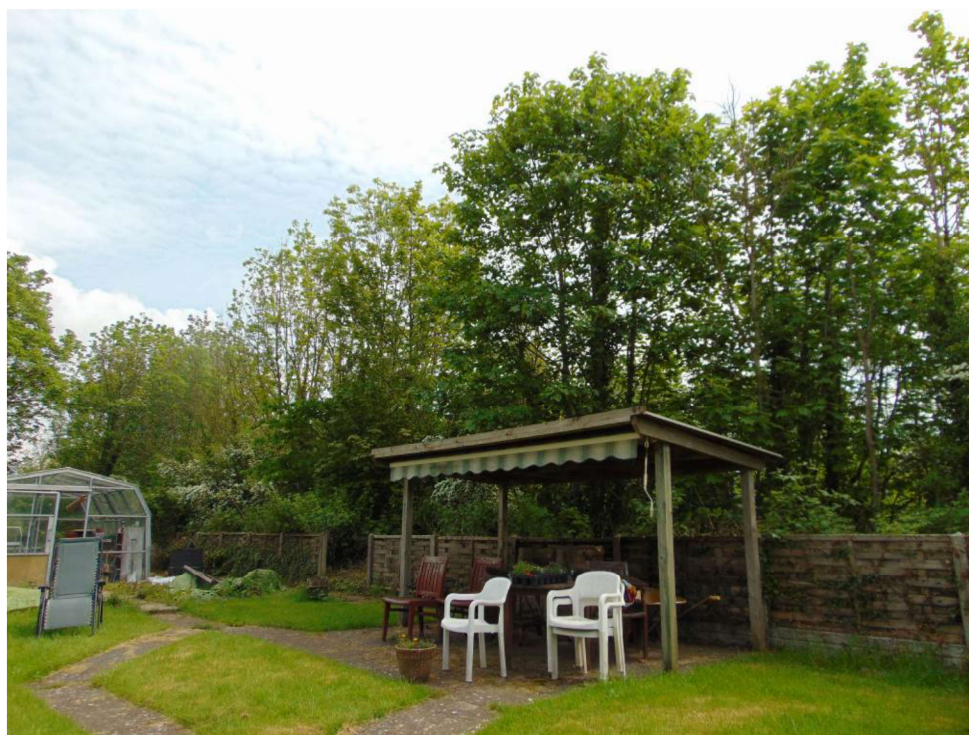
Figure 2: Group 1 – a mix of sycamore (*Acer pseudoplatanus*), ash trees (*Fraxinus excelsior*) and hawthorn (*Crataegus monogyna*) to the east of the property along the adjacent railway line. These trees are regularly coppiced to keep the railway line clear of leaf litter – and there are no encroaching branches from these trees onto the gardens of No. 3 Grindleton View. Some semi-mature ash trees are dead or in decline due to ash dieback disease.

- 4.2 This site is of a well-managed gardens with a boundary of trees to the east, west and north, wrapping around the site.
- 4.3 Group 1 is providing important screening of the site from the railway line but will be under the management of Network Rail – who are likely to regularly cut trees for the effectiveness of the rail traffic. This has happened cyclically in the past on this site. Currently, there is no significant branch encroachment from this group into the garden of No. 3 Grindleton View. Some ash trees have died in this group, but are not of a size or reach to give rise to any concern as to the consequences of their failure.

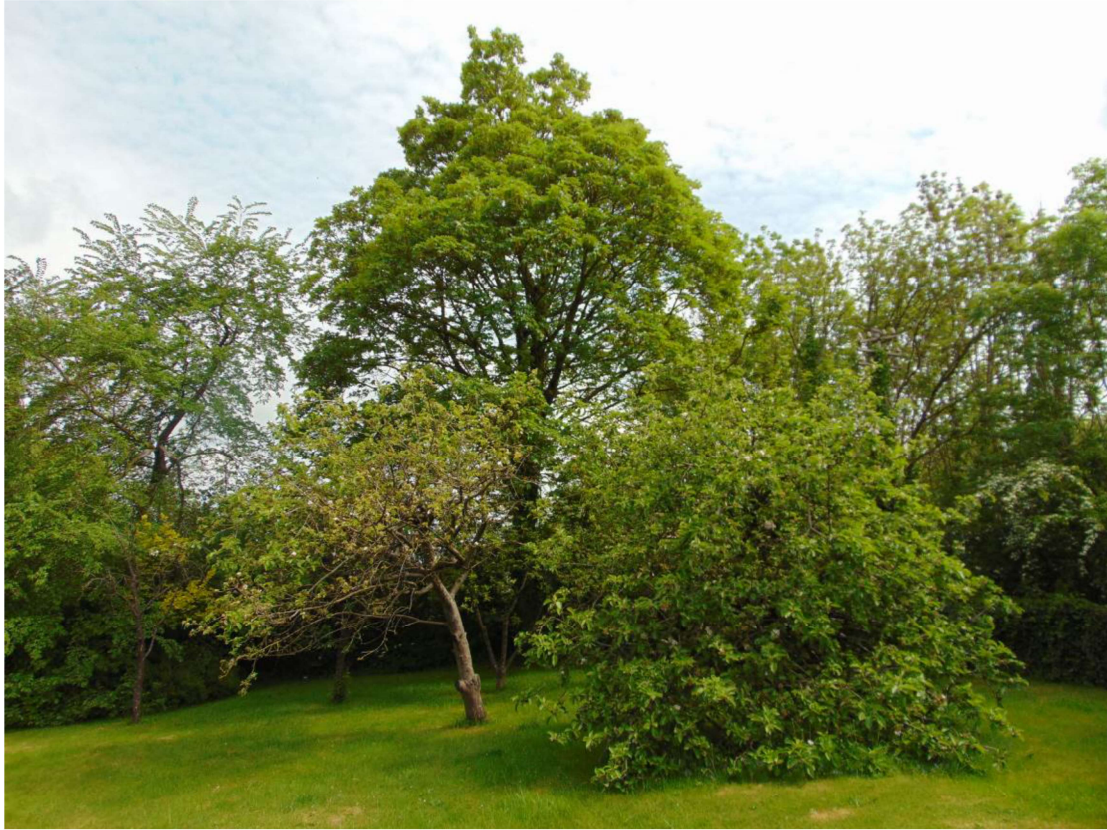
Figure 3: G2 – Group of six fruit trees, including a dead damson tree (far left), in the north-east corner of the garden, with T1 (rowan), T2 (sycamore) and T3 (elm) in the background (from right to left).

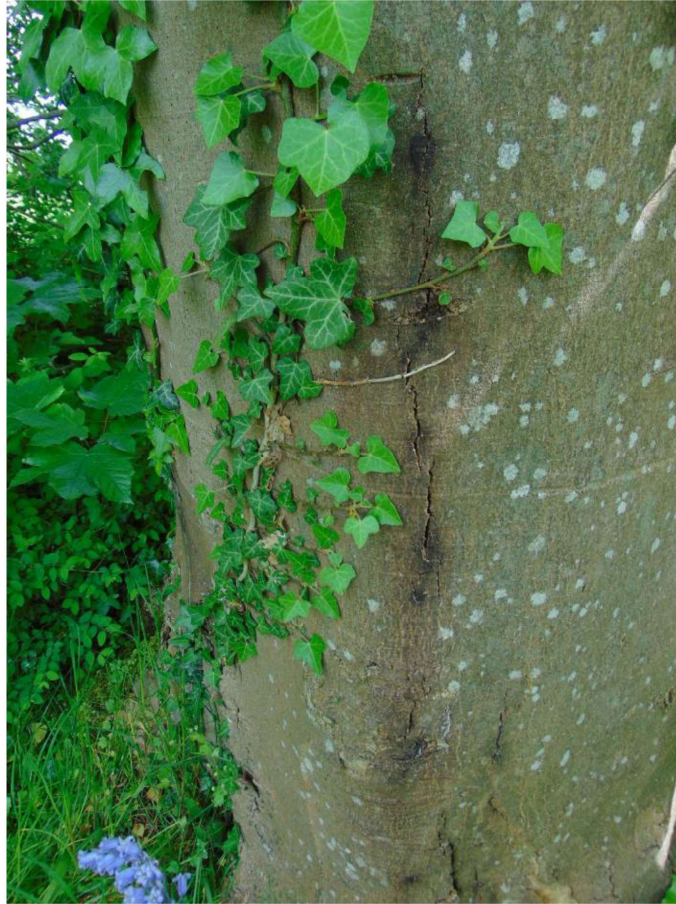
Figure 4: Bleeding canker at base of T2 (sycamore) – this tree will require regular monitoring and may decline due to this infection at its base.

- 4.4 A maturing sycamore (T2) has a bleeding canker – most probably caused by a *Phytophthora* infection, at its base. This can be a progressive disease that could cause decline and death of this tree – as well as inviting in root decay or basal decay. A previous bleeding location already exposes sapwood at the soil line. Regular monitoring of this tree’s condition is recommended. Currently, there are no scientifically validated treatments for *Phytophthora* in garden trees, and the tree is **not** situated in a wet area that requires draining.

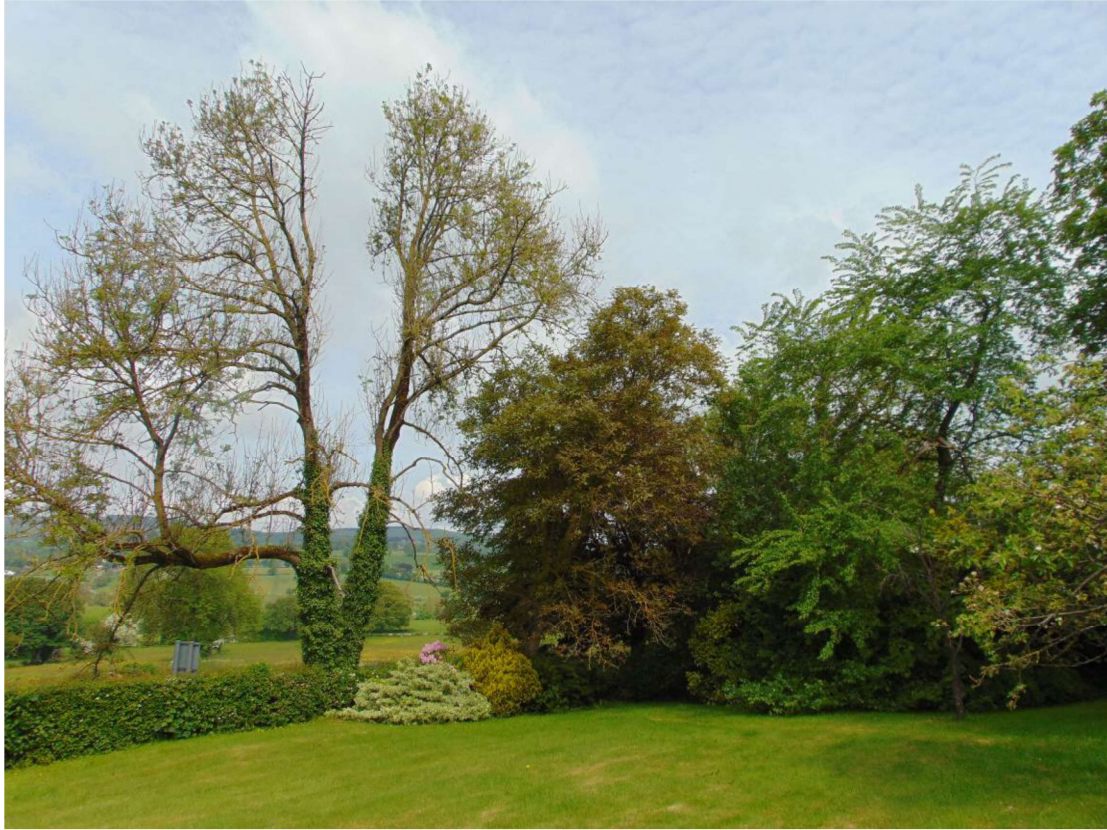
Figure 5: Internal view of trees in north-west corner of the gardens; (from right to left) elm (T3), walnut (T7) and declining ash tree (T8). The crown density of the ash tree is estimated at less than 30% and the living part of the tree's crown is dominated by previous epicormic growth, induced by ash dieback disease.

- 4.6 The dominant ash tree (T8) on the northwest side of the garden and elevated above Sawley Road, is in severe decline due to ash dieback disease, with little canopy left. It is highly unlikely to improve and, already, large pieces of deadwood threaten to fall into the adjacent roadway. National guidance on managing such affected trees recommends that the tree should be felled or made into a short snag (*e.g.*, retaining the lowest 4 metres of the tree’s stem for biodiversity purposes).

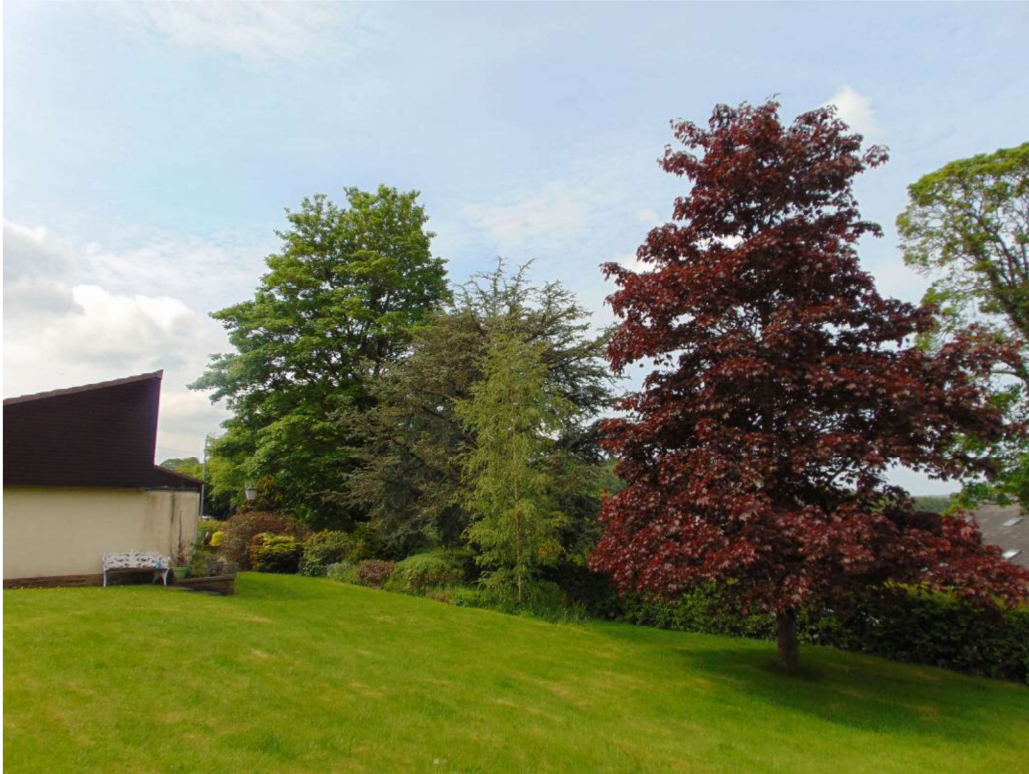
Figure 6: Internal view of the western-facing edge of the garden, showing T9 (Crimson King maple), T10 (birch), T11 (Atlas cedar) and T12 (sycamore) (from right to left)

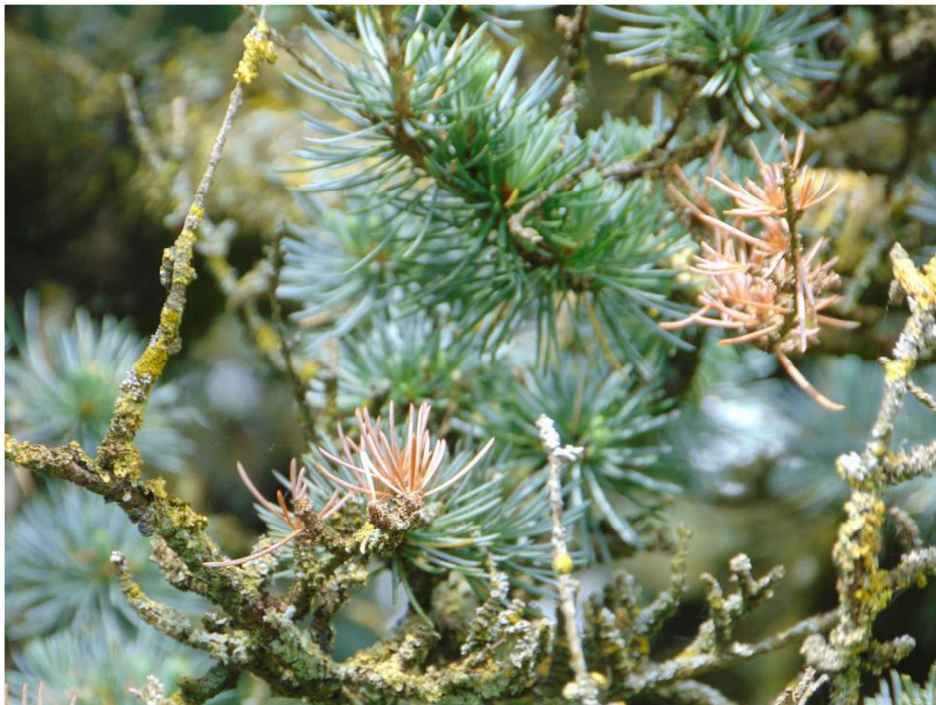
Figure 7: Symptoms of *Sirococcus* infection on the Atlas cedar (T11). Some local cedars have been lost to this disease. In this specimen, dieback is generally minor, so the tree can currently be retained and monitored.

- 4.7 The Atlas cedar (T11) has some noticeable tip dieback and symptoms of a needle infection (*Sirococcus*) – that has caused the death of many such cedars in the local area. It represents no significant hazard in its current state, and it may come to more of a decision in relation to garden design and aesthetics whether this tree is kept or not. This needle disease may persist just at the chronic level, allowing the retention of this tree.

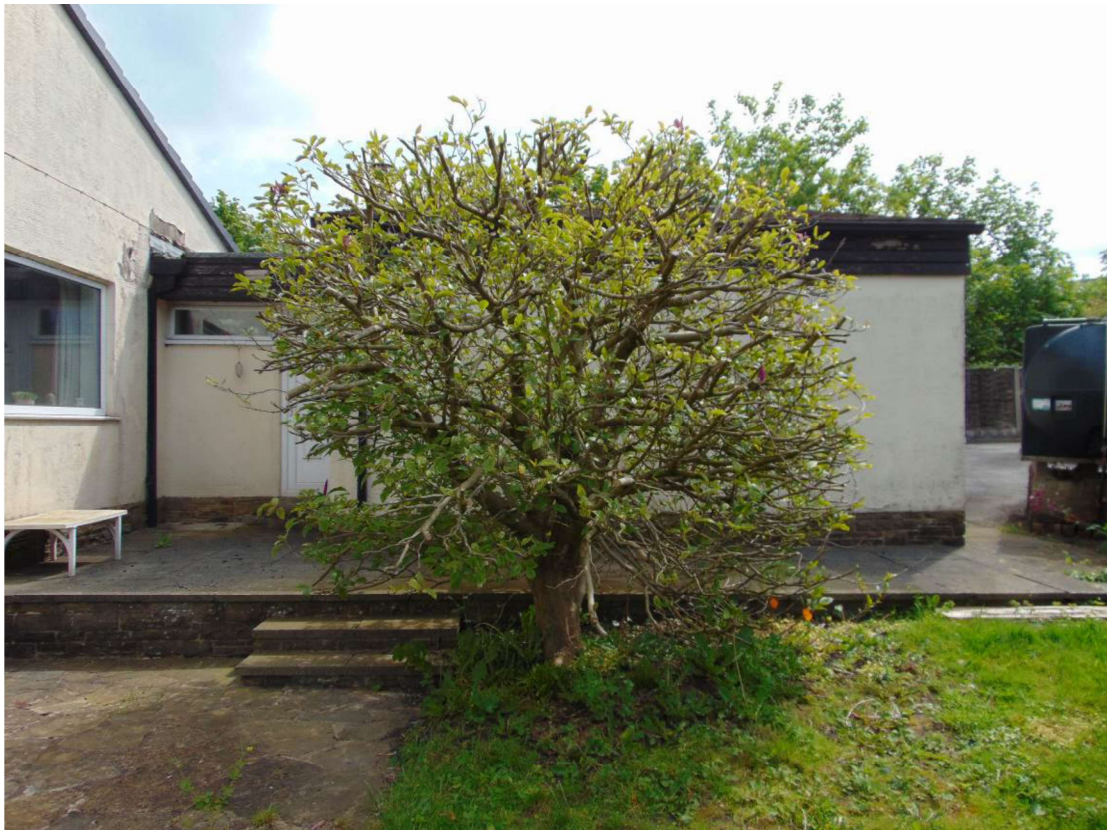
Figure 8: Magnolia (T13) to the rear of the existing property, which has been recently pruned to take on a bush-shaped form at 2.2 metres tall. Given its proximity to the building, keeping it as a topiary item may be an appropriate management approach.

- 4.8 A few trees would benefit from a minor crown lift (to 2 or 2.5 metres) to clear garden space to head height, or the adjacent pavement on Sawley Road. The magnolia (T13) would probably be best kept as a topiarized specimen, given its current form. These recommended works are provided in Table 2.

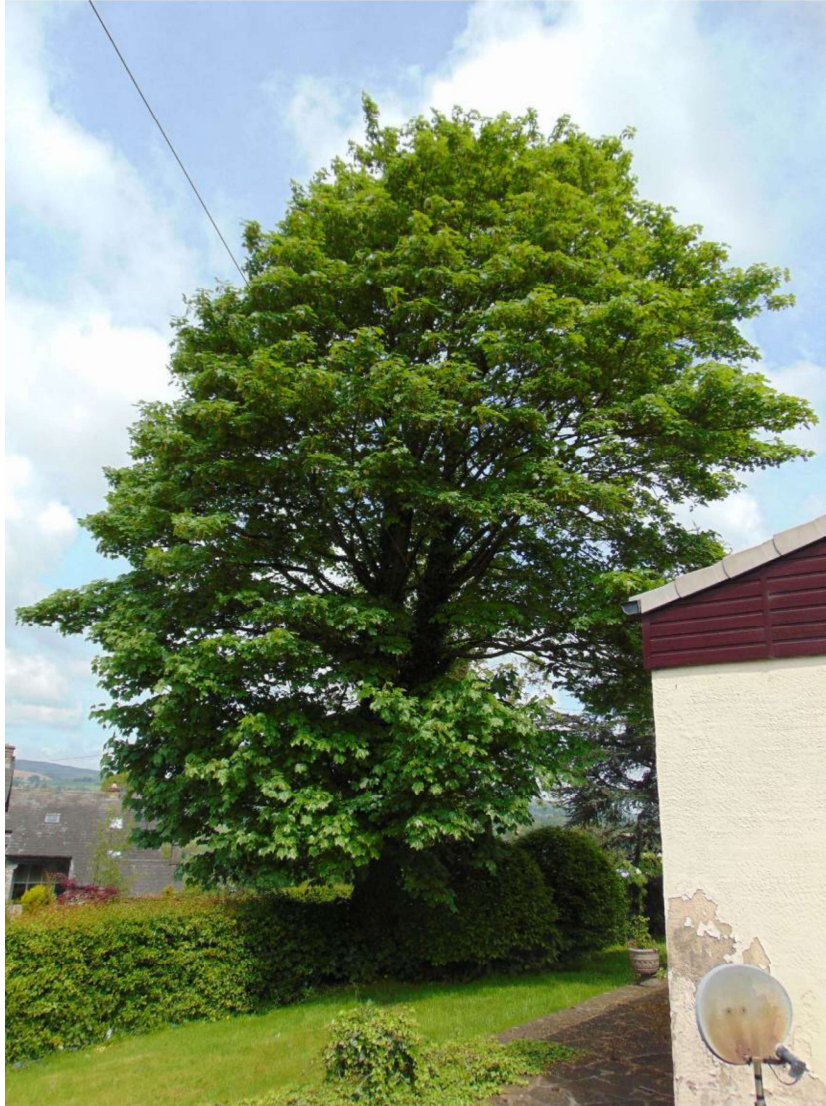
Figure 9: Mature sycamore (T12) viewed looking north. This tree is in good condition and considered an 'A' category trees. Some minor crown lifting and severance of the ivy on its stem are recommended to make the most of this good tree specimen.
