# Information on trees + condition from arborist

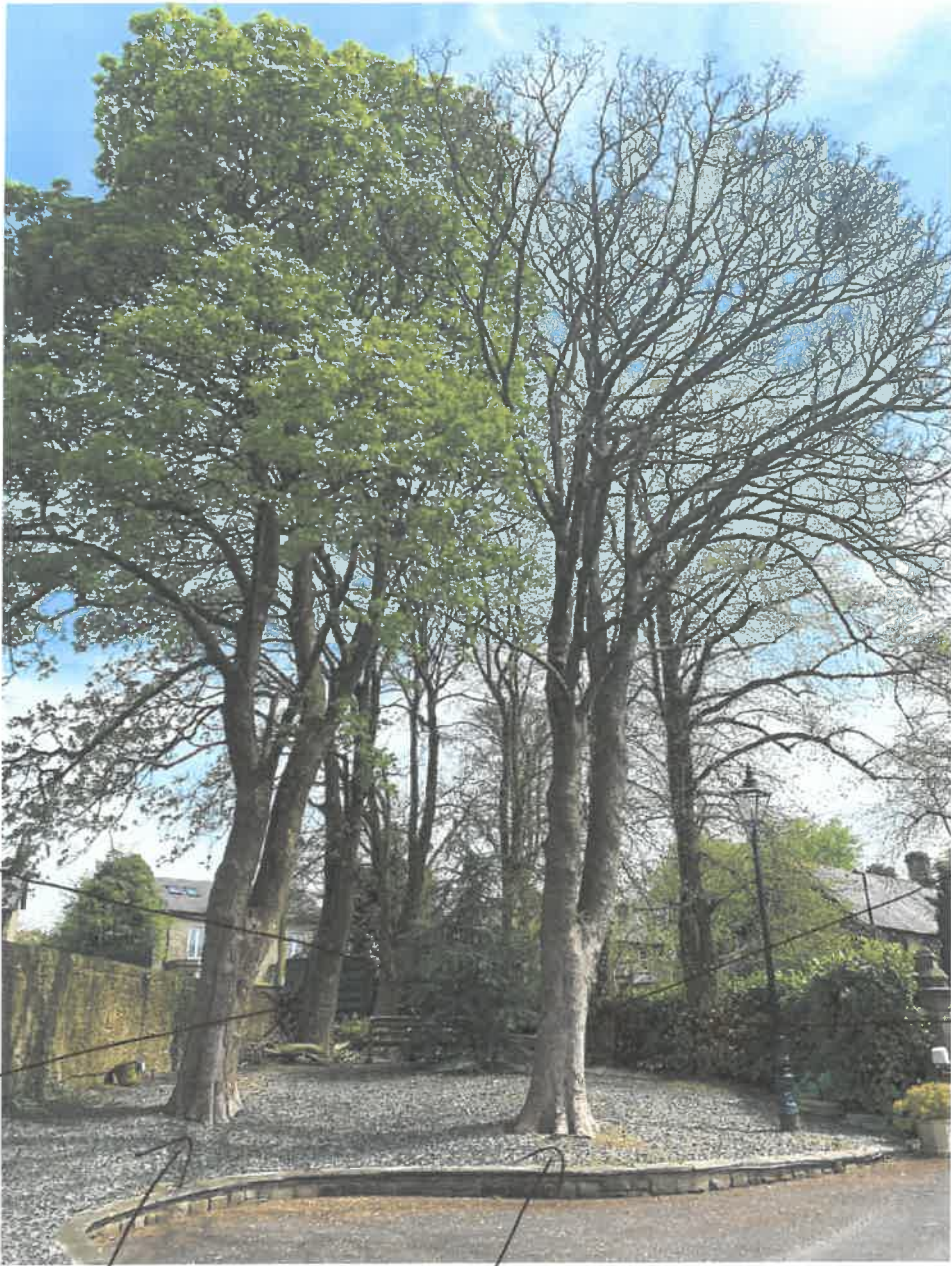
T1 – Sycamore with advanced dieback in crown and suspected Ustulina in amongst buttresses. To fell.

T2 – Sycamore – to crown lift lateral branches to clear parking area.

T3 – Sycamore – Crown lift

T4 – Sycamore – to remove due to dieback of crown and location as overhangs public highway.

All trees, especially sycamore show historical evidence of soil level having been raised when landscaping.

T5 – Lime – To crown lift & deadwood

T6 – Lime – To crown lift & deadwood

T7 – Lime – To crown lift & deadwood

Will replace both trees where possible – they may have to be planted in the back garden as the surface where trees are being removed from isn't suitable.
