# Tree Condition Report

**Location of property surveyed:**

16 The Rydings  
Langho  
Blackburn.  
BB6 8BQ

**Job Ref:** 1774

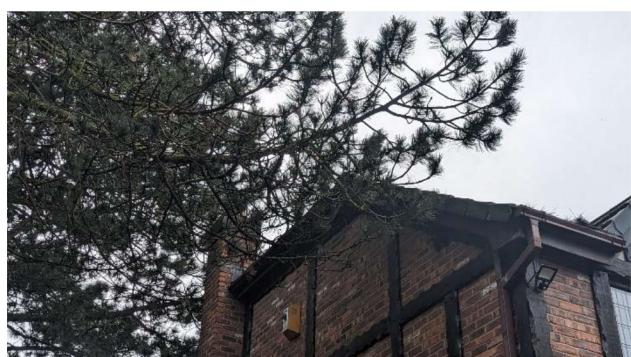
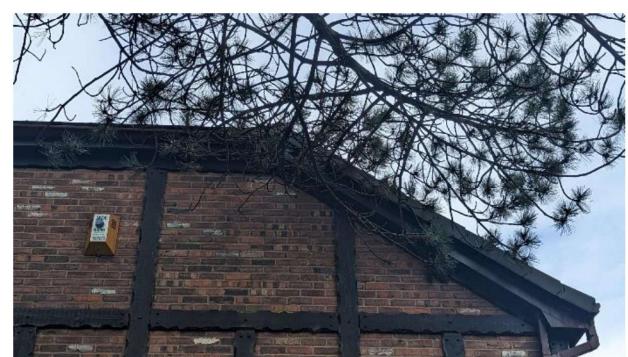
This is a single stemmed pine tree growing between the garage and the residential property. The lower branches are physically touching the roof and these branches need removing, see photographs. There is deadwood present within the tree, again, these need target pruning back to appropriate points. There are also several hung-up small branches and they should be removed from the tree to prevent them dropping, there is no significant risk from this as they are hung up security. The root spread of this tree is causing very slight lifting of the block pathing, but this is not significant enough to warrant any action at the time of inspection.

#### T4 – encroaching roof

T	4	Pine	1	600	15m-20m	14	Mature	Good	Good	20+	B1	– Lifting / damaging path	– No significant visual stem defects	– No significant visual branch defects	– Moderate deadwood 25-100mm dia+ – Encroaching building	– No significant visual foliage issues	– No fungi visible at time of inspection	– Road+ – Footpath - Public highway+ – Dwelling+ – Garden+ – Parking / driveway+ – Garage	YES	– Remove dead wood / crown clean+ – Reduce to clear building by 2m+ – Limb - Remove+ – Target prune old stumps	3mths	24mths

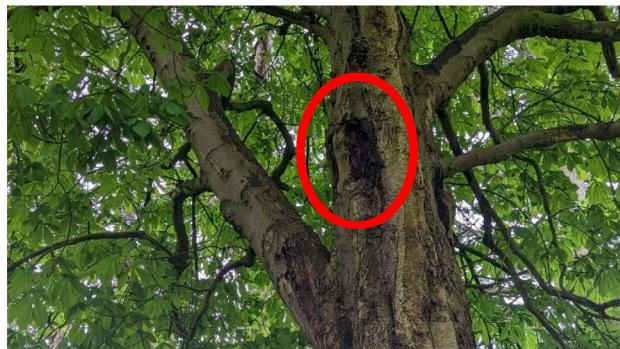
Located outside of the garden fence but within the client's boundary area. The tree is in full leaf with no visual signs of dieback within any of the crown area. The tree has one single stem that splits into 3 at approximately 5m. One of the leaders has a small area of bleeding canker, this is not seen to be a significant issue at the time of inspection but should be monitored in future years for spread and

extent. The canopy is not encroaching the roof of the garage at the time of inspection. No work is required on this tree.

T1 – small area of bleeding canker

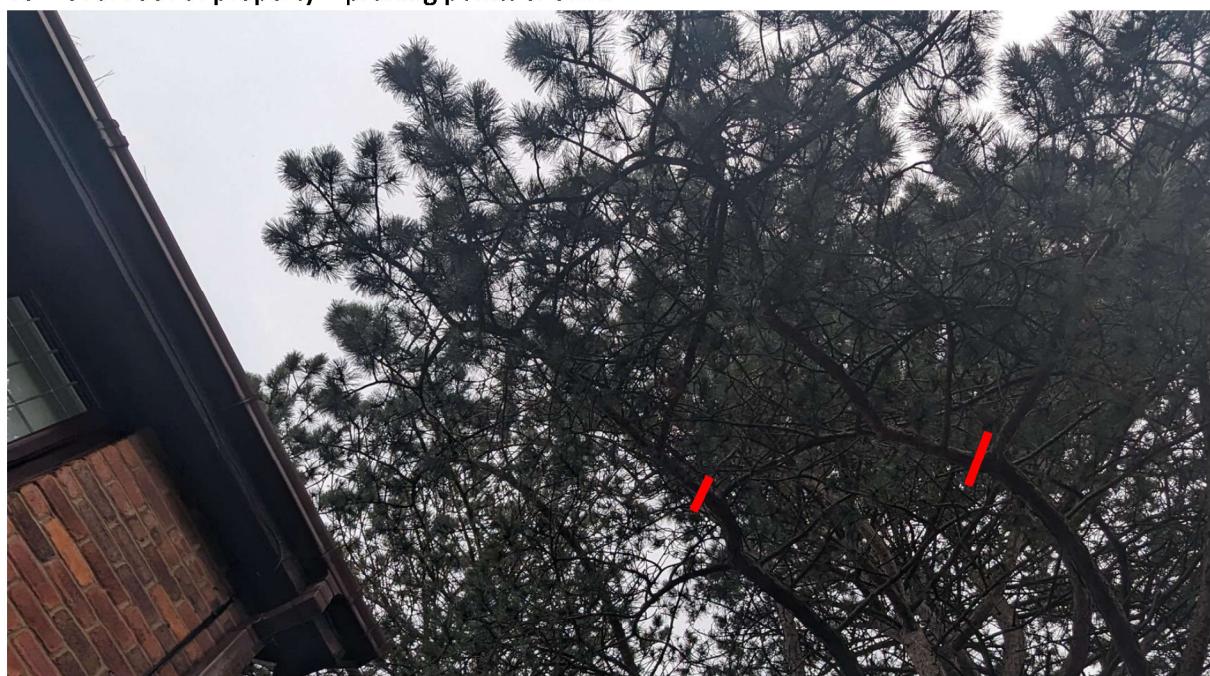
This is a single stemmed pine tree that does have ivy growing up the stem, it is recommended that this is cut back at ground level and the ivy is allowed to die back before being removed. There is deadwood within the tree, and it is recommended that this is pruned back to target pruning points. Parts of the canopy of the tree do encroach over the roof of the property, the entire limbs do not need removing, just reducing, the target pruning points can be seen on the attached photographs below.

T3 – over roof of property – pruning points shown.

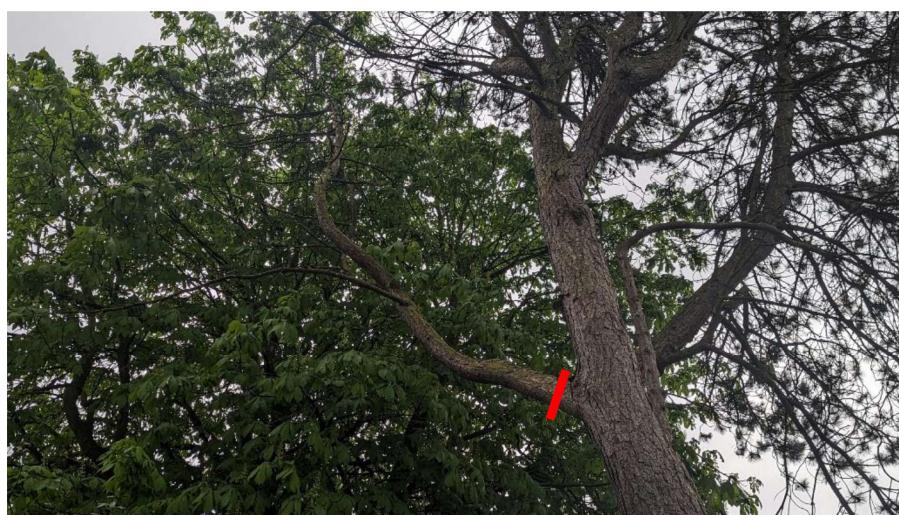
T3 – Pine – limb to be removed.
