ARBORICULTURAL IMPACT ASSESSMENT.

87 Ribchester Road, Clayton Le Dale, Blackburn, BB1 9HT

JULY 5, 2023
WALKERS TREE SERVICES
86 FULL VIEW BB2 4QF

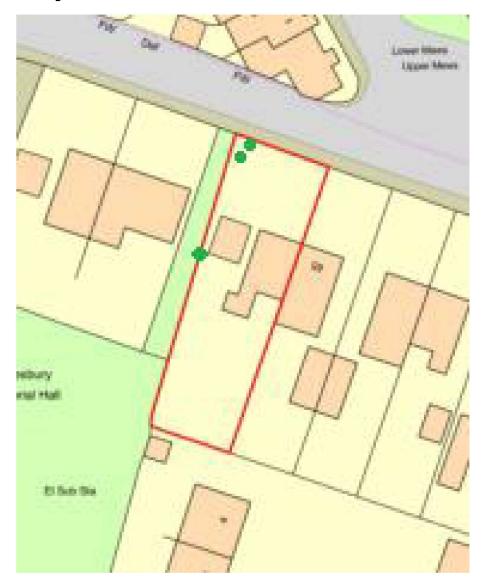
• Concerns regarding three trees onsite. The trees are in the front garden area and west side boundary of the property.

Approximate locations of the trees represented by the green dots. With Tree 1 at the top and Tree 3 being the bottom.
