23092916

New Dwelling – Overdale, Langho

15.09.23

**HUTCHINSON
WHITLAM
ASSOCIATES**

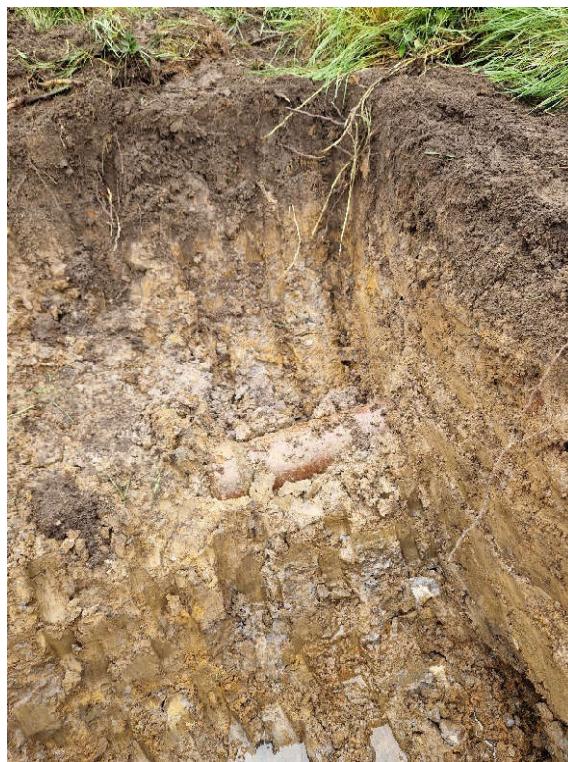
Figure 1 - TP3

Three trial pits were excavated, one at the front of the existing property (TP1), one at the rear (TP2) and one at a possible soakaway position in the garden (TP3).

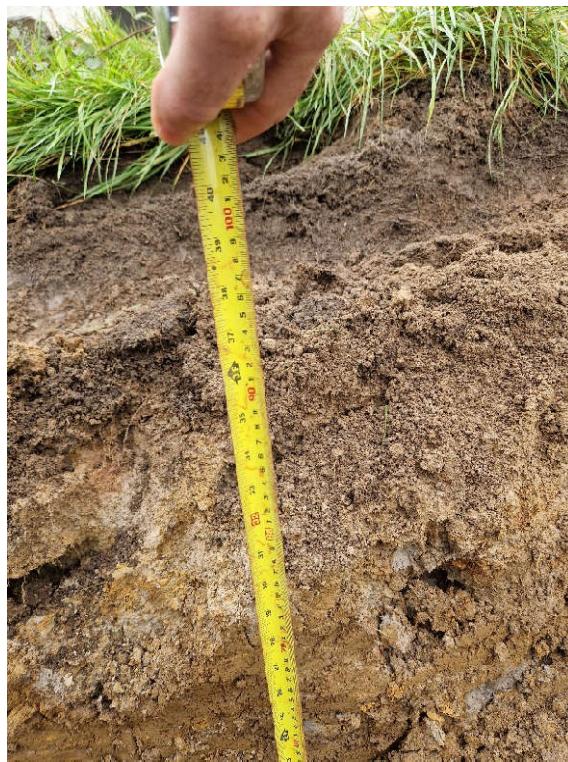
These trial pits highlighted the ground was consistent across the site and consisted of a thin layer of topsoil (max 200mm) overlying firm to stiff clay, becoming stiff with depth.

The natural clay soil will provide a suitable foundation on which to construct the foundations for the new dwelling, although the foundation depth will need to be adjusted to account for the Leylandi tree's adjacent to the boundary on the neighbouring plot. Clay samples will be sent to the laboratory for testing to determine its volume change potential in accordance with NHBC's "building near trees guidance".

Figure 2 - Shallow Topsoil overlying clay

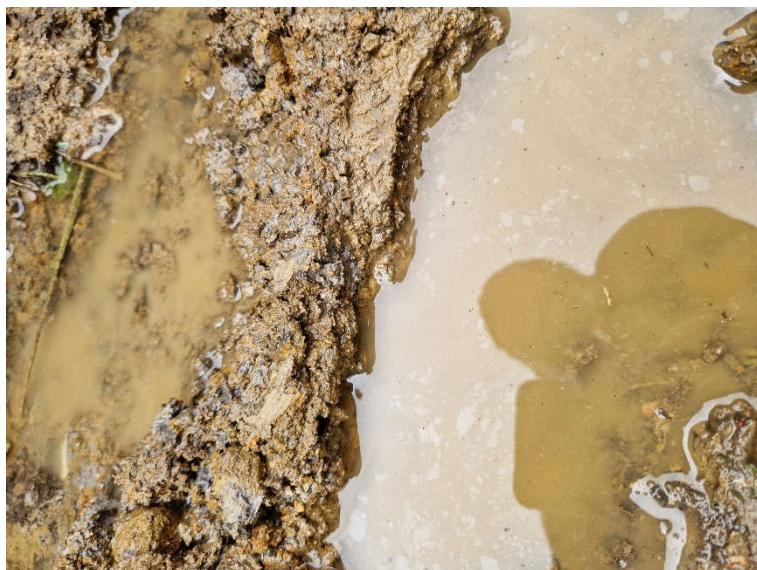
The firm/stiff clay identified across the plot was typical of local geology and was clean with negligible quantities of granular material. This soil type is associated with very poor infiltration rates and is therefore considered to be unsuitable for the discharge of water through infiltration (soakaways). The inspection was taken following a very brief period of rain and there remained standing water in the pit.

Figure 3 - Standing Water

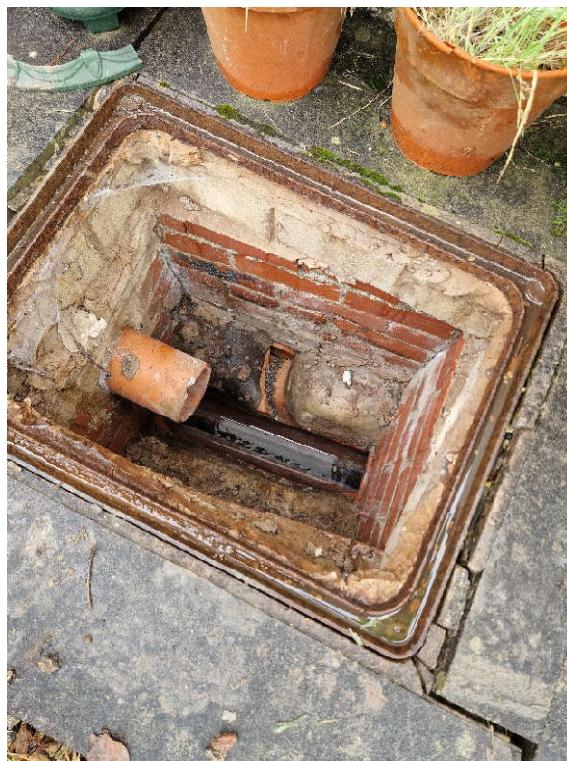
The current dwelling, as with the neighbouring properties discharge all surface water directly to the combined sewer that runs across the site. This was evident following inspection of the manholes at the rear of the property.

Figure 4 - Existing Surface water discharged to public sewer

It is therefore concluded that as infiltration is not possible and there is no watercourse near to the property, discharging surface water to the combined sewer as it currently does, is the best course of action.
