TPD/44-23/RGT/DGT

14th July 2023

**Former Castle View Print Works
Back York Street
Clitheroe
BB7 1LT**

Subject: Structural Report - Structural movement on right section of existing building

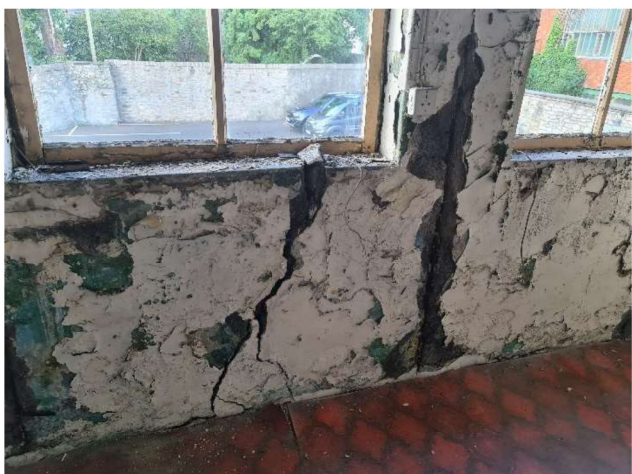
Photograph No. 1

Our inspection revealed that the primary structural movement is mainly limited to the two-story section of the building. Severe corrosion was observed on the existing lintels above all the openings, leading to displacement of the brickwork and cracks caused by the expansion of rusting steelwork. Please refer to Appendix A for photographs documenting these issues. Additionally, localized roof spread resulting from creep in the existing roof timbers has further contributed to structural cracks. The corrosion has significantly progressed and is now beyond a point where easy treatment is feasible.

Due to the extensive amount of brickwork that needs to be removed and rebuilt, coupled with concerns about the stability of the structure during these works, we suggest demolishing and rebuilding this section of the building using cavity wall construction. The project should include a new slate or tile roof, as well as new roof trusses. The new floors should be tied into the new wall to enhance stability. It is advisable to assess the suitability of the existing wall foundations; however, new foundations may be necessary.
