# Preliminary Roost Assessment

65 Mitton Road  
Whalley  
Lancashire  
BB7 9RY

For  
Anthony Wilson

# Gritstone Ecology

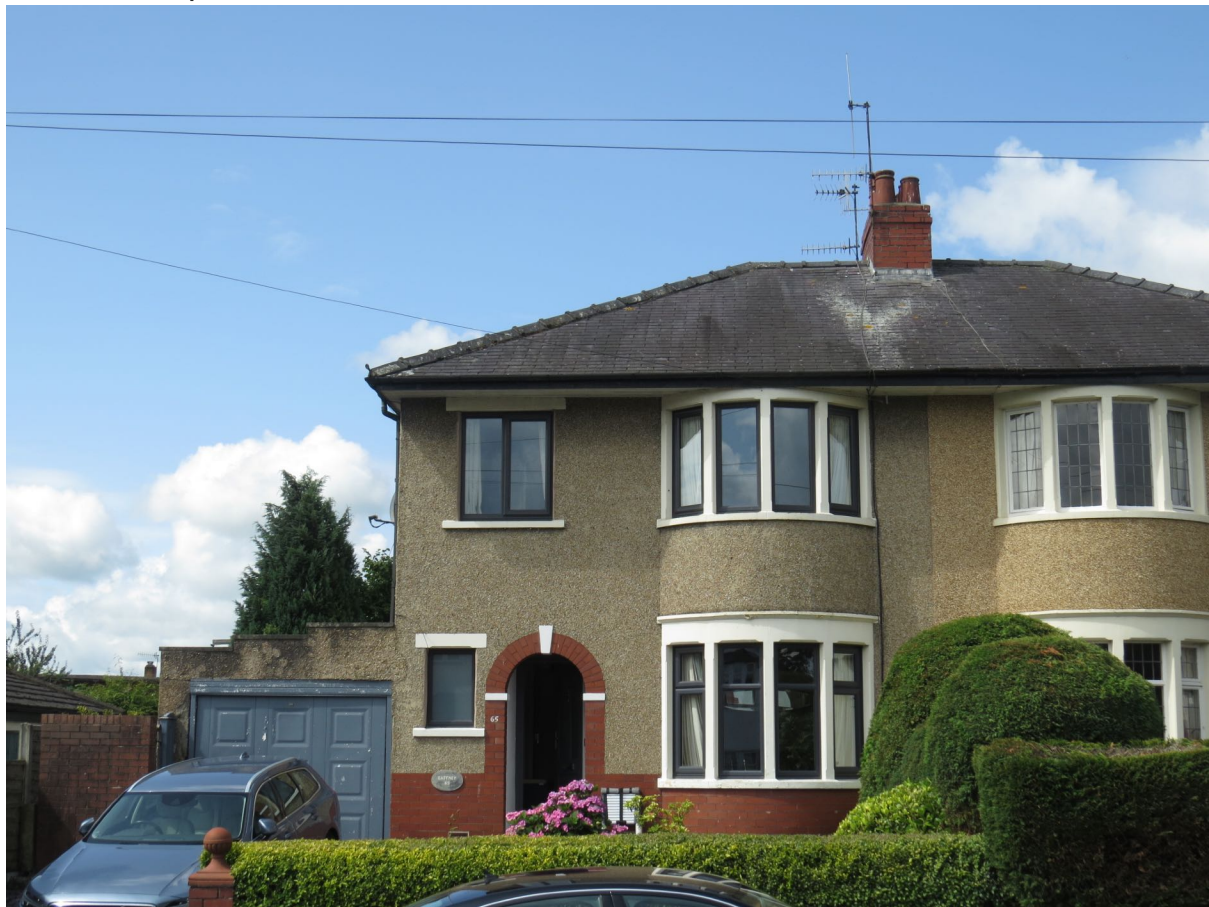
3.1a – The front of the house.

The building was constructed to a high standard, it is well maintained, and in good condition. Ridge tiles are fixed tightly, there are no damaged or missing ridge tiles. There are no damaged, slipped, or missing roof tiles. Roof tiles are tightly fitted, with no gaps between tiles. Timber fascia boards and boxed soffits are fitted tightly against the walls with no gaps. Walls and render are in good condition, with no missing mortar or cracks.

There are no features externally which are likely be used by roosting bats, and no evidence of use by bats was present during the inspection.

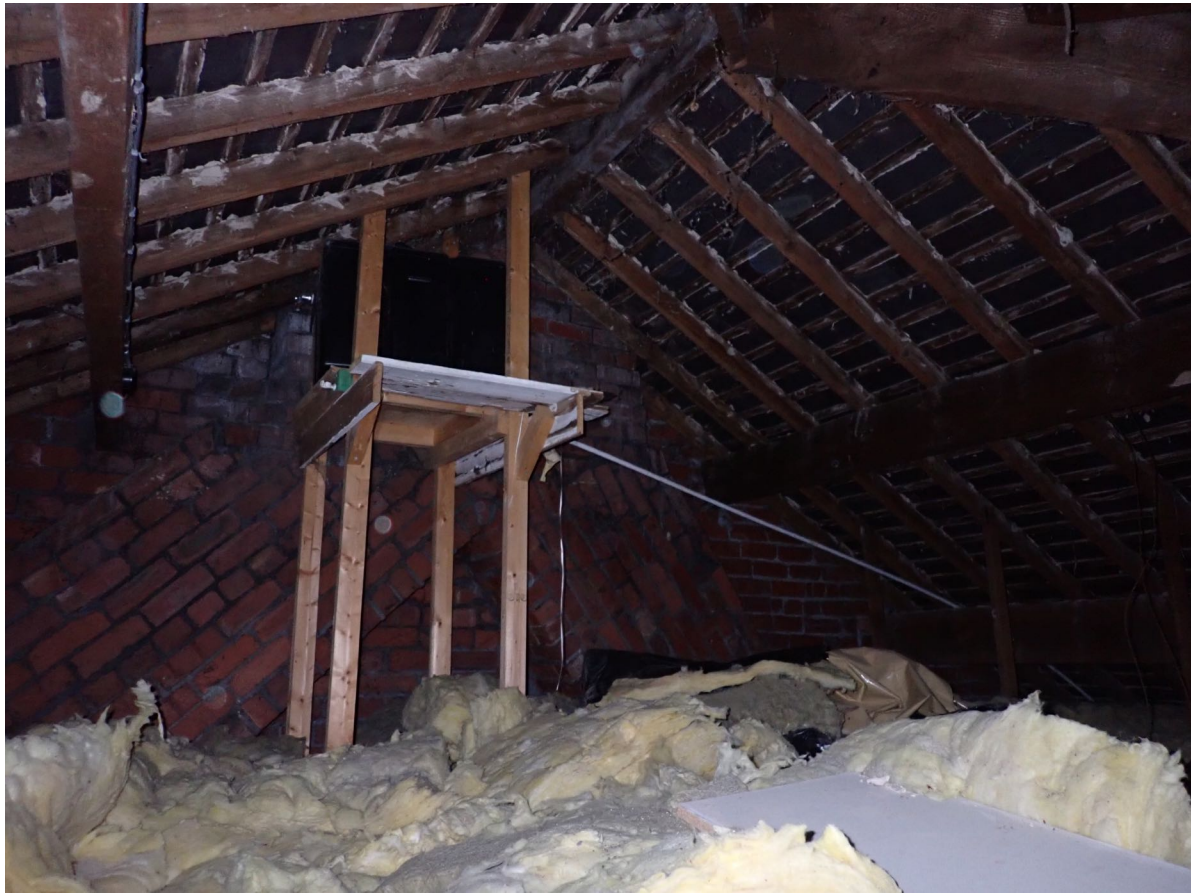
3.2a – The roof void.

The roof has a timber rafter and purlin structure, which is not lined, and the underside of tiles and timbers is exposed. The loft is insulated with mineral wool between ceiling joists. The roof is in good condition with no obvious gaps.

The wall cavity has been filled with insulation and was inspected at the wall plate using an endoscope. There are no gaps at the wall-plate; and there are no gaps which give direct access to the roof void from the outside. Boxed soffits open into the roof void and were inspected from above.

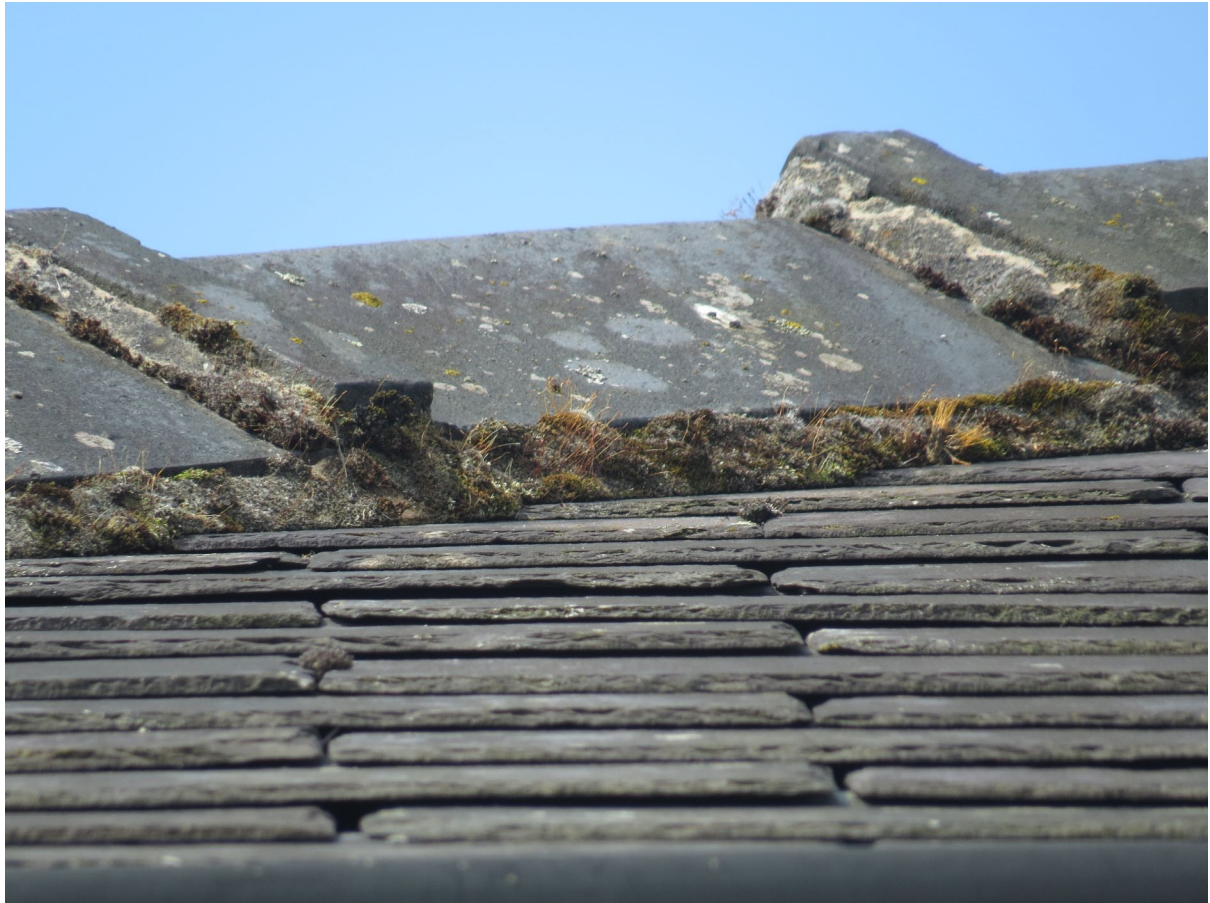
Roof and ridge tiles are in good condition; ridge tiles are sealed with cement. There are no gaps between roofing materials which could be used by roosting bats.

3– Roof and ridge tiles are in good condition with no suitable gaps.

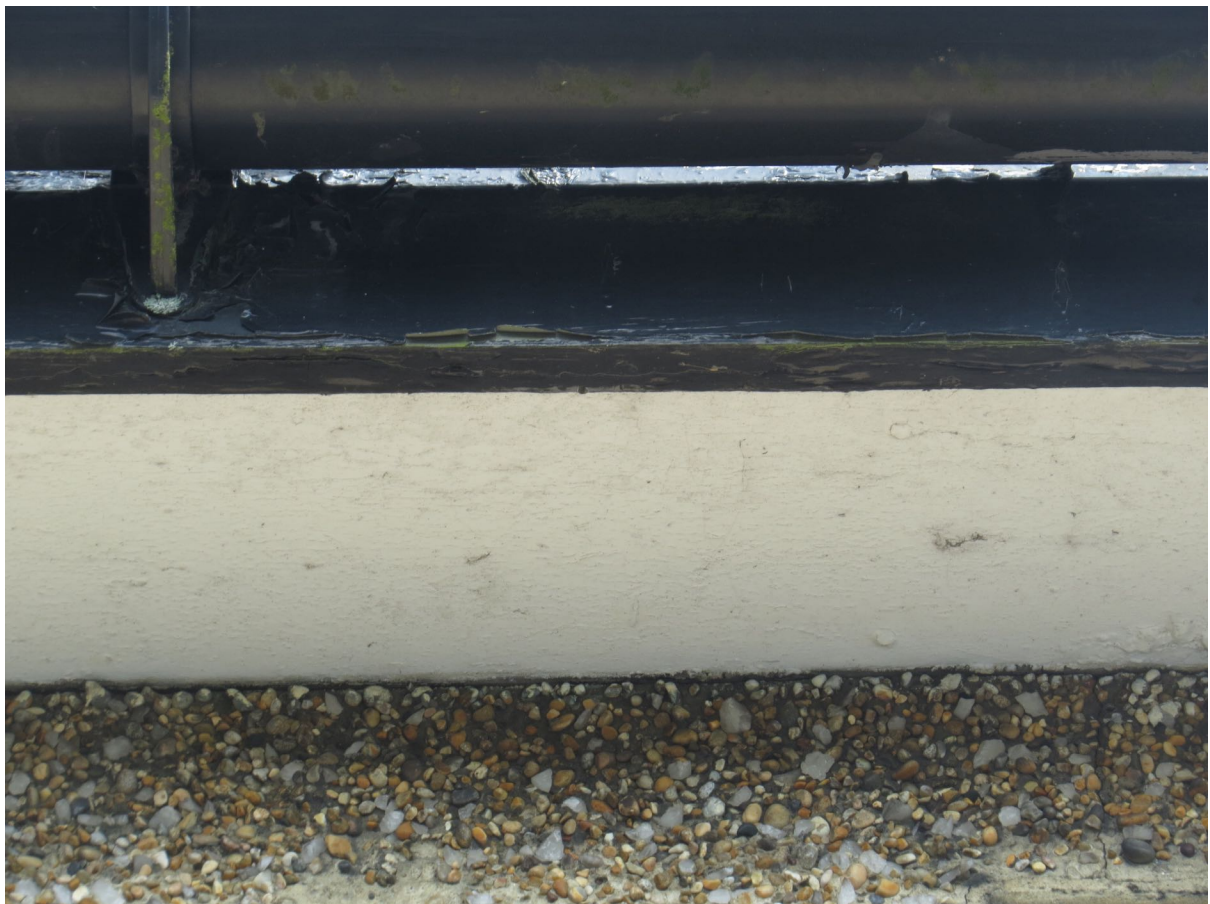
Timber fascia boards and boxed soffits at the eaves are fixed tightly against brickwork, with no suitable gaps; wall cavities and boxed soffits open into the roof void, and were inspected from above.

4 – Timber fascia boards and soffits at the eaves are fixed tightly against brickwork.

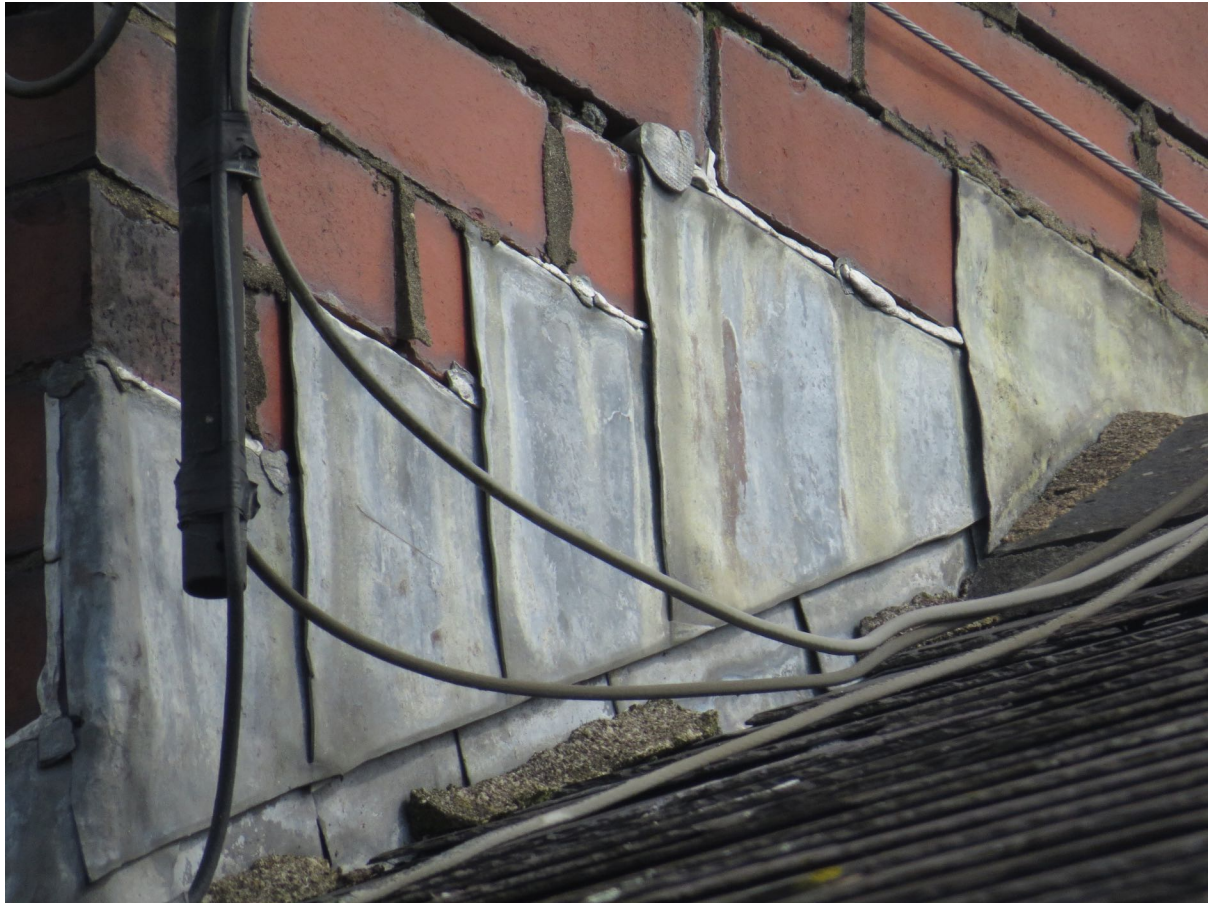
5 – Lead flashing is fitted tightly with no suitable gaps.

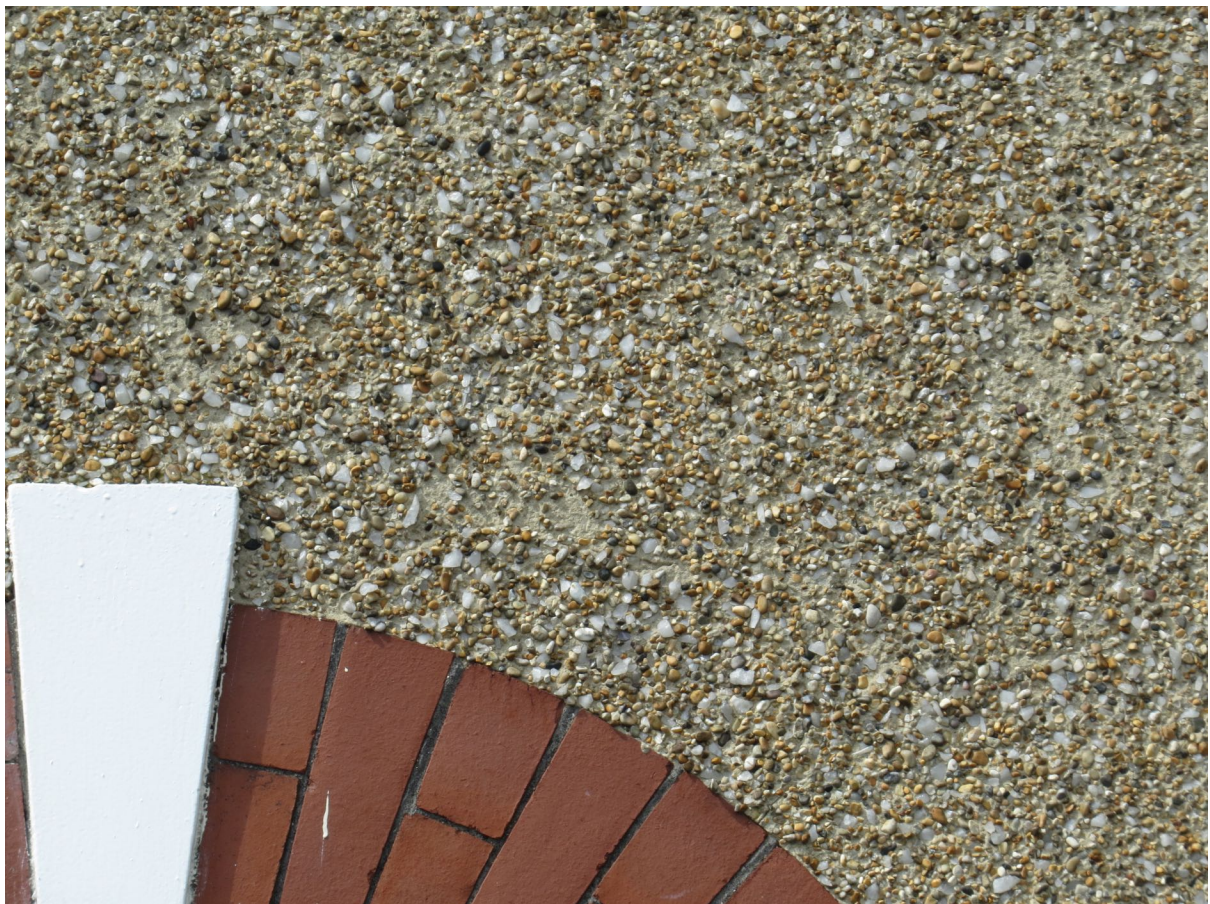
Walls are brick with an insulating cavity. The wall cavity has been filled with insulation. Walls are in good condition, with no cracks, or missing mortar which could be used by crevice dwelling bats.

6 – Brickwork and render are in good condition with no suitable gaps.

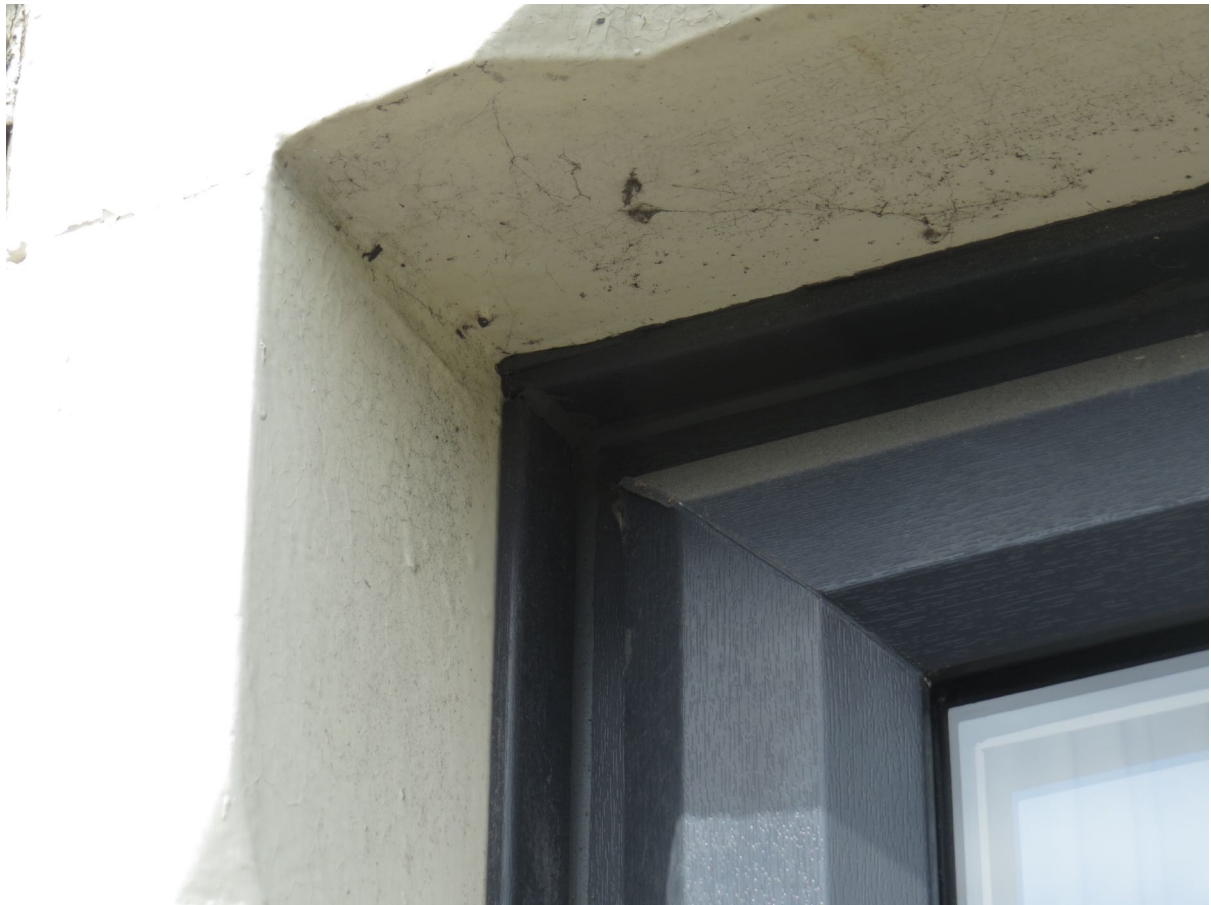
Window and door frames are fixed into the brickwork, gaps are filled with sealant, and offer no suitable roosting opportunities.

7 – Window and door frames are tightly sealed into brickwork with no suitable gaps.

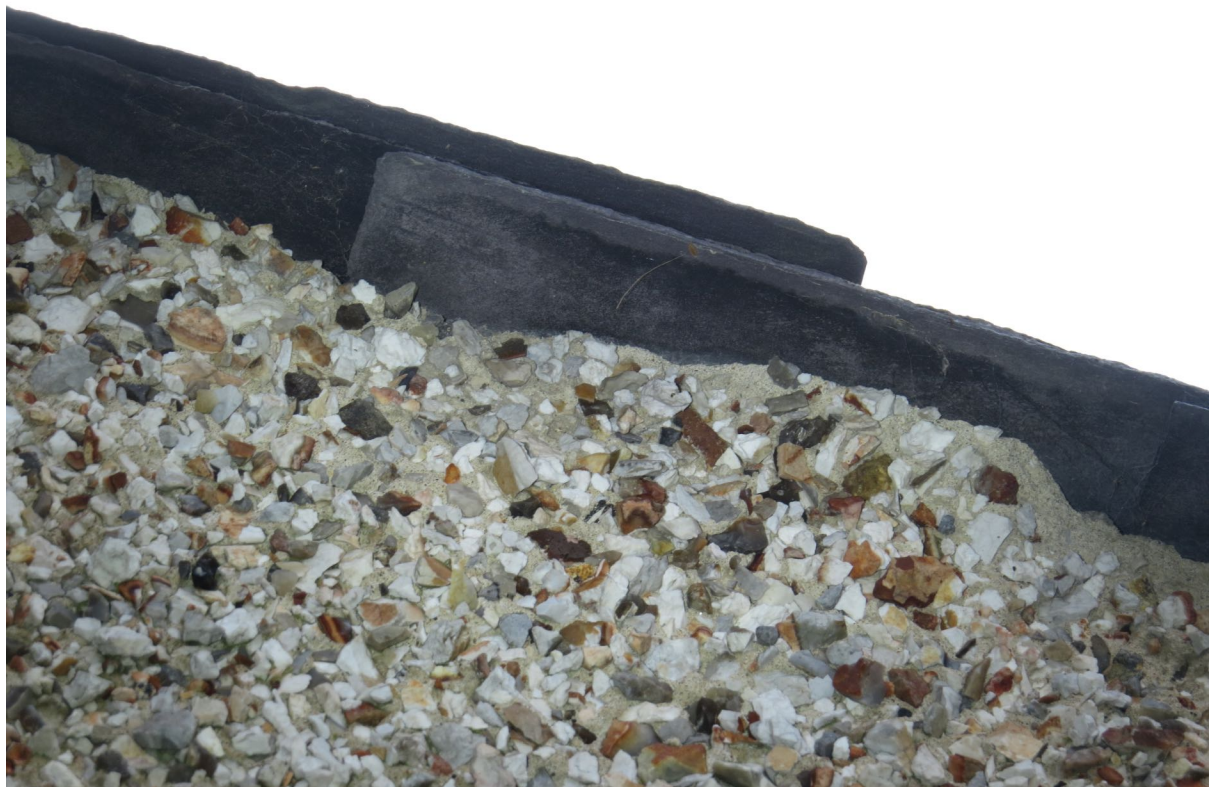
8 – End tiles at the verges are sealed with cement.

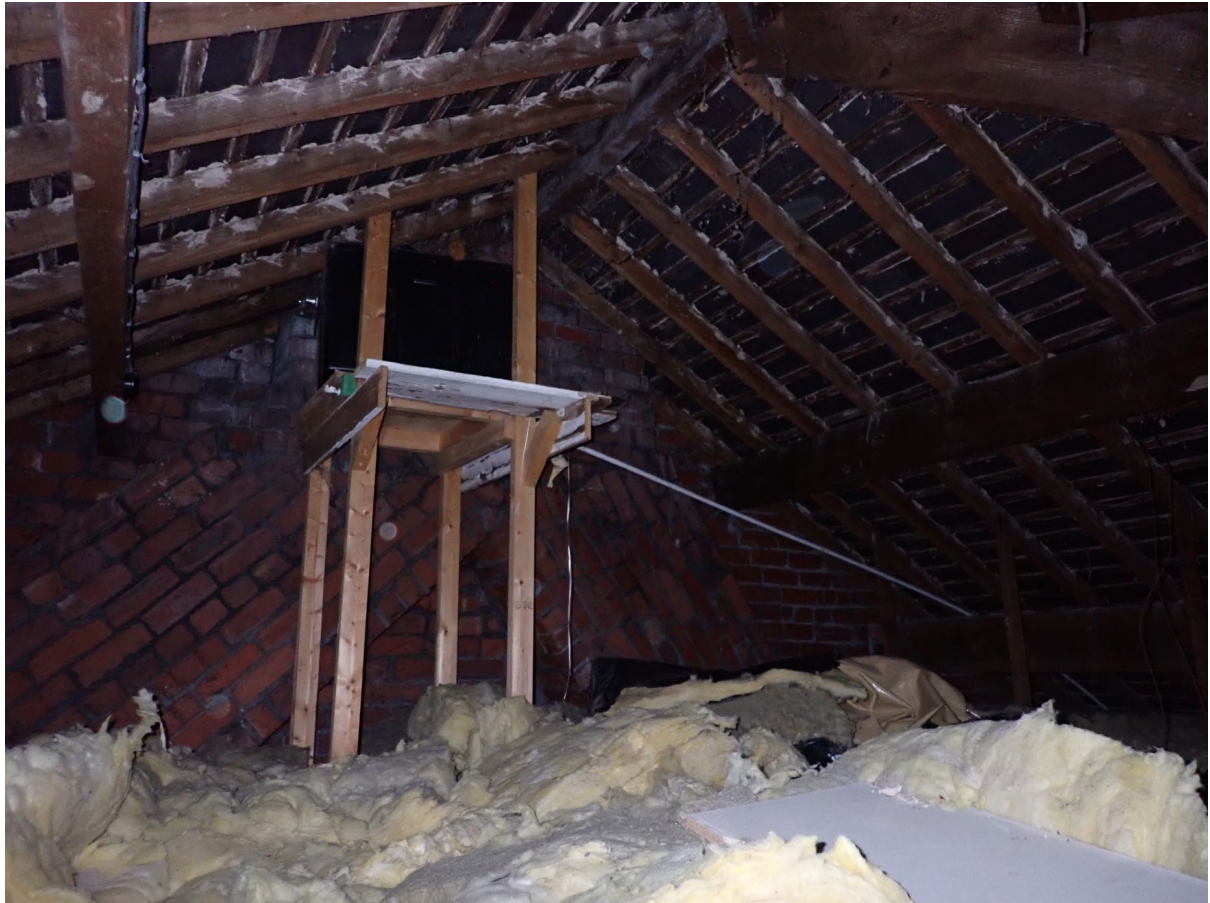
The house has a single roof void, which is not used for storage, it is undisturbed, and is only accessed for essential maintenance.

9 – The house has a single roof void which is not used for storage.

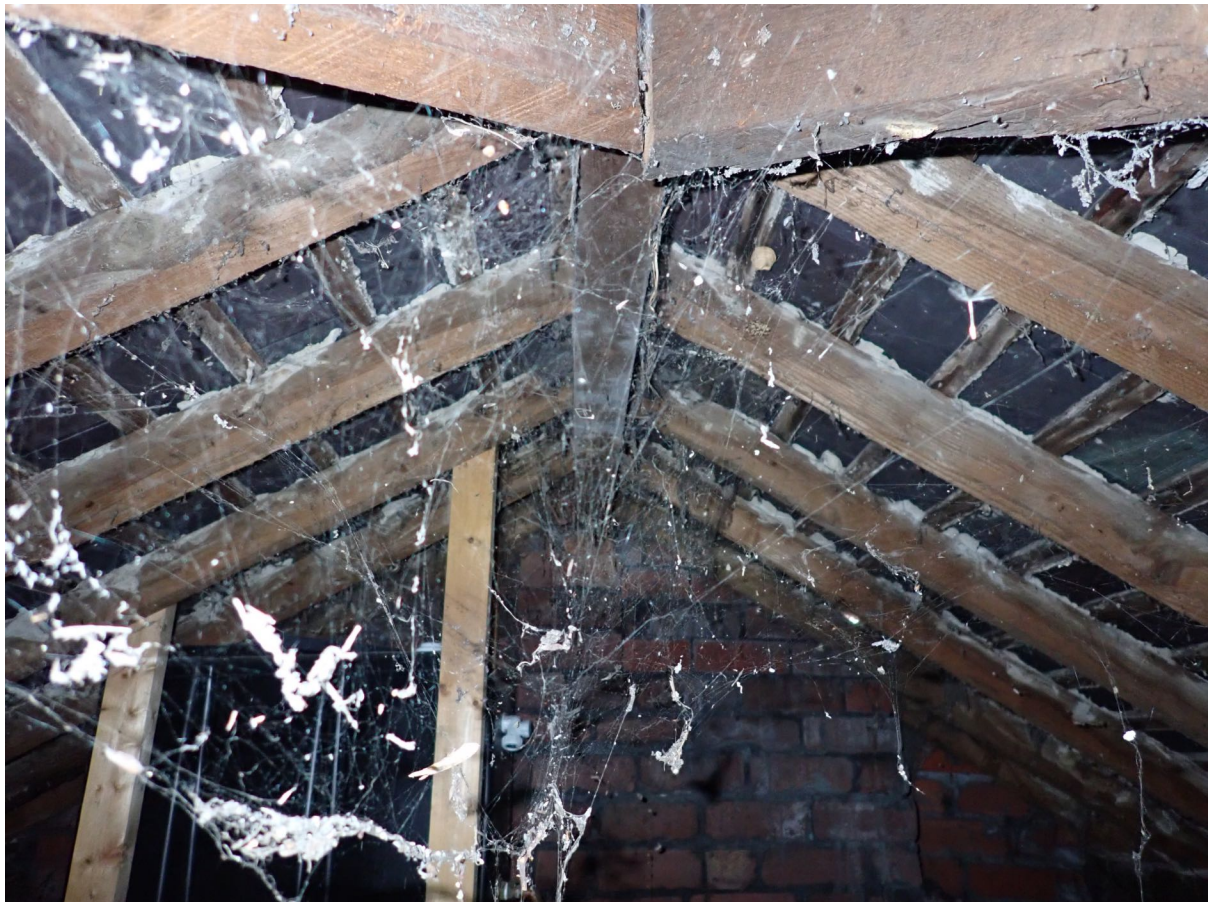
10 – Roof timbers are covered in dusty cobwebs.
