# **Small Outbuilding at Parsonage Farm, Church Street, Ribchester, PR3 3YE**

## **Structural Condition Survey for Conversion to Dwelling (Annexe)**

PSC-690-CAR2

June 2023 Rev A

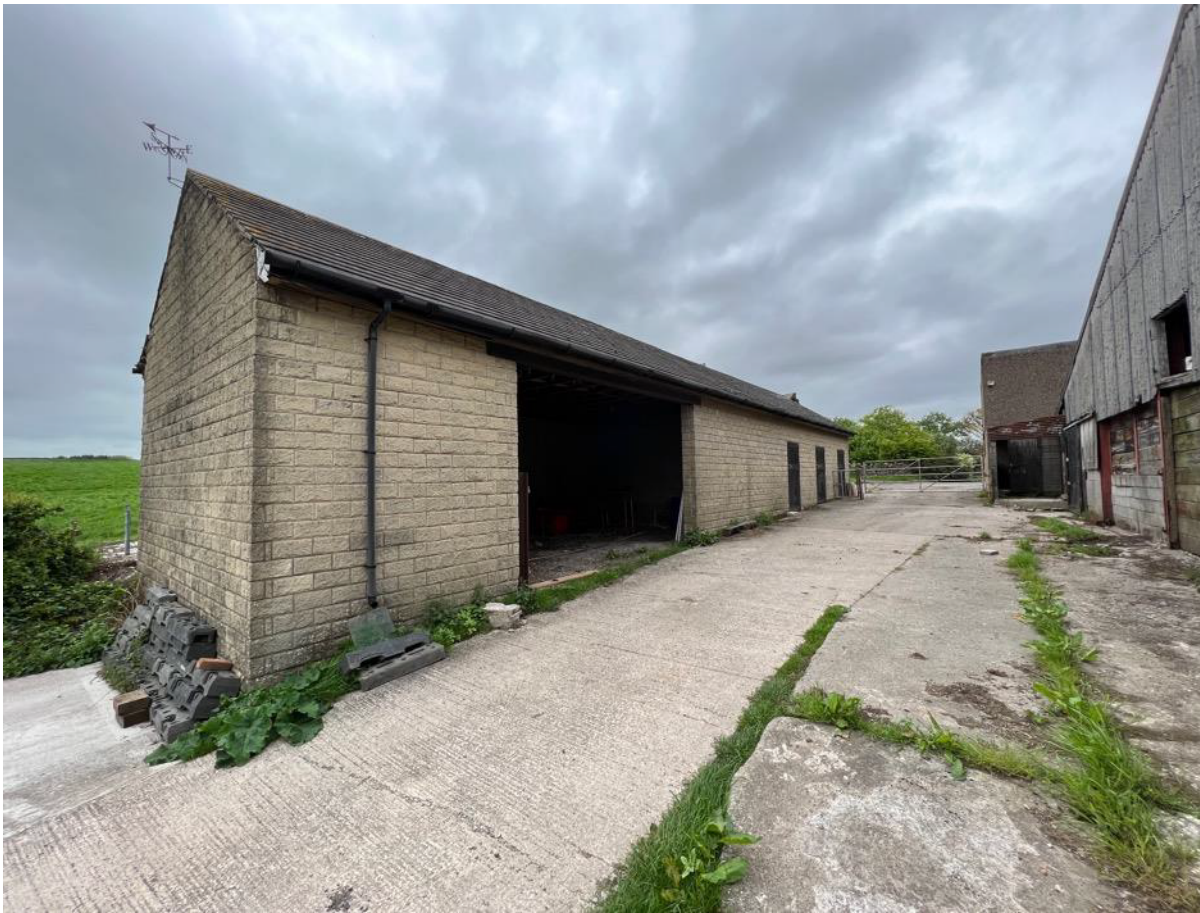
Photo 1 – South East Elevation

This elevation is constructed with an internal leaf of concrete block and an external face of reconstituted stone. The wall is 300mm thick and assumed to be solid as the internal leaf was measured as 140mm block. The wall has a large opening at the south end with 3 further wooden, stable doors to the north which provide access into the various sections of the barn. The wall is in good condition, plumb, well pointed and with no sign of structural movement. There is a steel beam supporting the roof trusses over the large opening and this is in good condition (photo 10). The elevation benefits from guttering and downspouts which are in good condition.

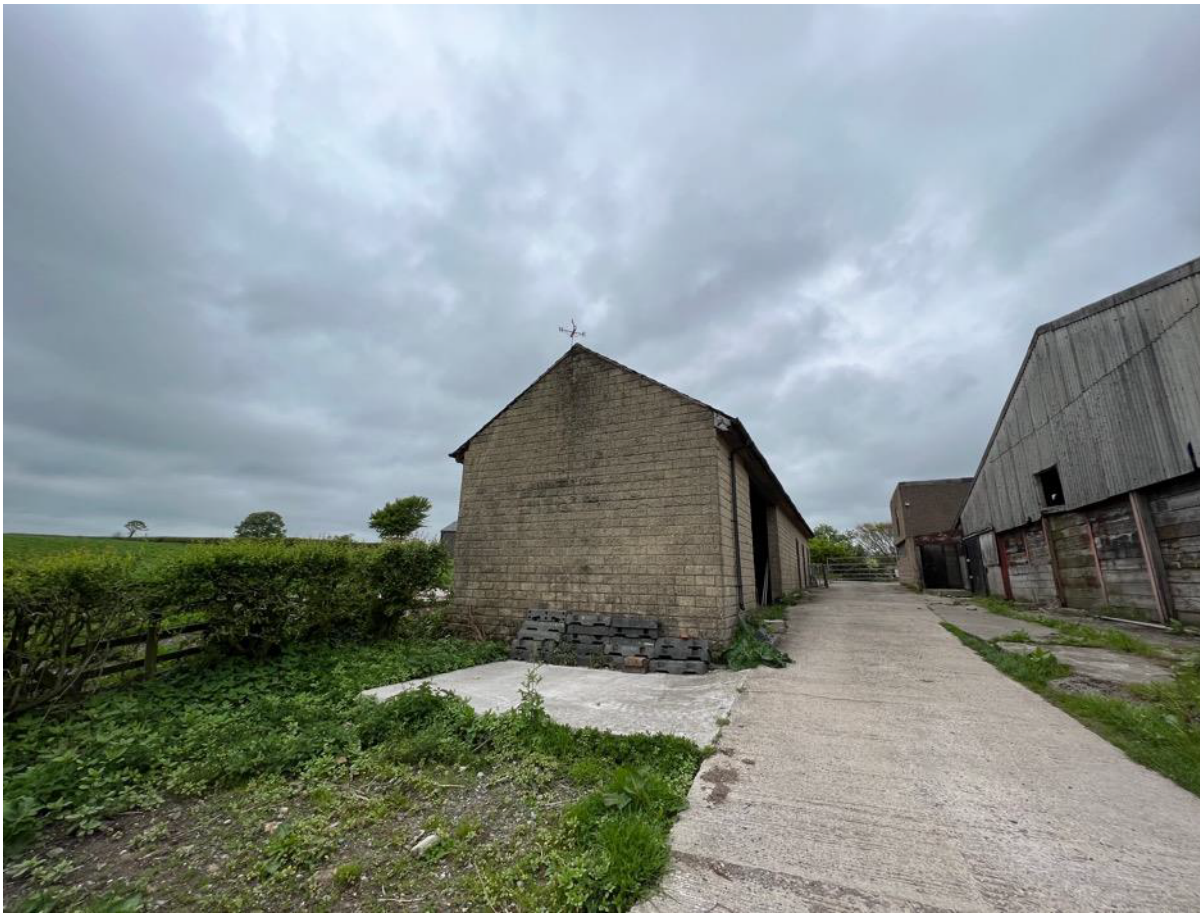
Photo 2 – South West Gable

The elevation is constructed as per the elevation described above and has no openings. The wall is in good condition, plumb, well pointed and with no sign of structural movement.

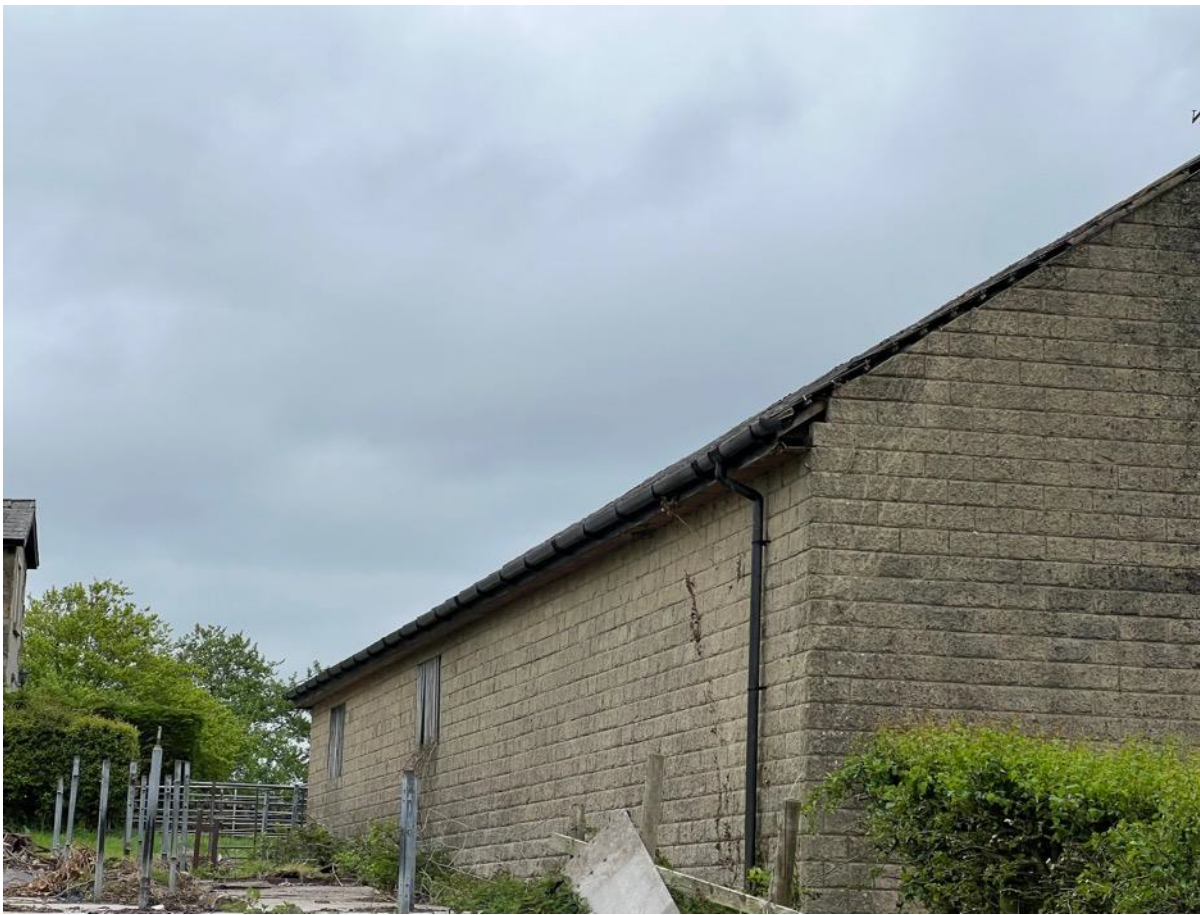
Photo 3- North West Elevation

This elevation is constructed as per the above walls. The wall has two window openings (unglazed) at the north east end of the building (photo 6). The wall is in good condition, plumb, well pointed and with no sign of structural movement. The elevation benefits from guttering and downspouts which are in good condition.

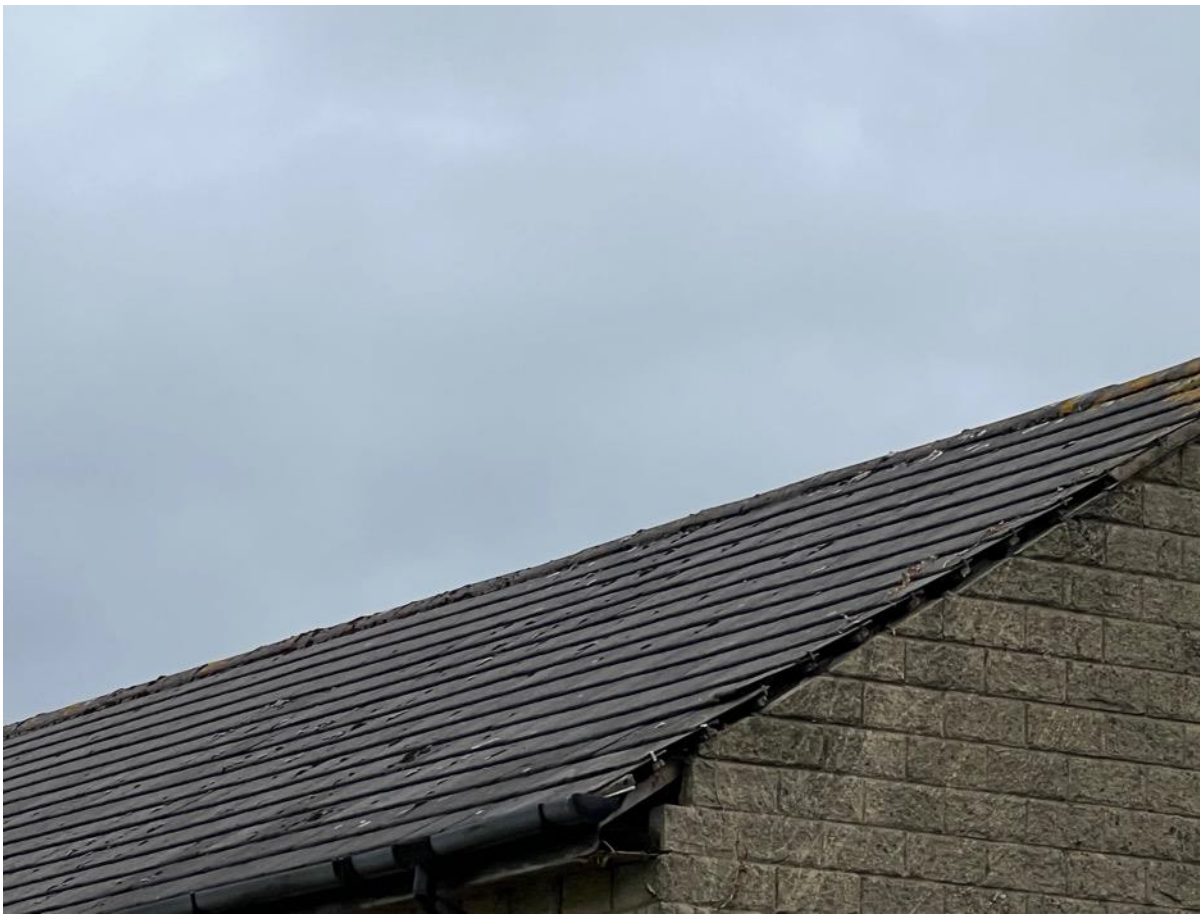
Photo 5 – Roof

The roof is slate supported by truss rafters and is felted. It is in good condition with the wall plate strapped down to the internal leaf of blockwork.

The roof structure appears more than adequate to support the addition of a ceiling and insulation but should be checked by an Engineer for the proposed loadings. All retained timber should be treated against rot/infestation. The condition of the building indicates that the introduction of further window/door openings should not be an issue.

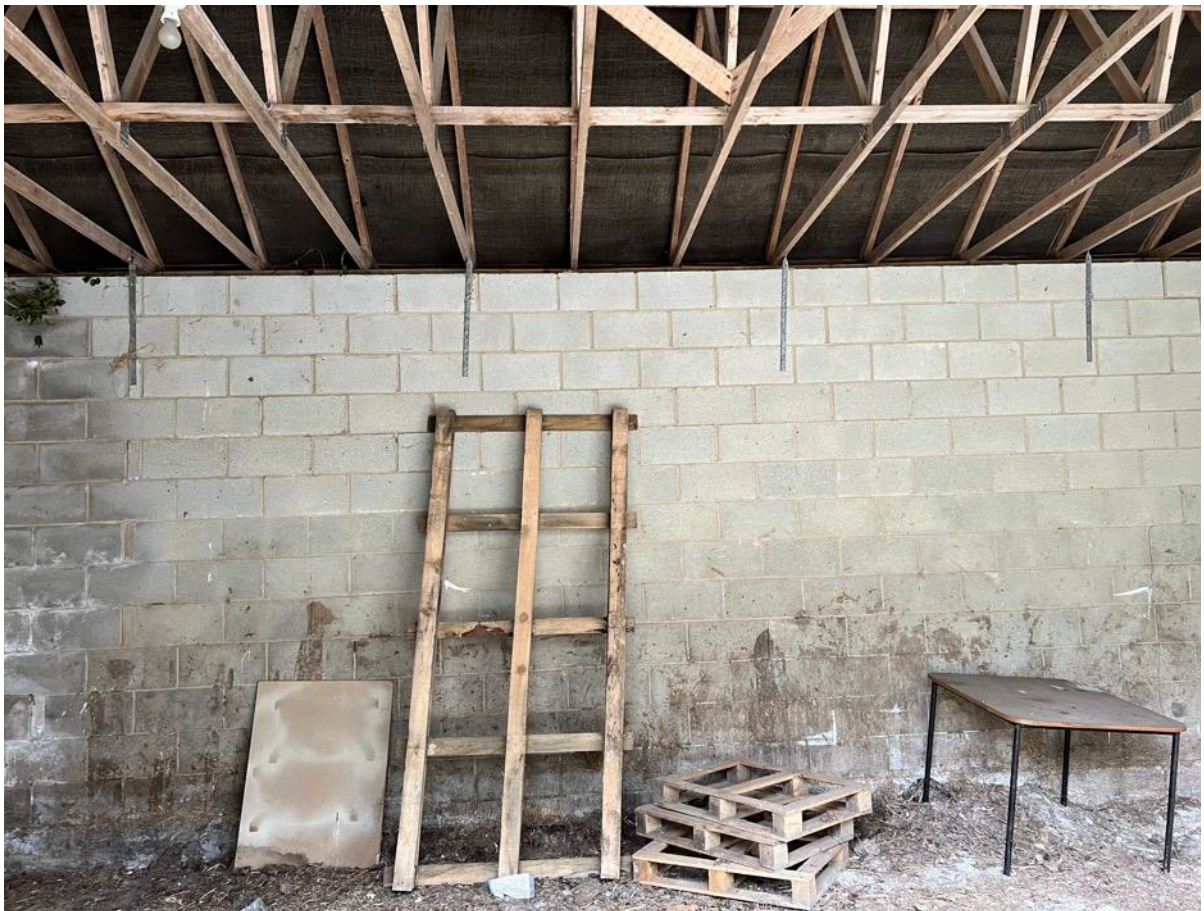
Photo 8 – Internal

Internal inspection indicated that the building is in good condition in terms of the masonry walls and the roof structure. There is no indication of any structural movement or damage. The floor is a concrete slab which is in good condition.

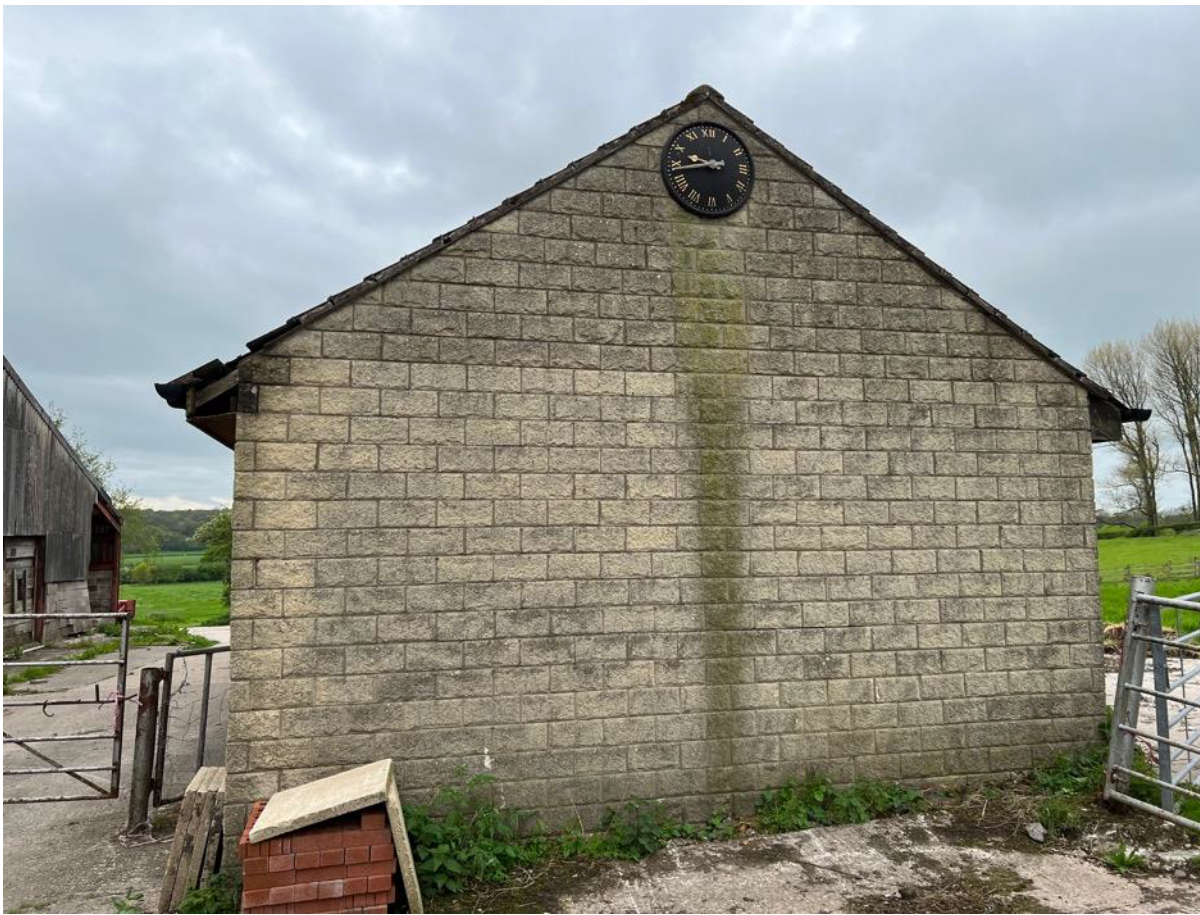
Photo 11 – North East Gable

The elevation is constructed as per the elevations described above and has no openings. The wall is in good condition, plumb, well pointed and with no sign of structural movement
