# **Barn at Parsonage Farm, Church Street, Ribchester, PR3 3YE**

## **Structural Condition Survey for Conversion to Dwelling**

PSC-690-CAR1 – Rev A

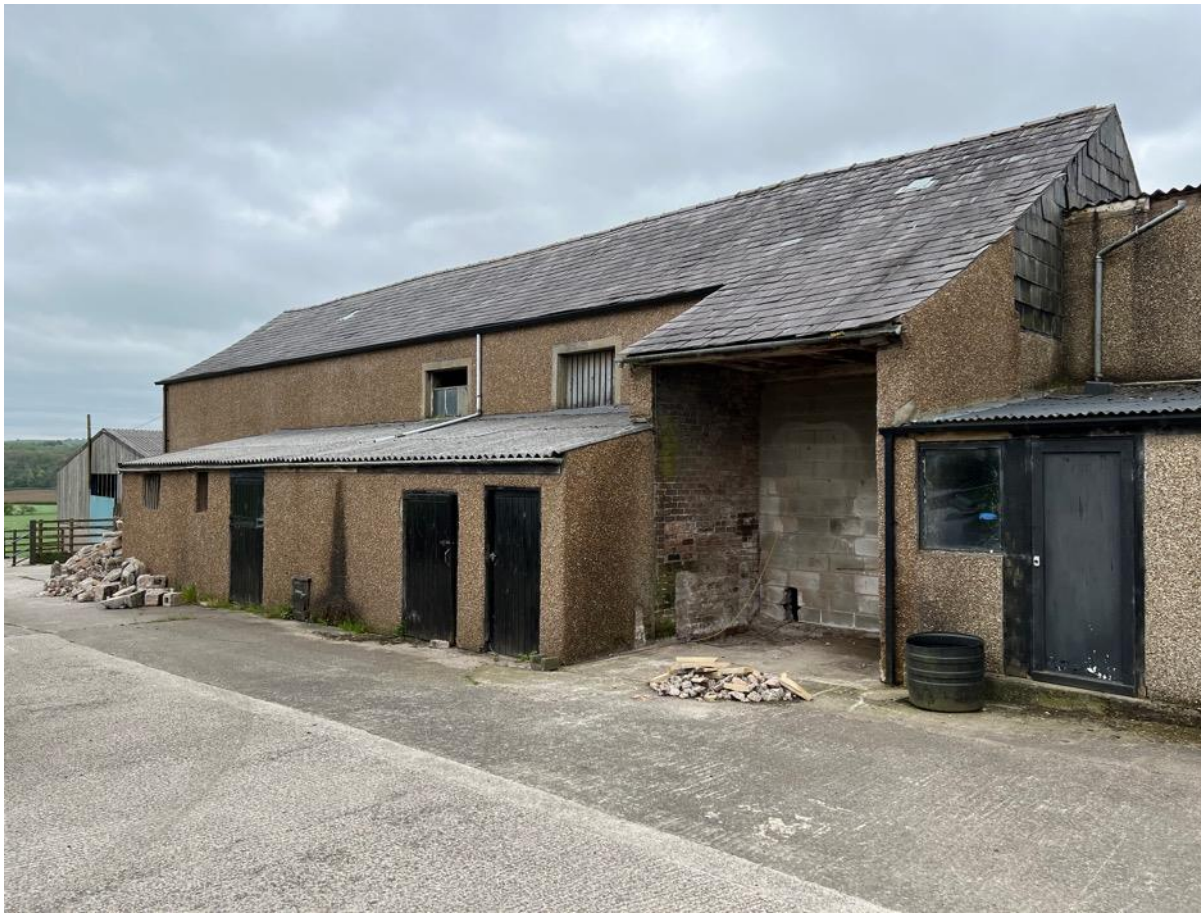
Photo 1 - North East Elevation

The original brick wall to this elevation is constructed with clay brick and is approximately 400mm thick. The wall has a pebble dashed render. Single storey extensions have been added to this elevation as can be seen in Photo 1. The proposals indicate that these are not proposed to be retained. In addition, the original barn has been extended to the northwest with a blockwork extension which has also been pebble dashed (photo 2). This extension appears to have replaced two original bays of the brick barn as evidenced by internal inspection and exploratory excavations externally. The walls to this elevation are generally plumb, the render is in reasonable condition and free from signs of movement. The elevation benefits from guttering and downspouts.

Photo 1 indicates slates to the gable where the extension abuts to the original barn.

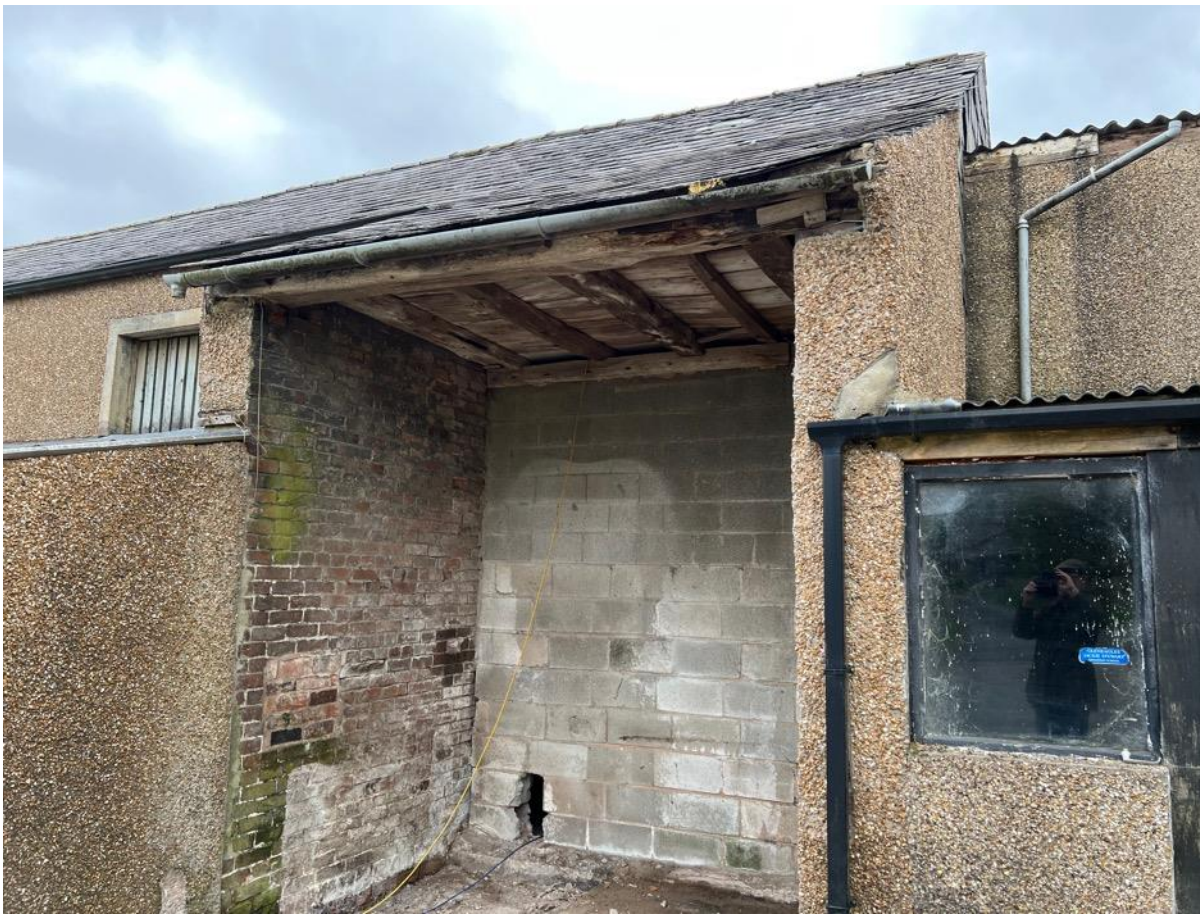
Photo 5 – North East Elevation – Original Barn Entrance

The original barn door (photo 5) has been blocked up with concrete blocks. Photos 5 to 7 show the original unrendered brickwork and the timber to the roof/overhang. The brickwork is in good condition, reasonably pointed and generally plumb. There are two high level window openings in the original wall, above the single storey extension (photo 9). At the eastern end there is a further window opening at ground floor level (photo 14). The original brickwork can also be seen in photo 15 which shows an area adjacent to the gable where the render has been removed at a low level. Again, the brickwork appears in good condition given the age of the building.

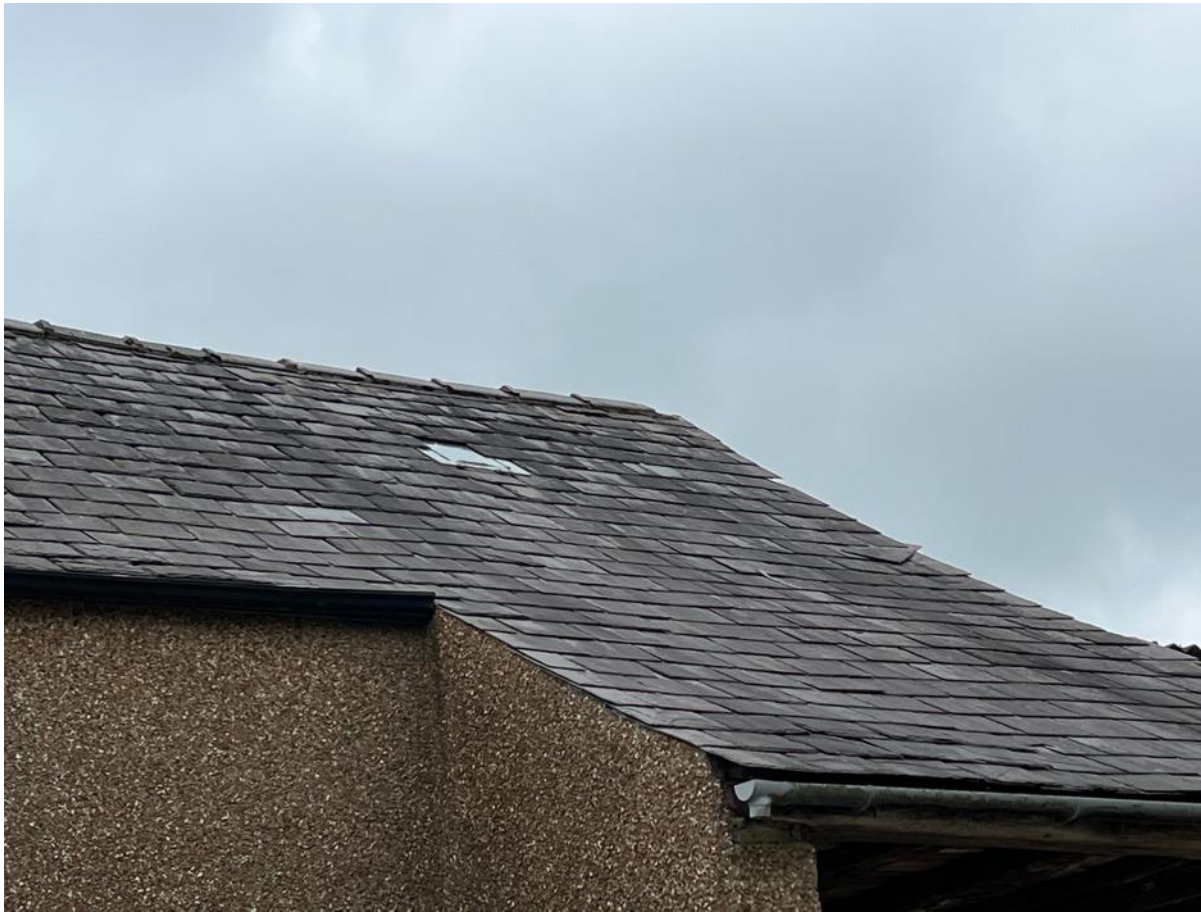
Photo 10 – North East Elevation Roof

The main roof is slate on traditional rafters, purlins and trusses which are discussed further below. The external views indicate the slates to be in good condition with no loss or damage. The roof appears not to have suffered from any major movement or deflection when viewed externally.

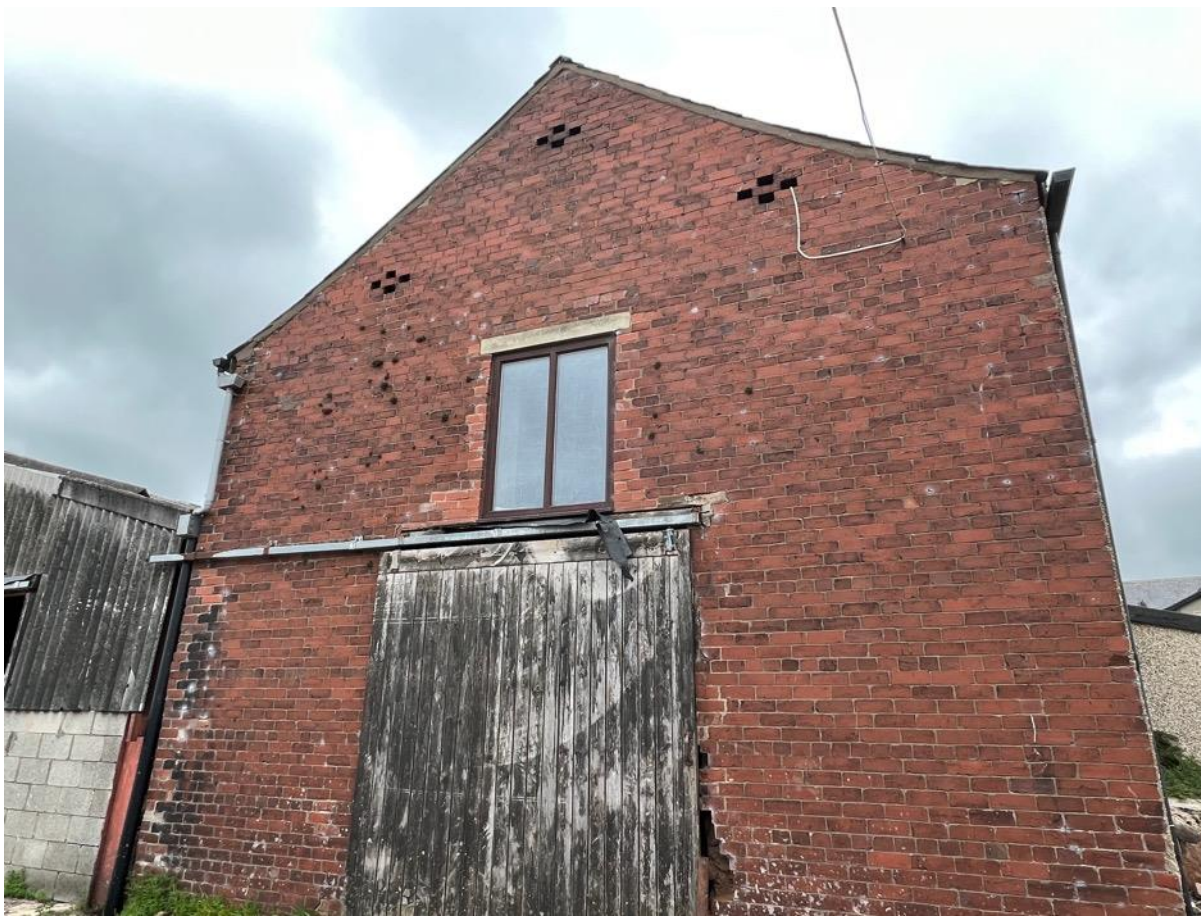
Photo 17 – South East gable

The elevation is a 500mm thick brick wall. It appears to have had an extra skin of brickwork added externally using Accrington Brick. The wall is in good condition, plumb and well pointed. There is no sign of structural movement. The elevation has a large door opening with a window above (photo 17). There are 3 vents in the brickwork above the window (photo 20). Photo 21 shows the steel column to the large steel framed extension to the south.

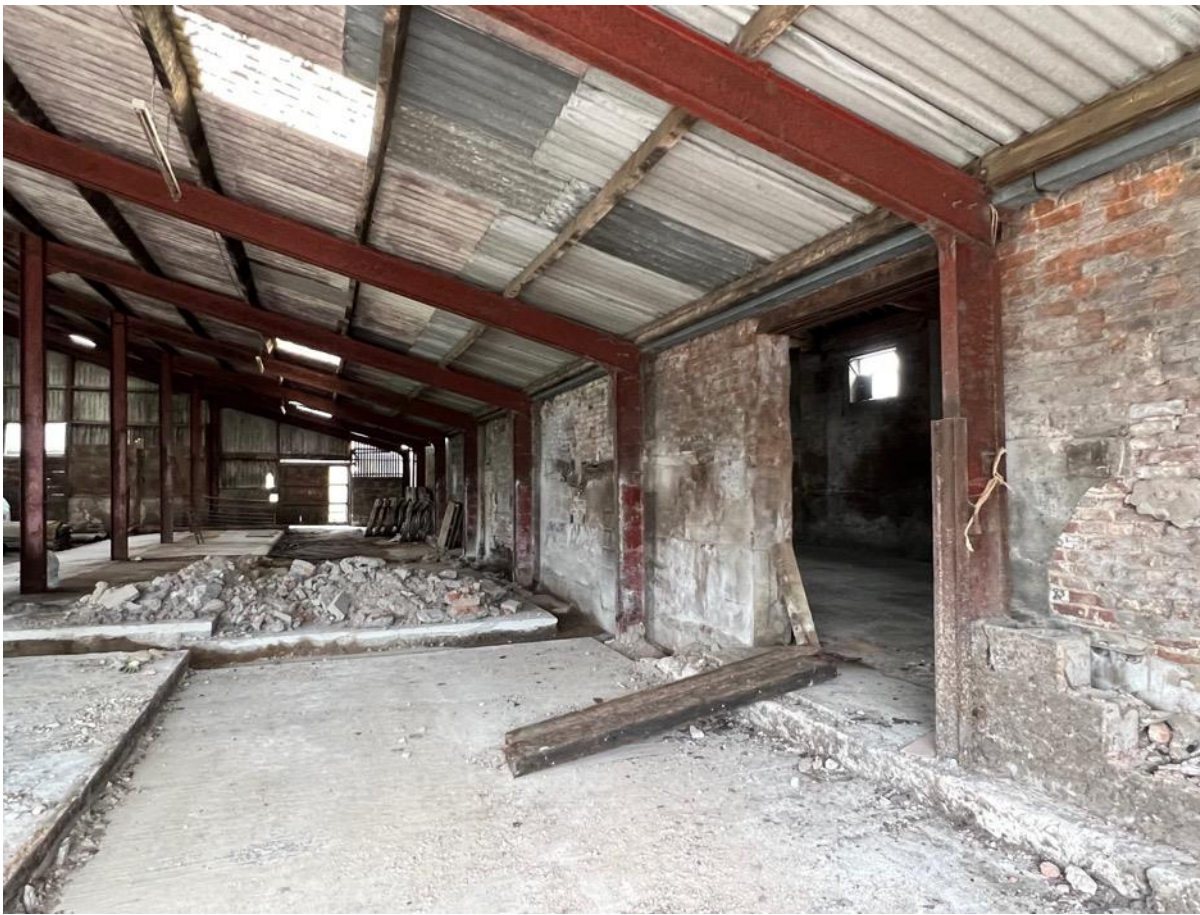
Photo 23 – South West Elevation

The south elevation of the brick barn sits within the large steel framed extension to the south as can be seen in photo 23. The brick walls are 400mm thick and the photographs illustrate that the wall has been repaired or had sections blocked up with concrete blocks (photos 29 to 31). There is a large opening in place at the eastern end (photos 23 & 24). A further window opening is in place at a high level towards the western end and this can be seen in photo 49. The walls are plumb and generally well pointed. There is no sign of movement to the wall.

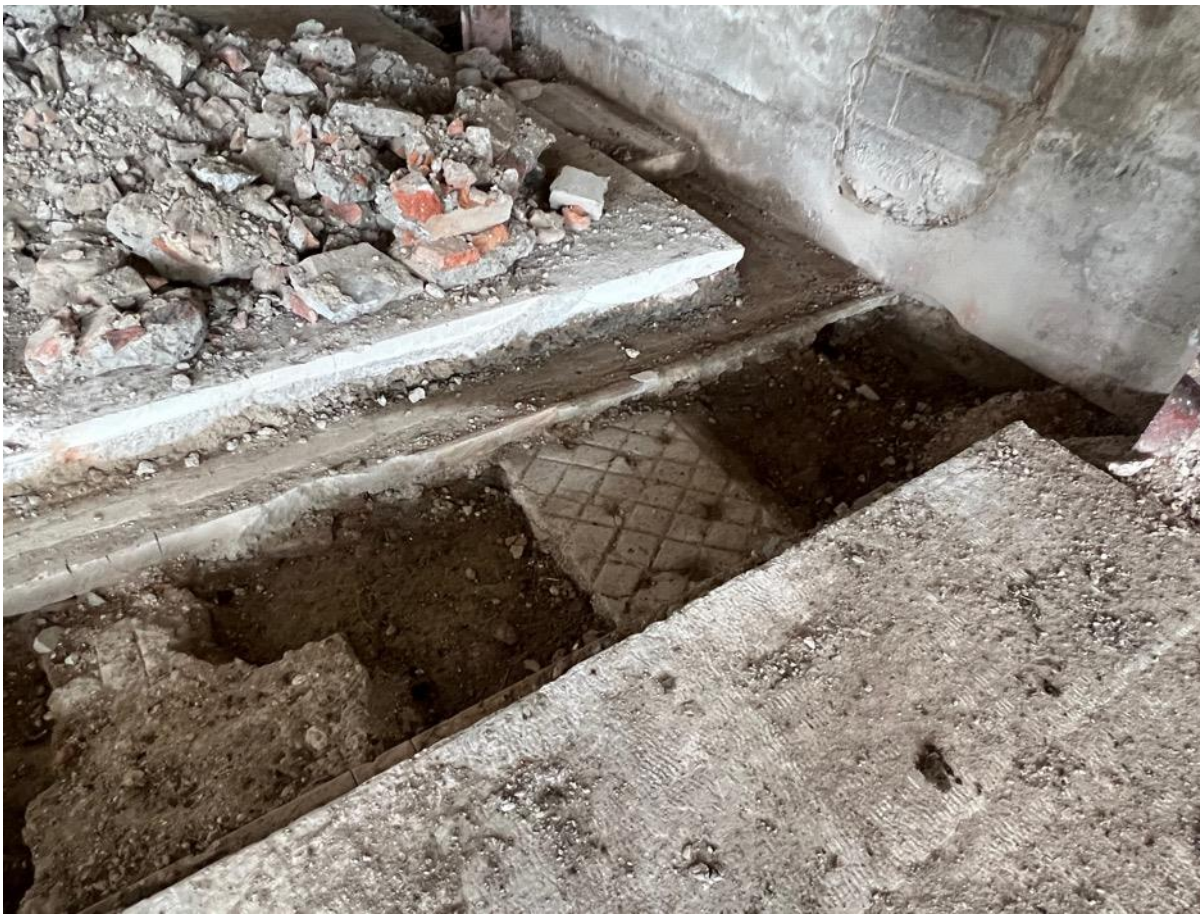
Photos 27 and 28 show excavations below the current floor which indicate that the large steel framed building to the south of the brick barn probably replaced a traditional rear section of a

Lancashire barn. The excavations indicate footings to such a building in place below the existing floor.

Photo 27 - South West Elevation – excavations to reveal former lean-to section

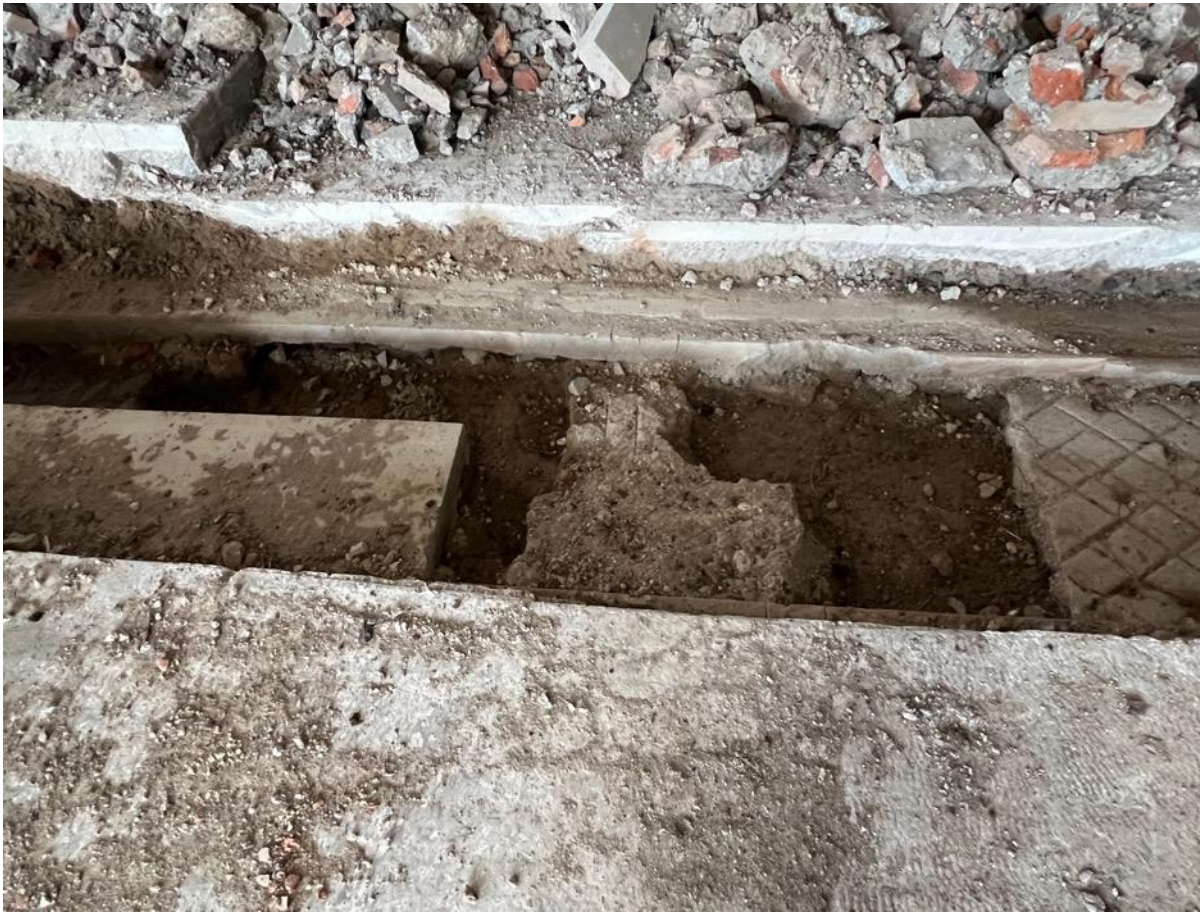
Photo 28 - South West Elevation – excavations to reveal former lean-to section

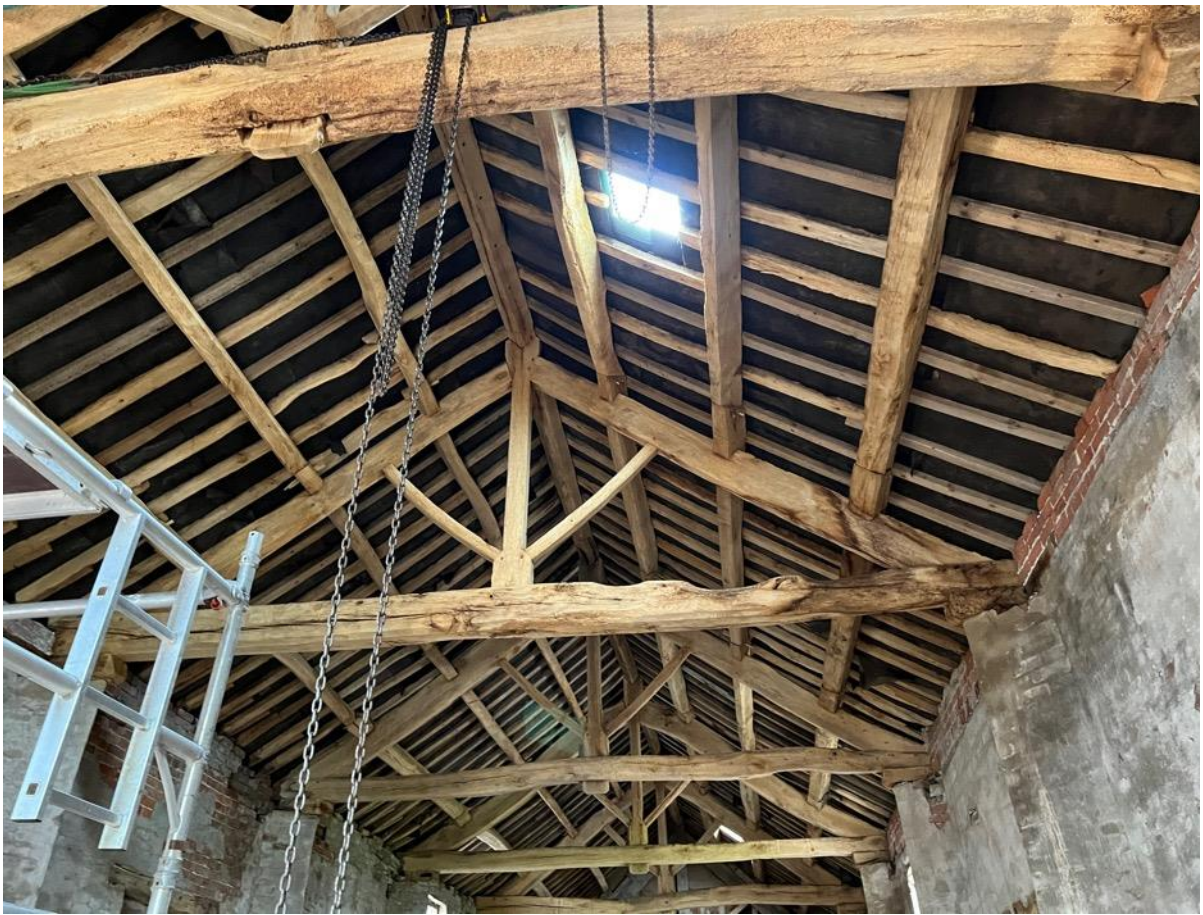
Photo 41 - Internal – main barn

The roof structure can be seen in photos 41 to 43 with the bearing detail of the trusses illustrated in photo 47. The trusses, purlins and rafters appear to be original and are generally in good condition. There are some issues with the trusses including spread and water ingress as indicated on photos 41 & 42. The standard of workmanship and quality of timber used is very high. The roof has been felted and re-slatted over the years.

The existing trusses and purlins appear to be in good condition with little sign of rot or infestation. There are some areas that need assessment and repair as noted above but the structure appears adequate for the loadings anticipated. All the timber retained should be assessed by a timber specialist, with regard to rot and infestation. All retained timber should be treated against rot/infestation and an indication of residual section given for structural purposes. All retained timber to be used structurally should be checked for structural adequacy.

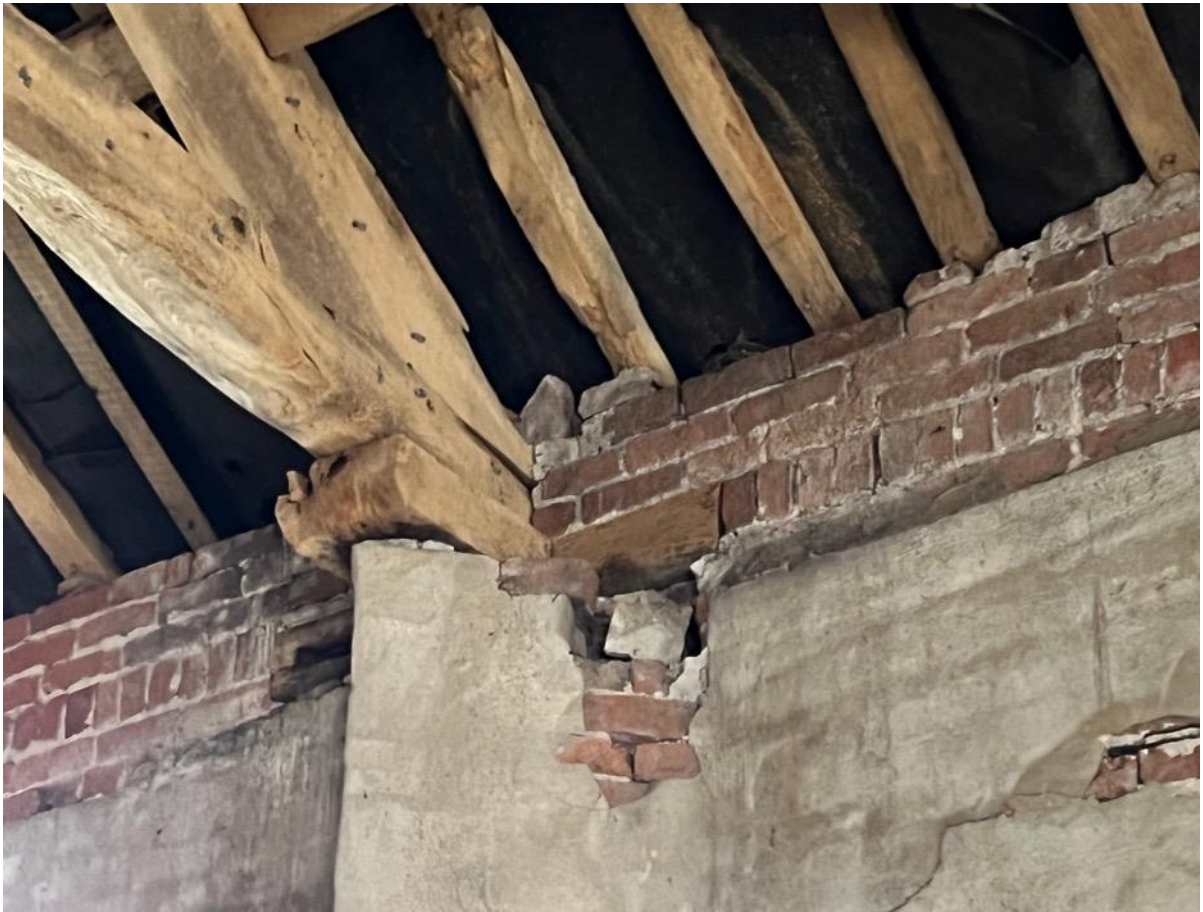
Photo 52 - Internal – main barn

The main barn is an open building to full height as can be seen in photo 40. The brick walls have triangular piers set at regular intervals (approx. 12 feet or 3.7m). These piers are 500mm long on each triangular side. They carry the king post roof trusses above. The brickwork is in reasonable condition but there are some areas of damage and lots of areas where openings have been infilled with blockwork or damage repaired. There is no indication of any structural movement or issues. Photos 46 and 52 show areas of damage to the piers but this is not due to structural movement and can be repaired.

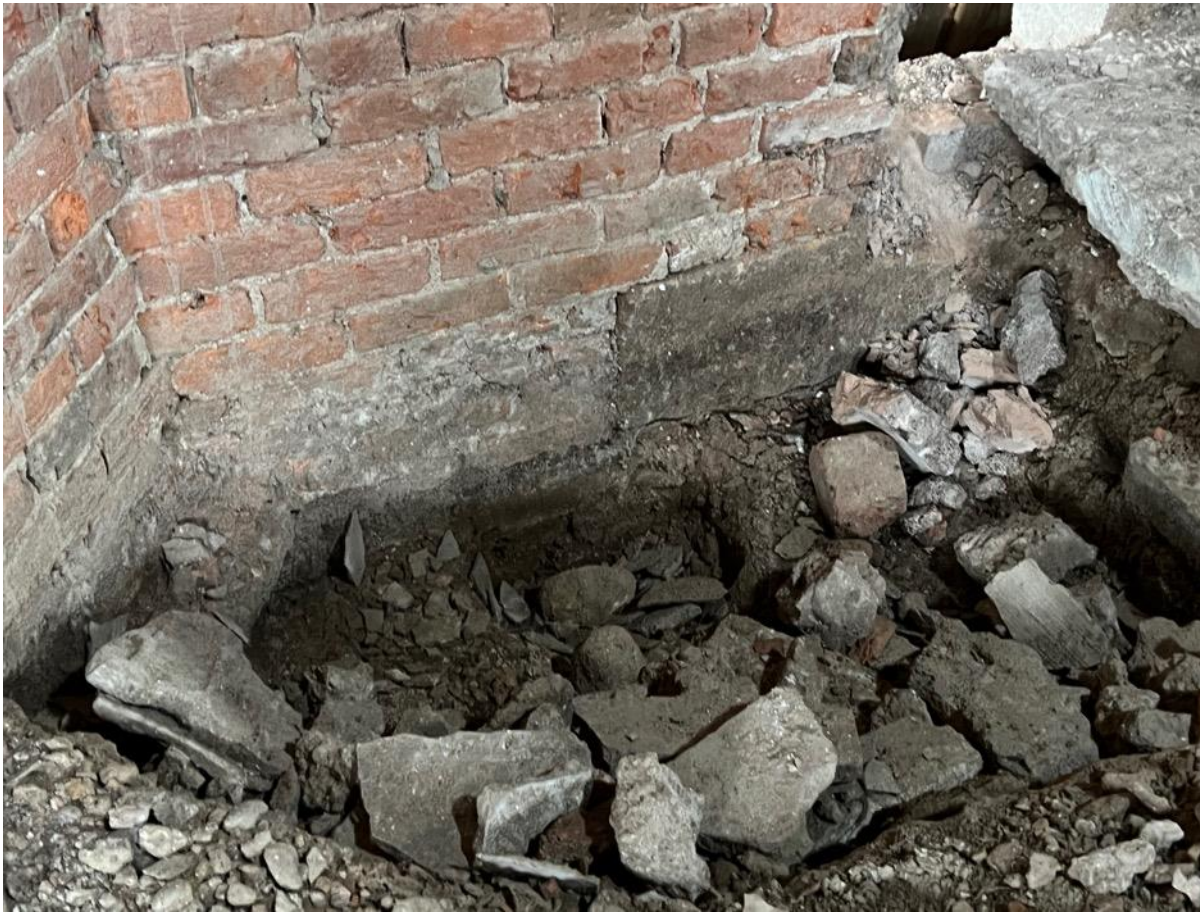
The barn has a concrete floor which is in reasonable condition. Photo 56 shows an excavation through the floor to expose the founding stones. These are located at a reasonable depth on a suitable bearing strata.

Photo 56 - Internal – main barn – excavation to founding stones

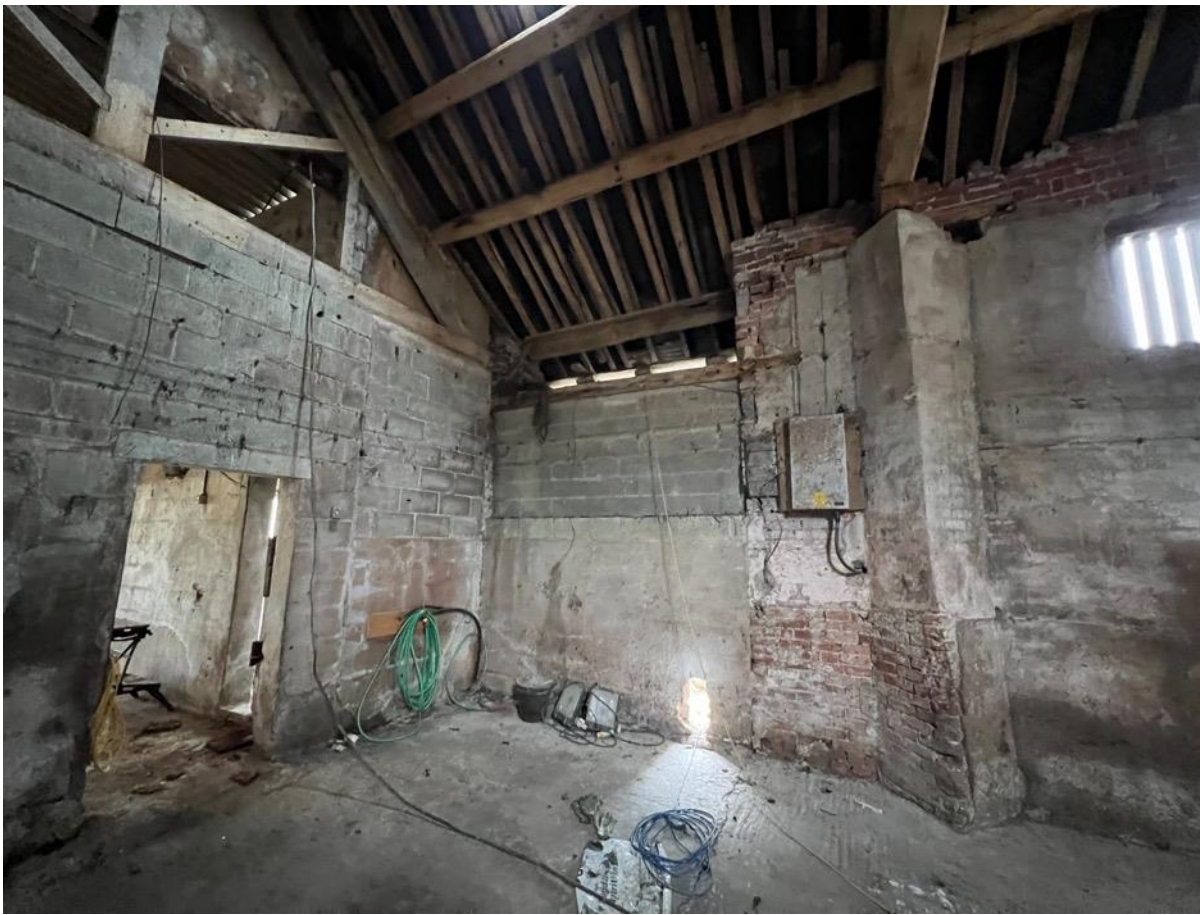
Photo 57 - Internal – main barn

As noted above, the brick barn appears to have originally extended by a further two bays to the west. These bays appear to have been replaced by the blockwork extension at the west end. This is further evidenced on photos 57 & 58 by the presence of a block wall constructed immediately adjacent to the barn door and located directly below a truss. This is clearly not original, and a truss would not have been located at the gable. This block wall is constructed with 200mm blockwork and is plumb and free from movement. There are two openings at ground floor through to the extension. The truss has been left open as can be seen on Photo 58.

As noted above, a new block gable wall has been installed under the westernmost truss (photos 57 & 58). This is at the junction of the original barn and the extension to the north west which is thought to have replaced two more bays of the original barn.

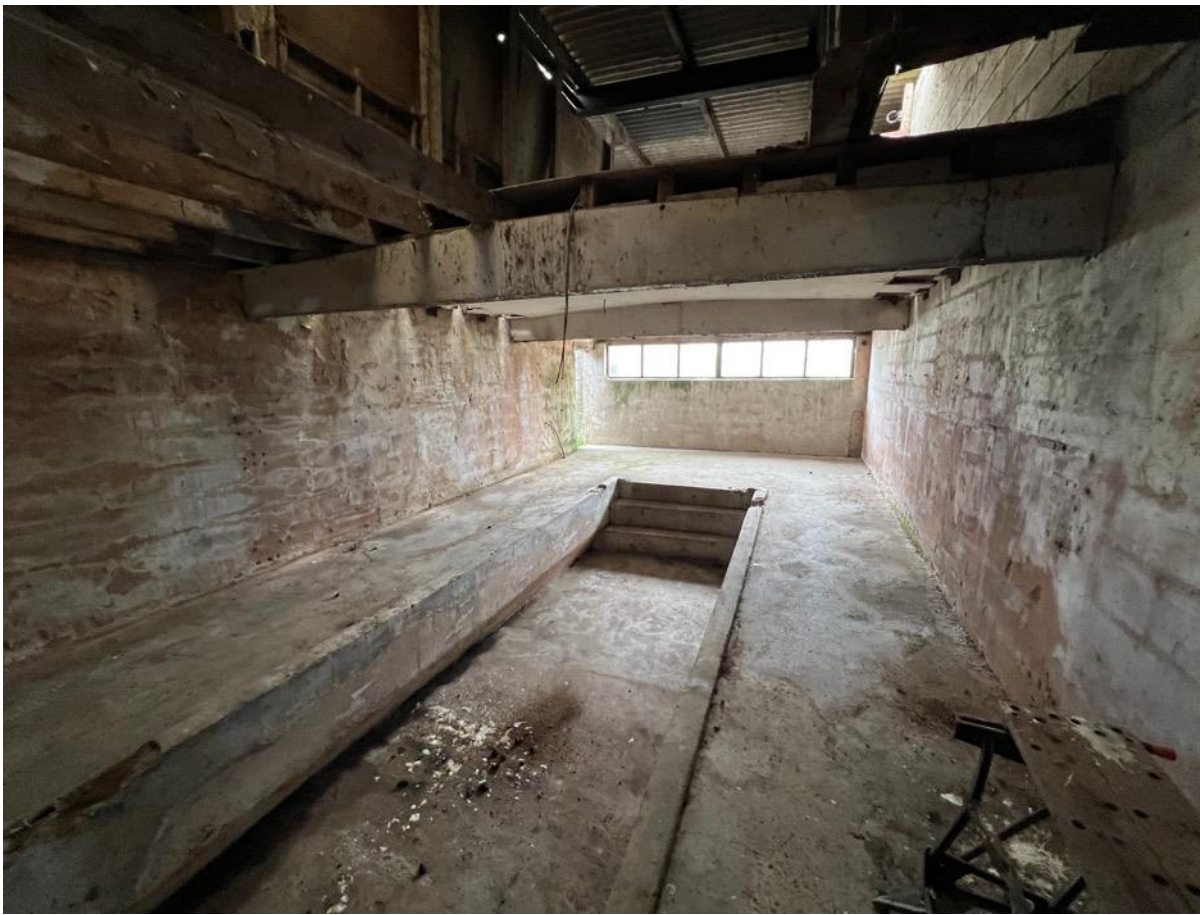
Photo 59 – Extension at north west end

The extension to the west forms a milking parlour (photo 59) plus an adjacent room (photo 61). The milking parlour has a loft above (photo 60). The extension is in good condition and free from movement.

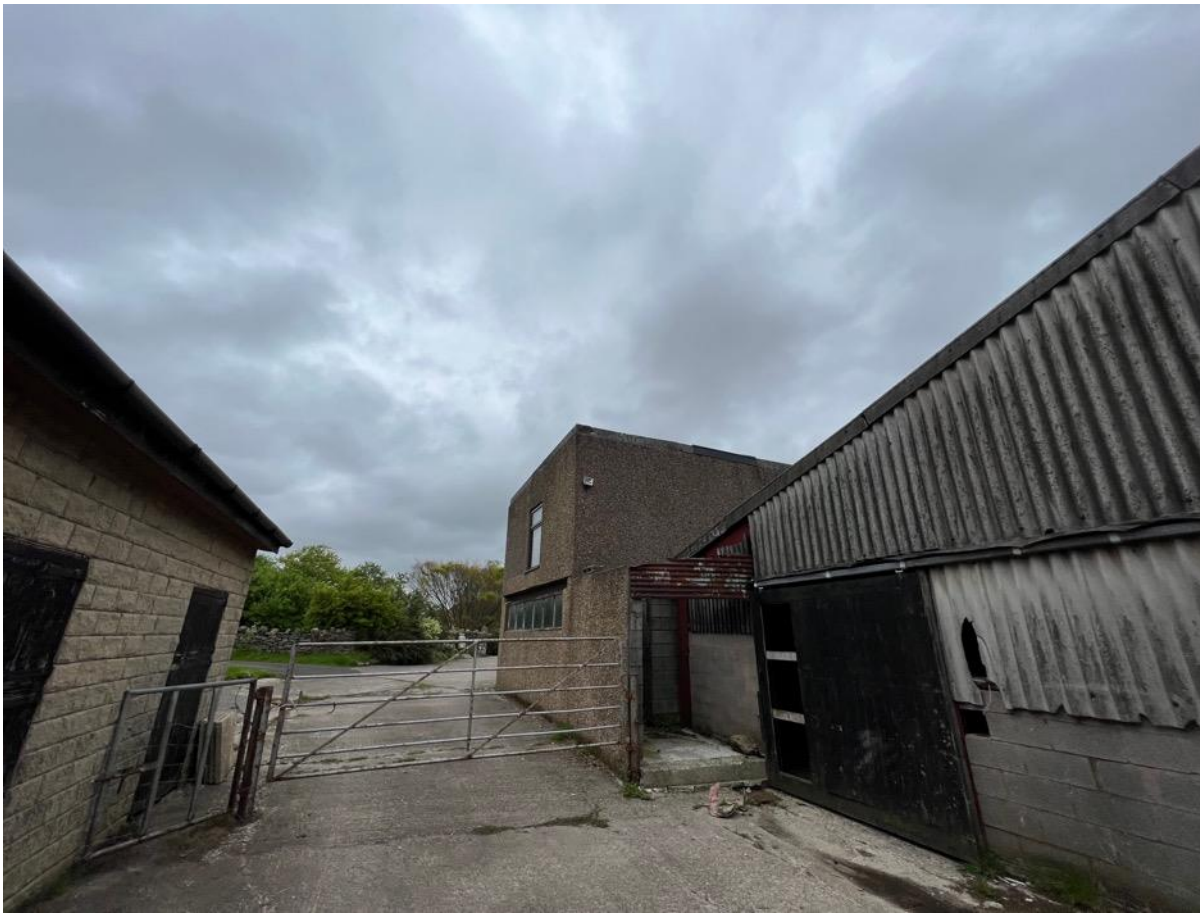
Photo 65 – North West elevation of extension

The section of wall on the south elevation of the extension at the west end can be seen in Photo 65. This is a block wall with pebble dashed render. The wall appears free from movement and in reasonable condition.

The new gable wall to the extension is shown on photos 32 and 65. This a rendered block wall, it is plumb and is free from movement. The elevation has a long window opening at ground floor level and a single window above. The longer window has a steel beam supporting the blockwork which is in reasonable condition.
