**Woodtop Farm, Thornley, PR3 2TS
Stone Barn**

**Structural Condition Survey for Assessing
Conversion to Residential Property**

PSC- 816-001

July 2023

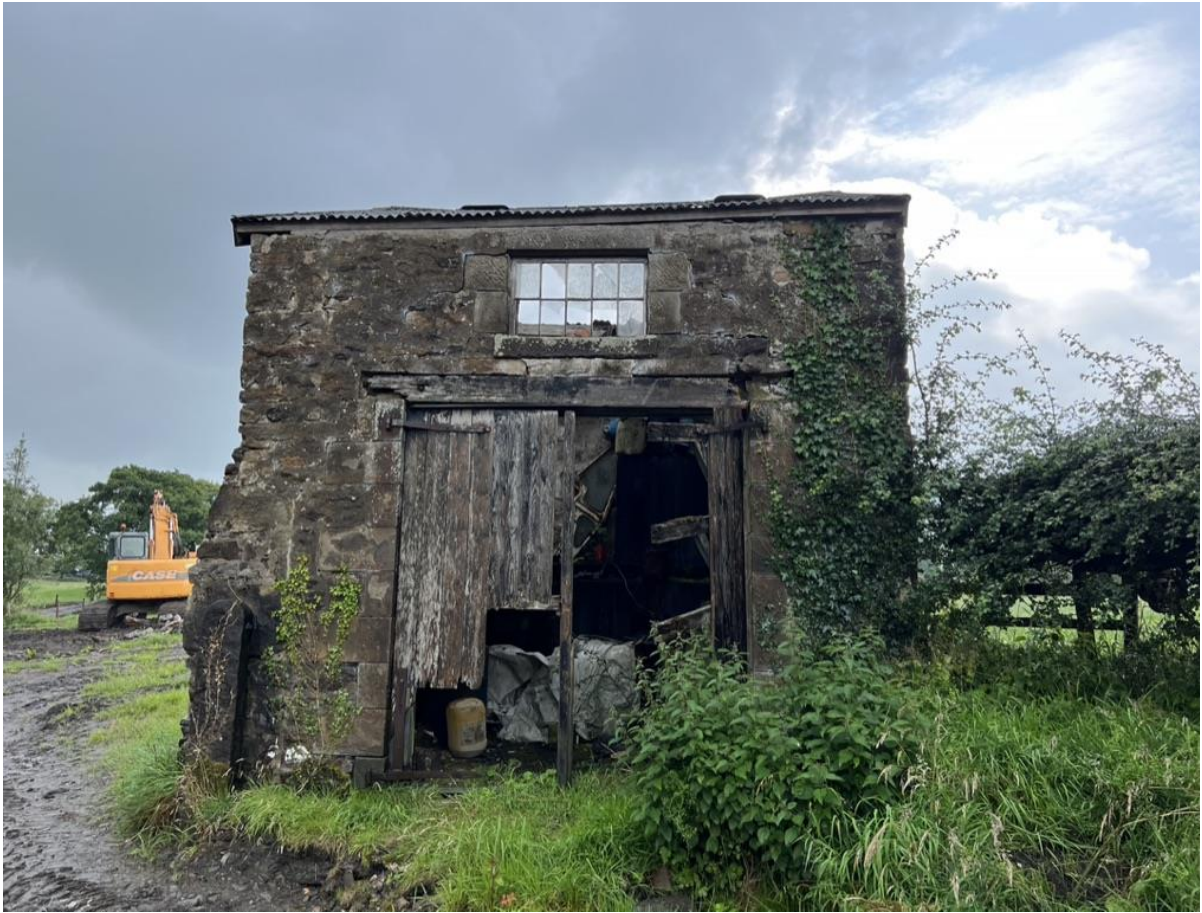
Photo 1 - North Elevation

The front elevation of the barn is built in random sandstone and the wall is 450mm thick. There is a large barn door on this elevation with a window located directly above (photos 1 & 4). The barn door has a wooden lintel to the external face of the wall which is in poor condition and failing (photo 2), leading to movement in the stonework above (photos 2 & 3). There has previously been an adjoining building to the east and removal of this building has damaged the north-east corner of the stonework as can be seen in photos 5, 6 and 9. This elevation would require a substantial amount of re-build covering around 50 to 60% of its area.

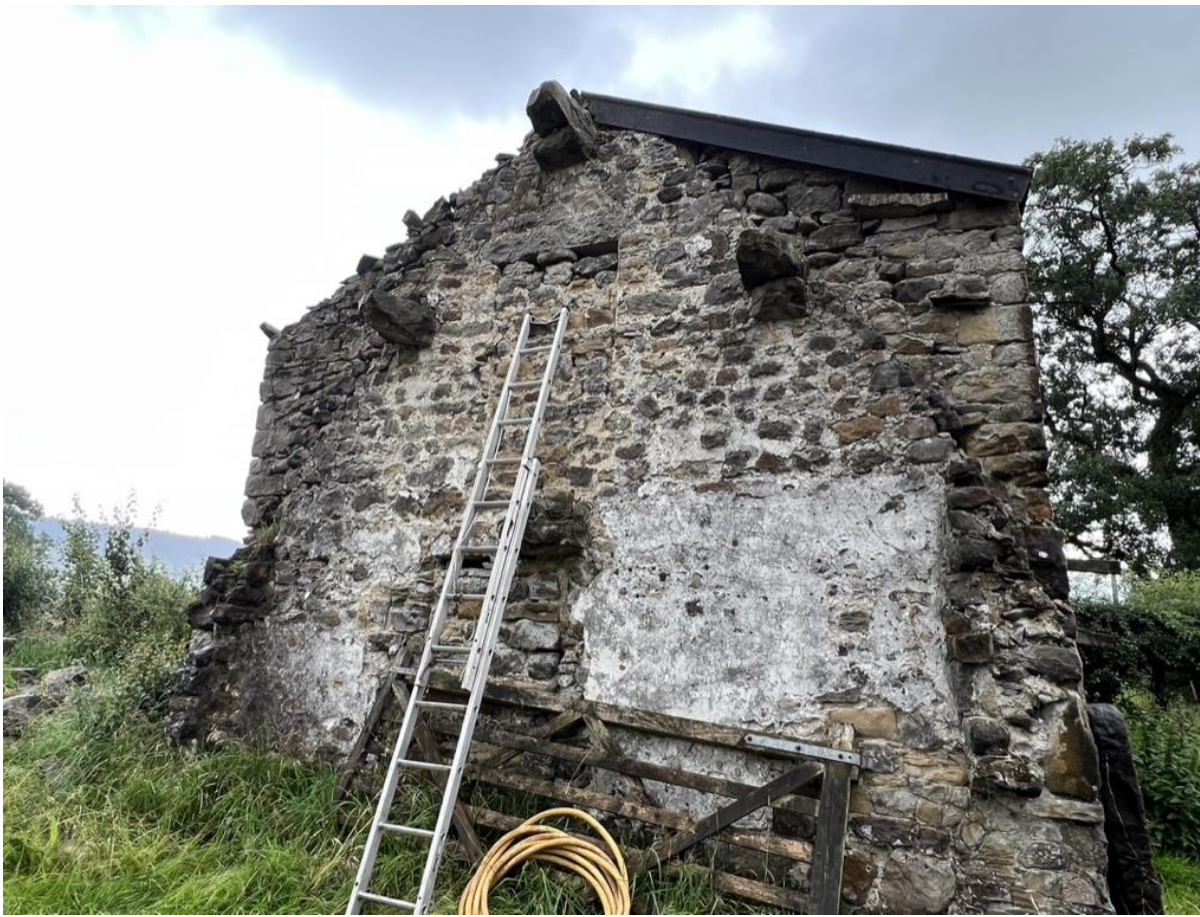
Photo 7 – East Elevation

The east gable of the barn is built in random sandstone and the wall is 450mm thick. Photo 7 illustrates the roof line of the former building which was previously attached to the east. There is also evidence on photo 7 of two former doorways, one at a lower level and one directly above at a higher level. The gable is damaged at each corner where the former building has been removed (photos 7 & 9). The stonework above the roof line of the former building is in very poor condition as is the infill to the former doorways. This elevation would require a substantial amount of re-build covering around 60 to 75% of its area.

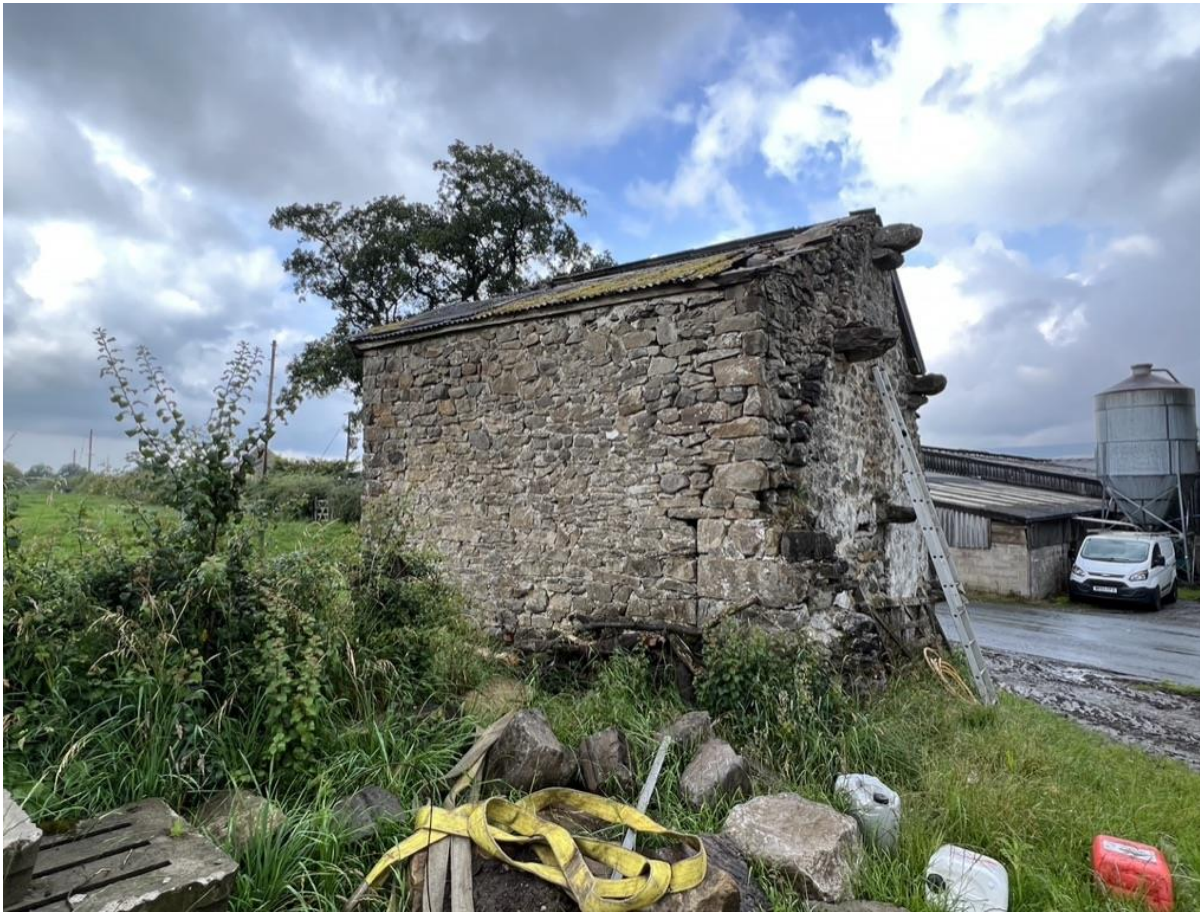
Photo 10 – South Elevation

The rear elevation of the barn is built in random sandstone and the wall is 450mm thick. The wall is damaged and has moved at the south east corner as can be seen in photos 10 to 12. This elevation would require an area of re-build of around 10 to 20% of its area.

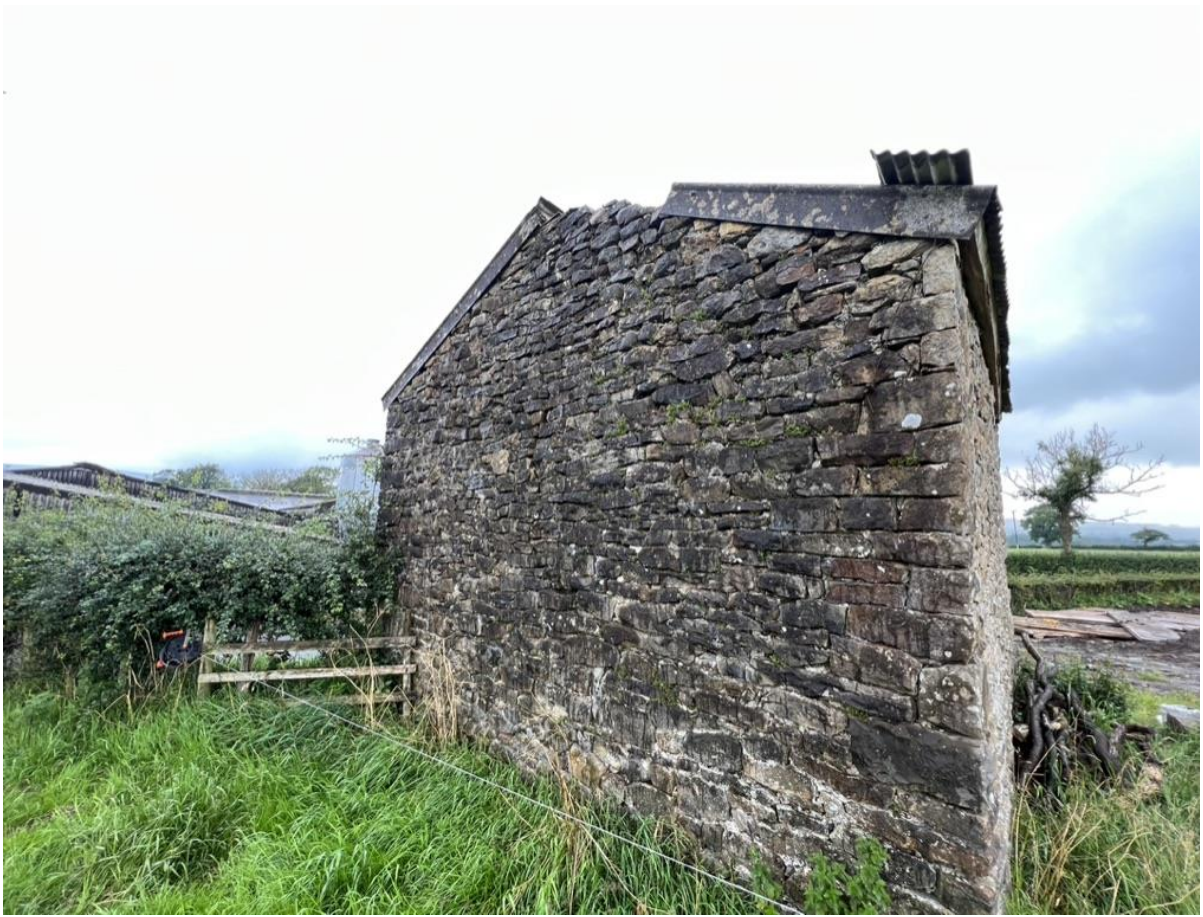
Photo 13 – West Elevation

This west gable is built in random sandstone and the wall is 450mm thick. The gable is in a reasonable condition and would not require any areas of re-build to its external skin.

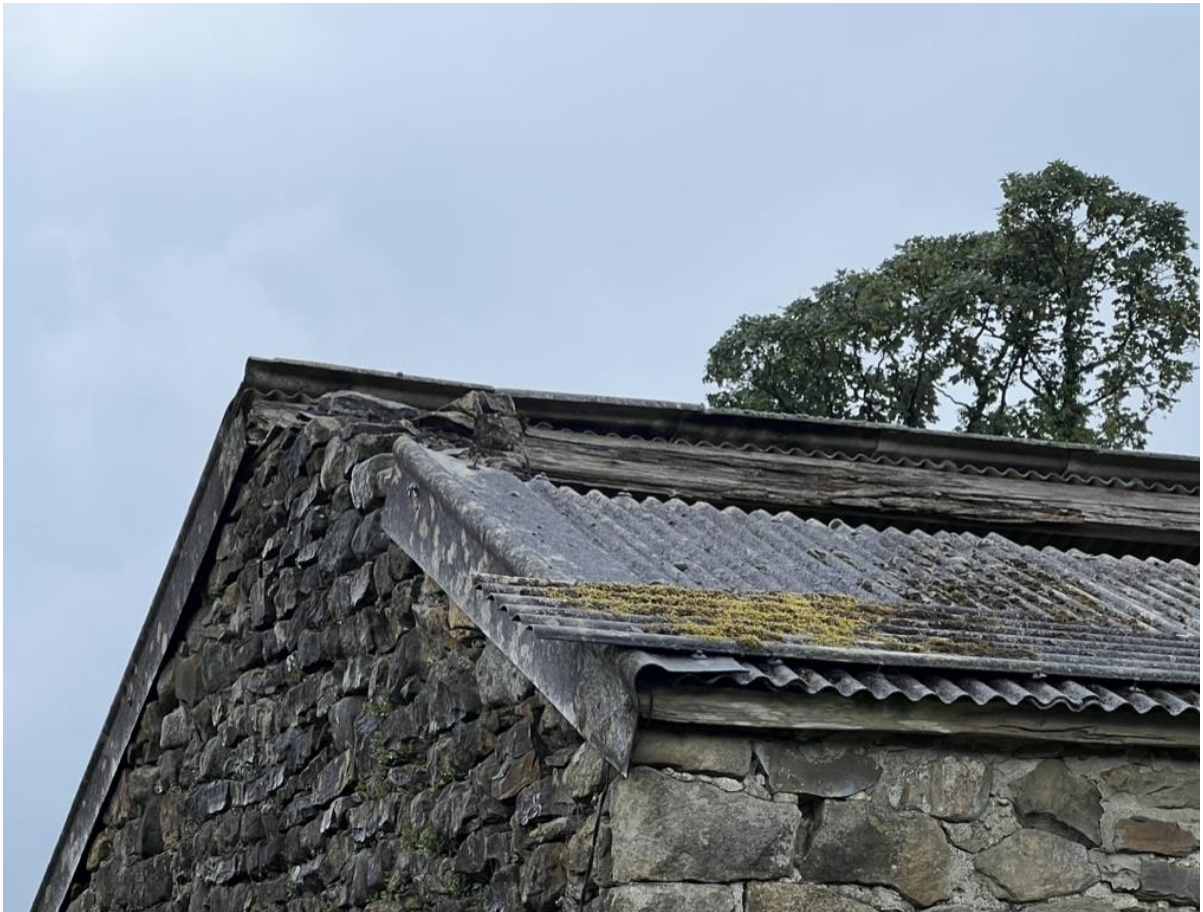
Photo 14 - Roof

External inspection of the roof indicates that there has been a loss of a large amount of the cement/asbestos roof sheets. This has left the timber purlins exposed. The barn would require a full re-roof.

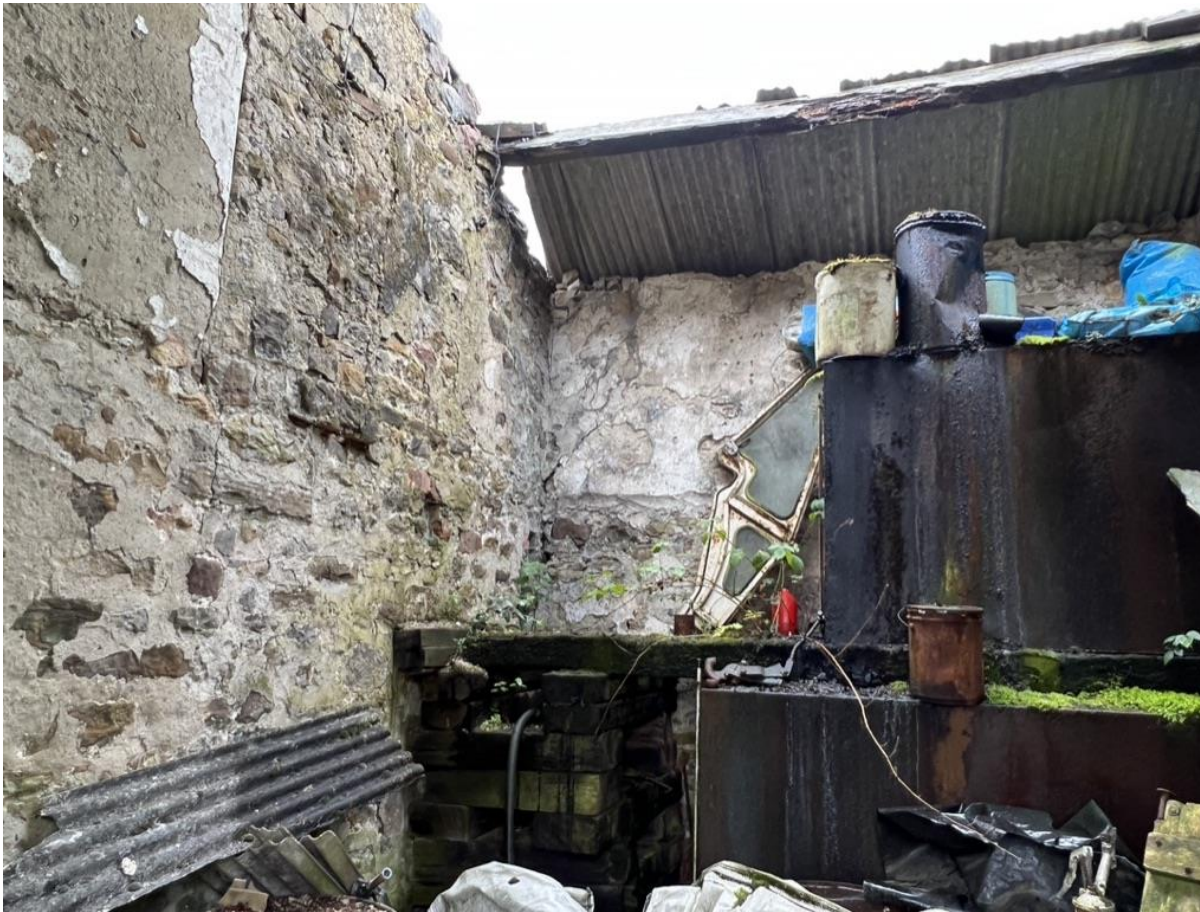
Photo 16 – Internal looking south east

The main roof to the building is carried by timber purlins spanning between the gables. As noted above the roof sheeting has been damaged leaving the timbers exposed. There is evidence of rot and failure to the purlins (photo 16).

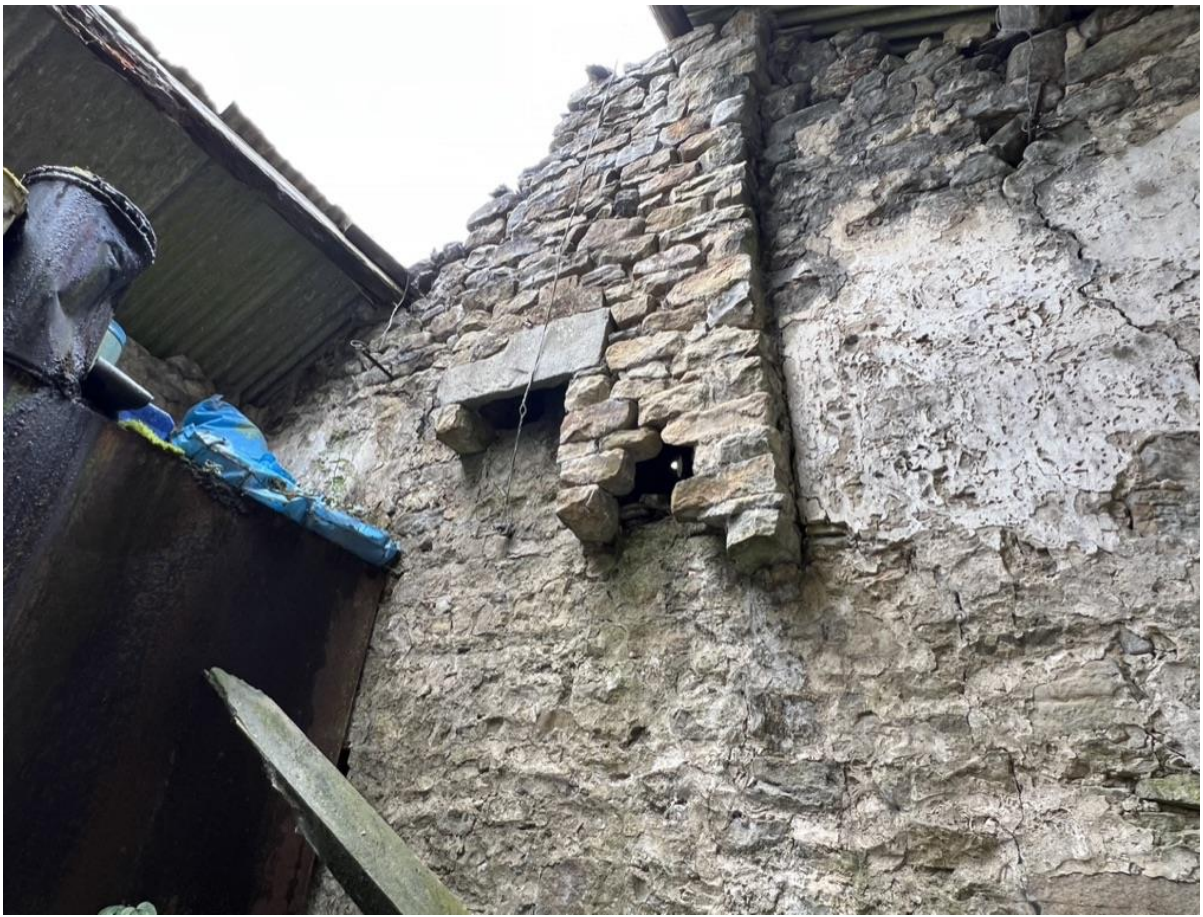
Photo 17 – Internal towards west elevation

Internally, the walls generally reflect the external findings. The west elevation appears to have had an internal flue for fireplaces at two levels. Photo 7 indicates this with the flue and upper fireplace still partially in place. There is evidence of movement to the inner skin of the west gable under the purlin bearing point (photos 17 & 19).

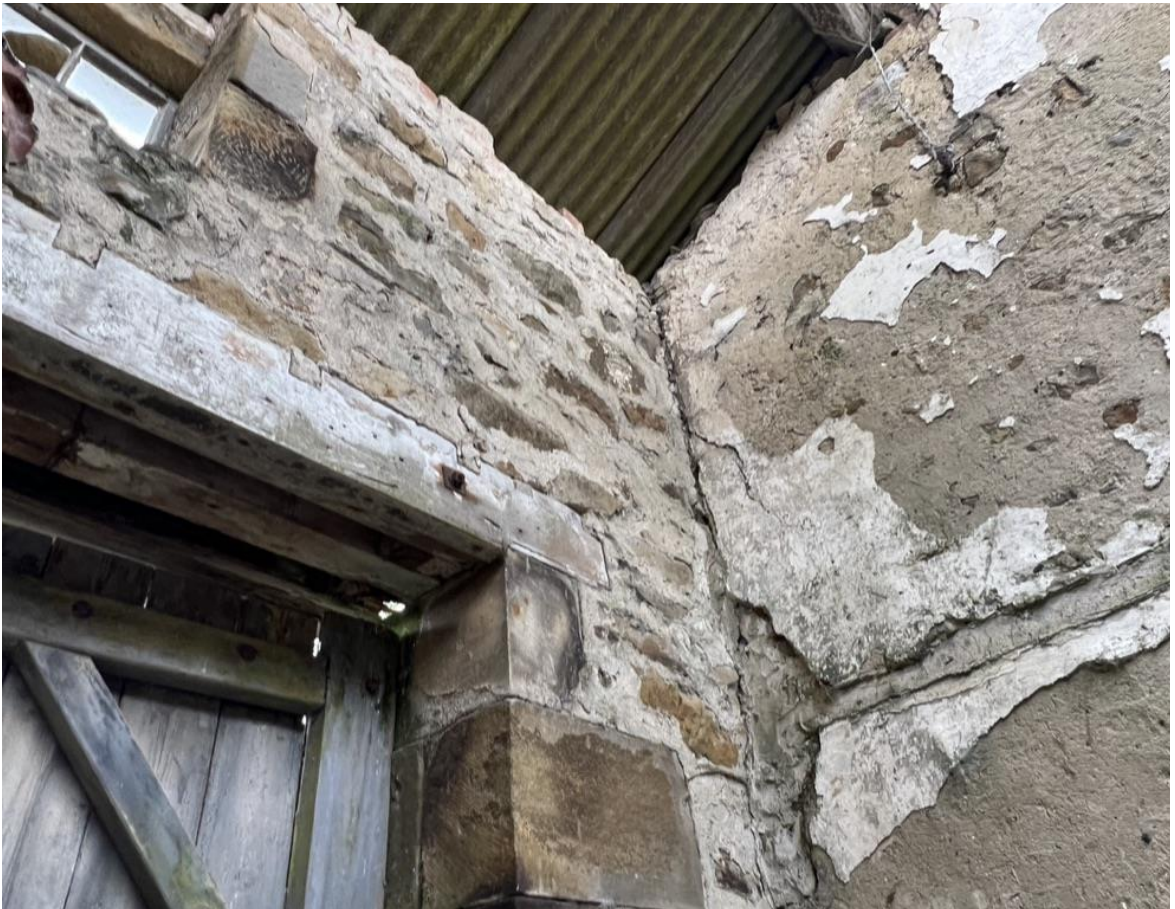
Photo 20 – Internal – north elevation

The two inner timber lintels to the main door are in better condition than the external lintel but are showing signs of rot (photo 20). There is only an external lintel to the window above (photo 21).
