**Paul Snape Consulting**

**Tilecroft Barn, Old Clay Lane, Thornley  
with Wheatley, PR3 2NB – Agricultural  
Building**

Structural Condition Survey for Assessing  
Conversion to a Residential Property

PSC-615-001 Rev A  
May 2022

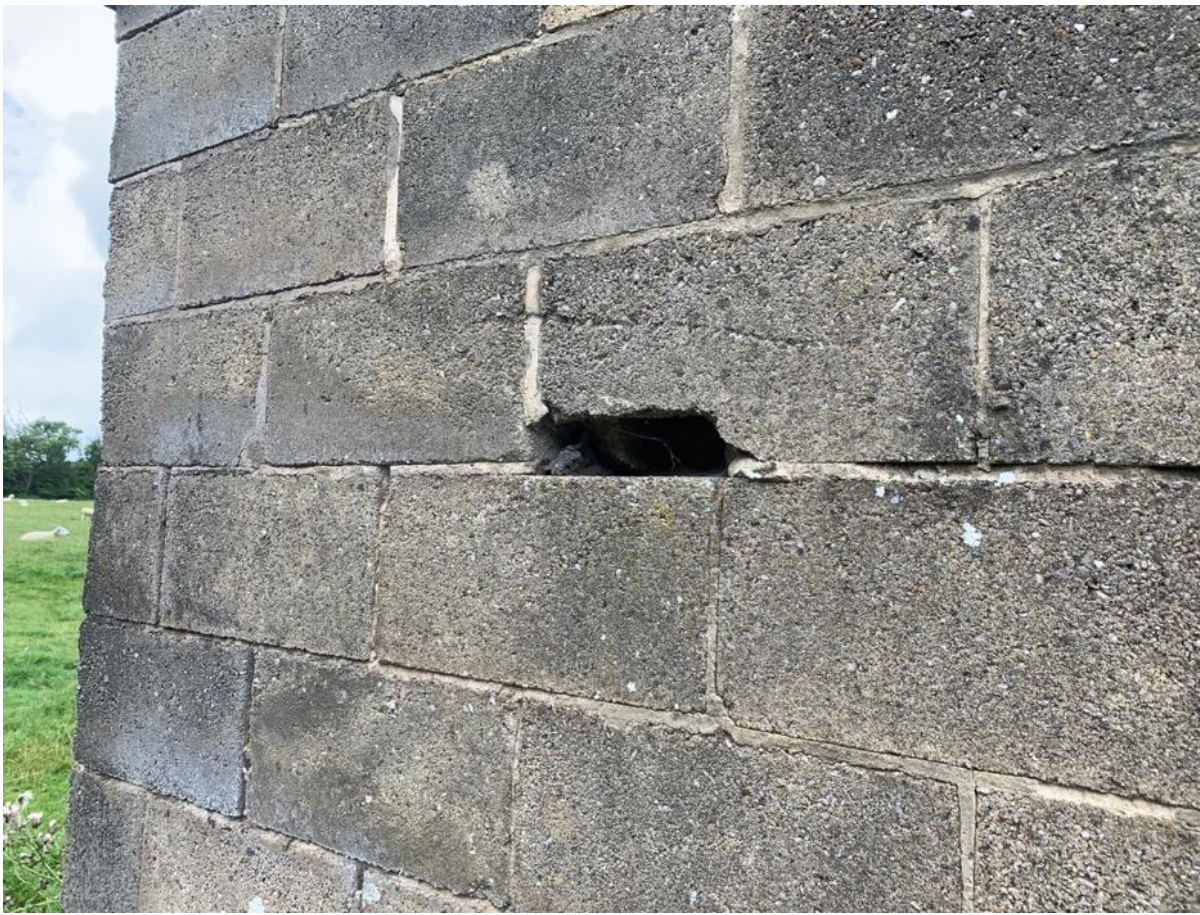
The gable end of the building has a large steel sliding door forming the access to the building. The wall is formed from 220mm thick concrete blocks and this is in reasonable condition with limited damage to the blockwork (photo 3). The wall has a DPC approximately 300mm above ground level. This appears to be a coarse bituminous DPC (photos 3 & 5). The wall is reasonably plumb with no obvious signs of movement. There is no guttering or downspouts to this elevation.

Photo 3 – South Elevation damage

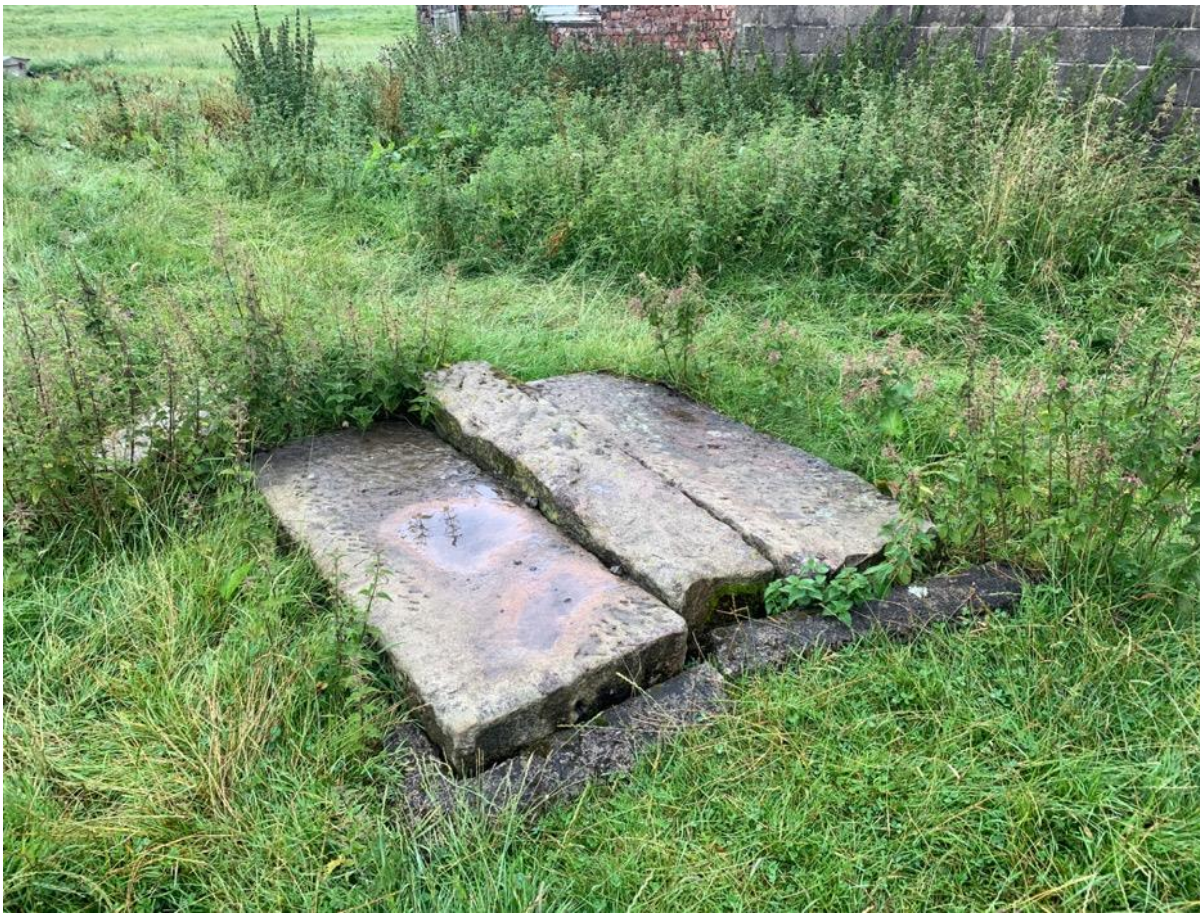
This elevation is constructed with 220mm thick blockwork with internal piers. It has 6 window openings and benefits from guttering and downspouts draining direct to the ground. The blockwork is plumb and in reasonable condition. The DPC noted above is also present in this elevation. The lintels above the windows are RC lintels which have signs of damage (photos 9, 11 & 13). The window frames are wooden and in poor condition cosmetically but without extensive signs of rot or infestation. Photographs 7 & 10 indicate the presence of a possible manhole or slurry tank adjacent to this elevation.

Photo 9 – Tank or manhole adjacent to west elevation

The existing building has a basic drainage system, comprising gutters and downspouts draining direct to ground. Any new system will need to be positively drained to soakaways or to a watercourse. The property will also require a sewage treatment plant if foul sewers are not available at this location. The manhole/tank noted adjacent to the west elevation will need further investigation work and removal/infilling.

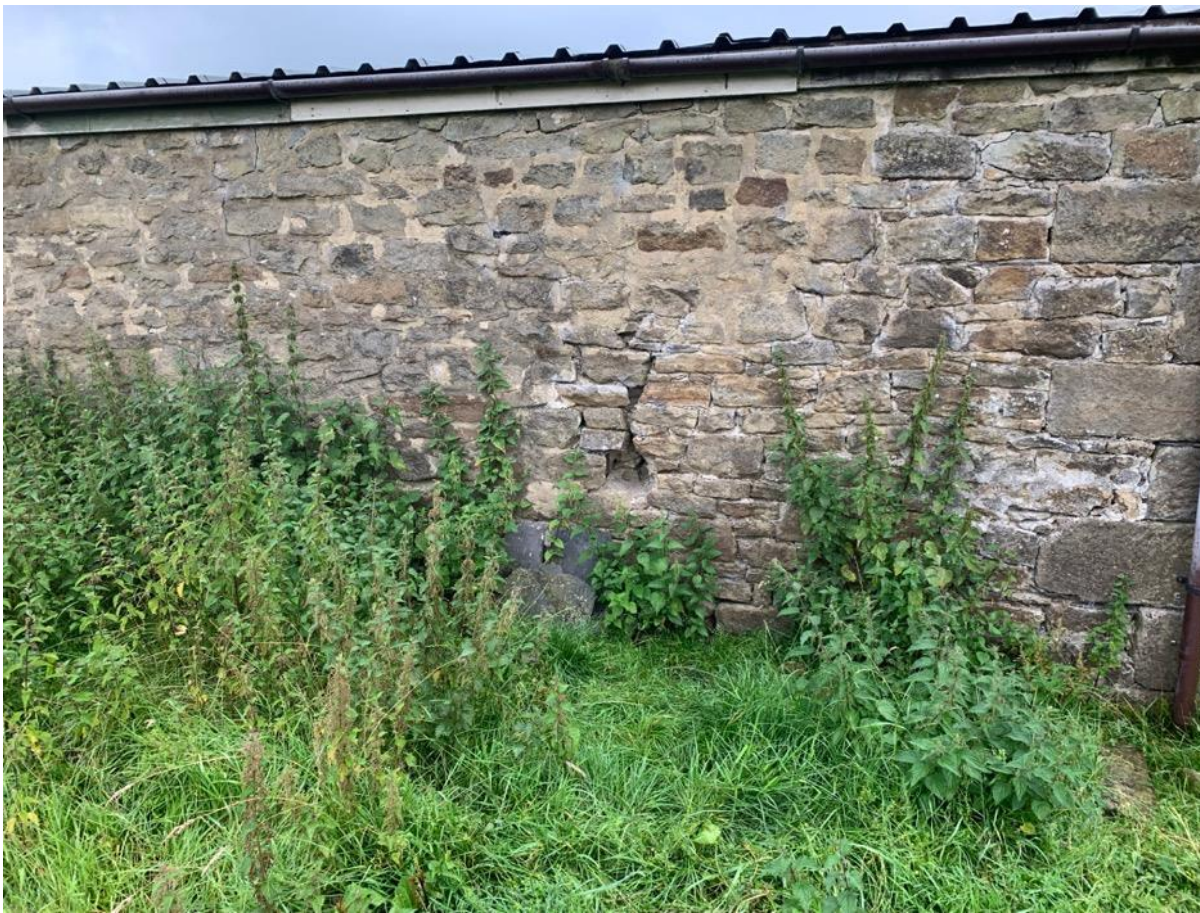
This elevation is in two parts, comprising the original stone section and the extended section in blockwork as indicated in photo 18. The stonework section is approximately 450mm thick and built with random sandstone. The wall is generally in a reasonable condition but there is some localised damage as indicated in photo 21. The stone wall is reasonably plumb with no sign of structural movement. The extended section to the east is built with 220 mm thick blockwork with a central internal pier and was probably constructed at the same time as the section of new building to the south. As with that building, there is a DPC in the blockwork but this is nearer to ground level at this location. In addition, there is a damp proof membrane present (photos 20, 22 & 23). It is not clear whether this is to the floor slab internally or part of a french drain system to this elevation. It is likely that it is part of a french drain system rather than a DPM under the internal slab.

Photo 21 – North Elevation – damage to stone

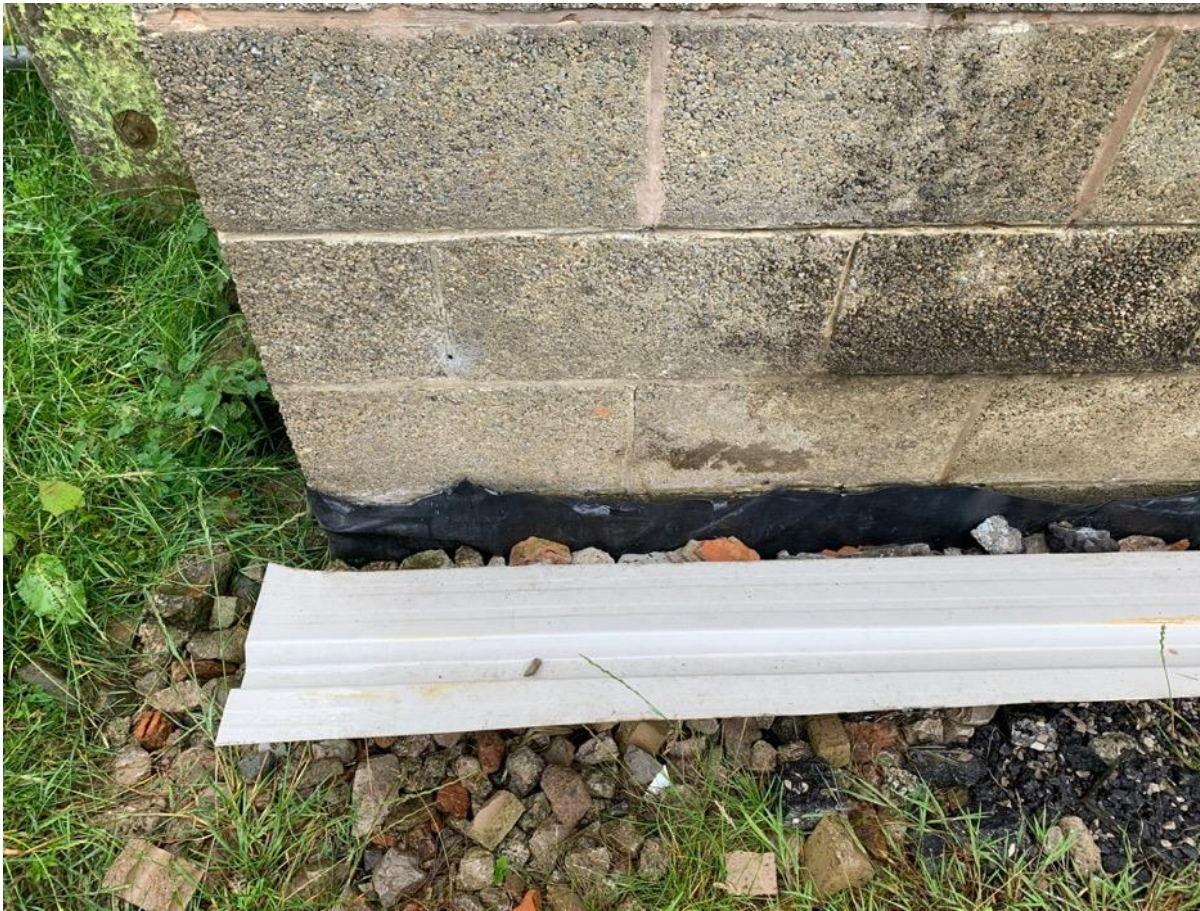
Photo 22 – North Elevation blockwork – DPC membrane

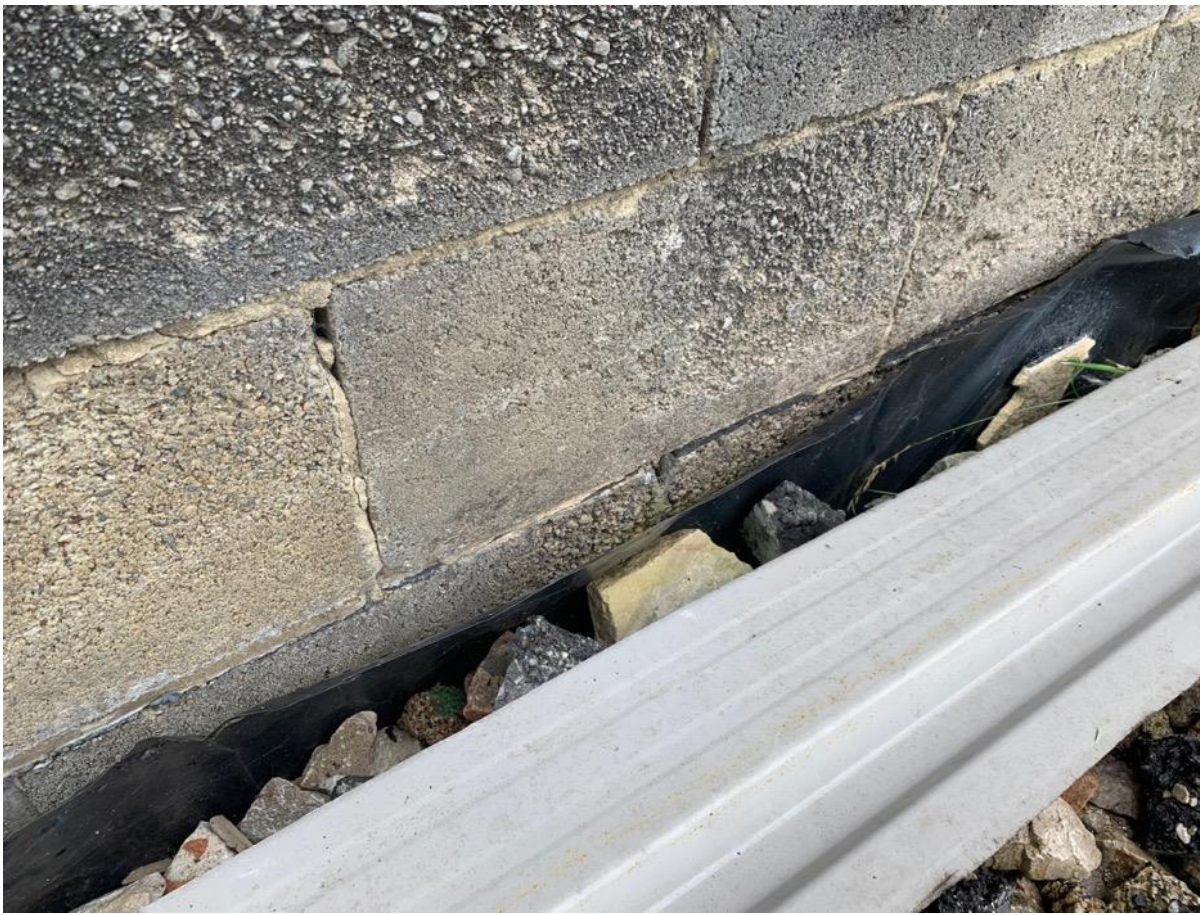
Photo 23 - North Elevation blockwork – DPC membrane

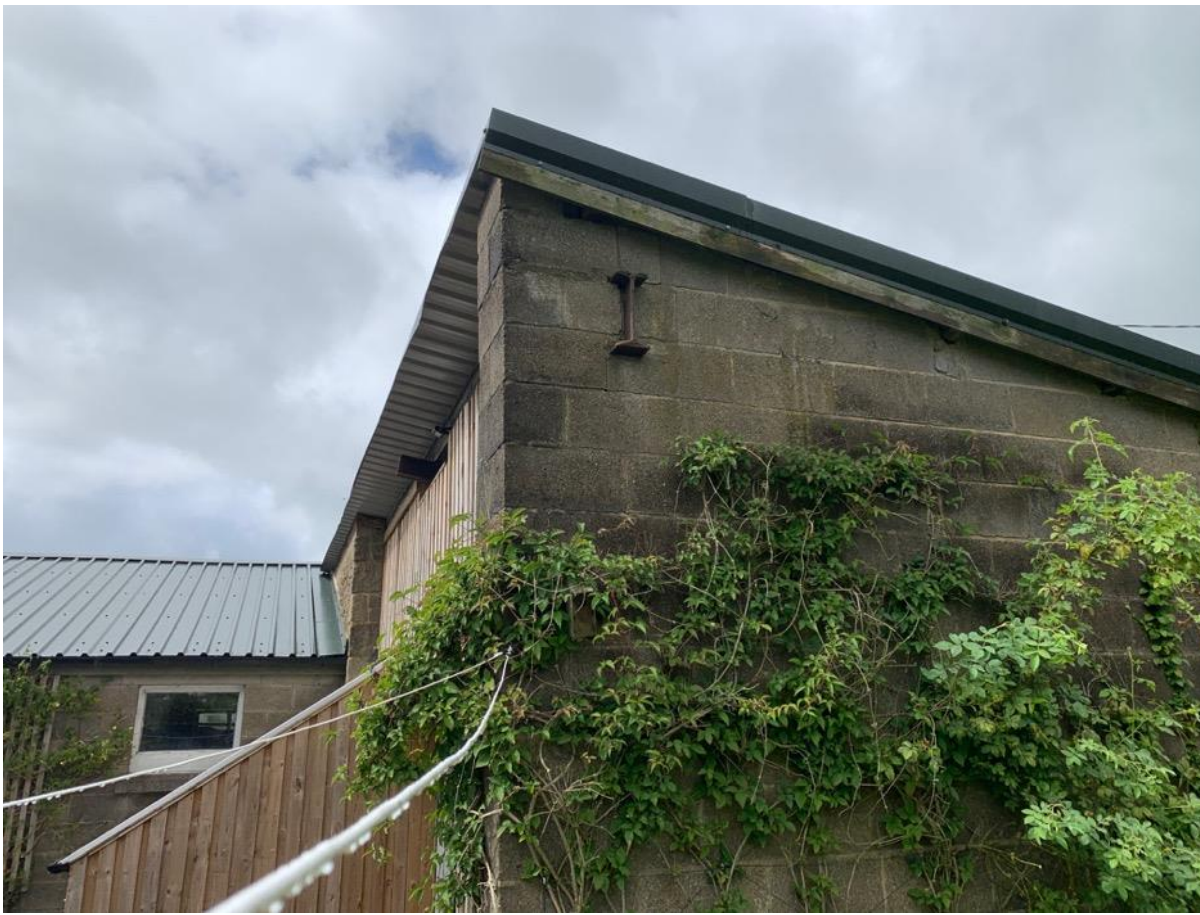
This elevation is constructed in 220mm thick concrete blockwork forming the gable to the extension of the original mono-pitched building. The wall has a central internal pier. The blockwork is reasonably plumb and well pointed. Areas of the elevation are covered in vegetation (photos 30 and 31). Photo 31 shows a roof beam penetrating this elevation and photos 28 & 30 indicate a chimney flue on this elevation. Photos 32 and 33 indicate structural movement in the plane of the elevation which may be ongoing. This movement is indicated internally and discussed below.

Photo 31 - East elevation of mono-pitch extension to original building indicating sheeting and penetrating I Beam

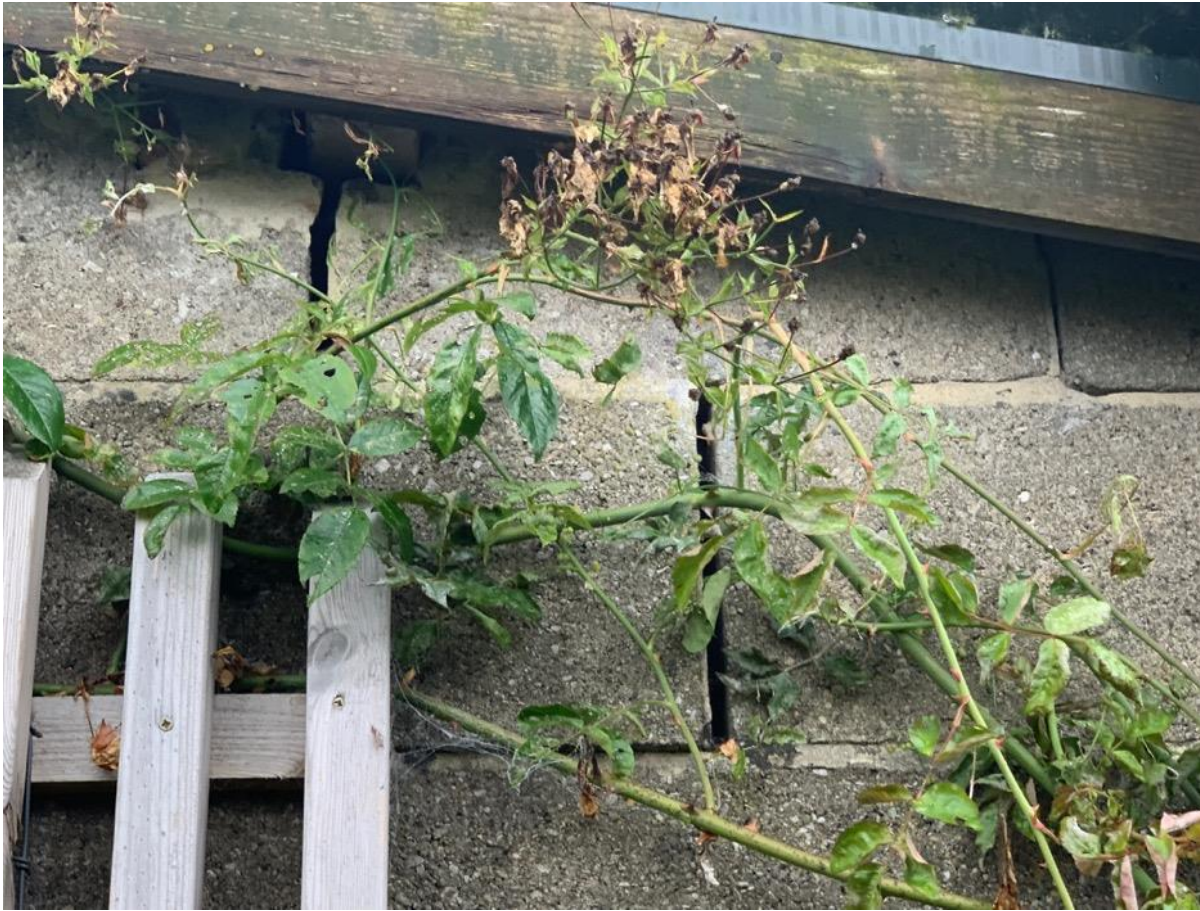
Photo 32 – East Elevation blockwork movement to extension to original building

It can be seen from the survey detailed above that this building is in reasonable condition in terms of structure, with limited movement and/or damage to the walls. Further investigation of the movement to the east elevation of the extended section of the original building will be required to ensure movement is not ongoing. Remedial works may be necessary to the foundation and or bonding/ties to the pier at this location. The roof structure and roofing sheets are in a reasonable or good condition.

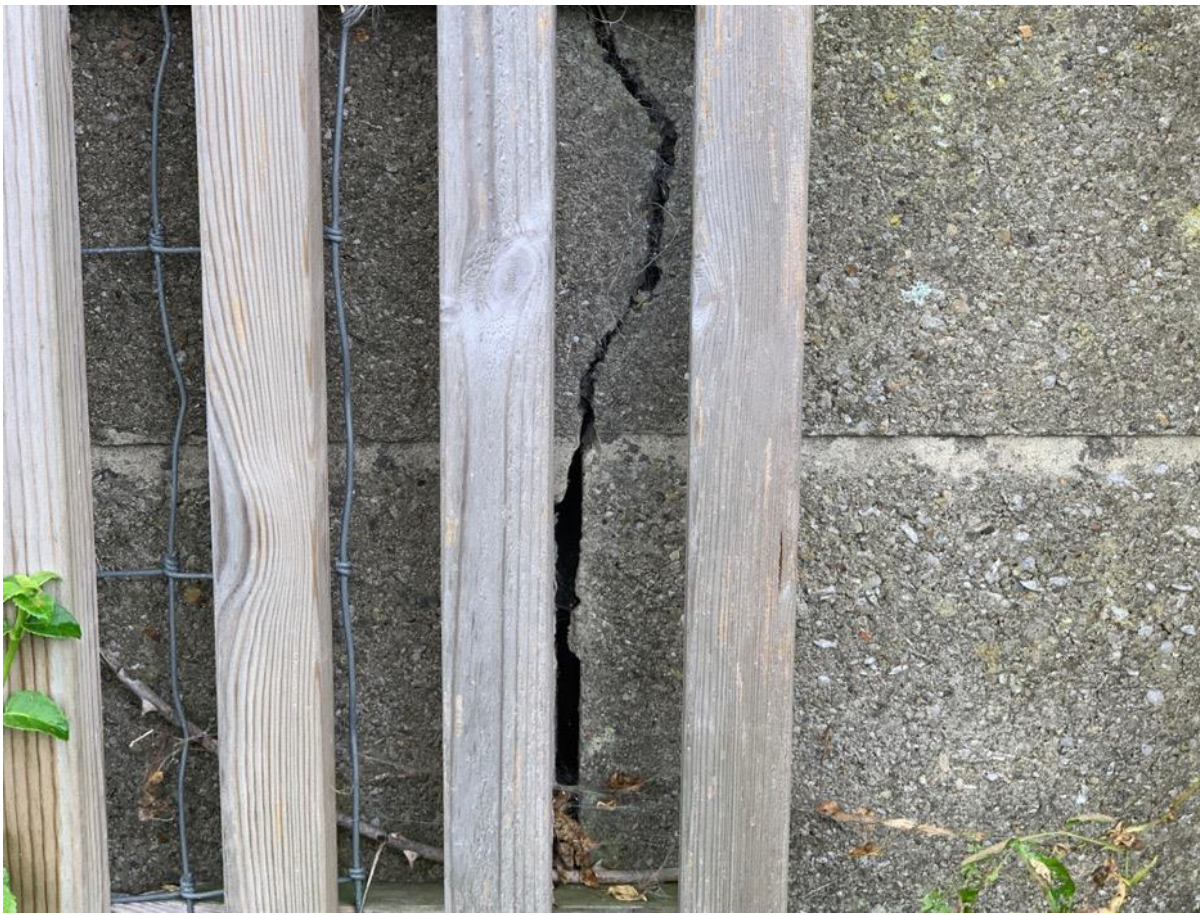
Photo 33 - East Elevation blockwork movement to extension to original building

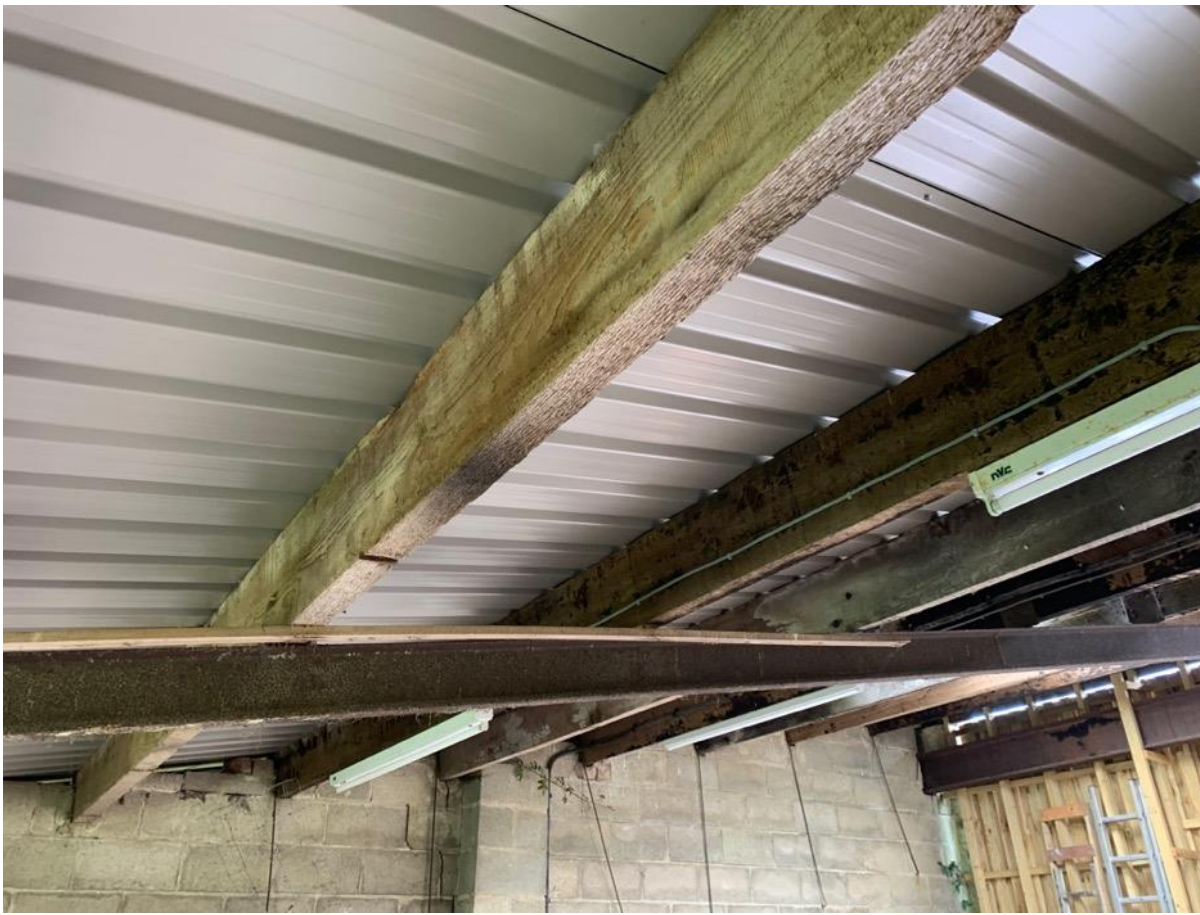
Internal inspection of this area confirmed the structural movement is the plane of the wall adjacent to the central pier on the east elevation (photos 58, 60 & 62). The movement appears to be to the north half of the wall which has rotated away from the pier. This may be due to inadequate bonding or brick ties at this location. The movement may be ongoing. Otherwise, the blockwork is well pointed and reasonably plumb in the vertical plane. The floor is of a concrete construction and in reasonable condition (photo 39). The roof is carried by a combination of steelwork and timber purlins. Photo 37 indicate some possible signs of rot to the purlins due to water ingress.

Photo 37 - Internal to extension of original building – timber purlin and block pier

The existing roof structures are in reasonable condition with two distinct areas. The mono-pitch roof has some poor timber sections which will need assessing and probably replacing. Similarly, the steelwork to this section will need to be assessed and possibly modified where it penetrates the gable walls. The newer lightweight trusses to the south will need cleaning and further assessment. All the roof structure will need to be assessed for the proposed loading from the roof and ceiling. Insulation to the roof will also be required and it may be possible to accommodate this within the new ceiling structure thus removing any need for further loading on the steelwork. The steelwork will need cleaning and given a protective coating as necessary. There are numerous windows and doors within the existing structure and there should be no need to introduce many more.

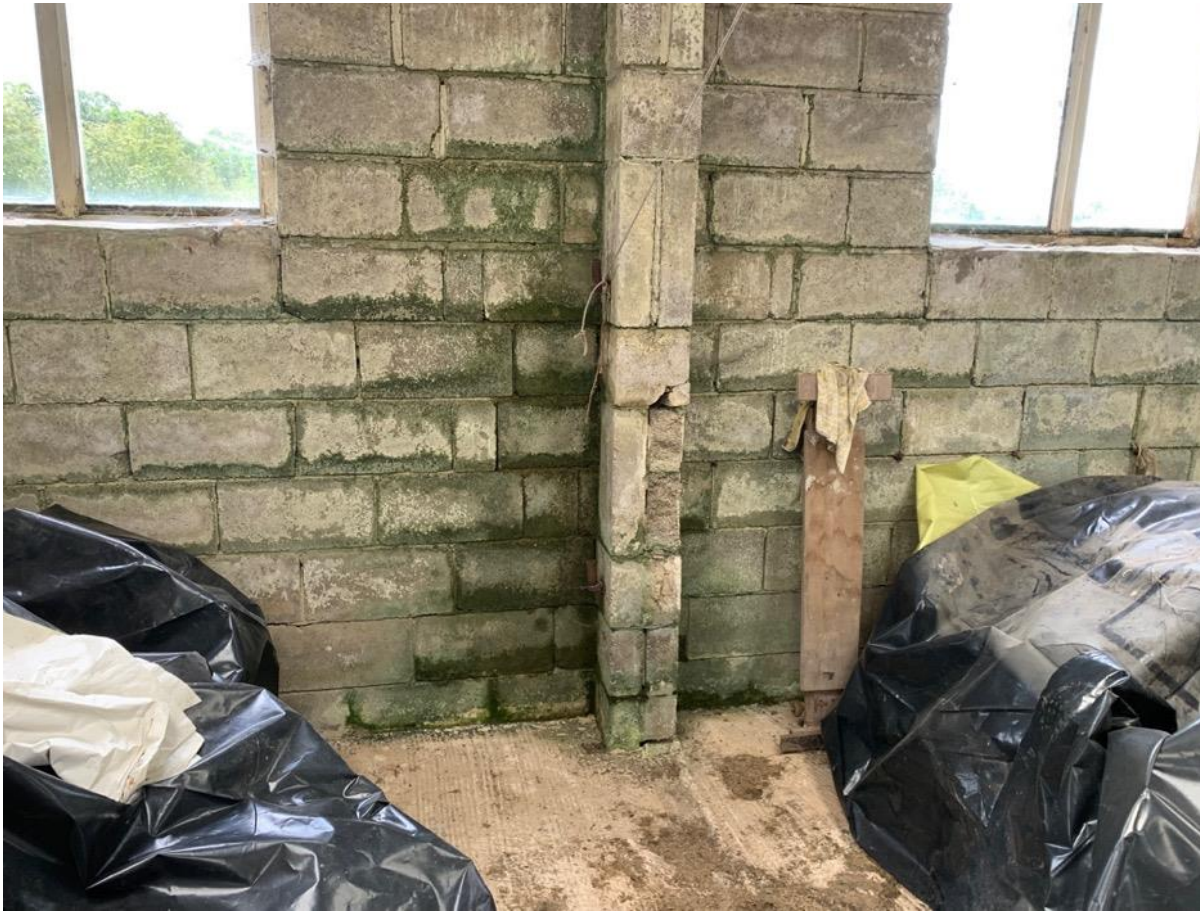
This large area runs south from the original building with the south elevation of that building forming the north gable. The blockwork elevations have equally spaced piers which provide support for the lightweight roof trusses (photo 47) as well as support to the walls. Some of the piers have slight damage at lower levels (photo 46) which may be from removal of former animal stalls. The trusses are noticeably covered in surface rust but appear to be structurally sound. They carry timber purlins which appear to have been replaced at some point, possibly when re-sheeting the roof. The north gable is the original stone/brick wall and photo 49 indicates a stranded first floor fireplace which indicates the original building may have extended south and was two storey. This wall also has evidence of damp at lower levels (photo 51). Similarly, photo 52 indicates damp penetration to the blockwork walls. Photo 61 shows the concrete floor slab which is in good condition. There is some vegetation growing internally on the blockwork as evidenced in photos 59 and 61.

Photo 52 - Internal to newer blockwork building – damp penetration and damage to pier

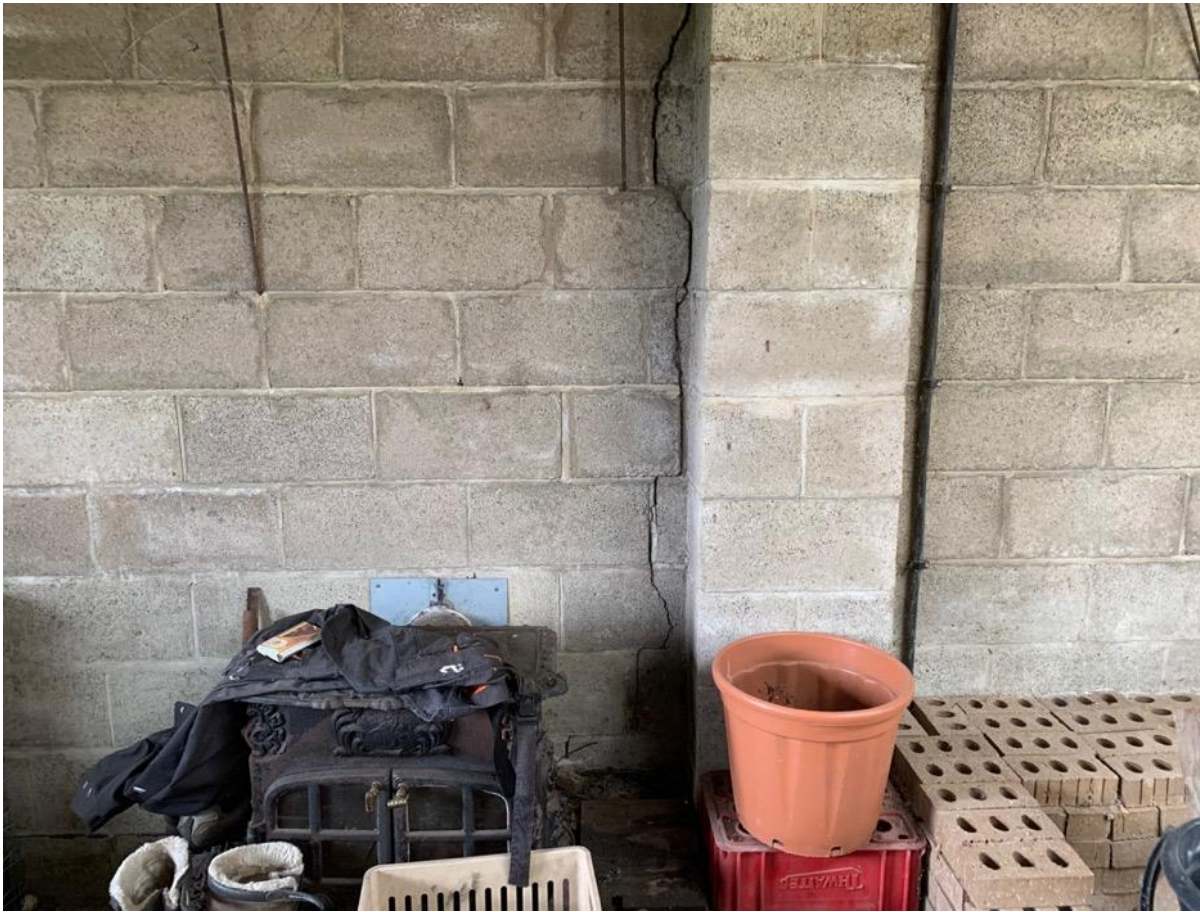
Photo 58 - Internal to original building extension – movement adjacent to pier

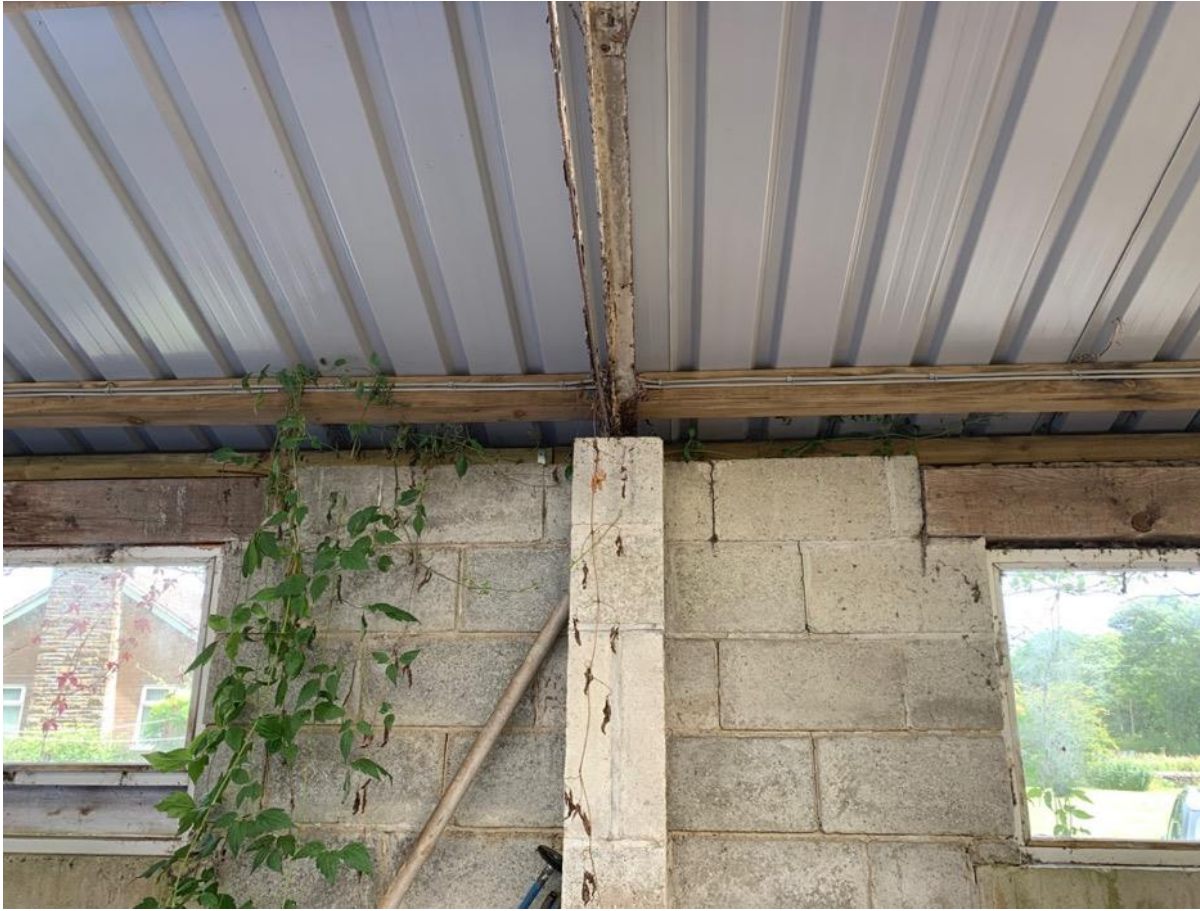
Photo 59 - Internal to newer blockwork building - vegetation

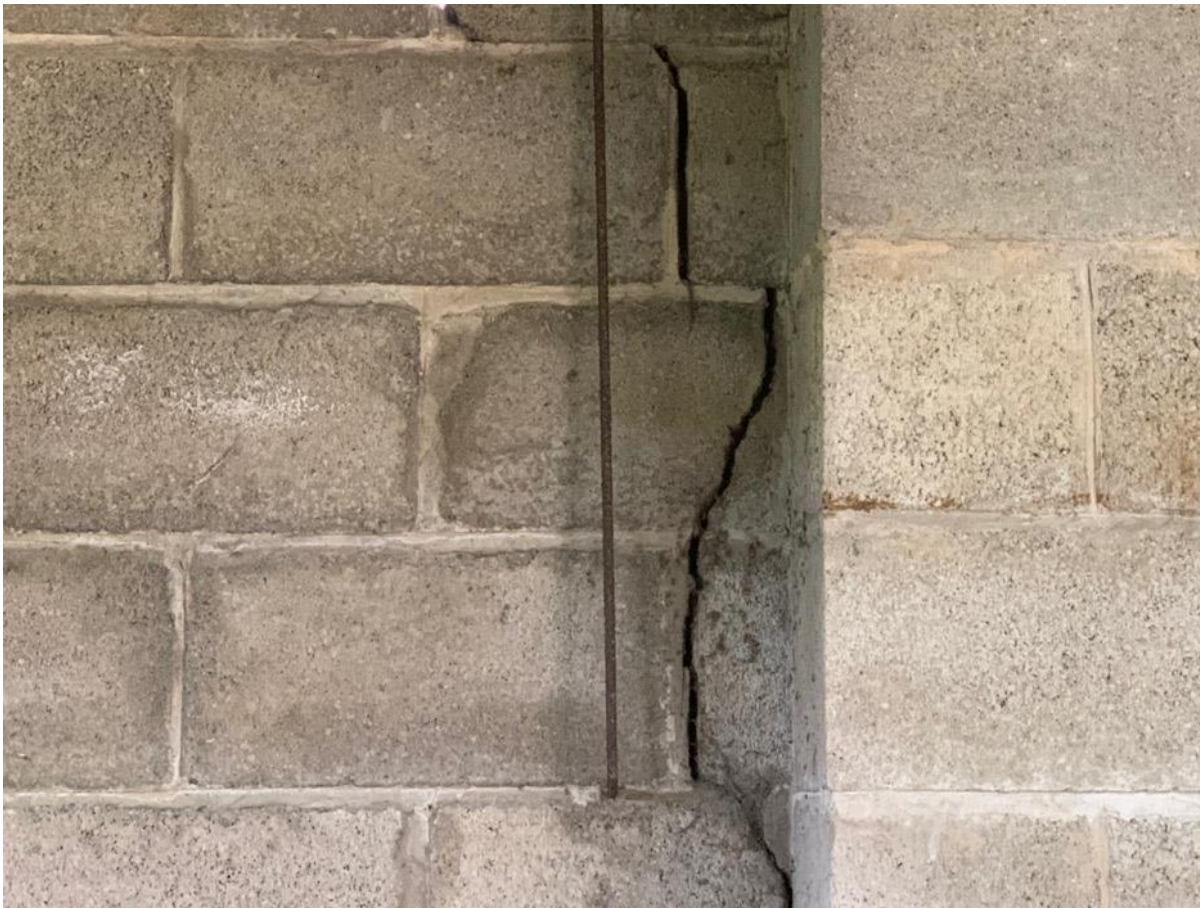
Photo 60 - Internal to original building extension – movement adjacent to pier

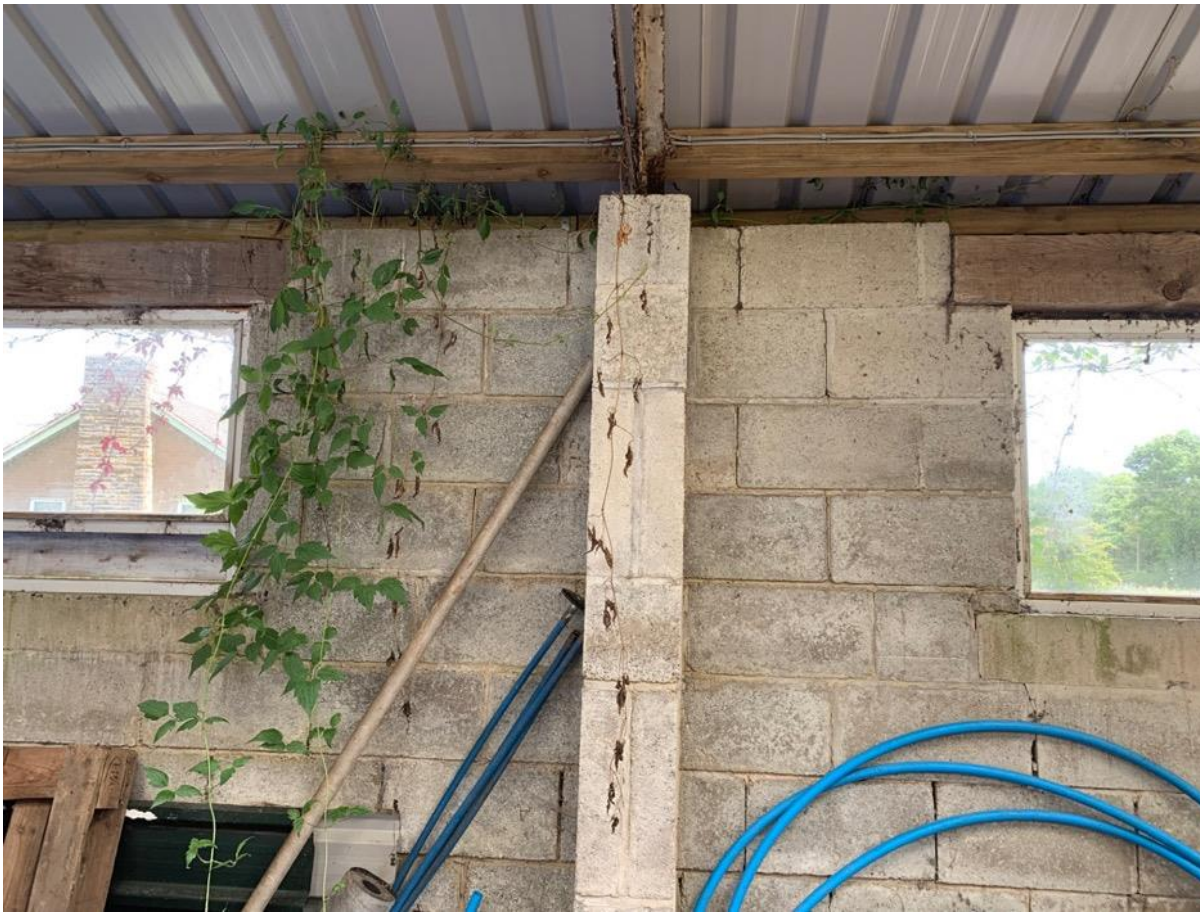
Photo 61 - Internal to newer blockwork building - vegetation

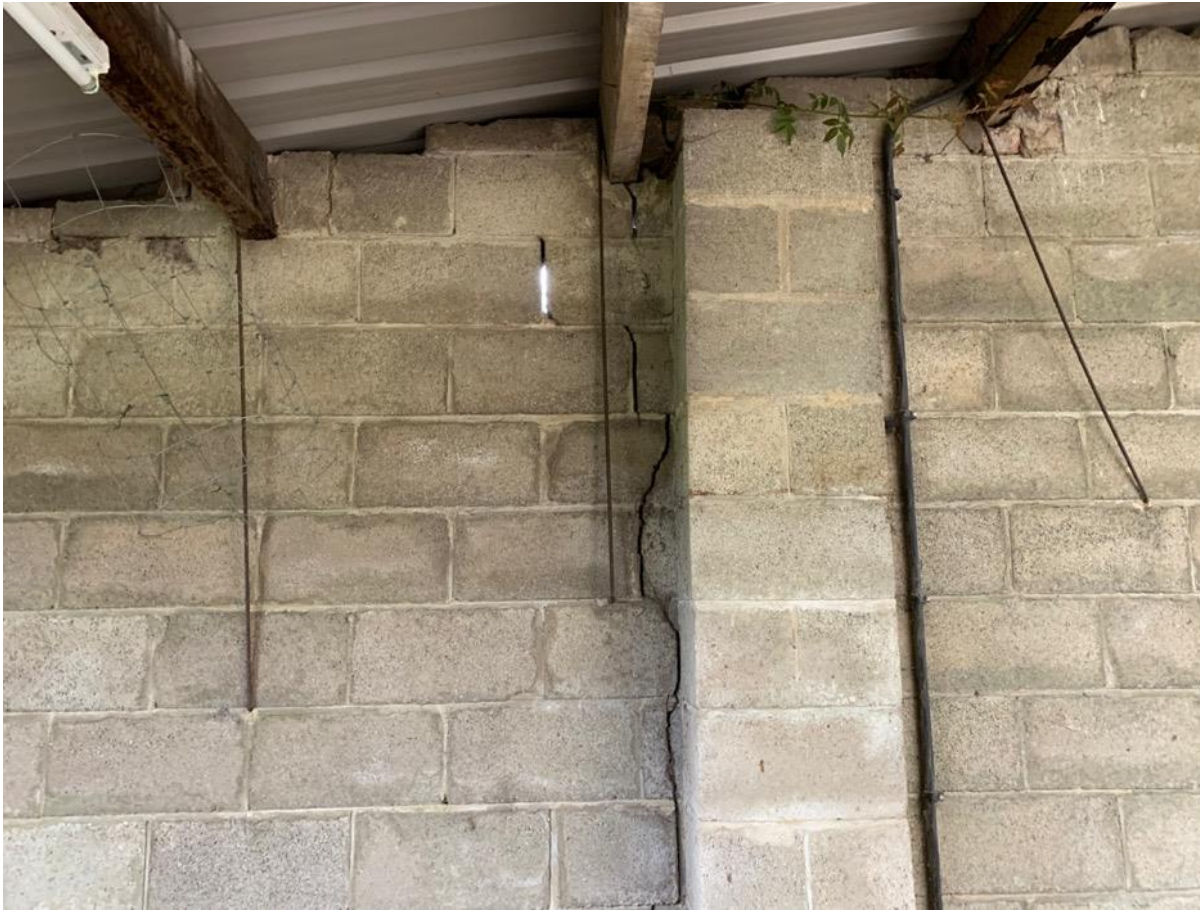
Photo 62 - Internal to original building extension – movement adjacent to pier
