THE ARCHAEOLOGY CO.

Barn at 5 Talbot Street, Chipping

Historic Building Survey

October 2023

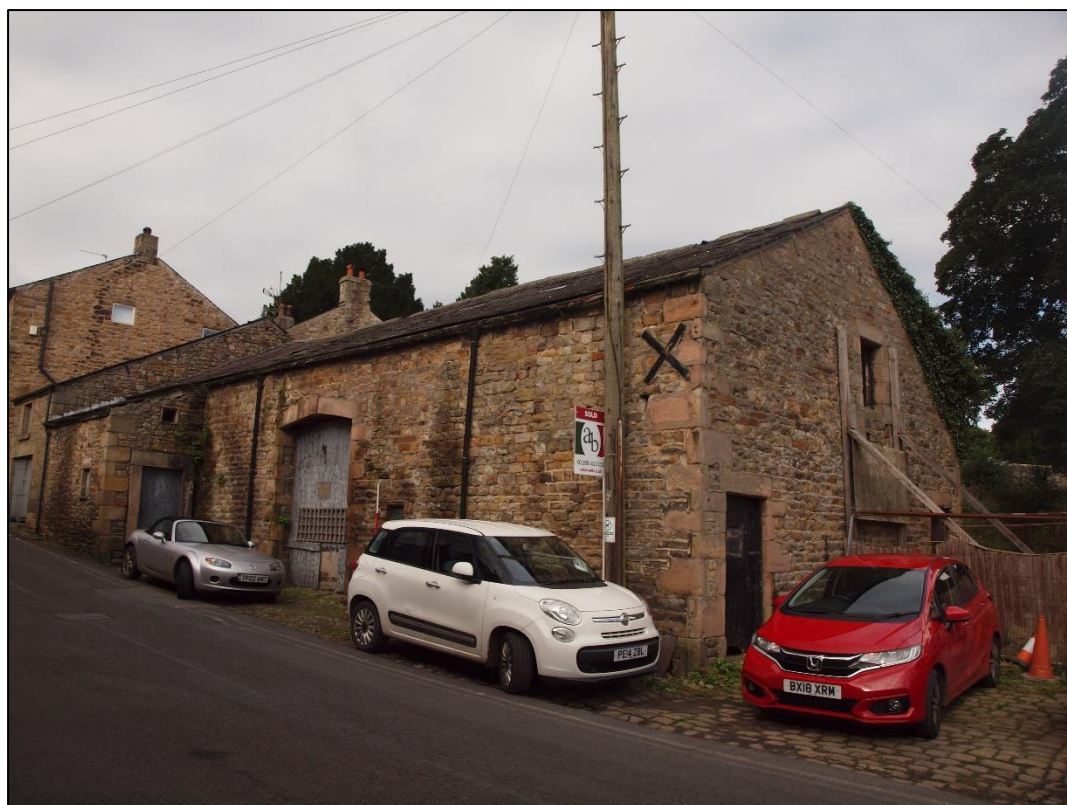
Plate 1: General shot of south elevation from Talbot Street

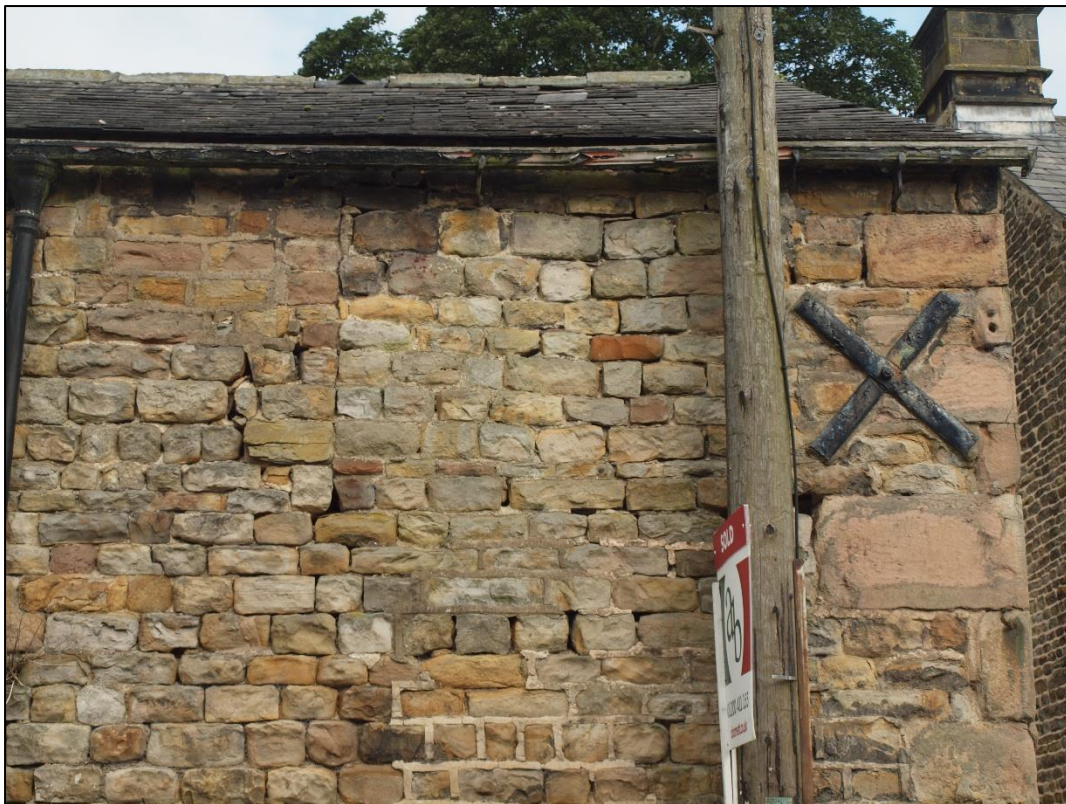
Plate 14: Blocked window at first floor level

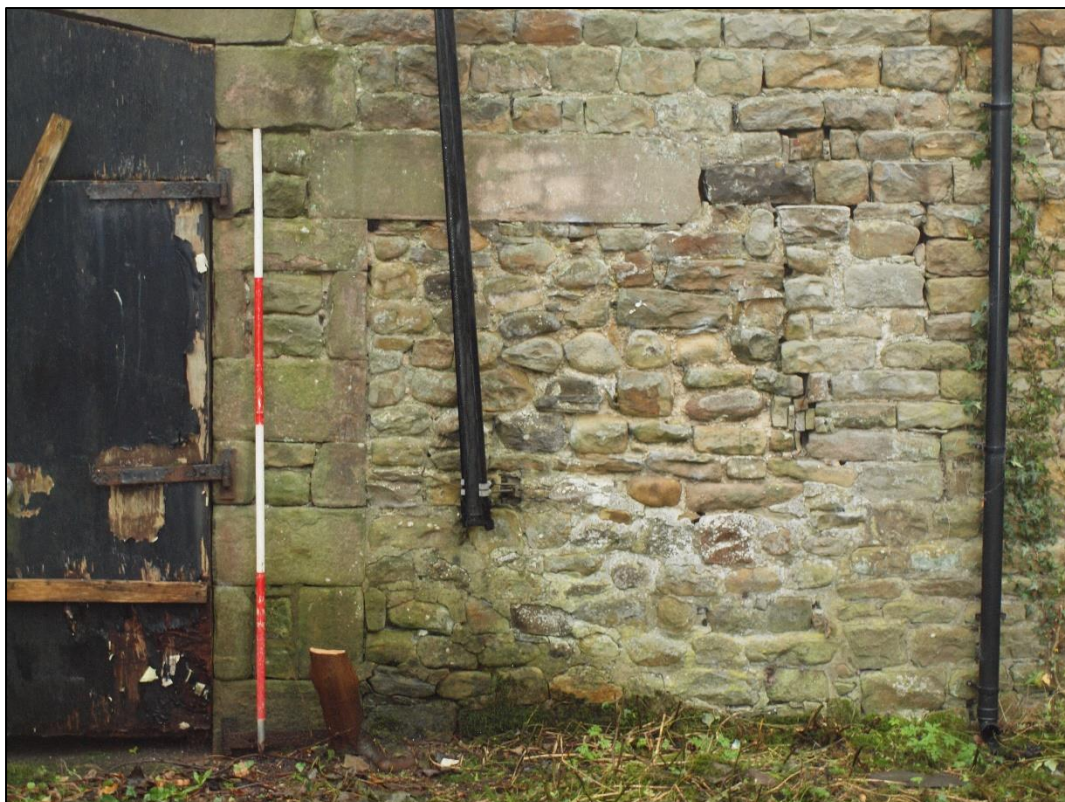
Plate 26: Detail of blocked doorway

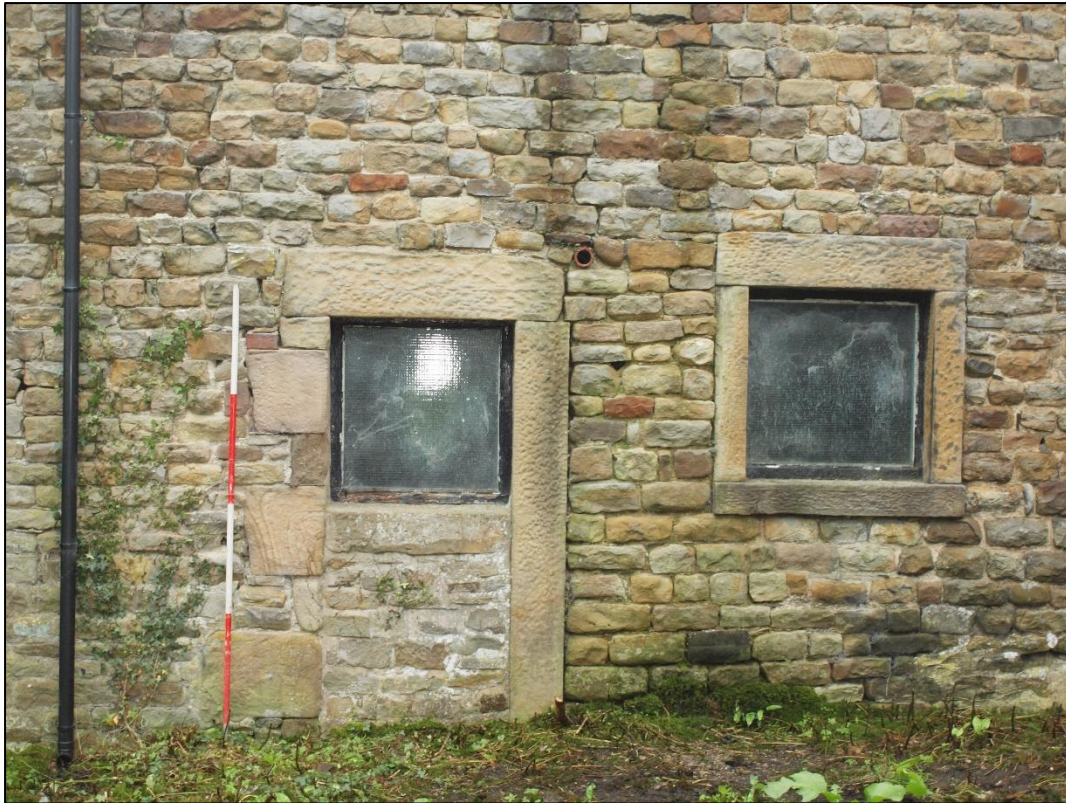
Plate 29: Doorway converted to window and window to the west

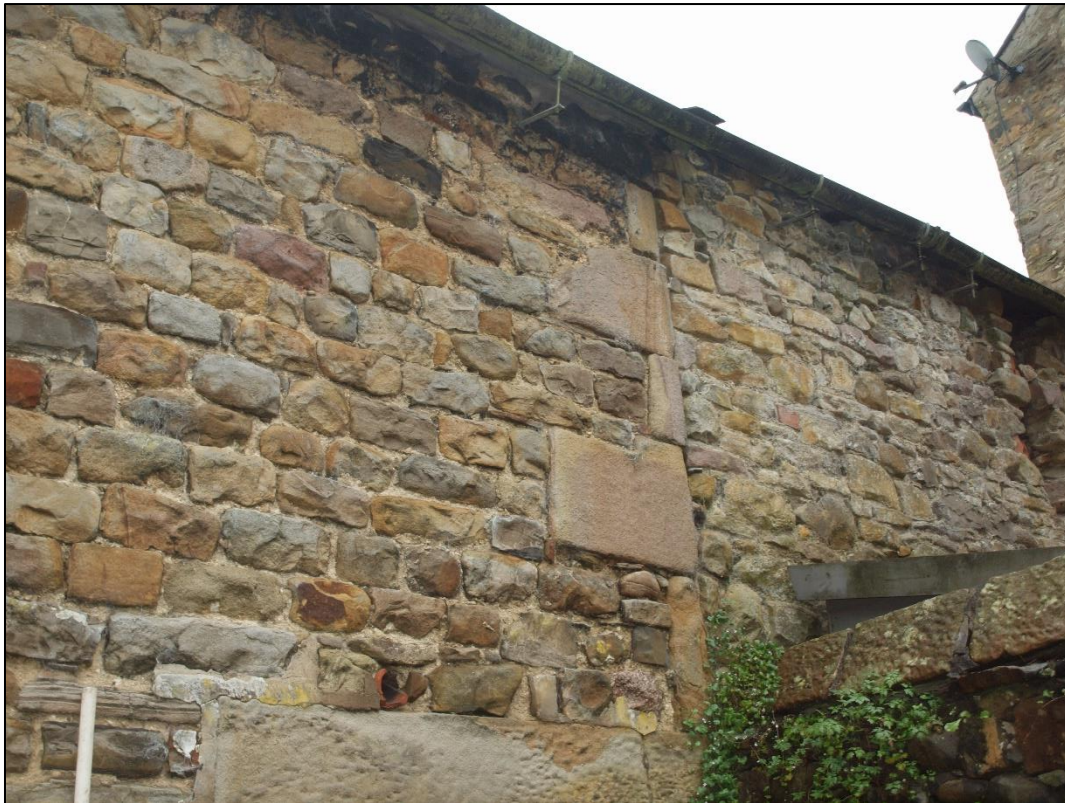
Plate 31: Straight joint with quoins marking end of original barn

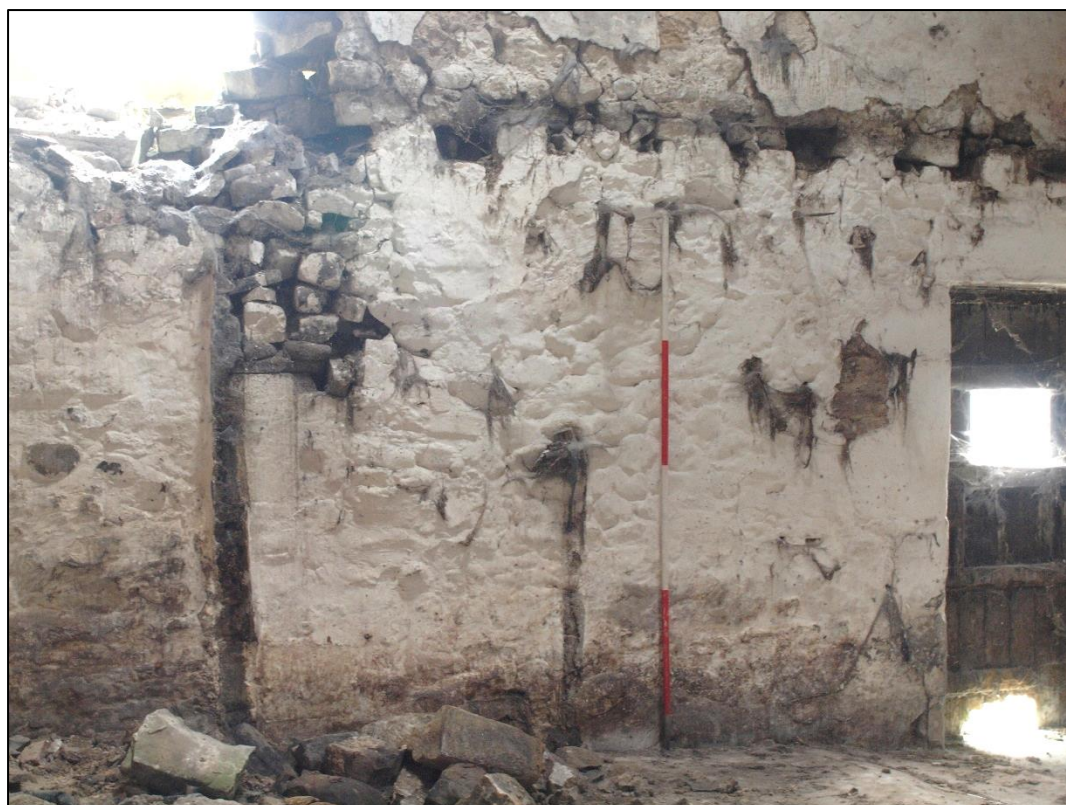
Plate 45: Scars of removed stalls in gable

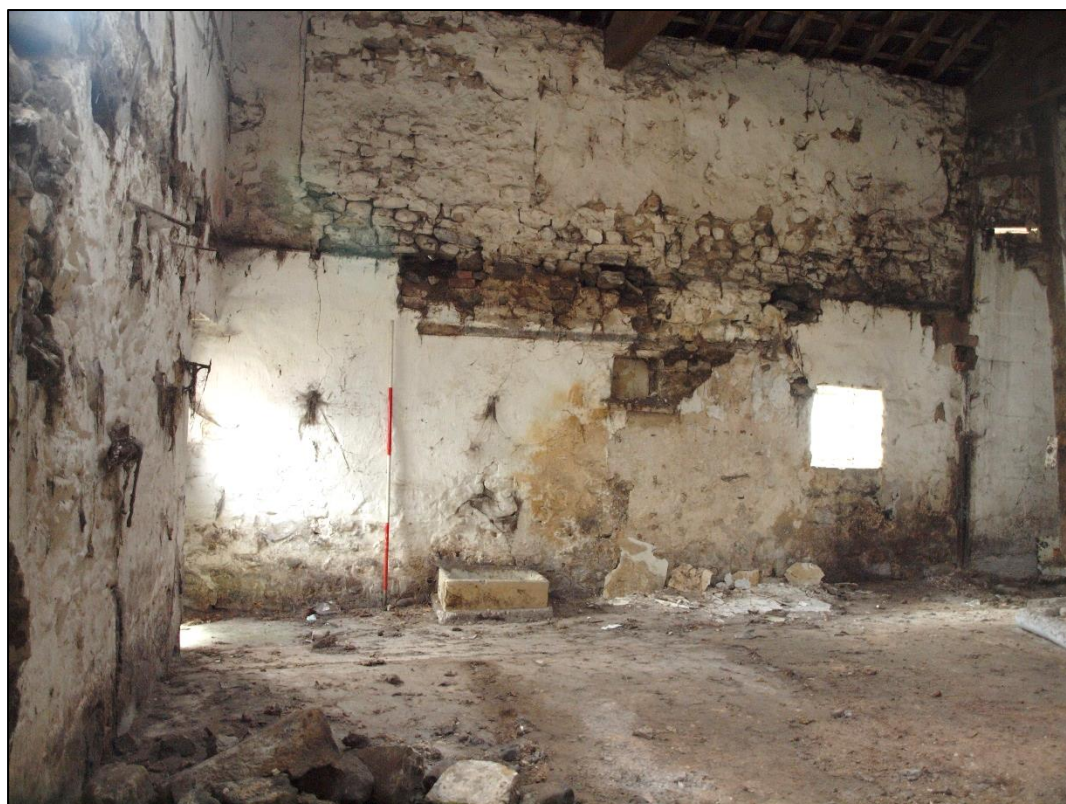
Plate 46: Eastern end of south wall showing blocked first floor window and ground floor niche

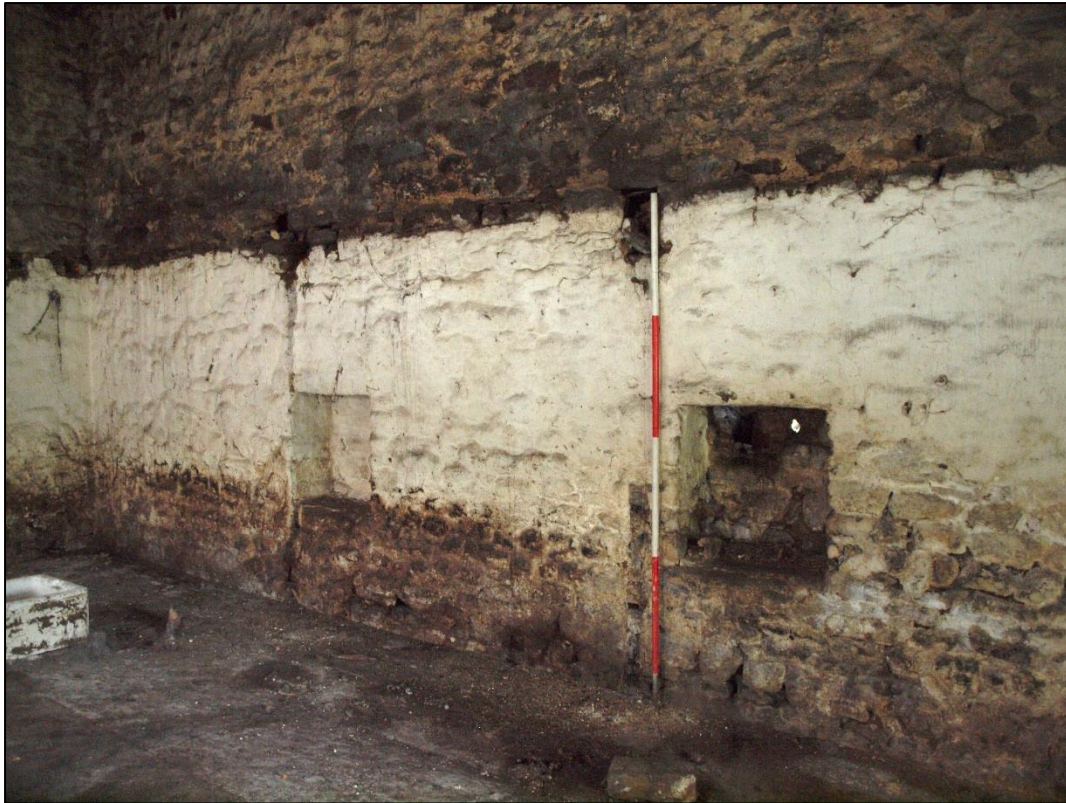
Plate 57: Blocked feeding holes in west wall

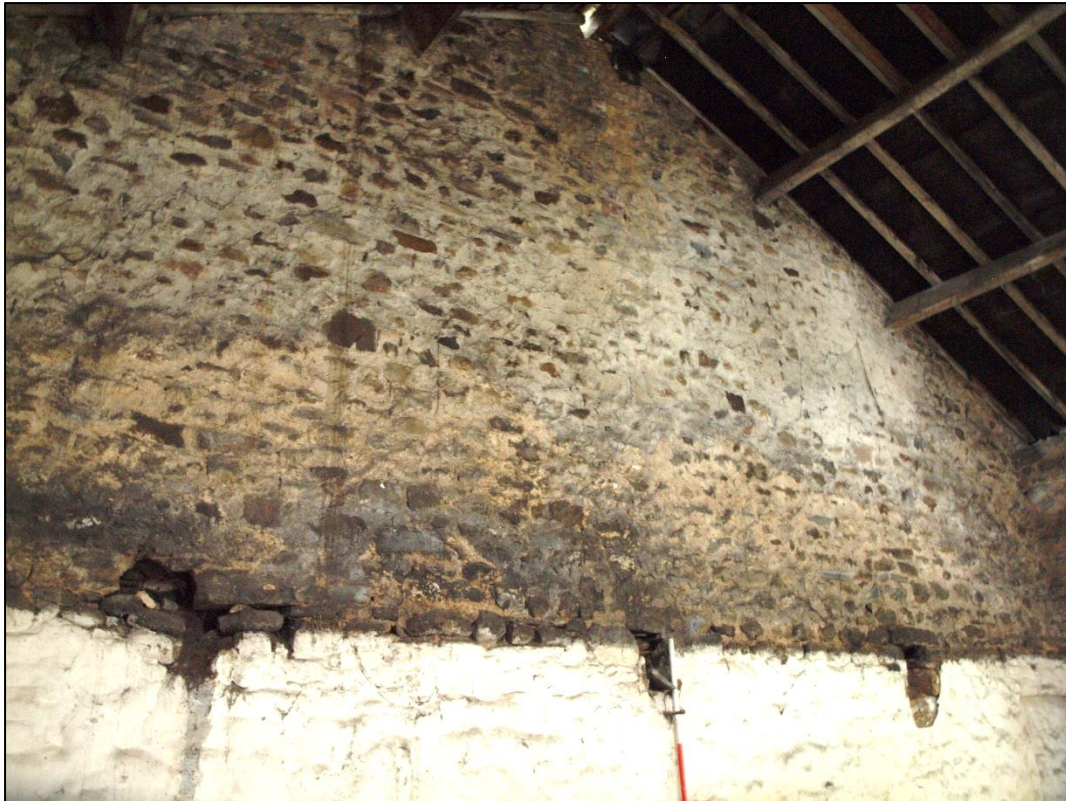
Plate 59: Detail of removed first floor joist holes and first floor of gable

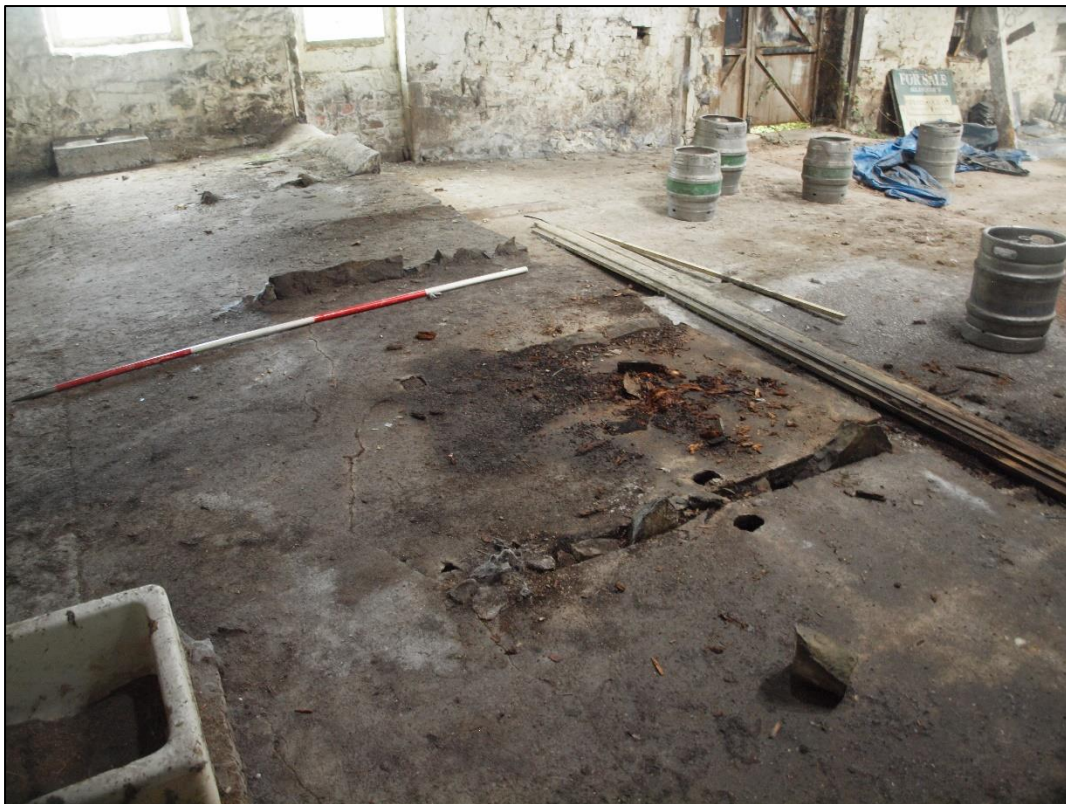
- 8.2 The building was stripped out internally around 2011, removing all interior details. Those that remain suggest the barn had been altered, with concrete floors and boskins installed.

Plate 60: Scars or removed boskins in concrete floor

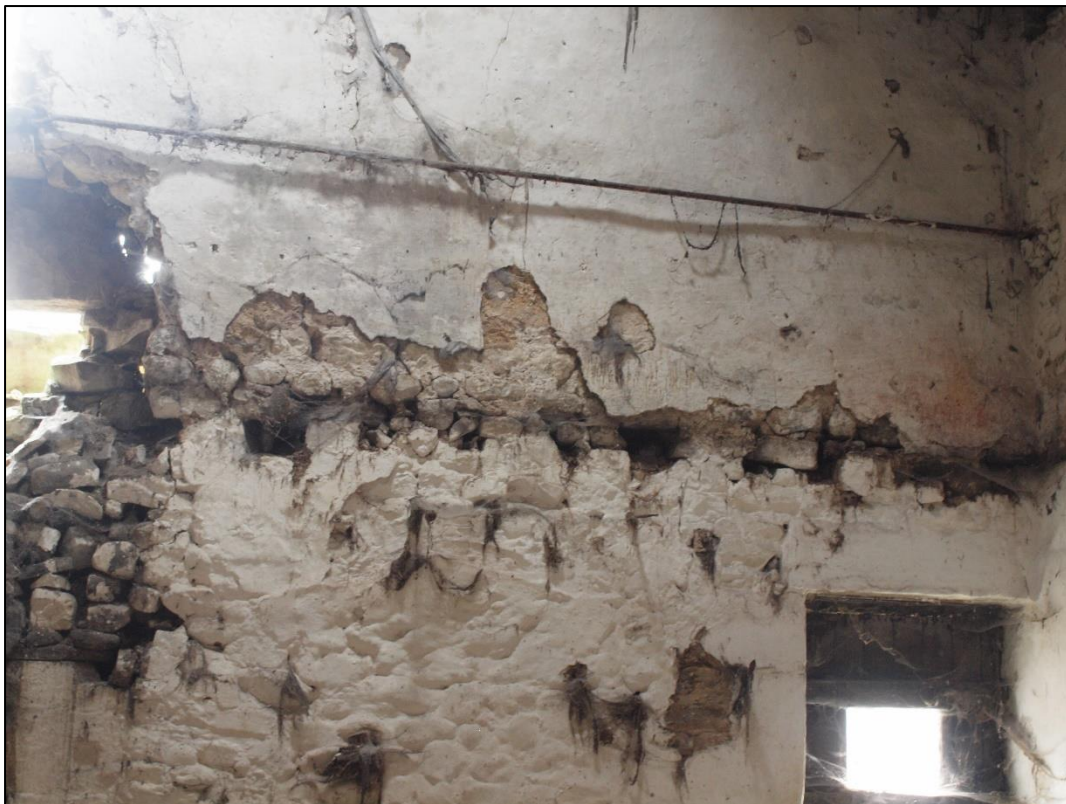
Plate 62: Joist holes in eastern gable

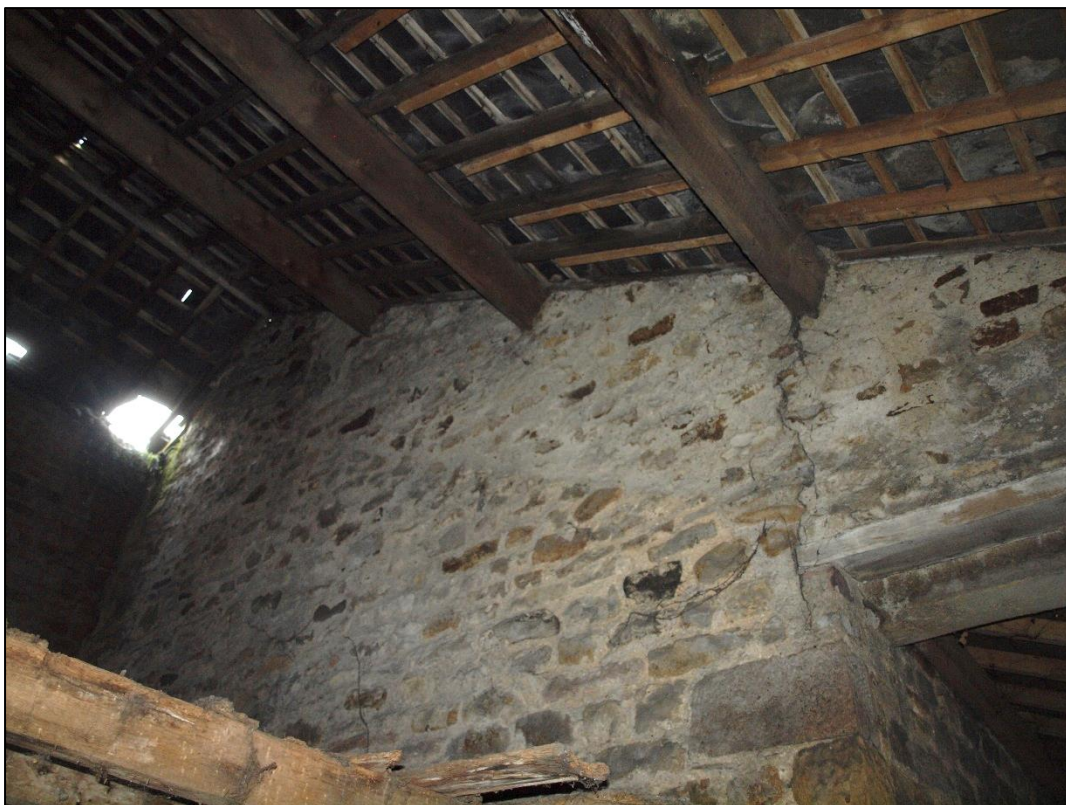
Plate 74: First floor gable showing rough joint

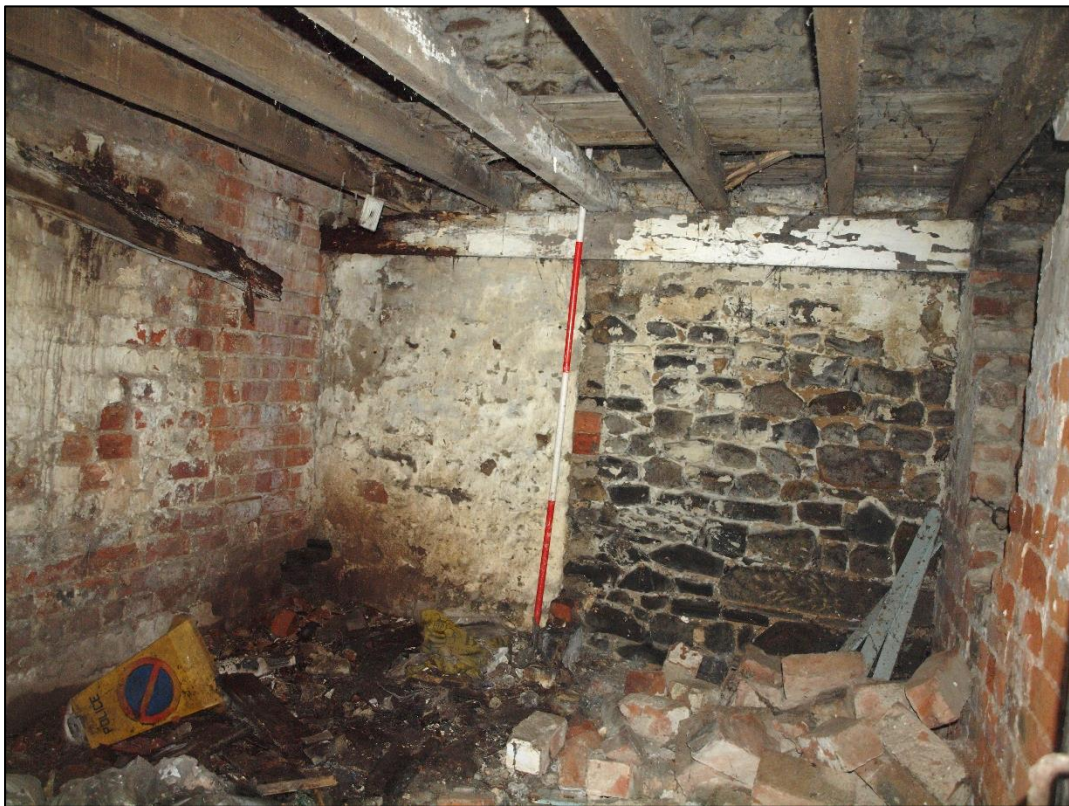
Plate 76: Central room of extension showing scar of removed brick wall

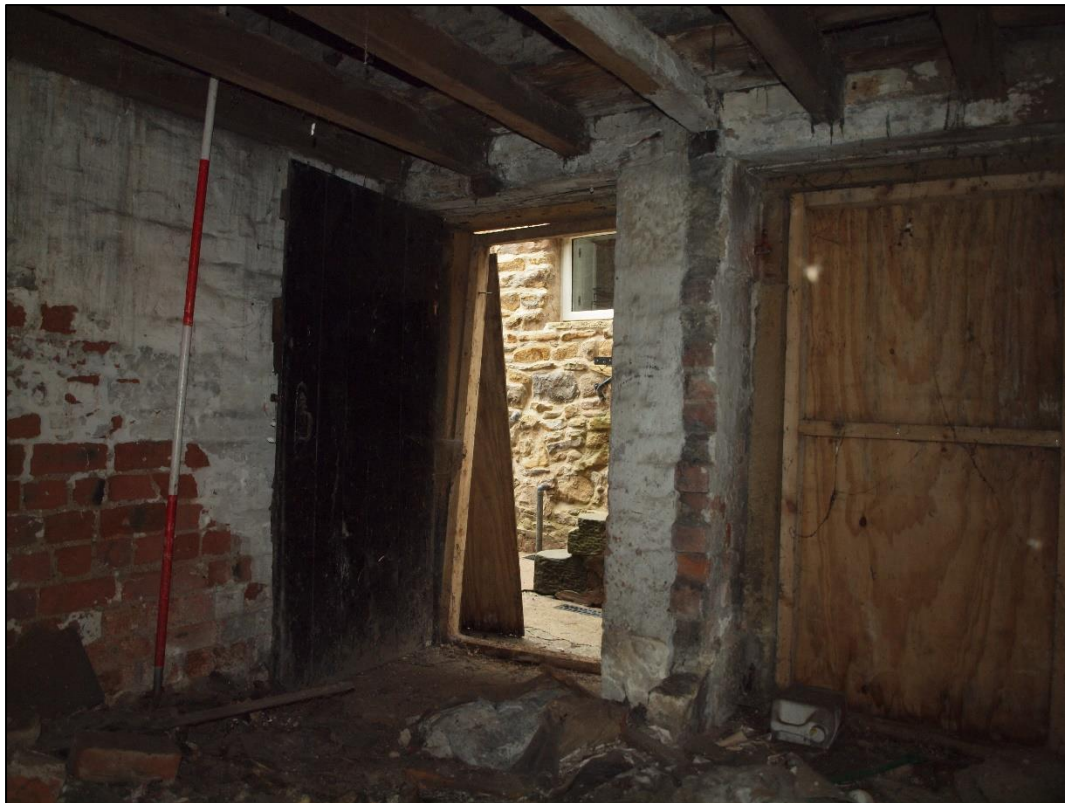
Plate 77: Doorways to west gable showing scar of removed brick wall
