Pendle Hill View

Ash T169 - TPO application to fell due to advanced ash die back on the grounds of increasing risk to people and property with the added consideration of the safety for contractors.

Interim inspection results July 2023

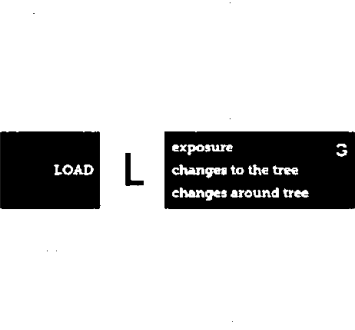
Ash (T169)

This tree is displaying signs of advanced ash dieback and is estimated to be cat 3/4 with in the region of 25-50% remaining live crown which is mostly made up of epicormic growth.

Whilst it is currently a tolerable risk consideration needs to be give to the safety of contractors that may need to dismantle this tree in the future as the risk increases.

The highest risk is failure of secondary limbs.

As this tree is in terminal decline it is recommended that an application to fell this tree is submitted for felling as soon as a decision notice is received.

If desired, the main stem could be retained (at a height no greater than the distance from the nearest target) to create a habitat feature in the interests of biodiversity.
