Report Date: 05/05/2023

SURVEY REPORT

Ash Knott
Little Bowland Road
Clitheroe
Lancashire
BB7 3BN

Dampness to the walls confined to the main spiral stairs/steps

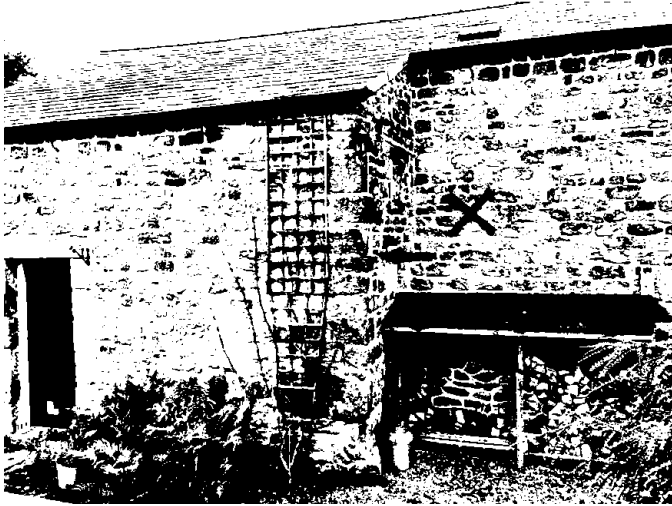
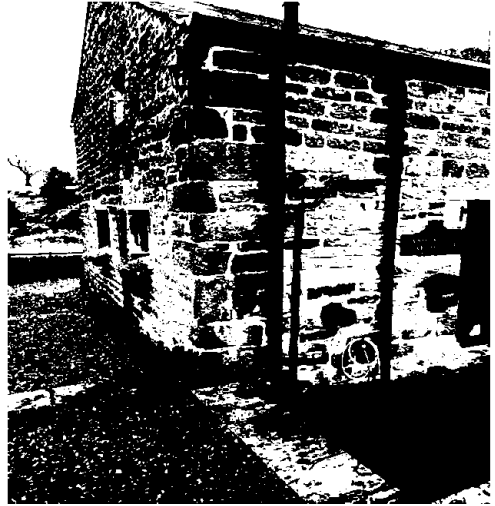
The left hand external ground levels are slightly higher than the internal floor levels and may allow some penetrating moisture ingress if there is no internal waterproof barrier
