## **STRUCTURAL REPORT**

**PEWTER HOUSE FARM,  
CARR LANE, BALDERSTONE,  
RIBBLE VALLEY BB2 7LN**

**CLIENT:** Pewter House Developments Ltd  
**PROJECT TITLE:** Pewter House Farm, Carr Lane, Balderstone  
**REPORT TITLE:** Structural Survey Report (Class Q Application)  
**PROJECT REFERENCE:** 22111

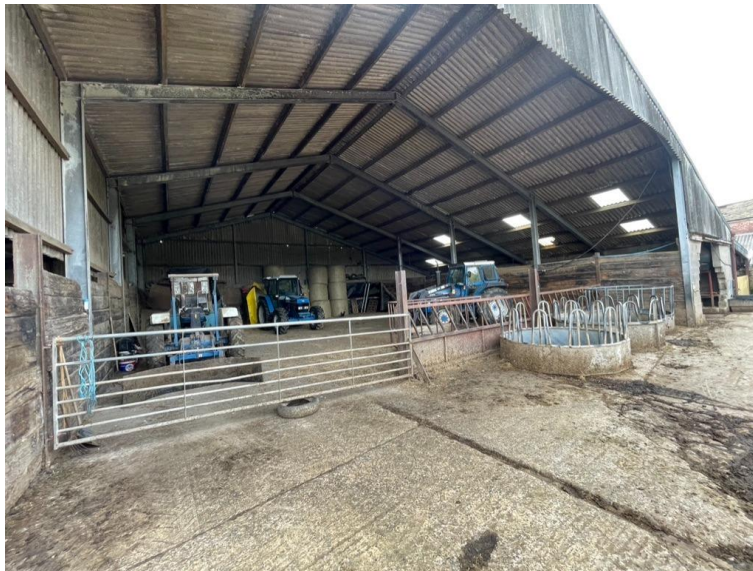
The barns consist of three duo-pitched steel portal frame structures which adjoin each other and are partially sheeted. Each structure consists of four bays (see photograph 1).

**1. Portal frames – concrete hardstanding, timber purlins, 4 bays**

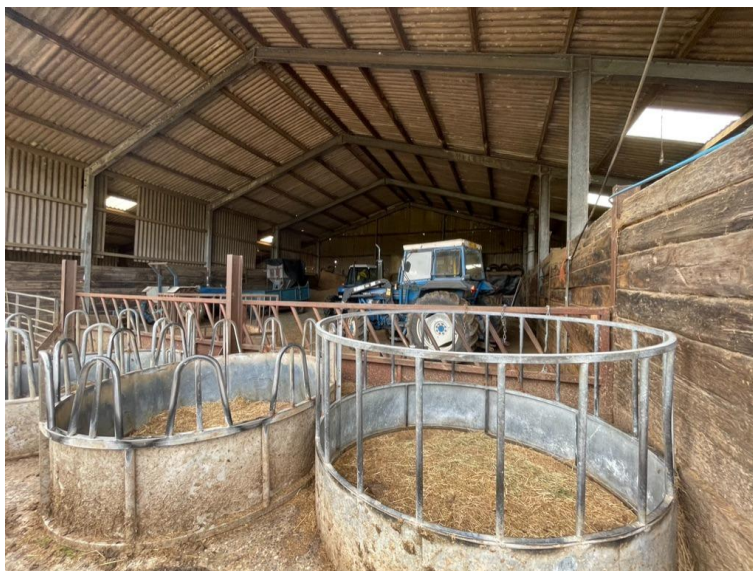
**2. Portal frame – mid structure, timber infill between columns**

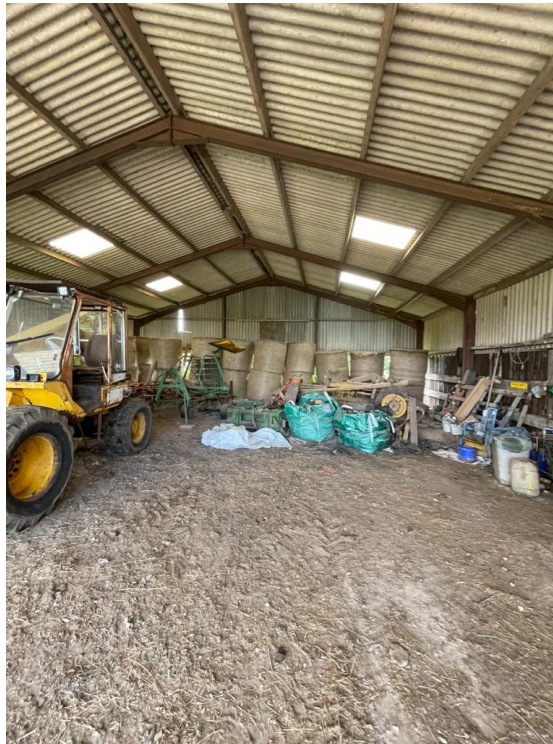
Foundations are unknown and at ground level the covering is mainly concrete hardstanding (depth and make-up unknown) and raised plinths with some areas unfinished (see photograph 3).

**3. Portal frame – unfinished ground**

Foundations will need to be investigated and, depending on the final form, some improvement works may need to be considered.

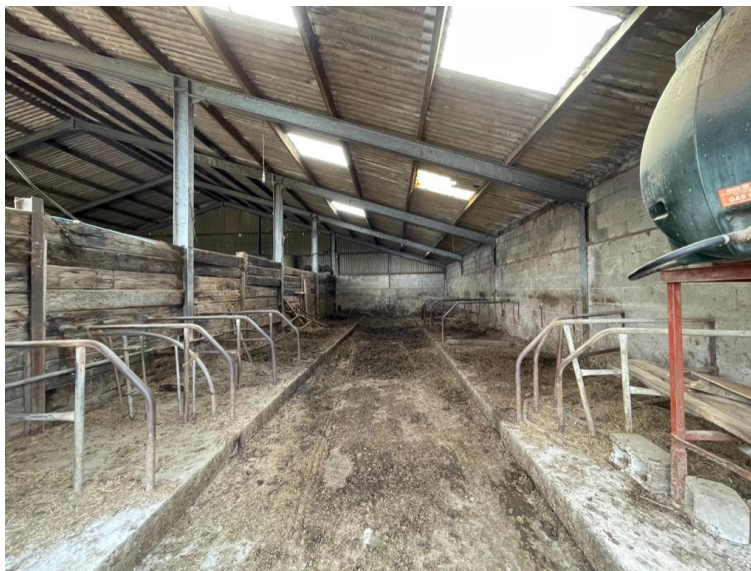
There is some blockwork and some timber infill between columns at lower level (see photograph 4) and in the absence of vertical bracing, it is considered that this is providing some longitudinal stability.

**4. Infill between columns longitudinally – timber sleepers and blockwork**

The structure currently relies on infill panels, sheeting and connections for stability. Some additional stability bracing may be required following detailed structural assessment.
