**Project:**  
**Springwood,**  
**Stoneyhurst,**  
**BB7 9PN**

Report Ref:  
23269-PWA-00-XX-RP-S-1000.F01

Prepared For:  
Zara Moon Architects

**Client:** Zara Moon Architects  
**Report Ref:** 23269-PWA-00-XX-RP-S-1000.F01  
**Project:** Springwood,  
Stoneyhurst,  
BB7 9PN  
**Report:** Structural Report  
**Status:** Final  
**Date:** June 2023

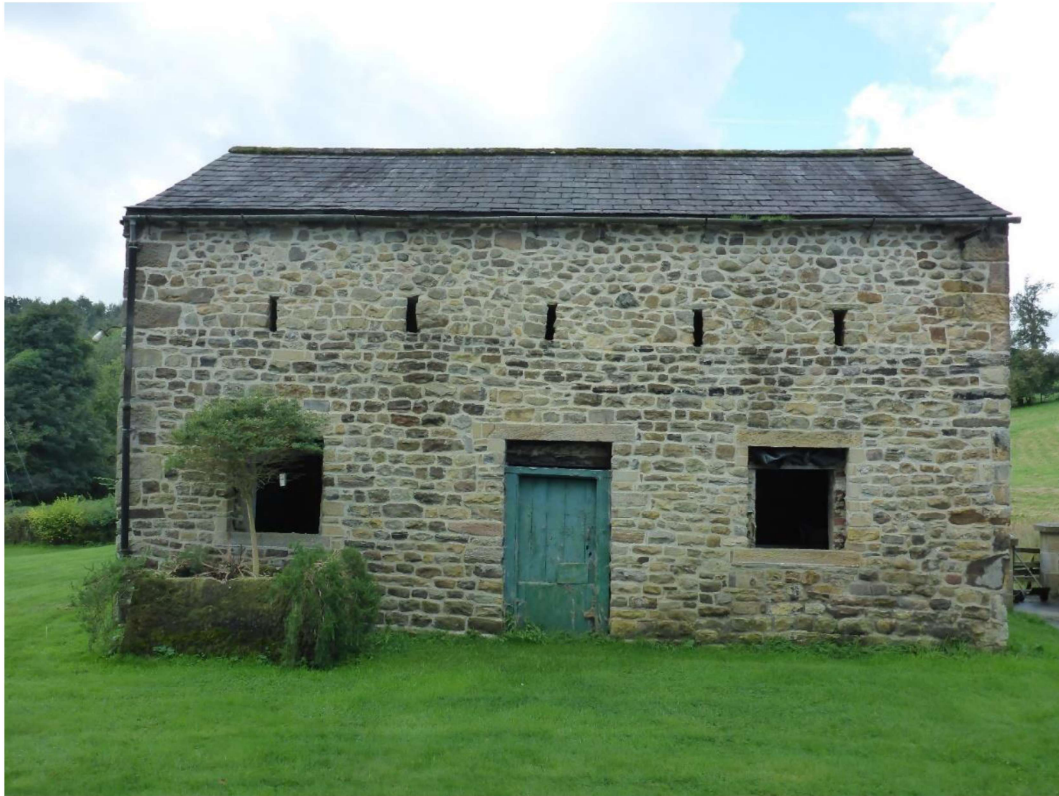
- 6.1. The front elevation of the barn has been repointed (photo 1), there are signs of cracking around the left hand window (photo 2). A bulge is also visible above the left-hand window close to the cracking (photo 3), the bulge could be as a result of a lack of ties within the rubble fill walls or due to the poor condition of the internal timber lintels.
- 6.2. The external stone lintels and sills around the windows and door on the front elevation are in good condition and show no signs of cracking or failure (photos 4-5)
- 6.3. The eastern elevation appears to have been repointed in some areas. There are signs of loose or missing mortar across the elevation (photo 6). Cracking can also be seen across the elevation and is more focused around the openings and eaves level (photos 7-8).

*Photo 1 – Front elevation that has been pointed*

- 7.3. The open bed joints in the external walls should be raked out and filled with a suitable lime mortar, as should all minor cracks elsewhere in the stonework, both internally and externally. Loose/missing stonework should be locally re-built and re-pointed with lime mortar. Walls should be monitored for further movement.

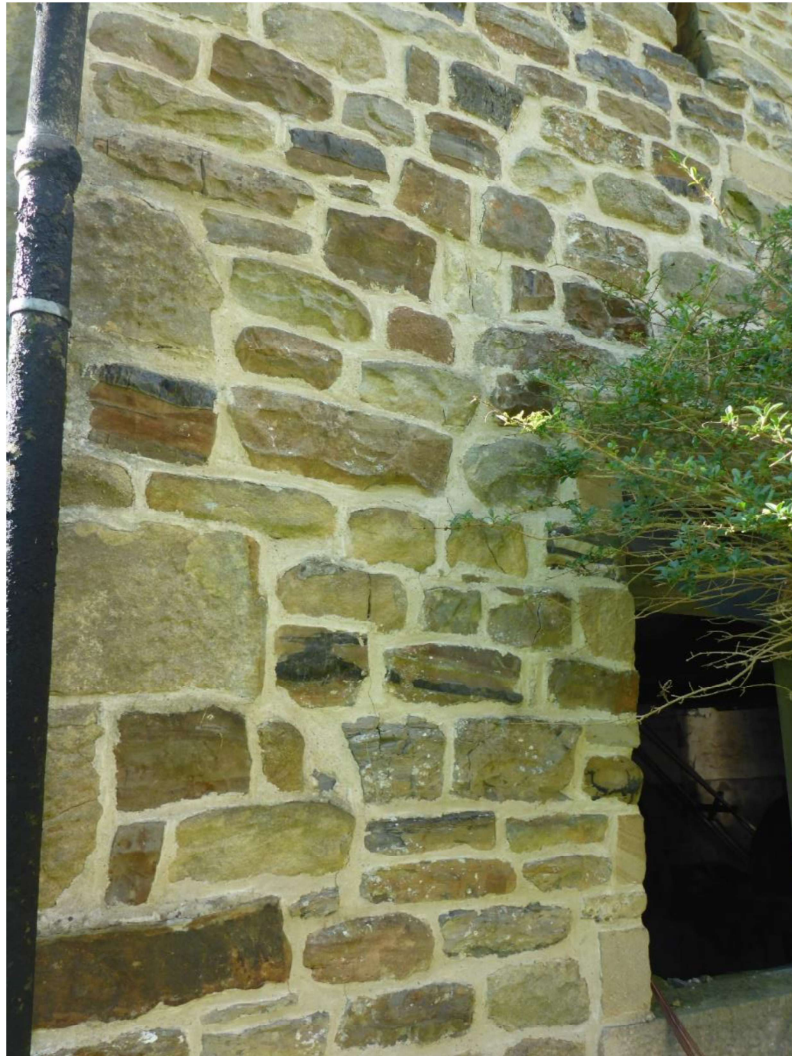
*Photo 2 – Cracking around window on front elevation*

- 7.7. Cracks over 5mm in external walls should be repaired using the Helifix HeliBar crack stitching repair method (appendix B) and repointed. Further monitoring may be required to ensure no further movement occurs.

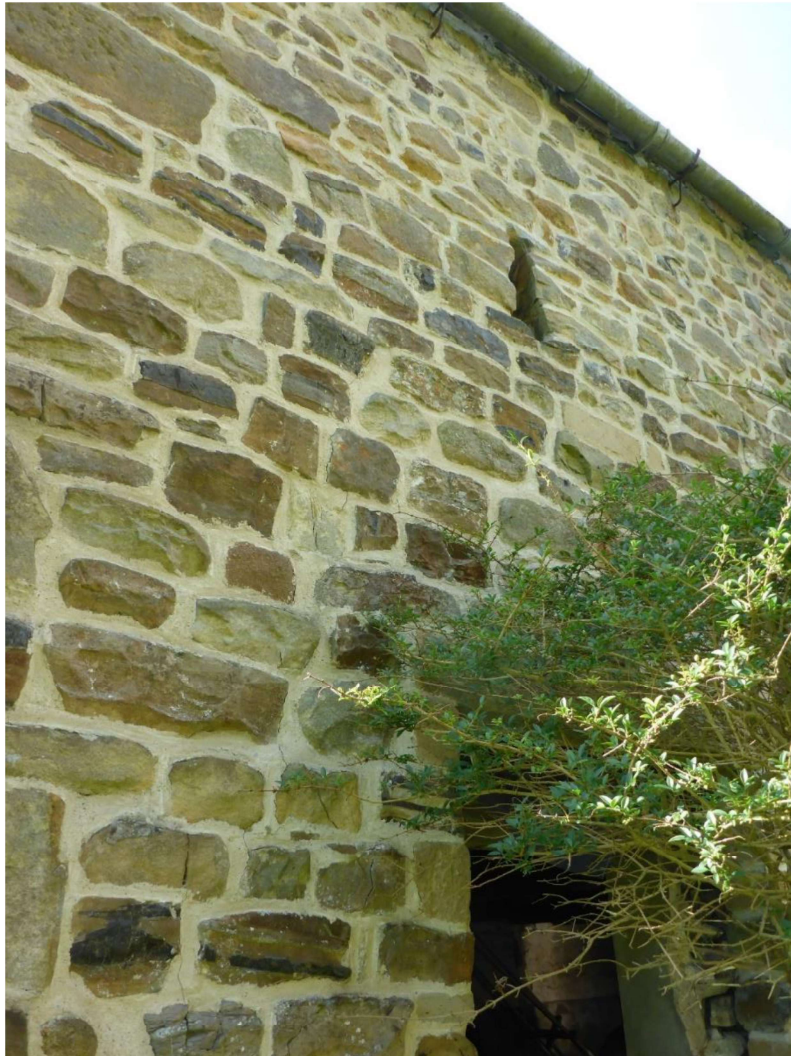
*Photo 3 – Bulging masonry above front elevation window*

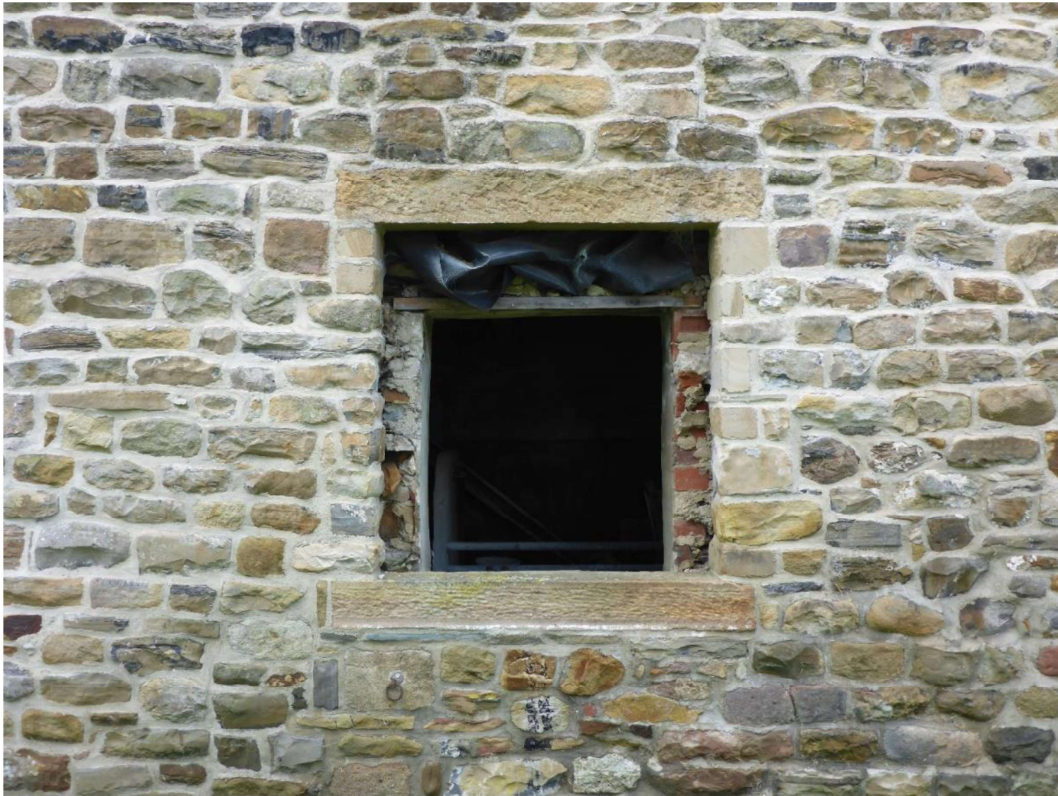
*Photo 4 – Stone lintel on front elevation*

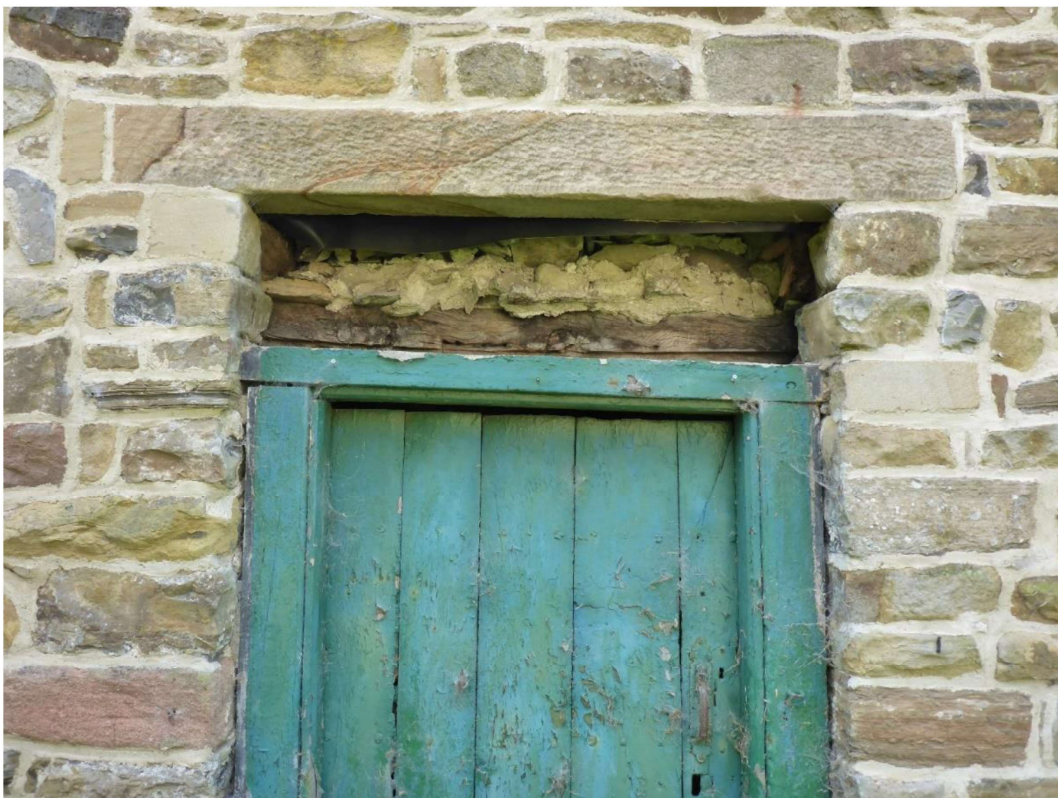
*Photo 5 – Stone lintel over door on front elevation*

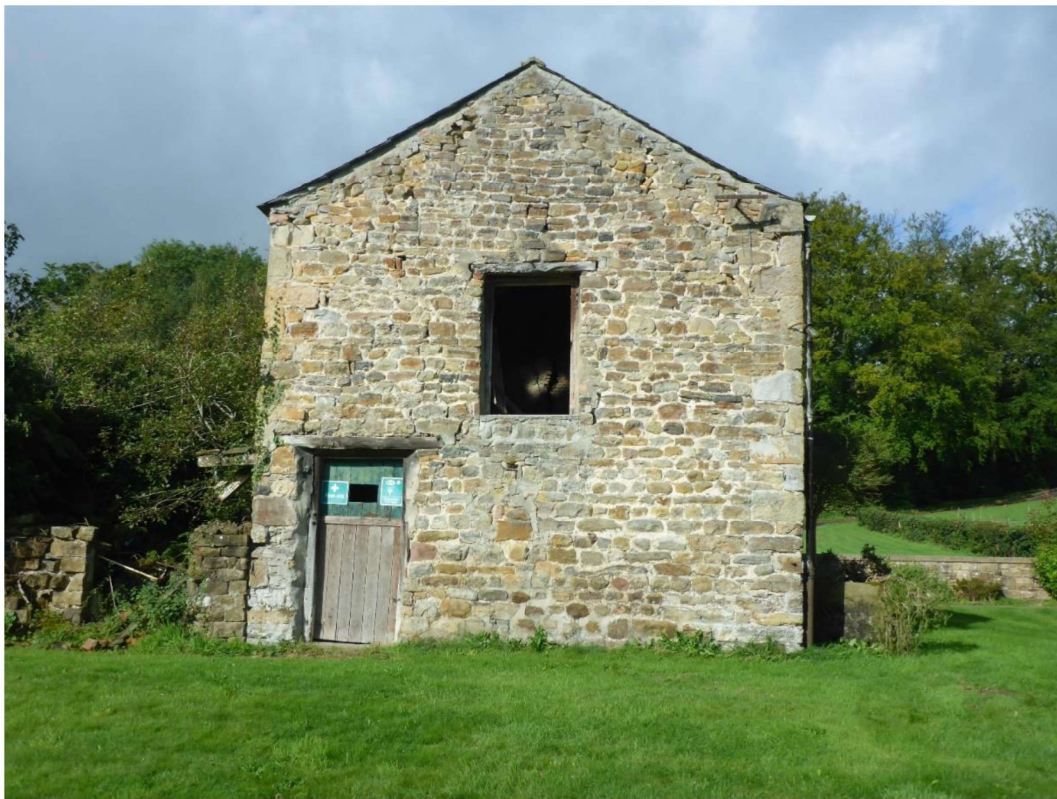
*Photo 6 – Eastern elevation with missing mortar and partial repointing*

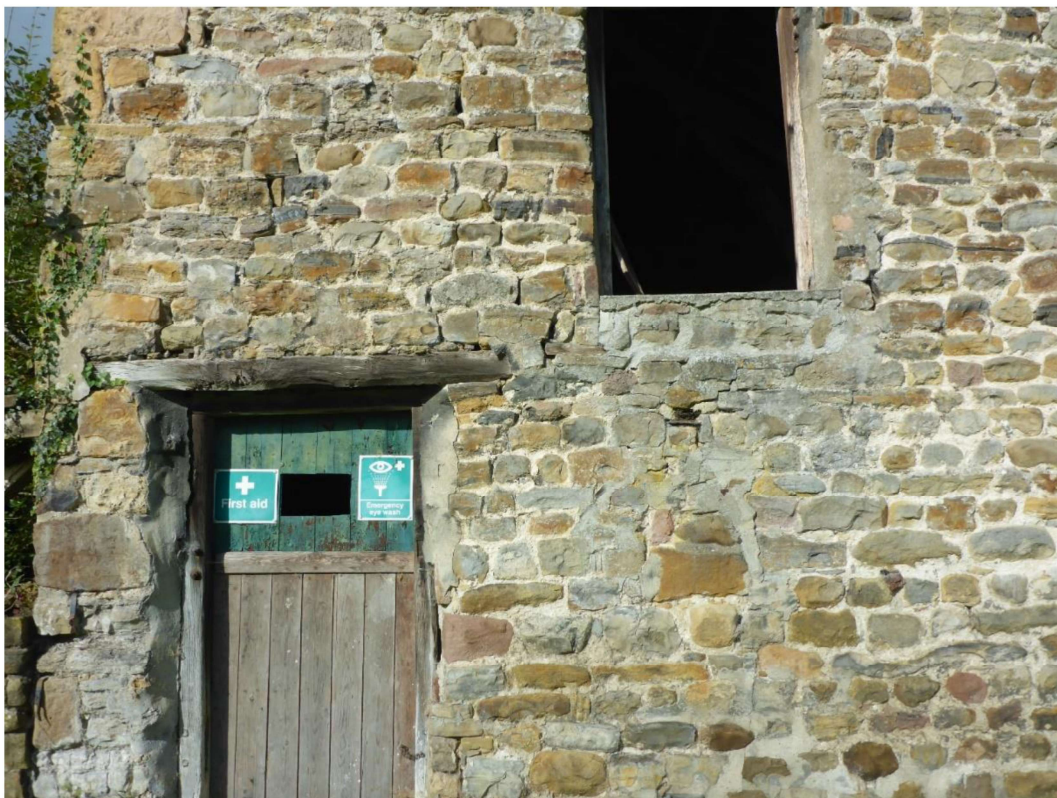
*Photo 7 – Cracking around openings on eastern elevation*

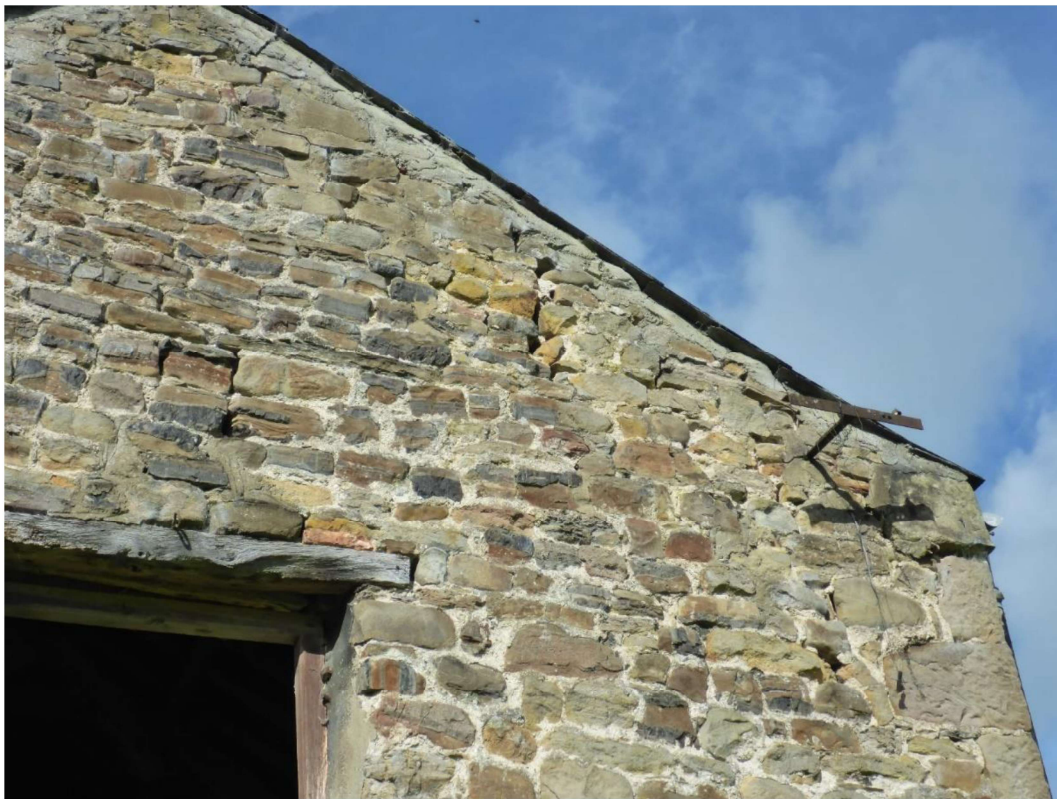
*Photo 8 – Cracking and missing mortar at eaves level of eastern elevation*

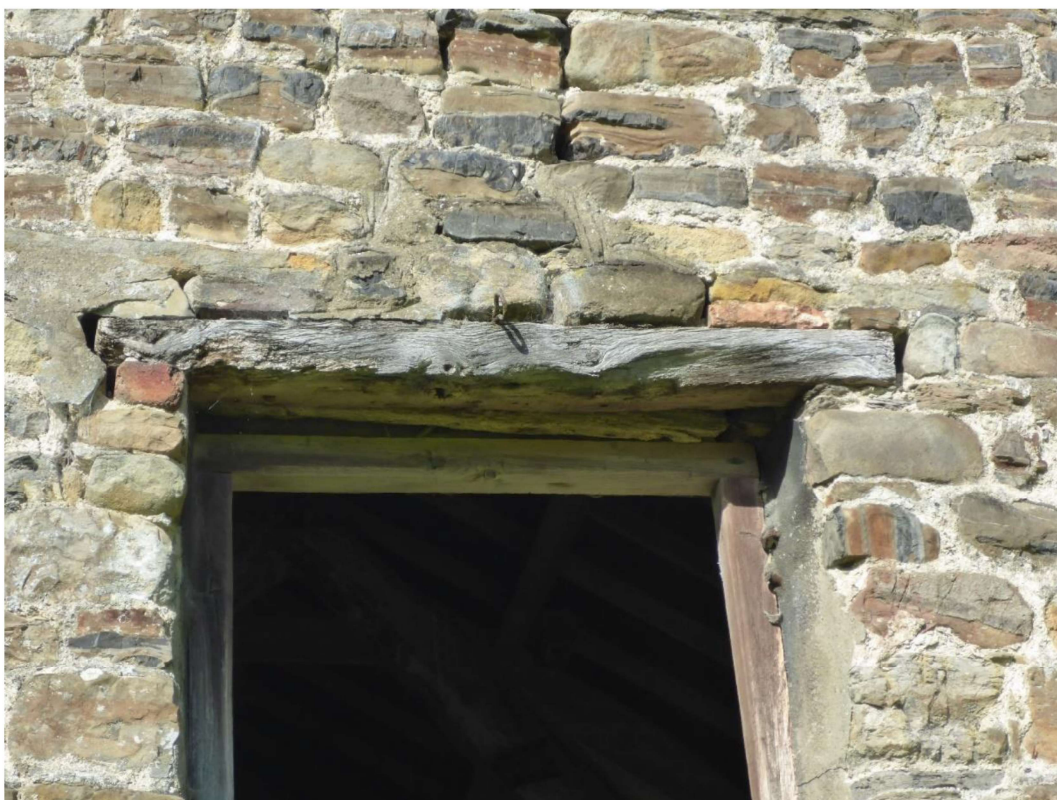
- 6.4. Timber lintels are present over the doorway and hay loft door, the lintels are in poor condition and show signs of wet rot (photos 9-10). This is likely as a result of the timber not being maintained and treated allowing the effects of the weather to affect them.

*Photo 9 – Timber lintel over hay loft opening*

- 7.5. All timber lintels should be removed and replaced with a suitable alternative. Any cracking above the openings can then be repaired using the Helifix HeliBar crack stitching repair method (appendix B) and repointed.

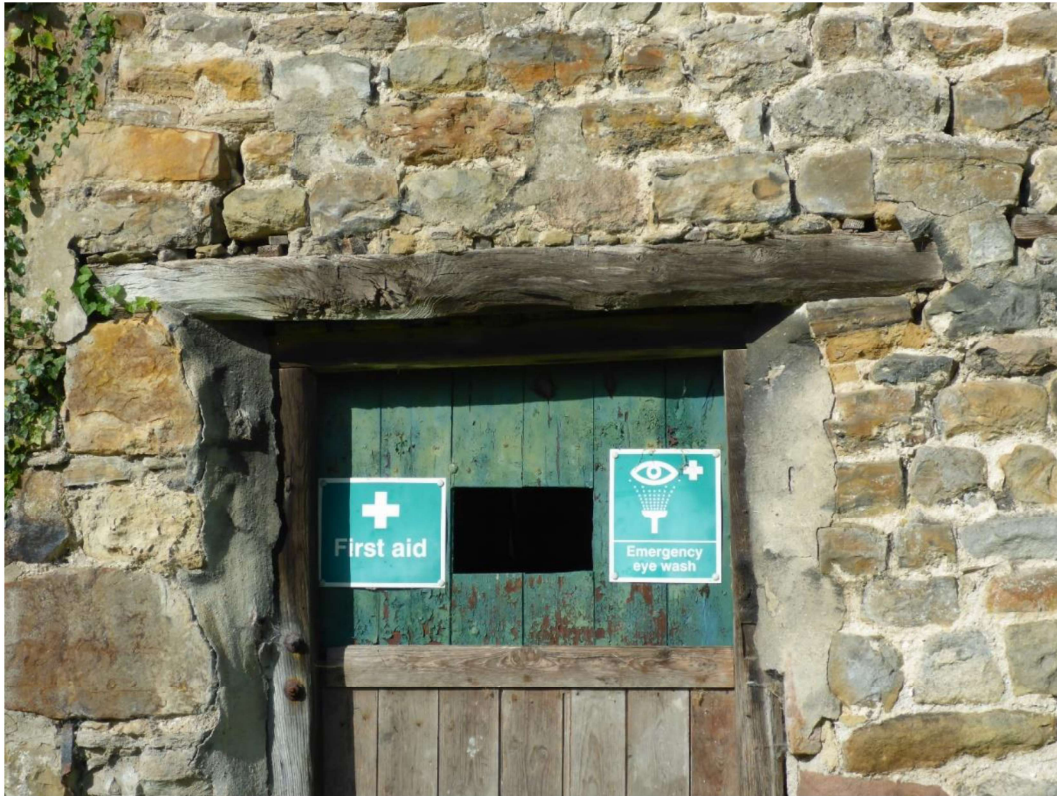
*Photo 10 – Timber lintel over doorway*

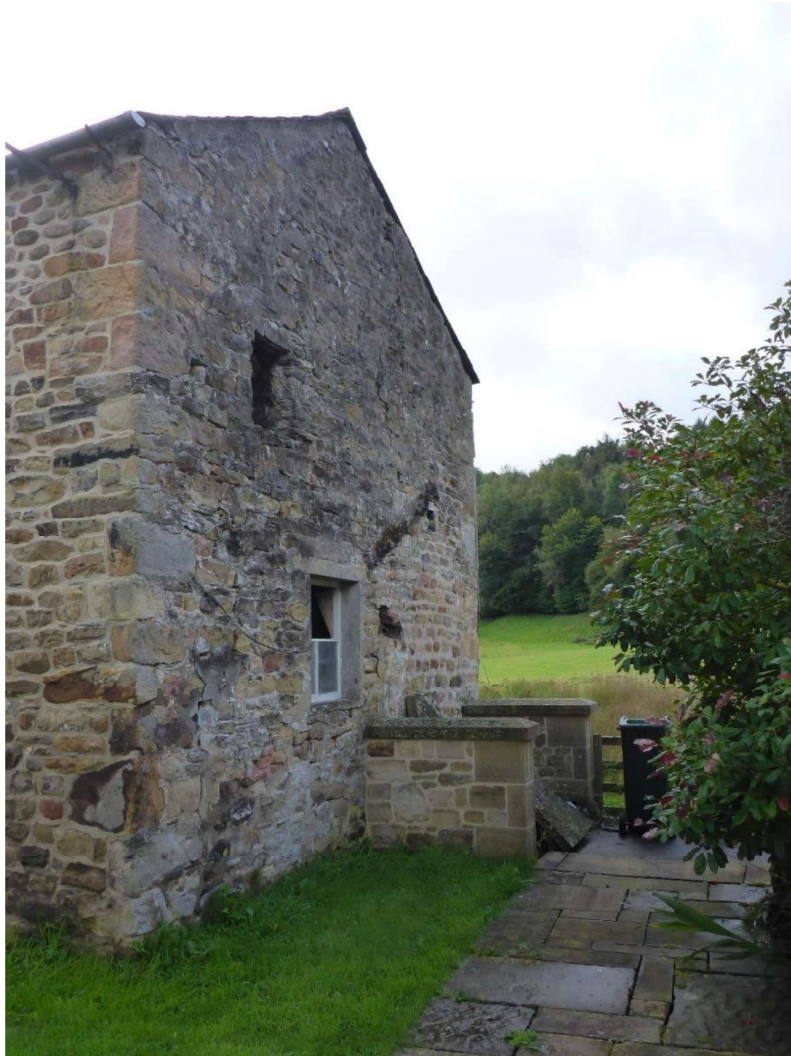
- 6.5. The western elevation of the barn is in poor condition externally, across the elevation there are signs of loose/missing mortar as well as missing stonework (photos 11-13). Cracking can also be seen across the elevation (photos 14-16). Cracks in masonry structures indicate movement has occurred. This could mean settlement has occurred in the foundations of the property.

*Photo 11 – Western elevation of barn*

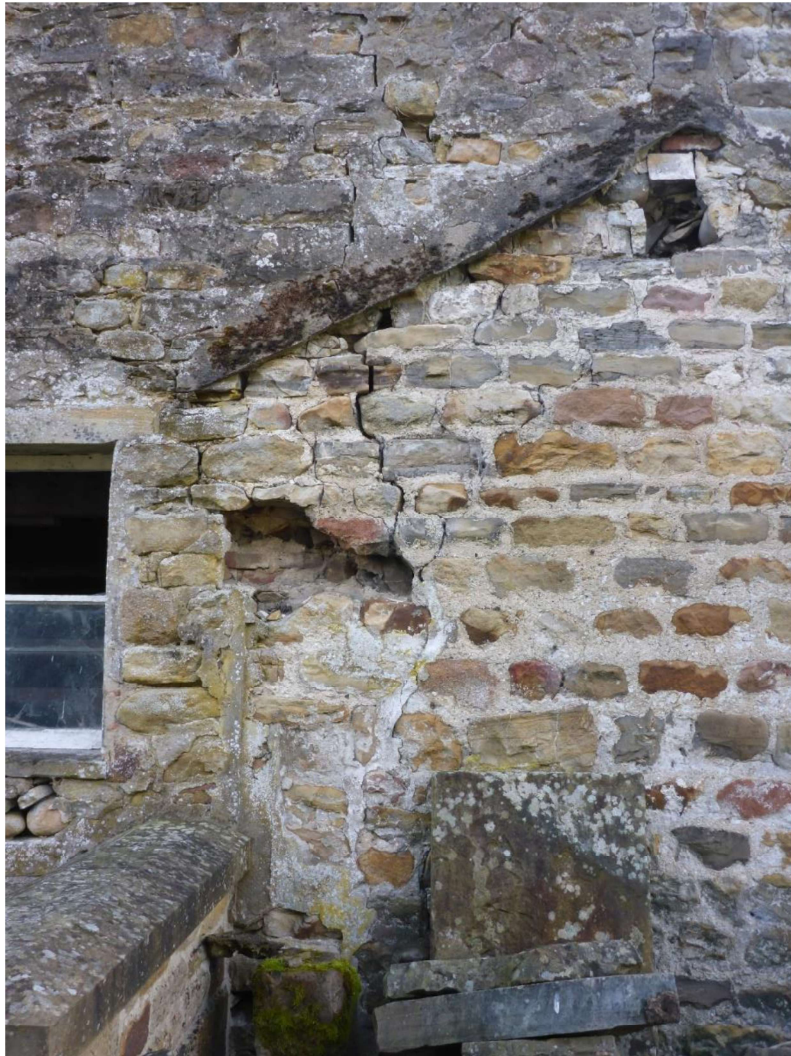
*Photo 12 – Cracking and missing masonry on western elevation*

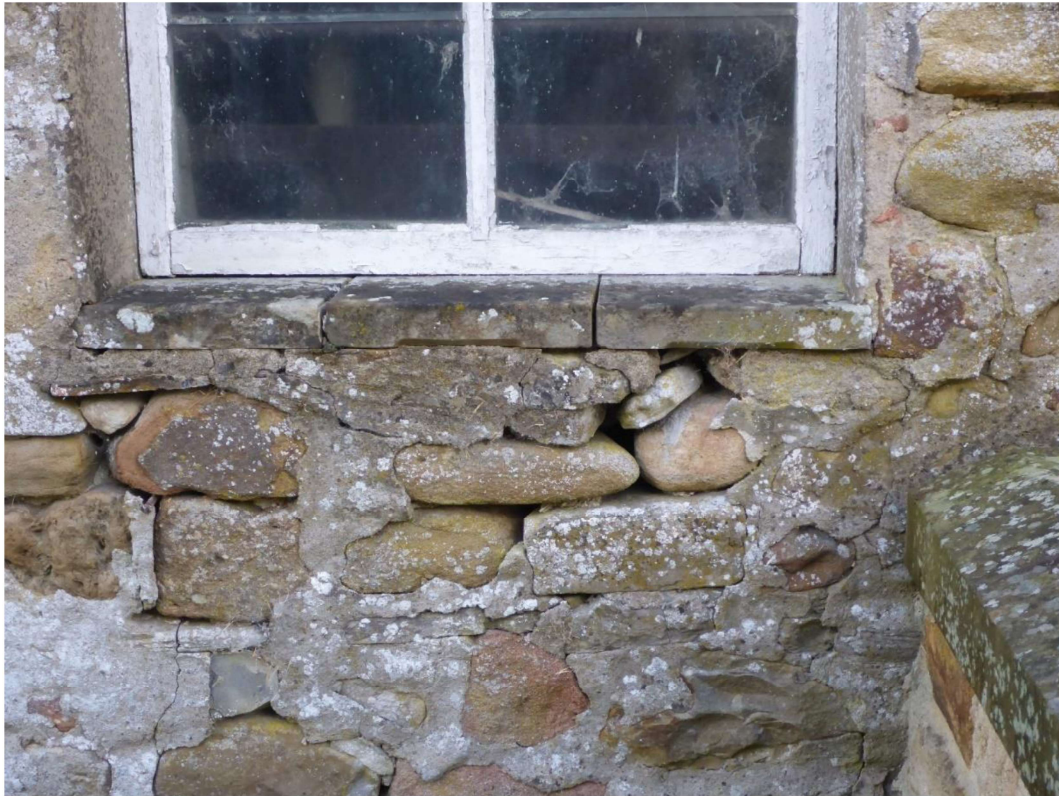
*Photo 13 – missing mortar on western elevation*

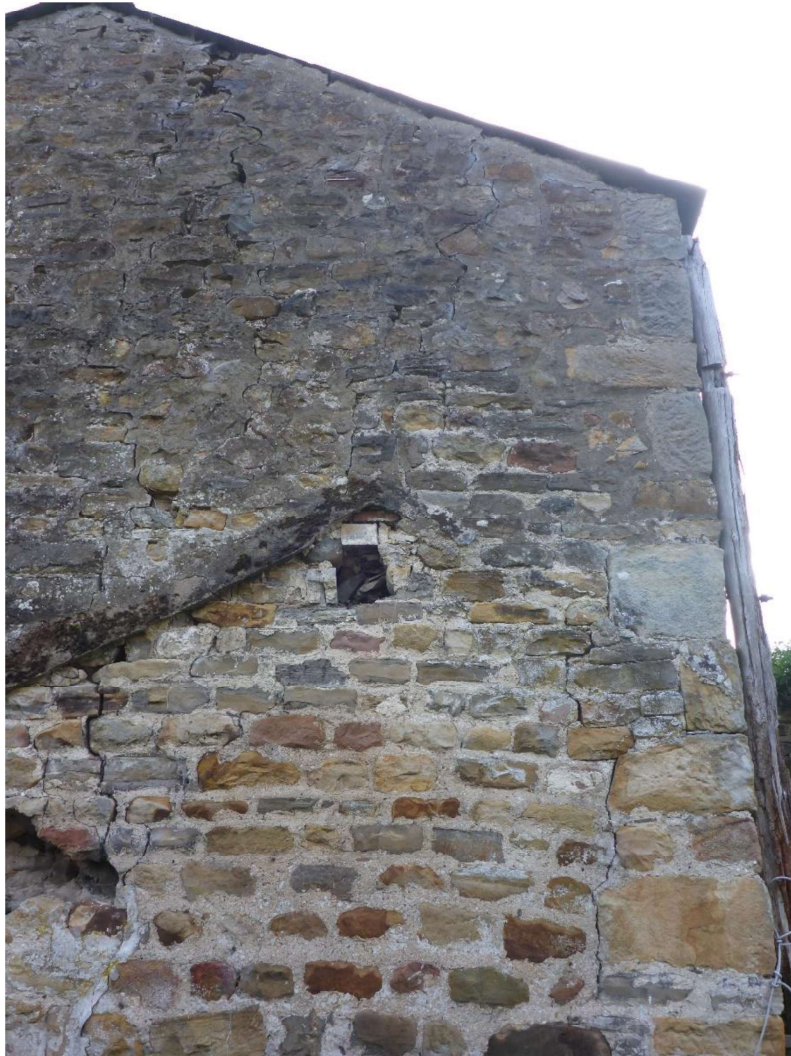
*Photo 14 – Cracking on western elevation*

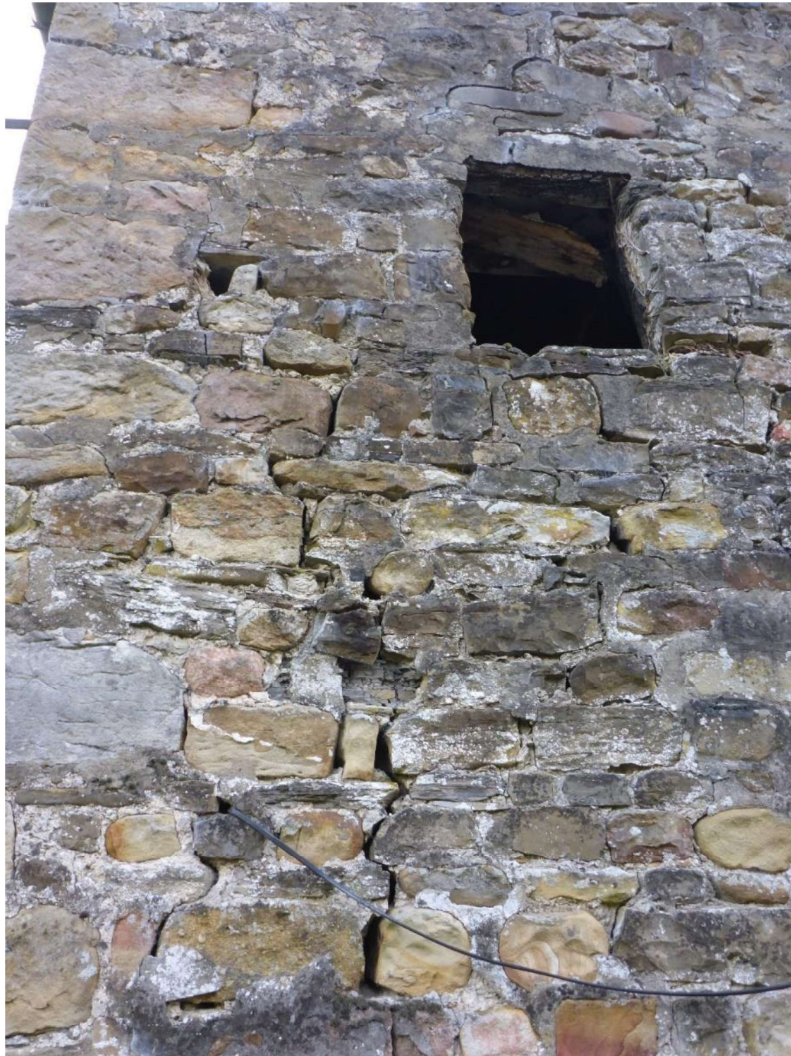
*Photo 15 – Cracking on western elevation*

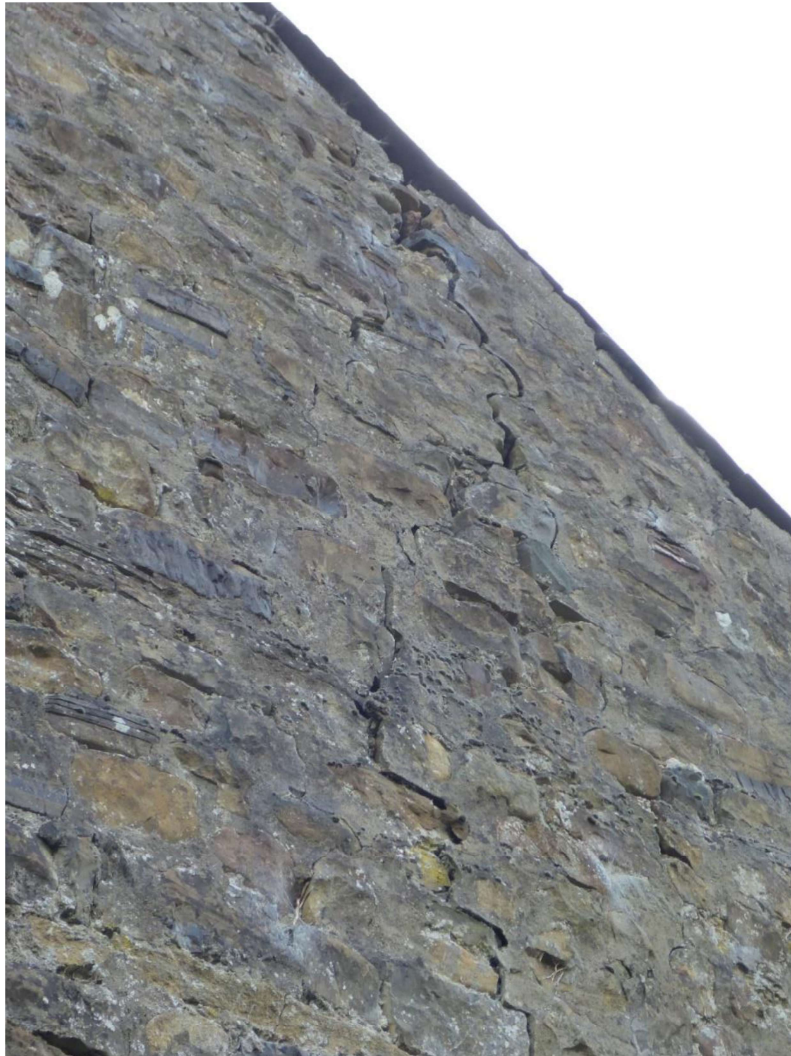
*Photo 16 – Cracking on western elevation*

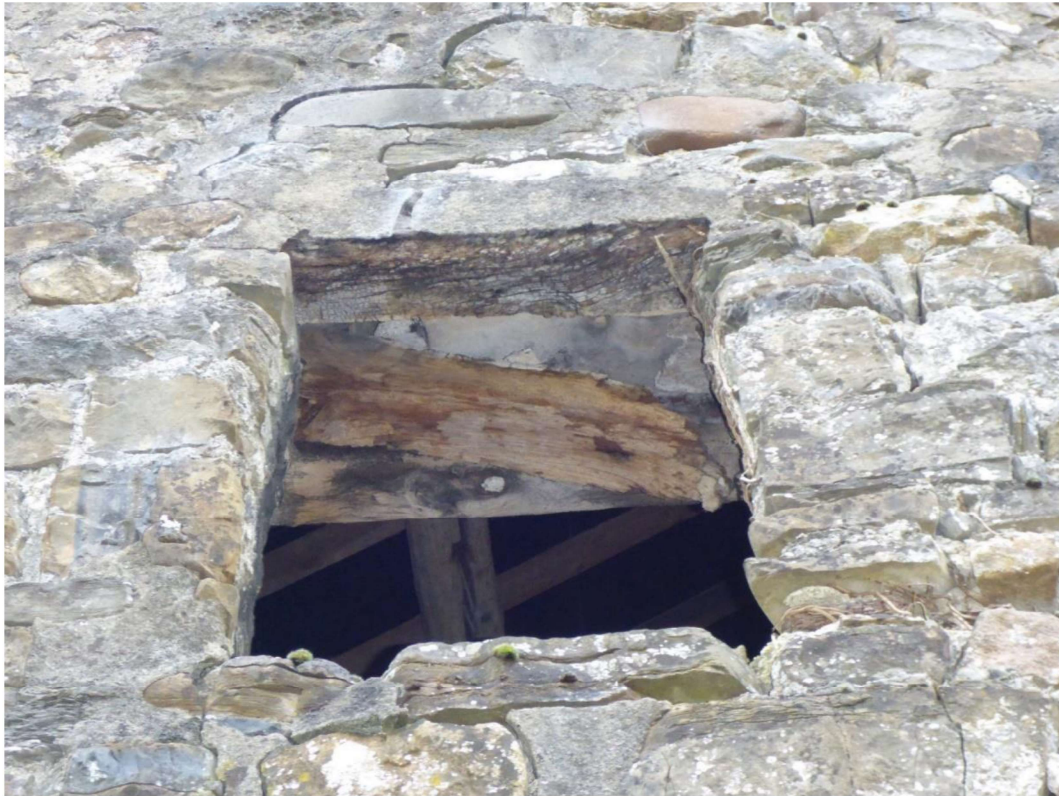
- 6.6. Stone lintel can be seen externally on the western elevation over the ground floor window, the lintel appears to be in good condition with no signs of cracking or failure. Timber lintel is present over the first floor window, the lintel is in poor condition and has been affected by wet rot (photo 17).

*Photo 17 – Rotten timber lintel at first floor level*

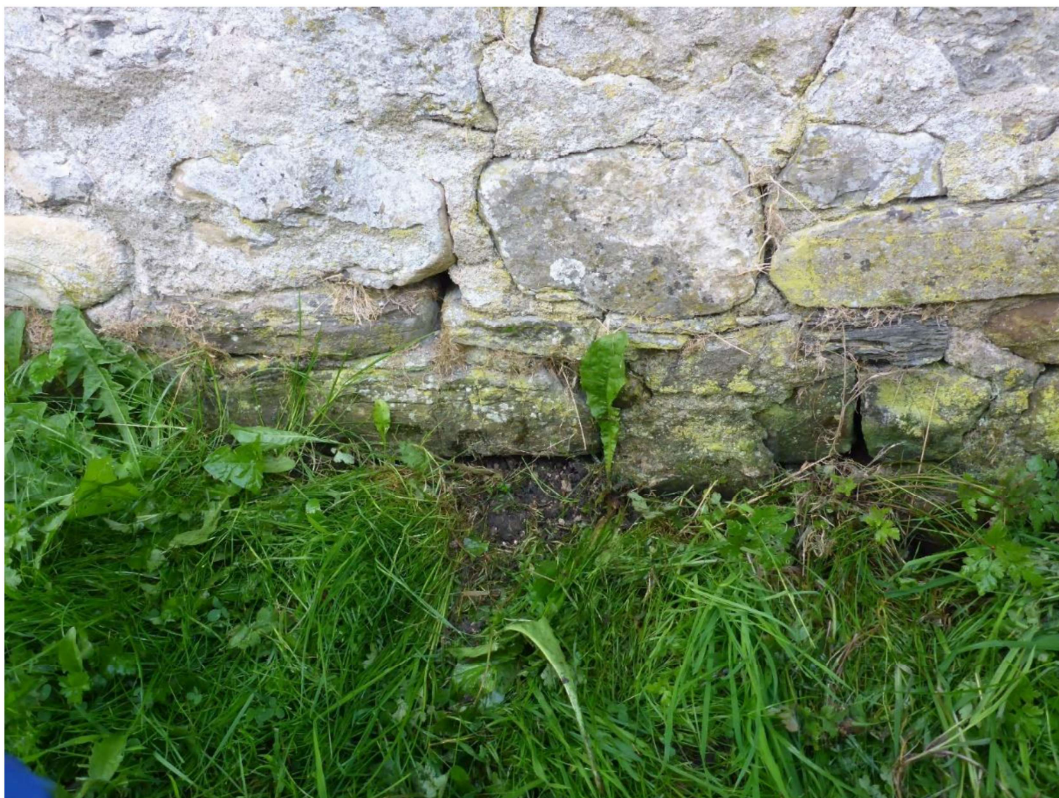
- 6.7. Foundation stones are visible externally indicating that there is likely to be no/little foundations beneath ground floor level (photo 18).
- 6.8. The rear elevation of the barn appears to be in fairly good condition for the age of the barn, however access was limited due to the collapsed lean to building to the rear of the barn (photos 19-20). Areas of loose/missing mortar can be seen in some areas (photo 21)

*Photo 18 – No sign of foundations or foundation stones*

- 7.9. Further investigations should be carried out on the depth and size of the existing foundations, it is likely that the majority of the movement within the structure has been caused by movement in the foundations. Underpinning may be required to the foundations to stabilise the structure and reduce any further movement. From reviewing geological records in the area, we expect that the ground consists of Devensian till which is susceptible to heave.

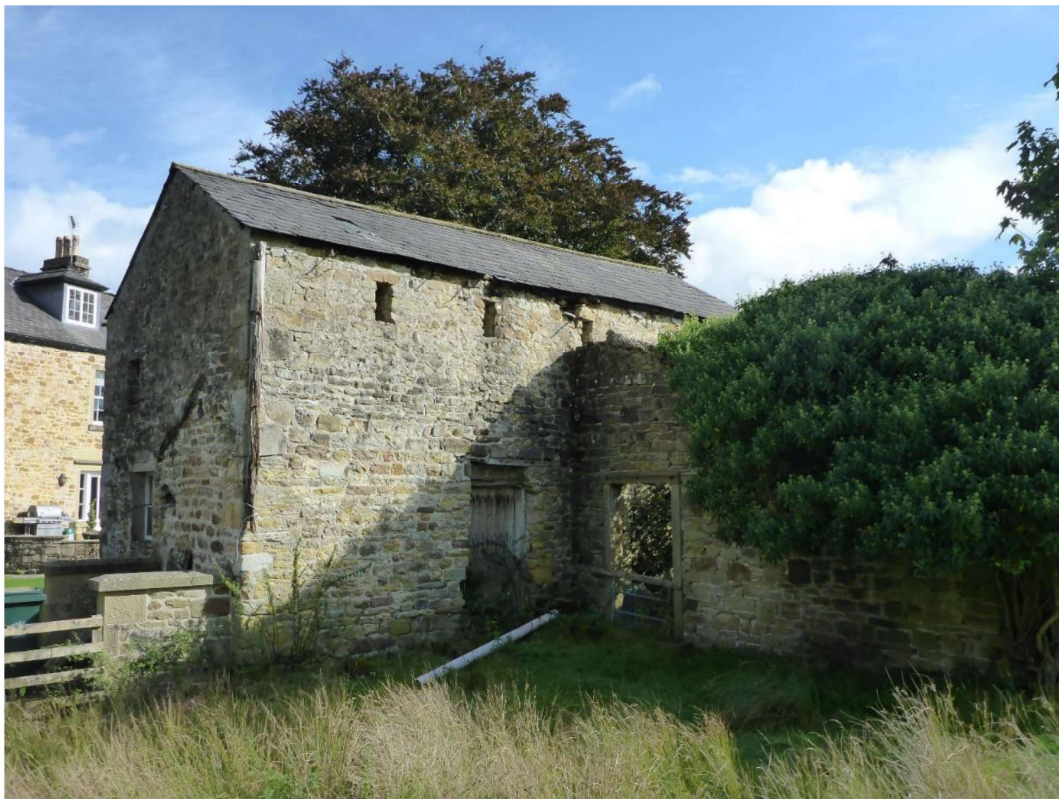
*Photo 19 – Rear elevation of barn*

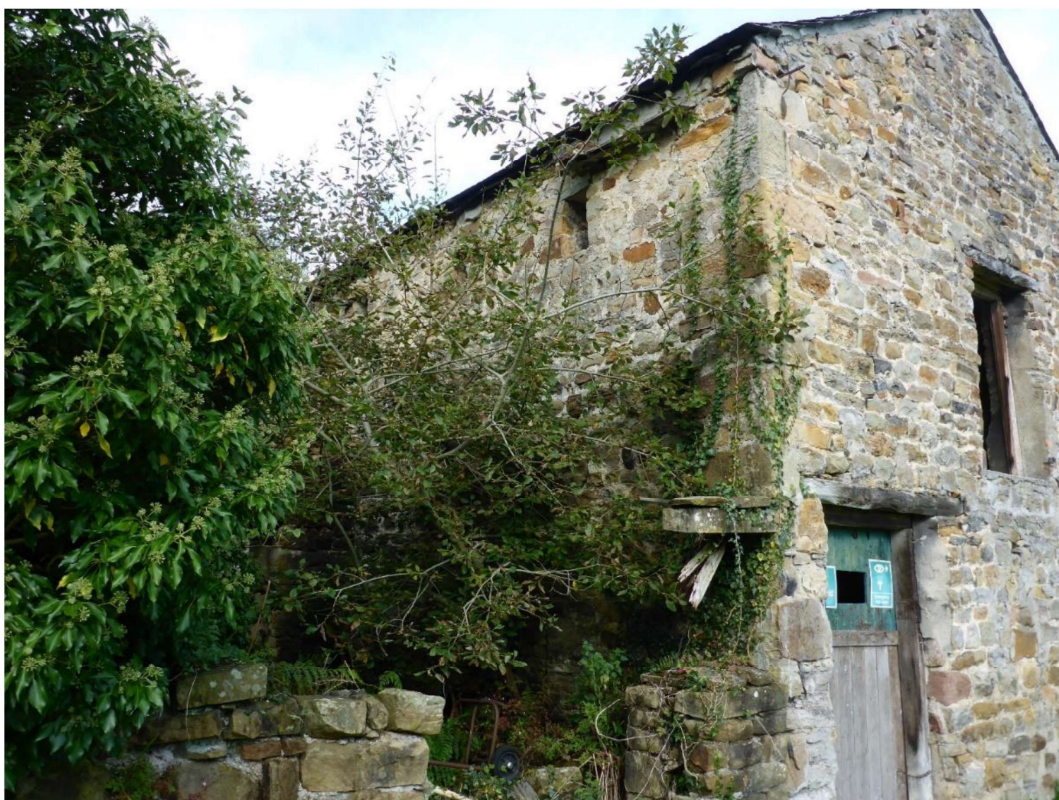
*Photo 20 – Rear elevation of barn and derelict lean to*

- 7.11. If proposals for the site include the conversion of the lean to building to the rear of the barn, the remaining structure will require taking down and being rebuilt with suitable foundations.

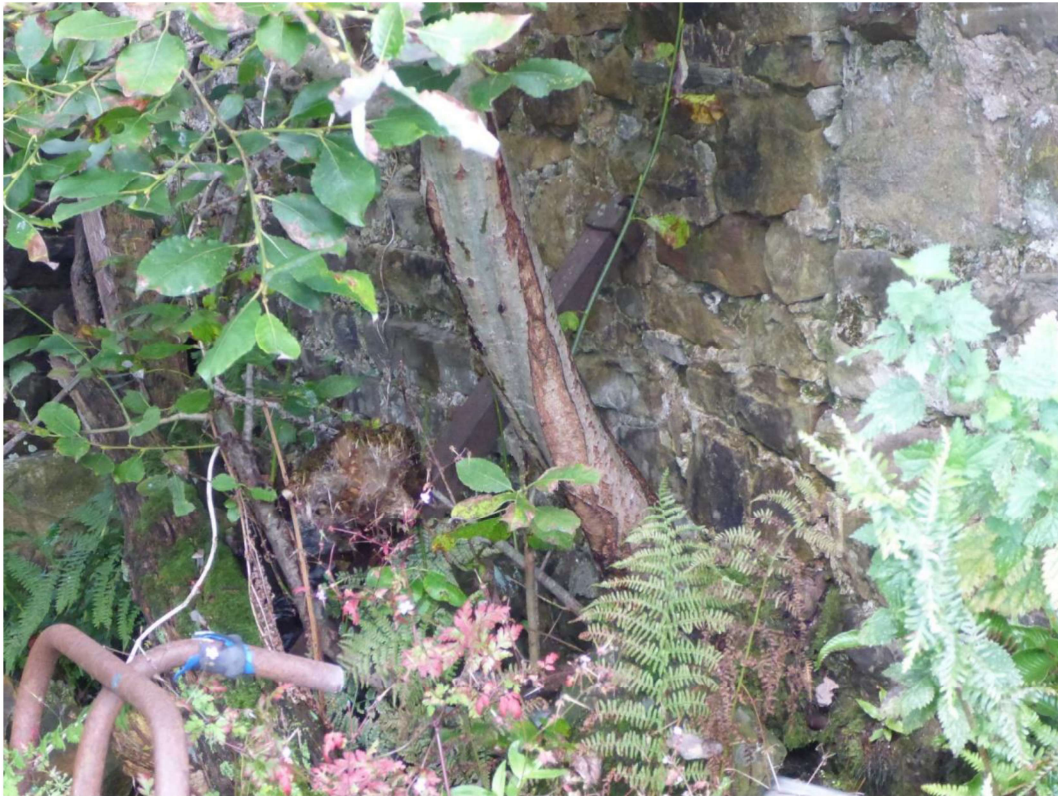
*Photo 21 – Missing mortar on rear elevation*

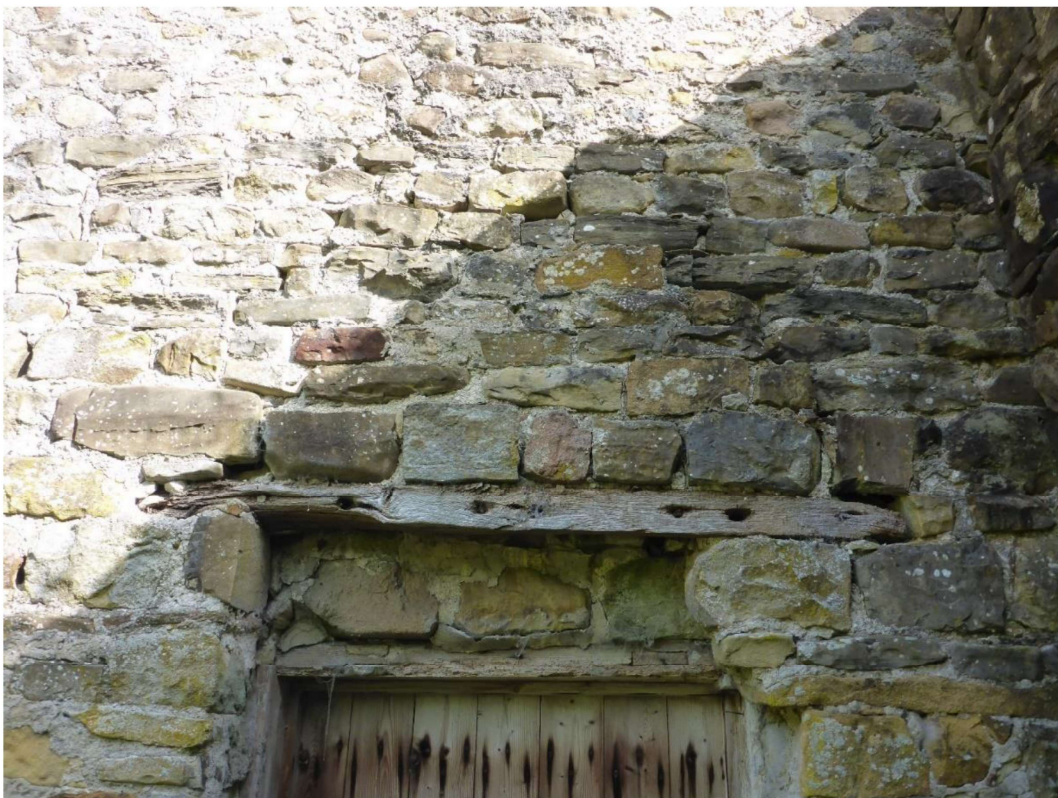
- 6.9. Over the doorway is a timber lintel, the lintel is in poor condition and is showing signs of dry rot (photo 22). As a result of the poor condition of the lintel, the masonry above has started to crack and bulge.

*Photo 22 – Diagonal cracking over rotten timber lintel*

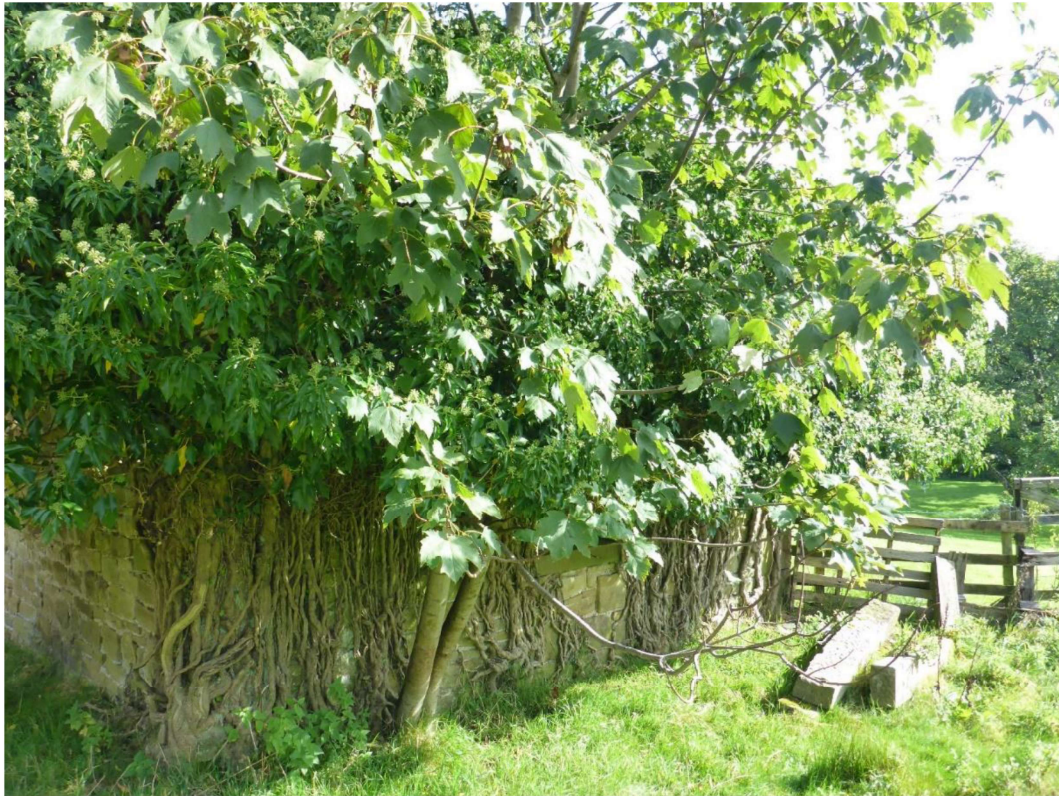
*Photo 23 – Derelict lean-to to rear of barn*

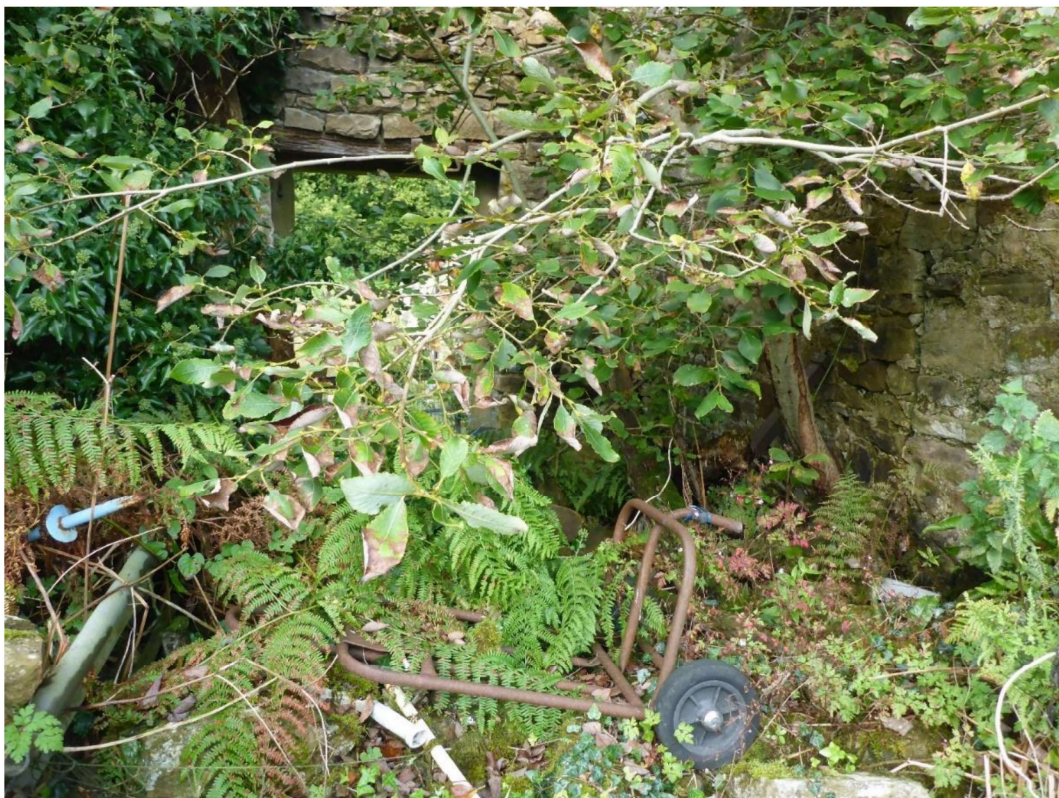
- 6.11. Trees are growing in close proximity to the rear elevation of the barn and the lean to (photo 24). Trees can cause movement in the foundations therefore further investigations of the foundations and their depths should be undertaken to confirm if any nearby trees are affecting the structure.

*Photo 24 – Tree growing in close proximity to rear wall of barn*

- 7.10. Trees located in very close proximity to the building and its foundations should be removed and foundations assessed for any damage. Trees on site should also be

assessed to ascertain if any of the nearby trees are affecting the foundations. Depending on the landscape proposals for the site trial pits would be advised to confirm the ground conditions.

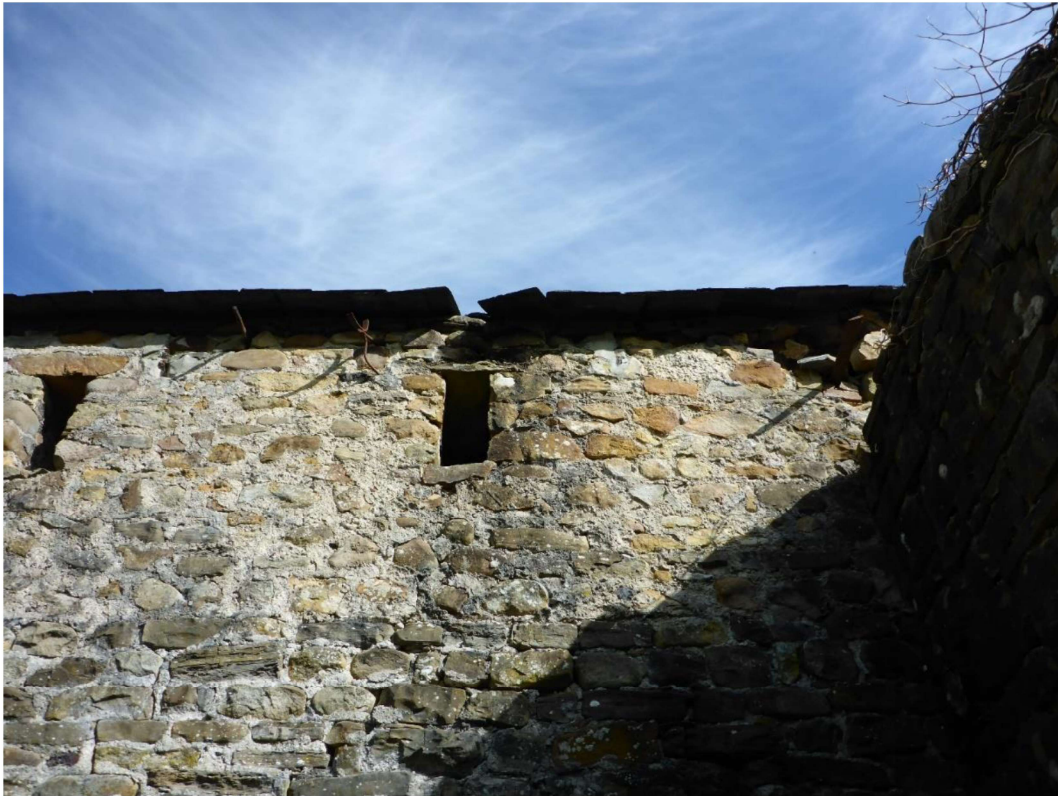
- 6.12. The roof appears to have been re-roofed recently therefore the roof looks to be in good condition, there is one slipped slate to the rear (photo 25) but other than this the slates are in good order and the ridge is level.

*Photo 25 – Slipped roof slate to rear*
