**Project:**  
**Springwood,**  
**Stoneyhurst,**  
**BB7 9PN**

Report Ref:  
23269-PWA-00-XX-RP-S-1000.F01

Prepared For:  
Zara Moon Architects

**Client:** Zara Moon Architects  
**Report Ref:** 23269-PWA-00-XX-RP-S-1000.F01  
**Project:** Springwood,  
Stoneyhurst,  
BB7 9PN  
**Report:** Structural Report  
**Status:** Final  
**Date:** June 2023

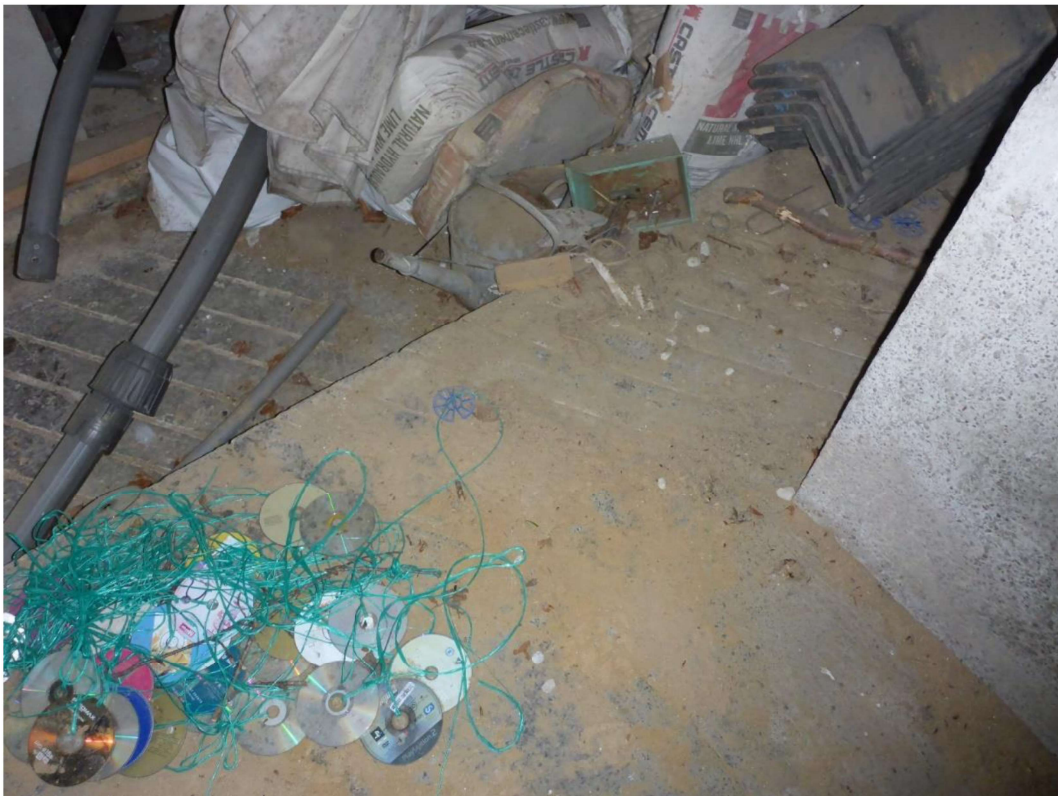
- 6.13. Internally, the barn is being used for storage at ground floor level therefore access was limited. The concrete ground floor slab appears to be in good condition with no obvious signs of cracking (photos 26-27).

*Photo 26 – Concrete floor internally*

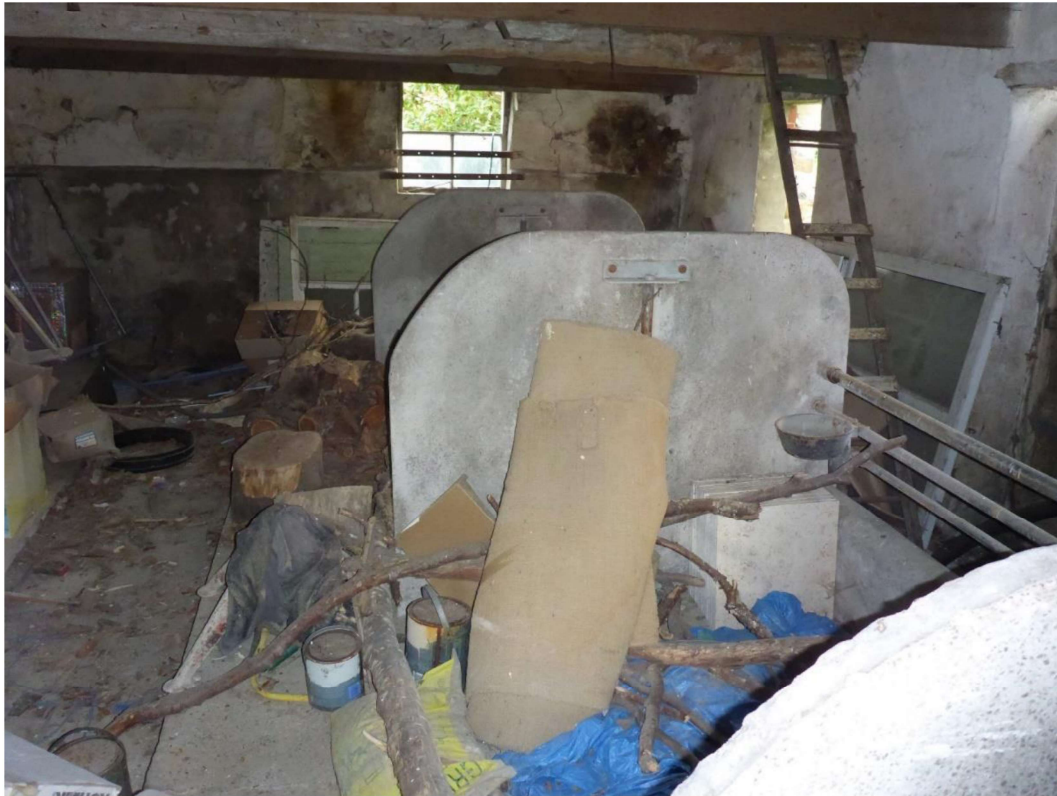
*Photo 27 – Internal layout of barn at ground floor level*

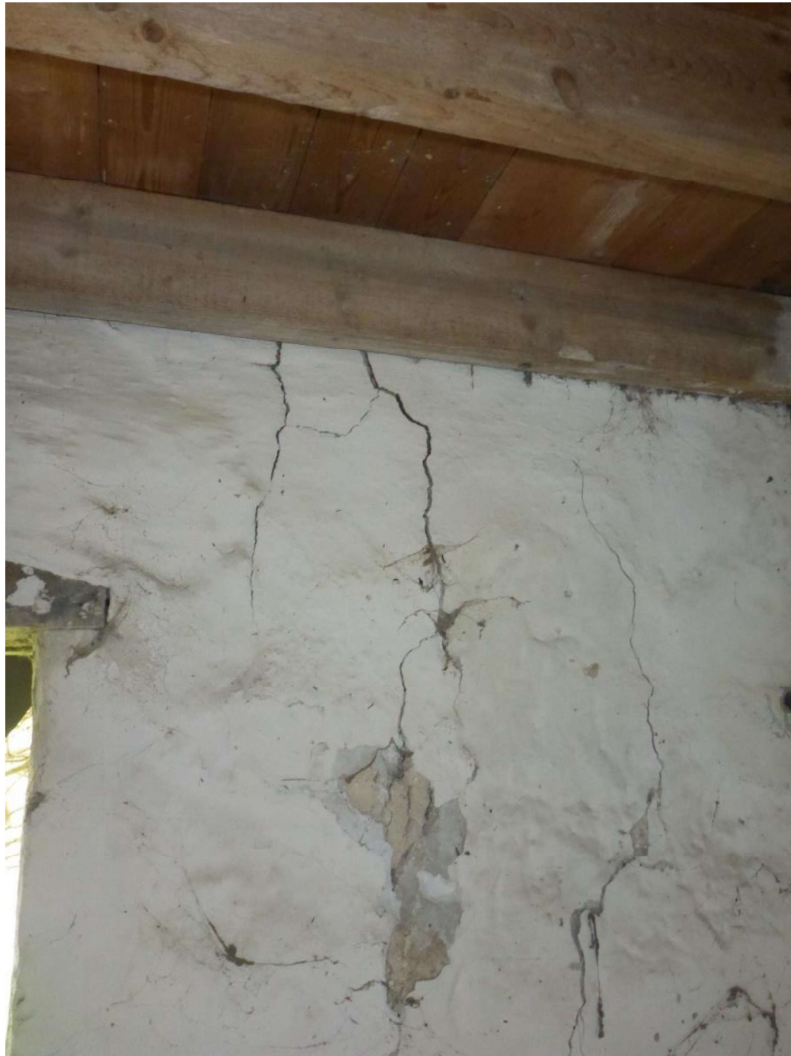
- 6.14. Vertical cracking can be seen internally at ground floor level that appears to mostly originate from first floor level (photo 28).
- 6.15. The first-floor structure looks to have been replaced with a modern timber floor (photo 29), originally the first floor would have likely span between the ceiling ties of the upper cruck however, the first-floor joists now span between a series of timber beams that have been installed alongside the ceiling ties. The timber beams are in good condition. Cracking can be seen beneath the bearing of the timber beams supporting the first floor structure (photo 30), it is likely that no padstones have been provided beneath the beams to spread the load into the masonry.

*Photo 28 – Cracking in internal masonry*

- 7.7. Cracks over 5mm in external walls should be repaired using the Helifix HeliBar crack stitching repair method (appendix B) and repointed. Further monitoring may be required to ensure no further movement occurs.

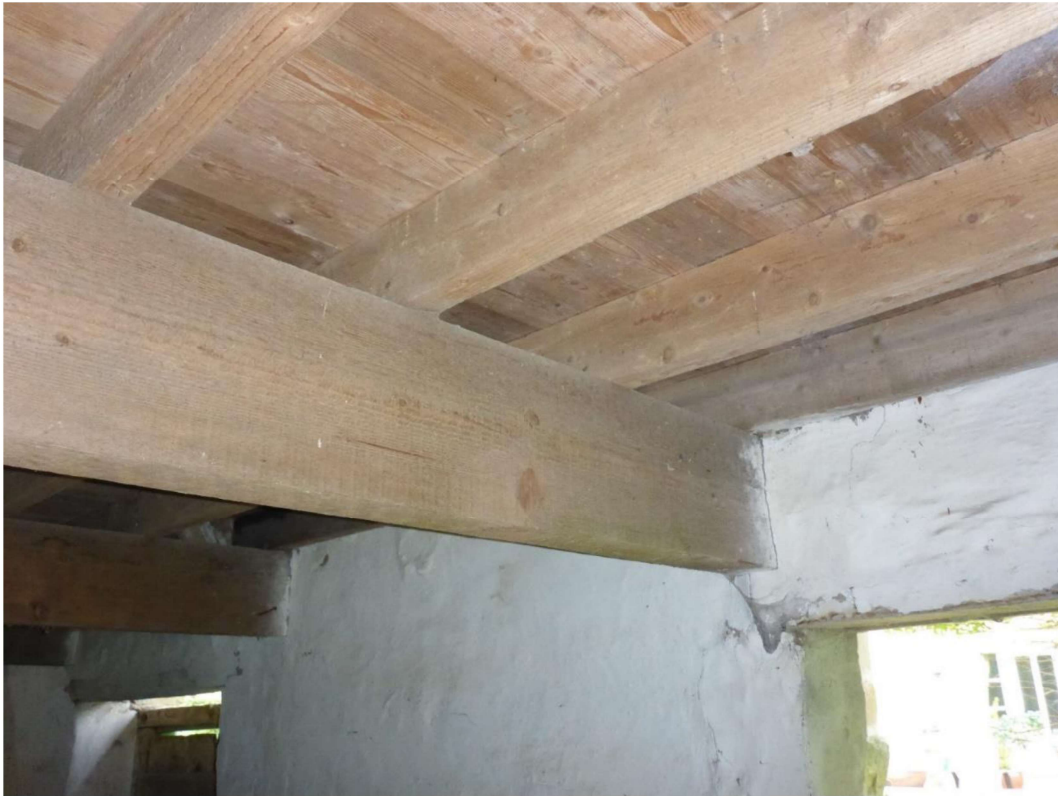
*Photo 29 – Sawn timber structure for first floor*

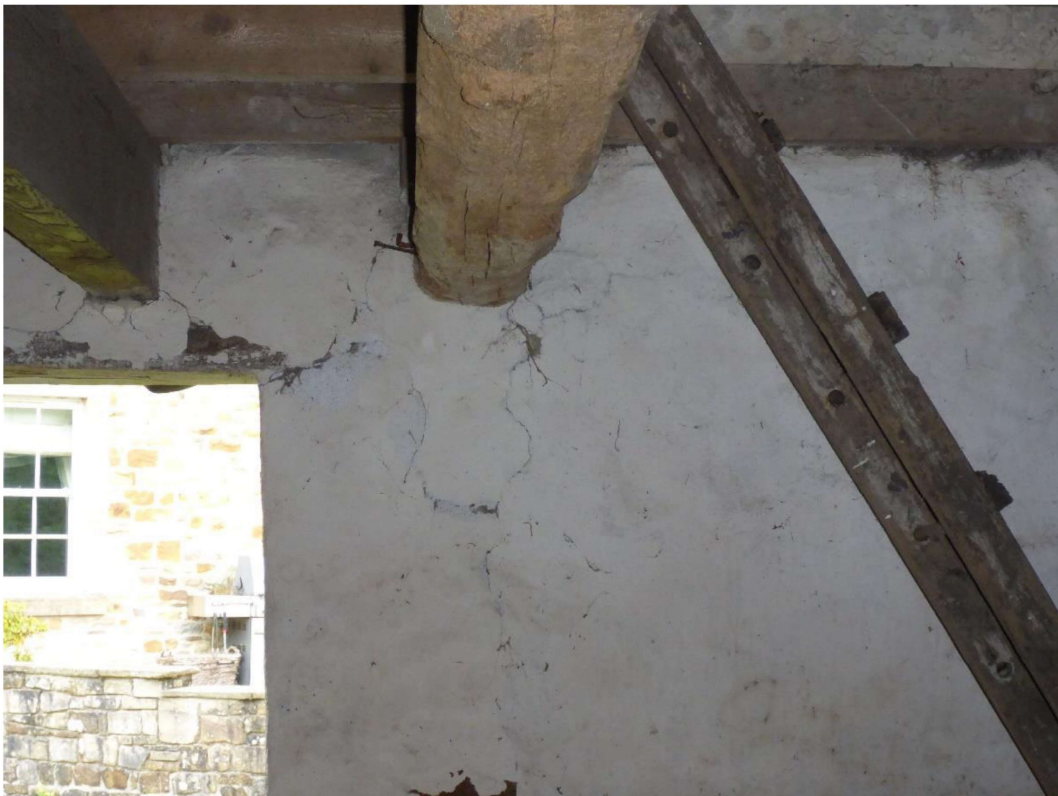
*Photo 30 – Cracking beneath bearing of timber beams*

- 7.6. Suitably sized padstones should be installed beneath the bearing of the timber beams supporting the first floor. This will allow the load from the first floor to be safely transferred into the masonry. Any cracking below the bearings can then be repaired using the Helifix HeliBar crack stitching repair method (appendix B) and repointed.

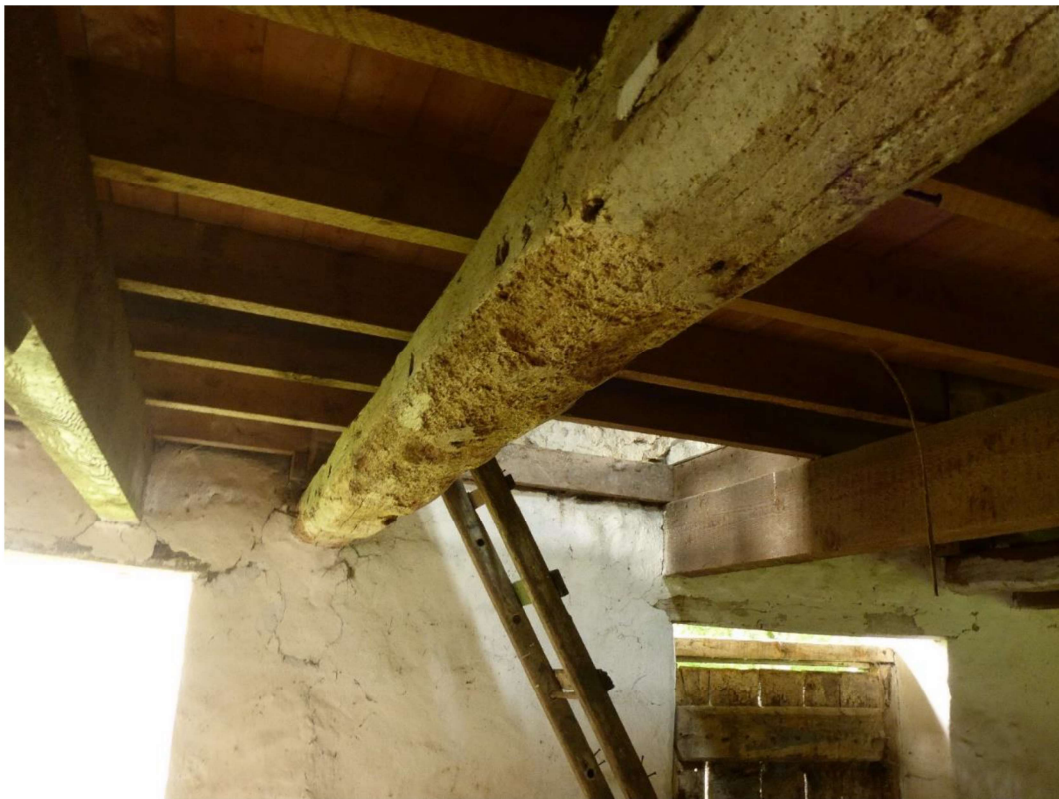
- 6.16. The ceiling ties of the upper cruck are in poor condition and show signs of dry rot as well as woodworm (photos 31-32). Historically, the ceiling ties of the upper cruck would have supported the first floor joists, however with the introduction of the new timber beams this is no longer the case.

*Photo 31 – Sawn timber structure alongside original ceiling ties of upper cruck*

- 7.8. Due to access limitations the condition of the existing timber cruck and purlins are unknown. Some of the timber members appeared to be rotten and indicated signs of woodworm therefore a timber specialist should be consulted to verify the existing timbers that can be retained and make any suggestions for recommended timber treatments.

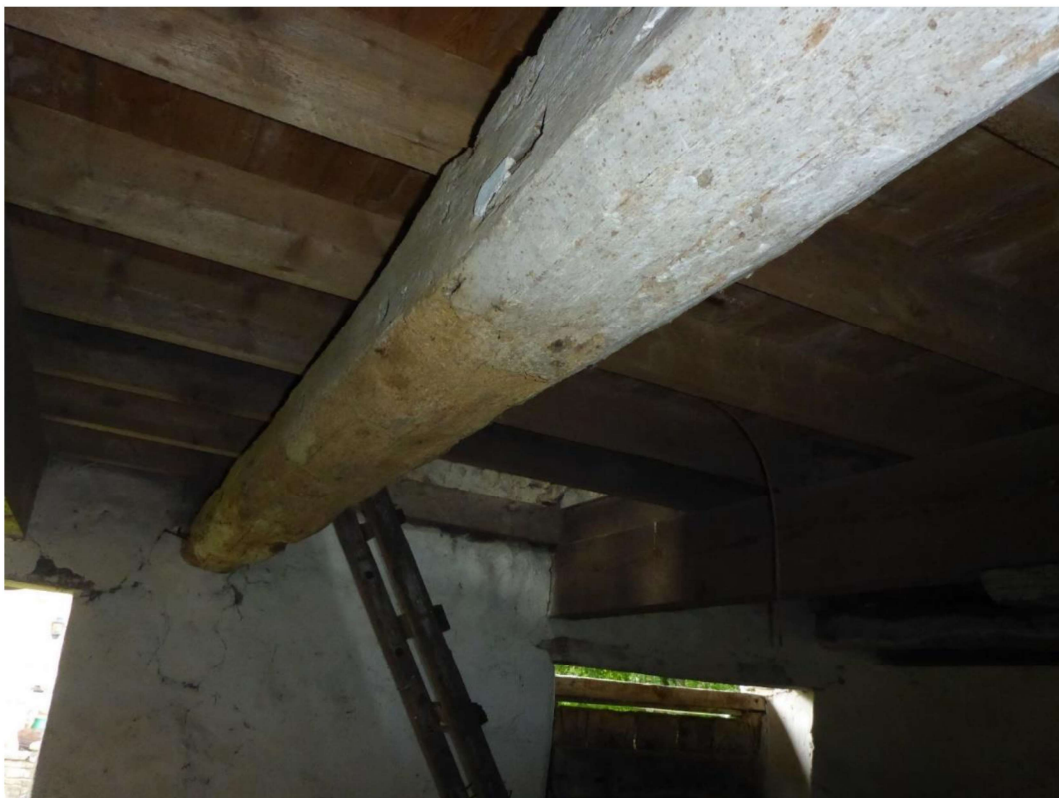
*Photo 32 – Dry rot and woodworm on ceiling tie of upper cruck*

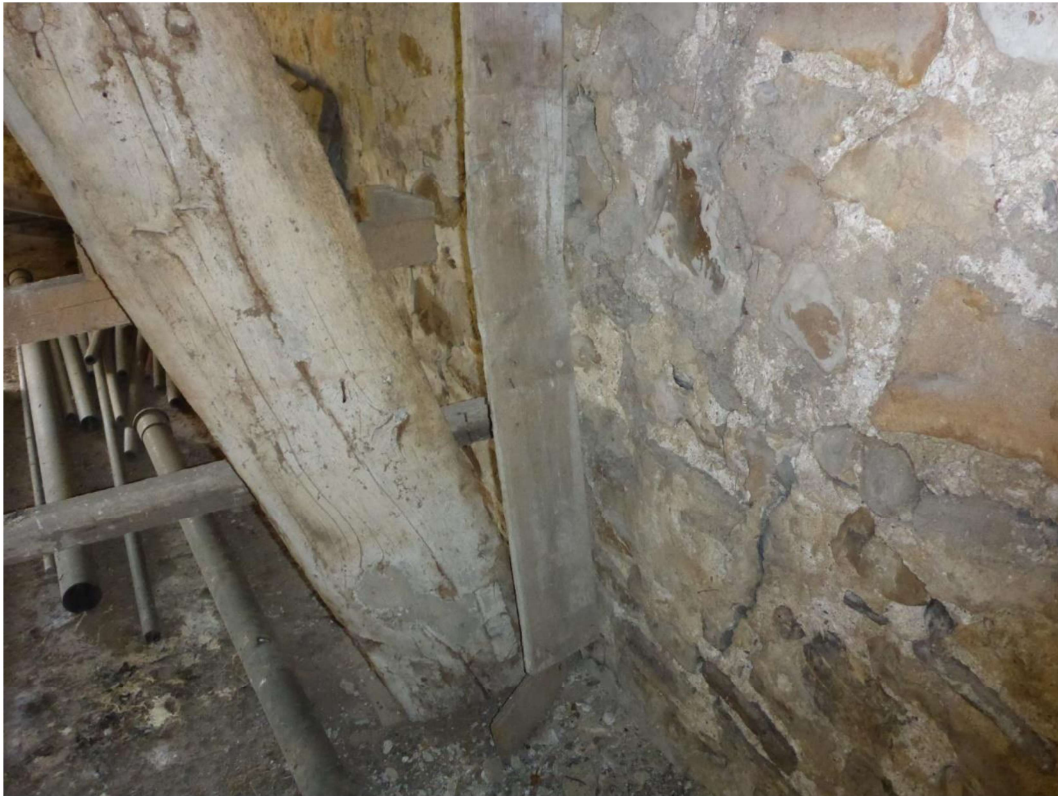
- 6.17. At first floor level, the curving members of the upper cruck are in poor condition with signs of dry rot and woodworm in some areas (photos 33-34). The cruck frames also appear to twist slightly and do not run parallel with the gable walls (photo 35). The tie beam towards the top of the cruck has been removed on one of the frames, remedial works have been undertaken with a small timber tie placed higher than the original tie. This appears to be insufficient (photo 36).

*Photo 33 – Upper cruck with signs of rot and woodworm*

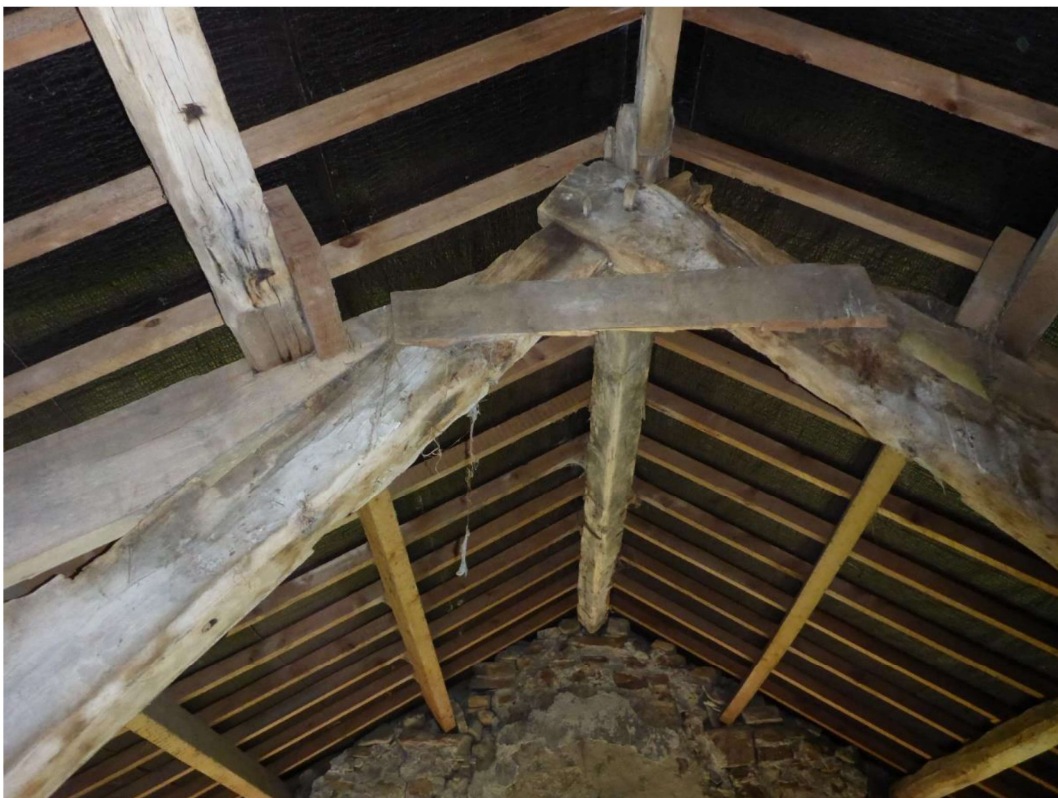
*Photo 34 – Upper cruck with signs of rot and woodworm*

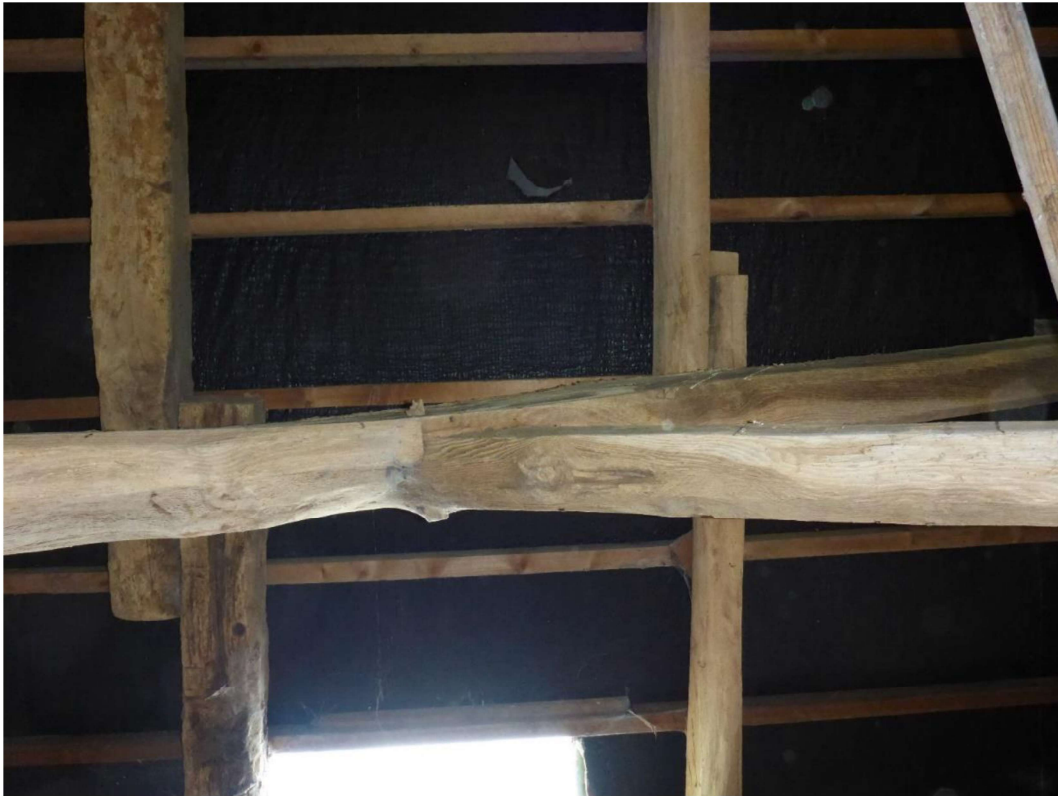
*Photo 35 – Possible twist in upper cruck*

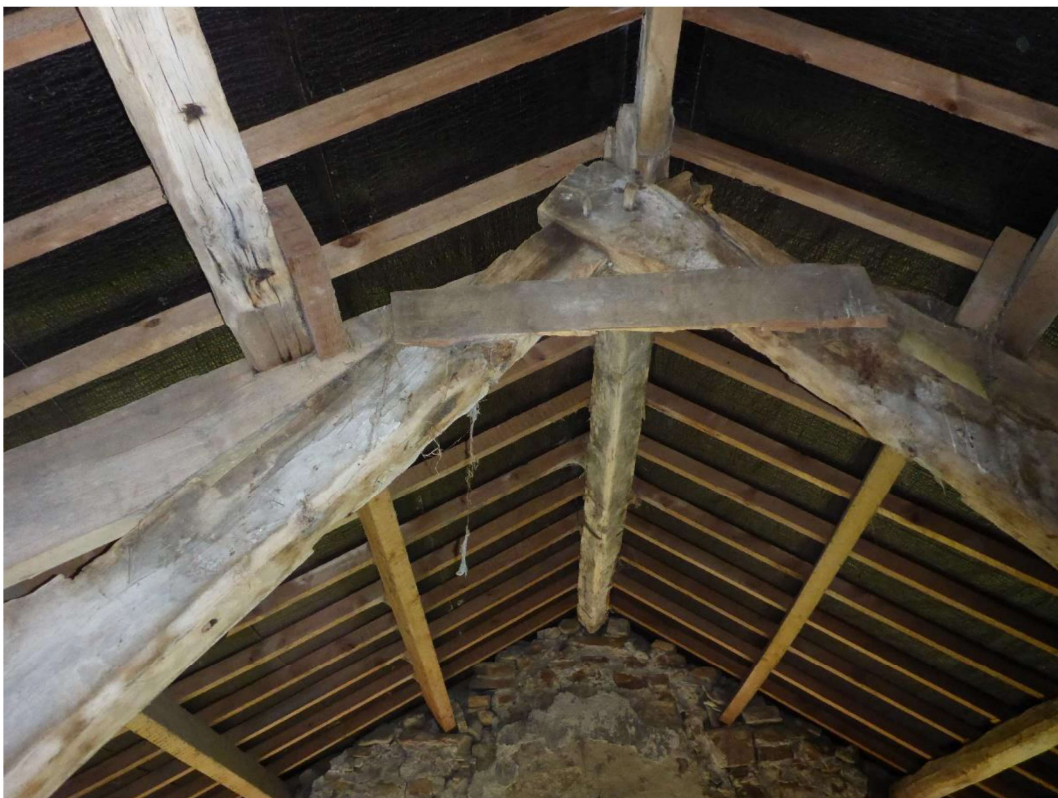
*Photo 36 – Replacement tie on upper cruck*

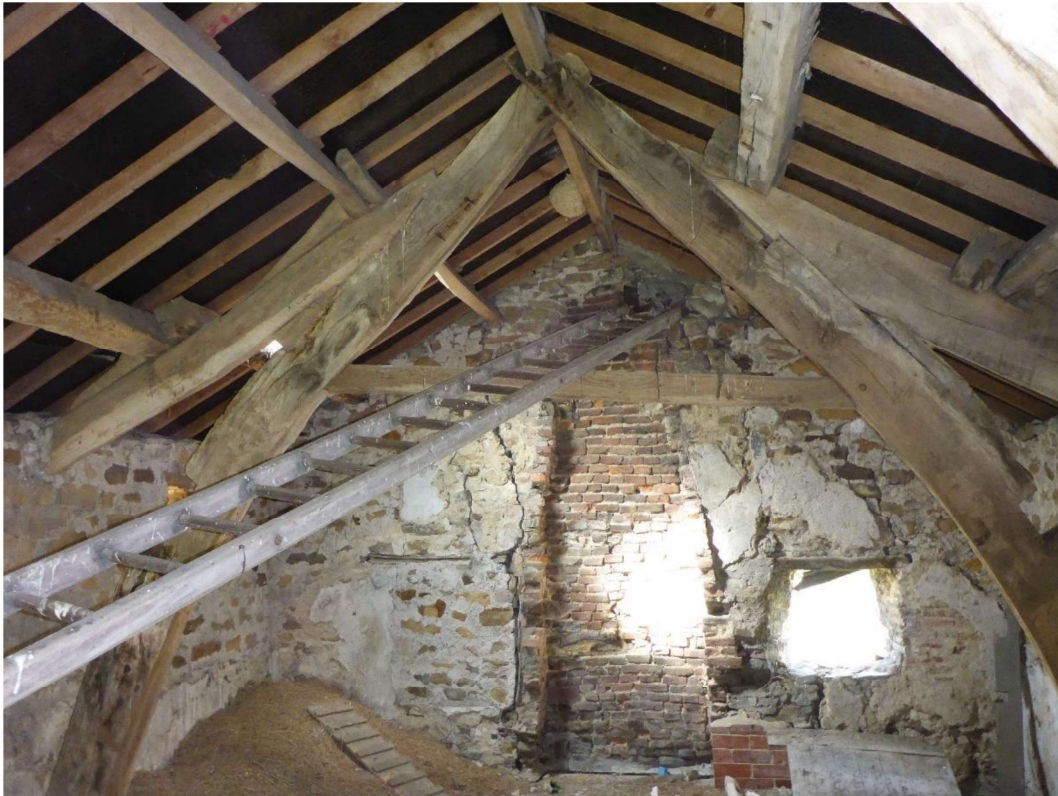
- 6.18. The upper cruck supports the roof purlins and ridge beam. Purlins have previously been replaced. The original purlins show signs of dry rot as well as woodworm and are in a poor condition (photos 37-38). The new purlins are sawn timber and visually appear to be in good condition.

*Photo 37 – Original and replacement purlins supported from upper cruck*

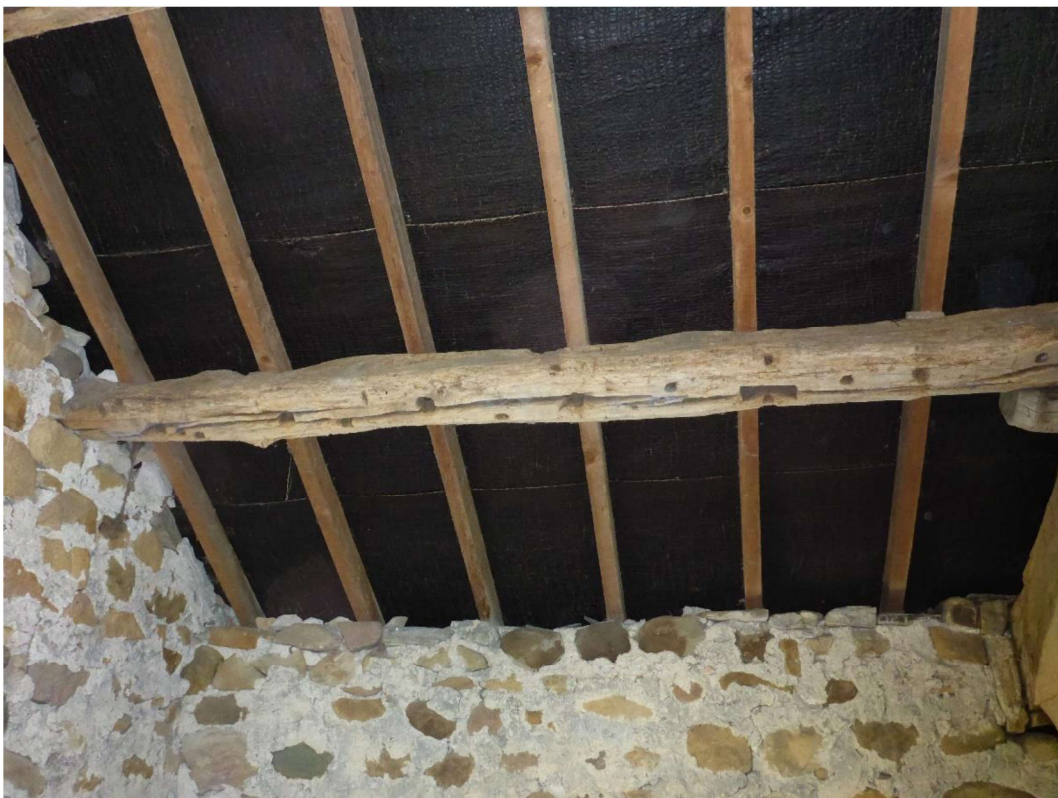
*Photo 38 – Condition of original purlins*

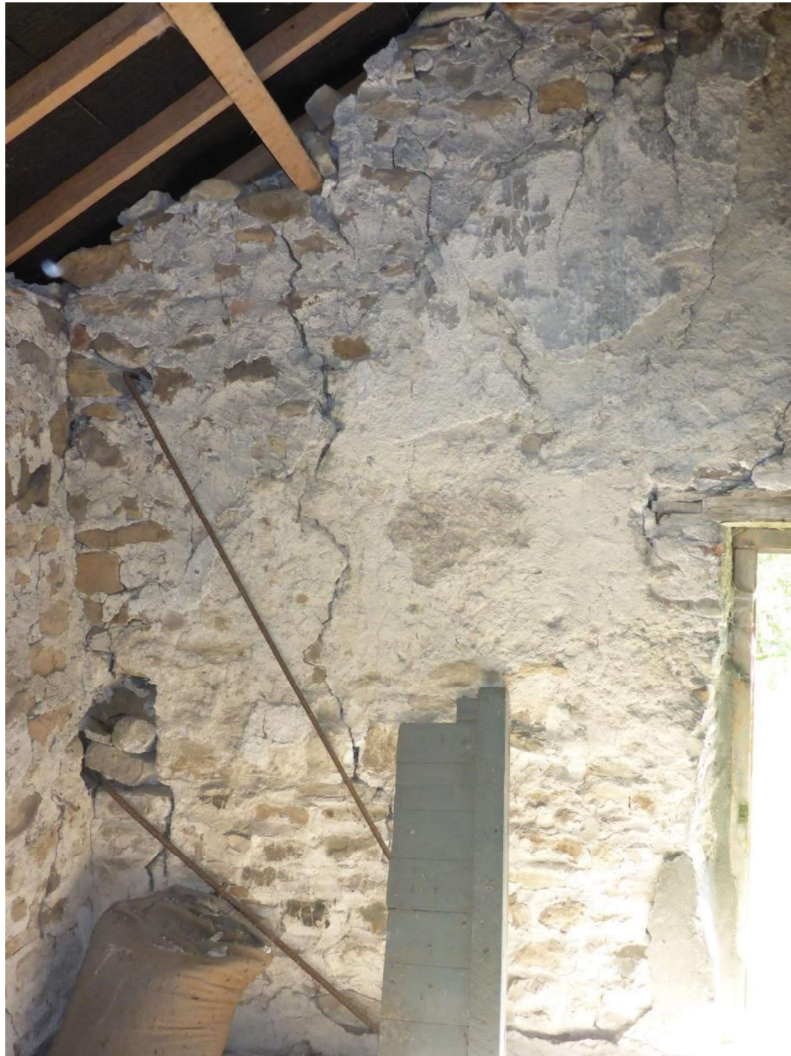
- 6.19. Cracking can be seen across most of the external walls at first floor level with the largest cracks measuring up to 45mm wide (photos 39-41). The cracking is likely as a result of a lack of ties within the building as well as movement to the foundations.

*Photo 39 – Cracking in external wall at first floor level*

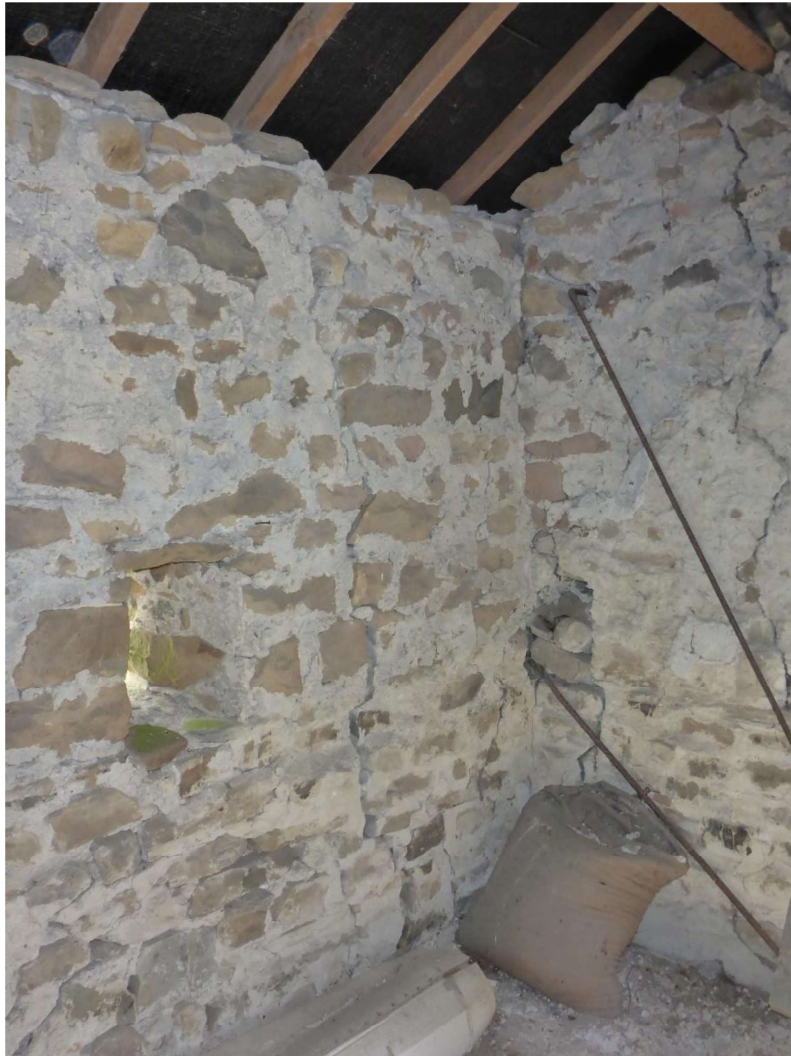
*Photo 40 – Cracking in external wall at first floor level*

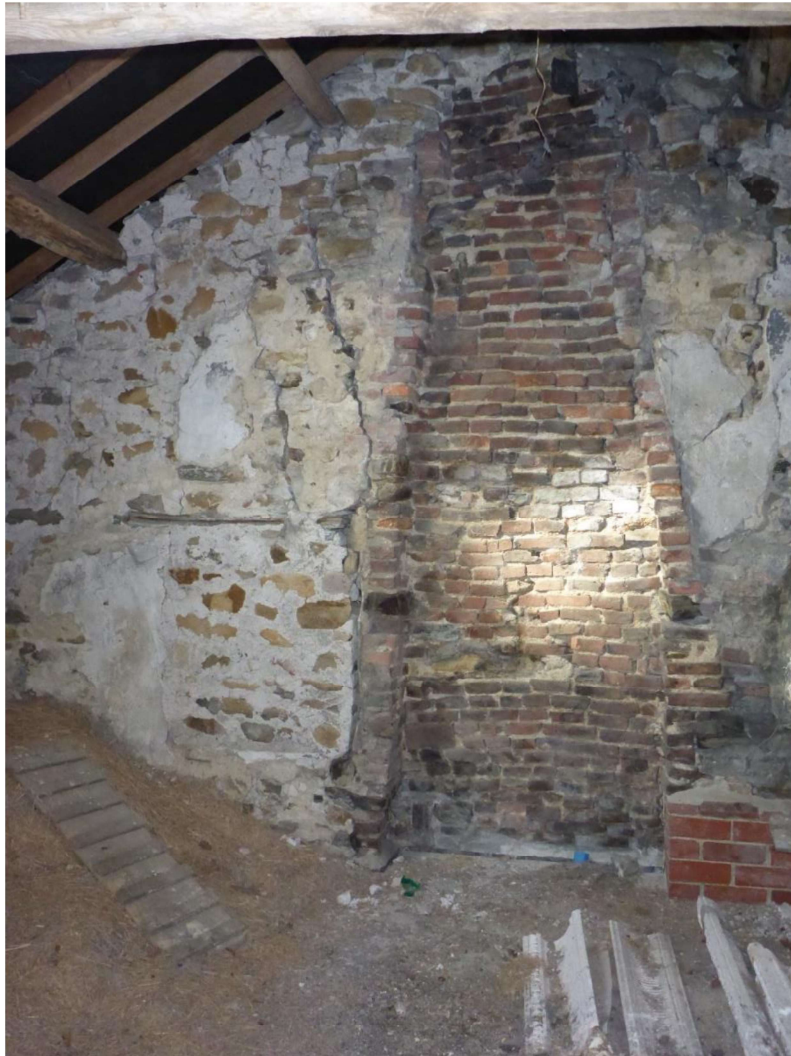
*Photo 41 – Cracking in external wall at first floor level*

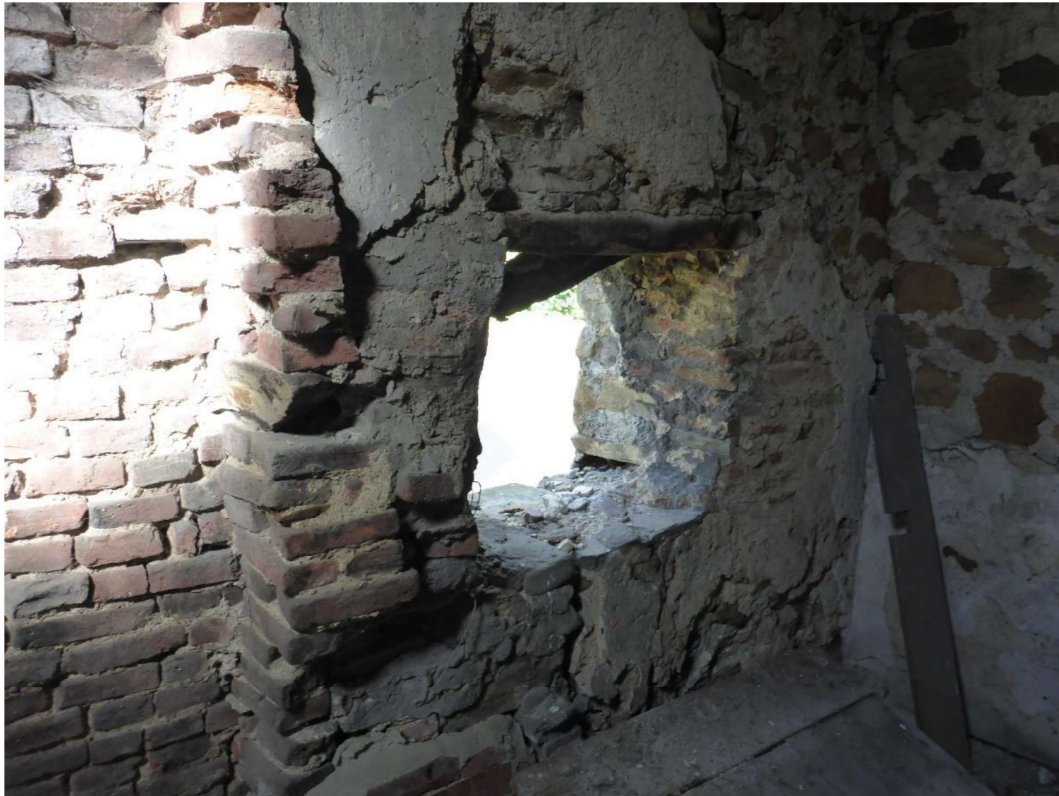
- 6.20. Timber lintels are located over the windows and doors internally, most of the lintels are in poor condition (photos ), with some of the lintels failing (photo 42).

*Photo 42 – Failed timber lintel at first floor level*

- 7.5. All timber lintels should be removed and replaced with a suitable alternative. Any cracking above the openings can then be repaired using the Helifix HeliBar crack stitching repair method (appendix B) and repointed.
