Tree Condition Report

17 Elm close,
Calderstones,
Whalley
BB7 9UT

15/09/2023

Job Ref: 1828

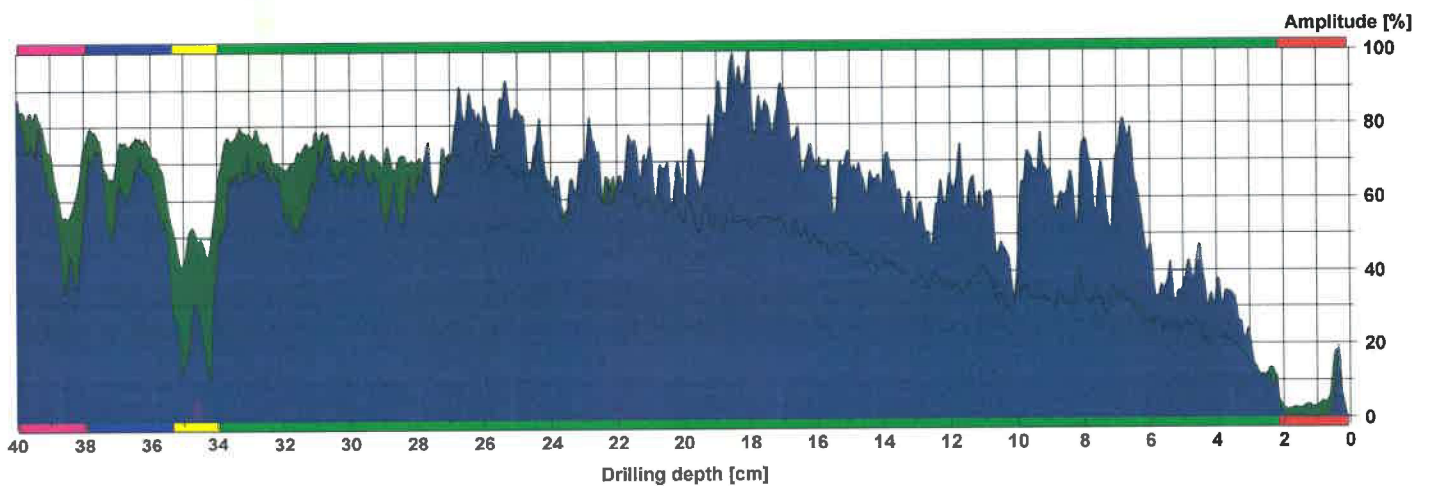
T1-OAK-300MM-HEIGHTM001.rgp

From	0,1 cm	to	2,2 cm	:	Outer Bark
From	2,2 cm	to	34,0 cm	:	Structural wood
From	33,9 cm	to	35,3 cm	:	defect
From	35,3 cm	to	37,9 cm	:	Structural wood
From	37,9 cm	to	40,0 cm	:	defect
From	0,0 cm	to	0,0 cm	:	Structural wood

The tree has a slight fect within the inner section of the stem but this is not seen as being detrimental to the trees stability.
