**CONVERSION ASSESSMENT**

**PROPOSED PARTIAL CONVERSION OF  
THE BARN AT  
LORDS FARM  
BOLTON BY BOWLAND  
CLITHEROE**

**FOR THE CLOSES PARTNERSHIP**

| <b>Date:</b> | <b>Oct 2023</b> |

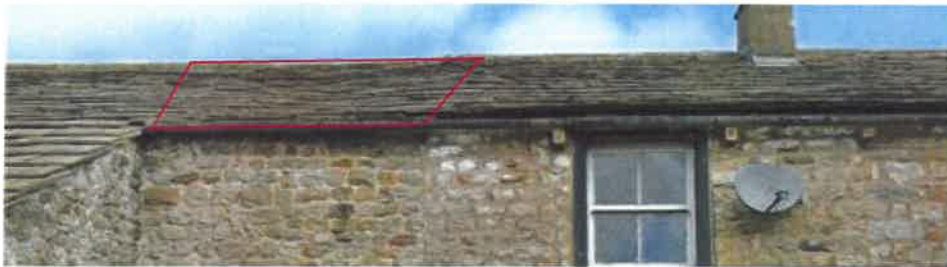
Photograph– Showing the condition of the roof to the main barn ( south east elevation) .( section being affected by the conversion highlighted in red)

- 2.2 The roof to the main barn is in average condition, along its length with no obvious slipped or cracked slates.

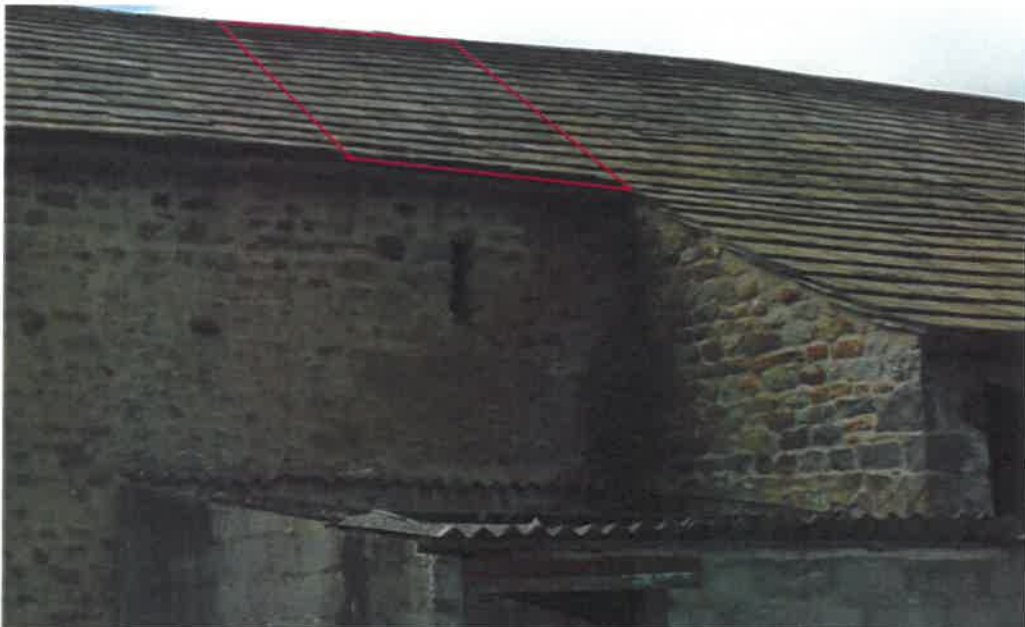
Photograph– Showing the condition of the roof to the main barn ( North west elevation) .( section being affected by the conversion highlighted in red)

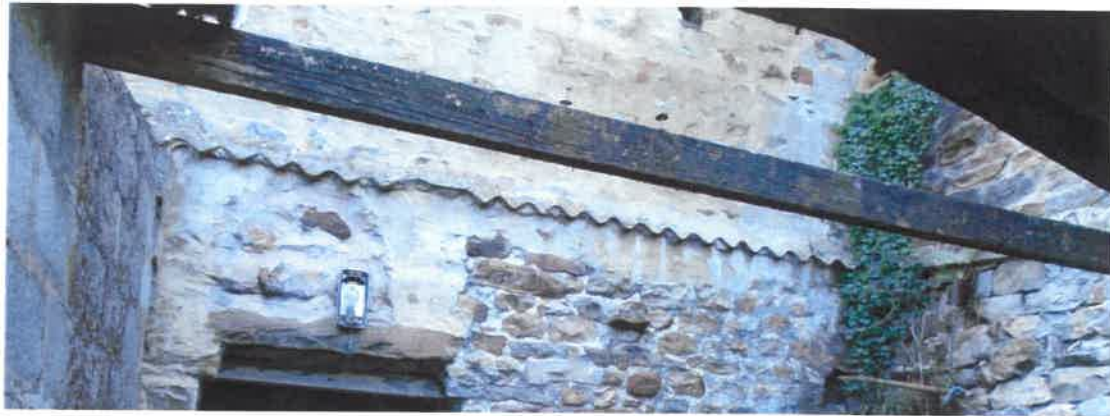
- 2.3 The remaining structure on the lean to roof is timber purlins and a small section of corrugated steel at the eaves. This will be replaced with a grey slated roof during the conversion works.

Photograph– Showing the condition of the roof structure to the Lean to.

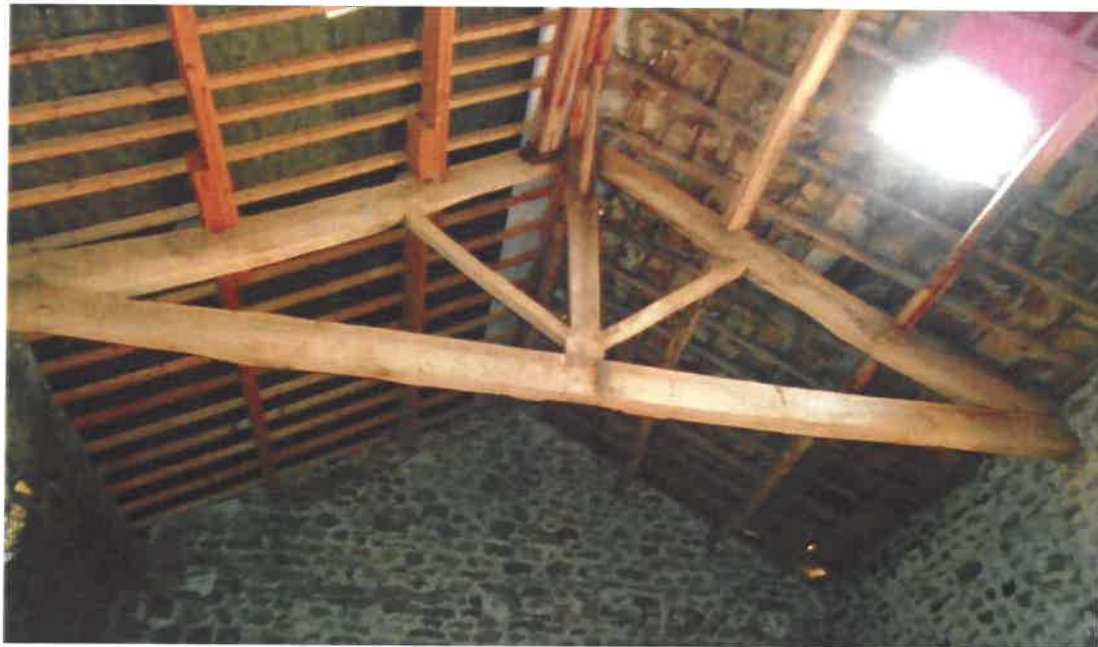
- 2.4 The main barn has a traditional timber roof construction, comprising of trusses, purlins and rafters with a slate finish, felt is present to the rear pitch.

Photograph (– Showing the roof structure to the main barn.

- 2.6 The timber roof structure to the main barn could only be inspected from ground floor level. The roof timbers however appeared in good sound condition. The timbers appeared dry, including at the ends where they are built into the solid masonry walls.
- 2.7 All the timbers will be treated accordingly during the works. It appears as though the majority of the roof timbers to the main barn will be retained during the conversion.
- 2.8 The roof slates will be stripped off during the works to enable any roof structure repairs to be undertaken (if necessary) and a breathable roofing membrane to be fitted, the existing slates will then be re-fixed.

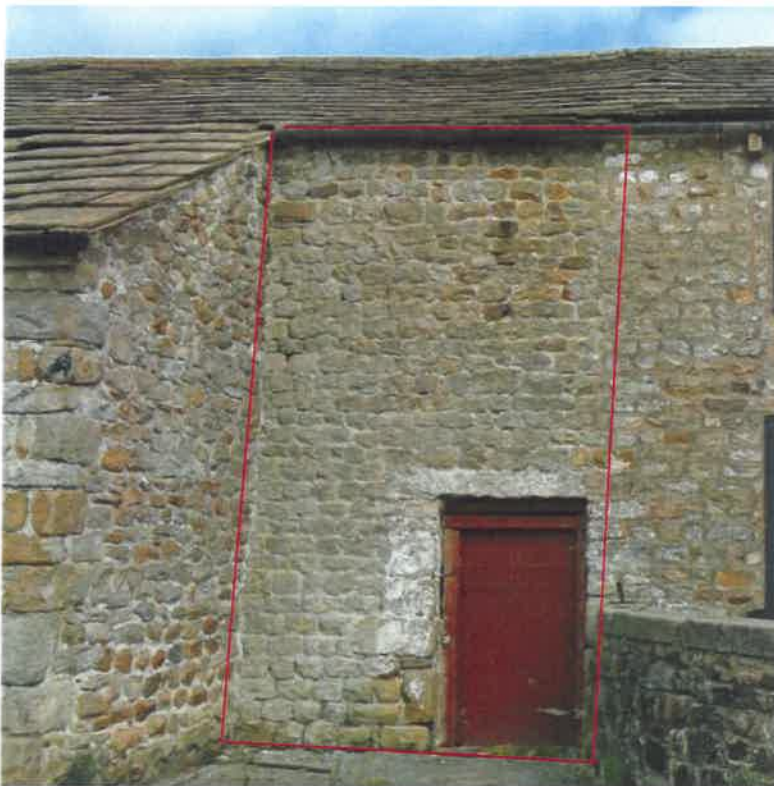
Photograph – Showing the front elevation wall, the door in this elevation has a stone lintel / head over the opening. The head is in good condition.

2.10 The walls were in reasonable condition given the barns age. The walls were straight and true. All of the walls will need re-pointing during the conversion works.

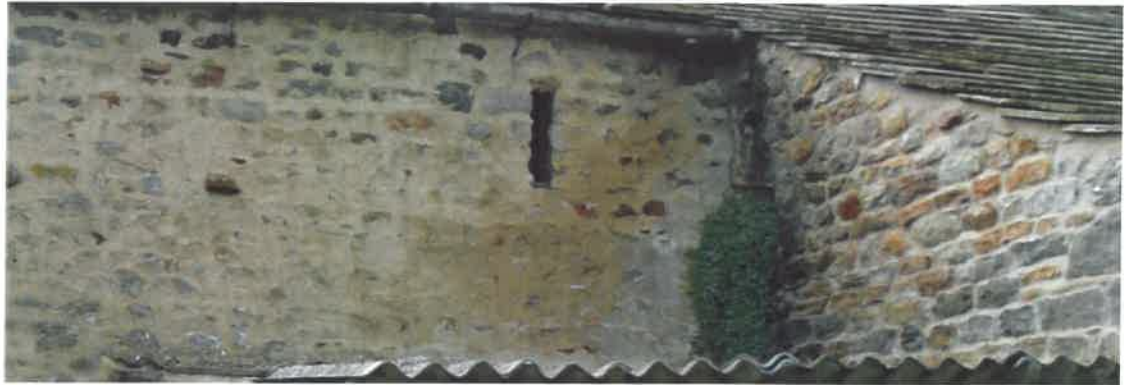
Photograph– Illustrating the condition Rear wall above the Lean to.

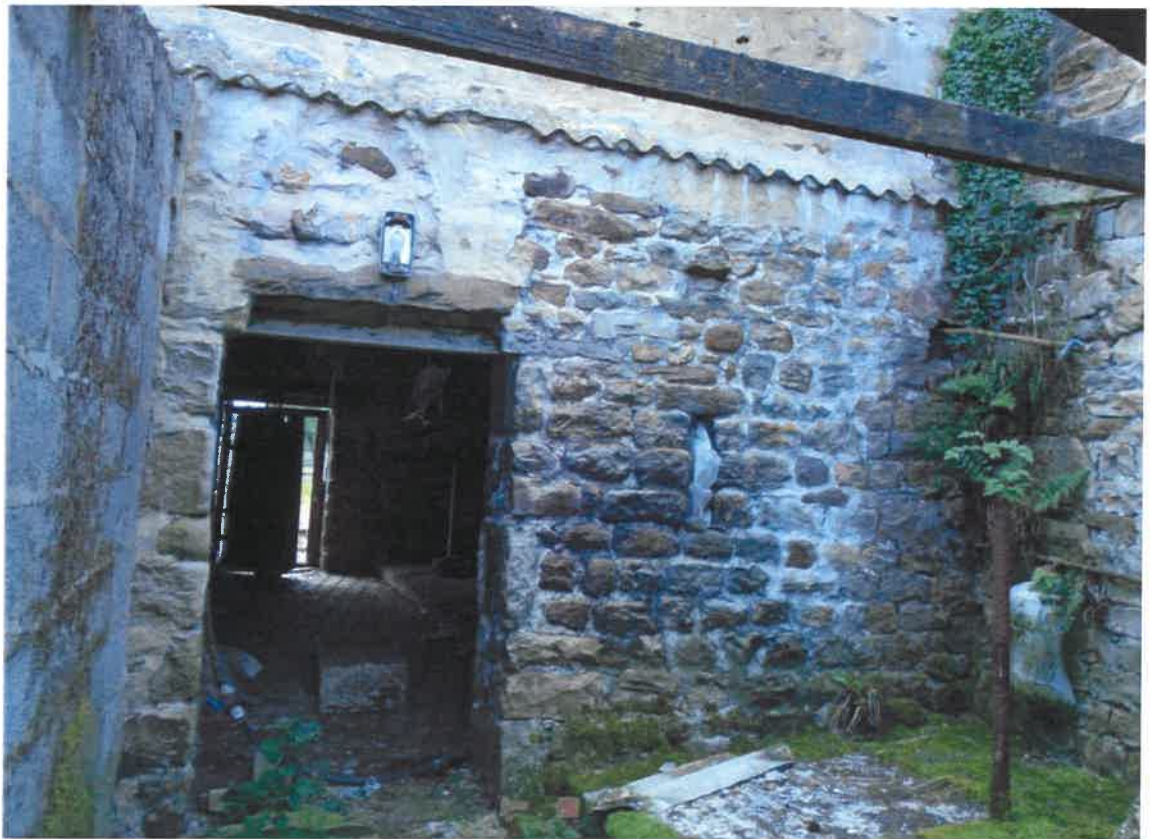
Photograph – Illustrating the condition rear wall within the lean to.

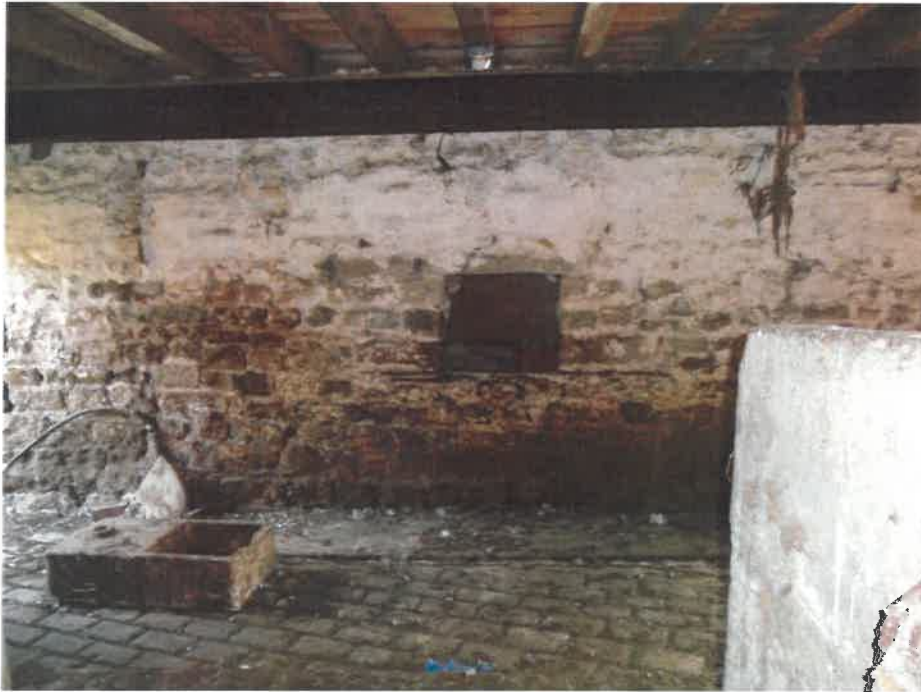
- 2.12 Internally the walls were in good condition overall, no structural issues were noted at the time of inspection.

Photograph– Illustrating the condition of the internal wall adjacent to the house.

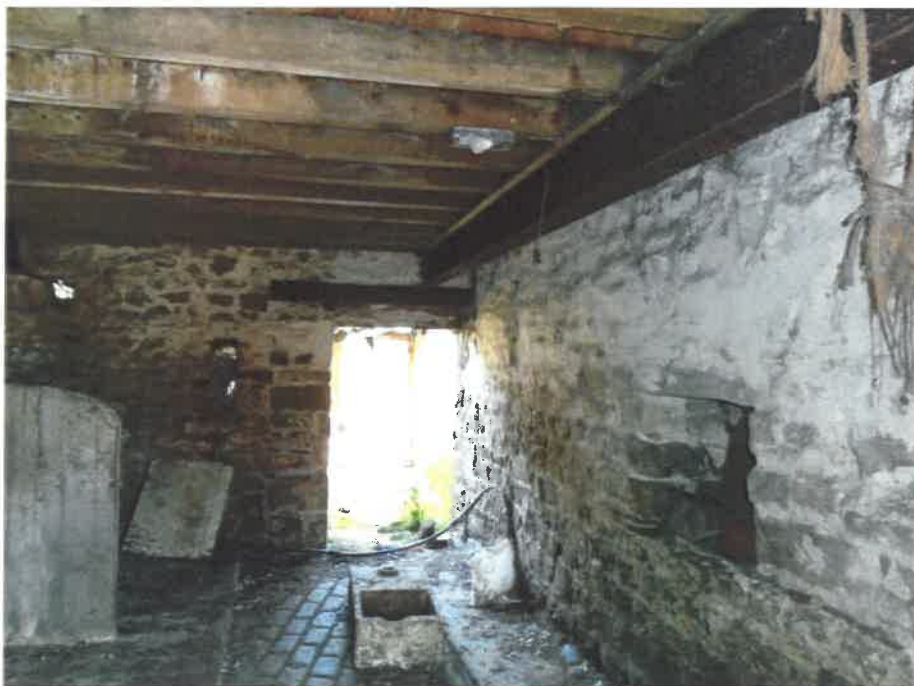
Photograph– Illustrating the condition of the internal rear wall.

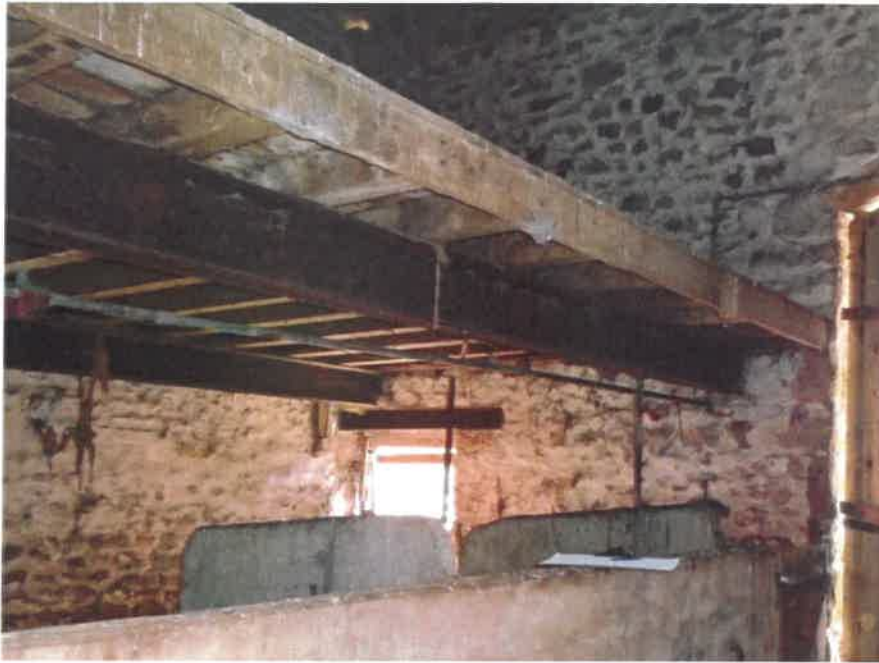
Photograph– Illustrating the condition of the internal front wall.

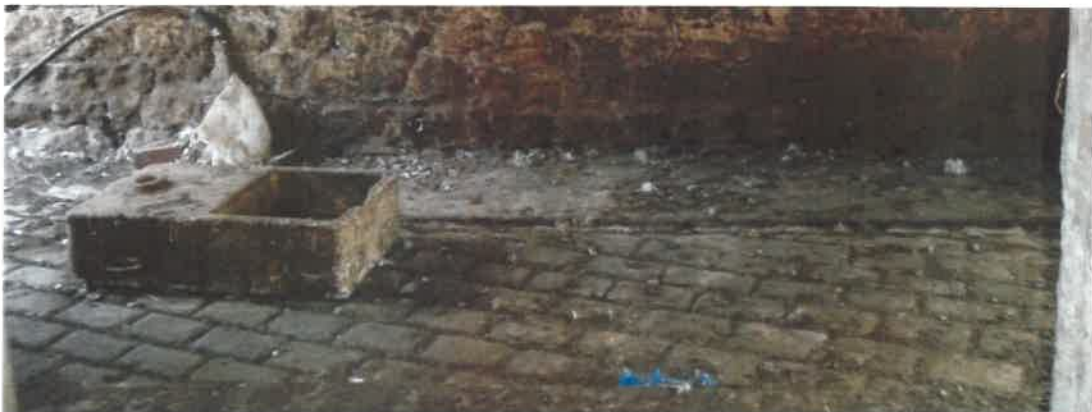
Photograph– Illustrating the condition of the internal floor .

- 2.13 The existing ground floors to the barn and outbuilding are currently a mixture of earth and stone setts. It is proposed that the existing floors will be dug up and a new insulated concrete slab constructed to meet the requirements of the building regulations.
- 2.14 The existing first floor will be removed during the conversion works and a new timber first floor will be constructed and supported by new block load bearing lining walls, to be built up off new concrete foundations. The new block lining walls will also be used to support the roof structure and new ceilings.
