# Tree Condition Report

Clitheroe Castle

Ribble Valley Borough Council

**Job Ref: 1835**

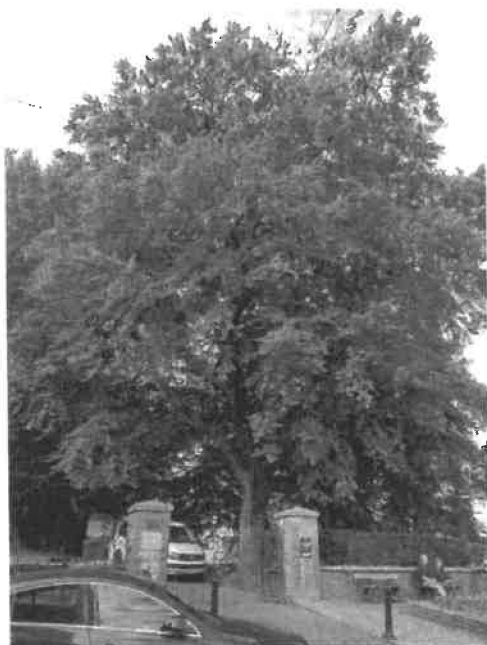
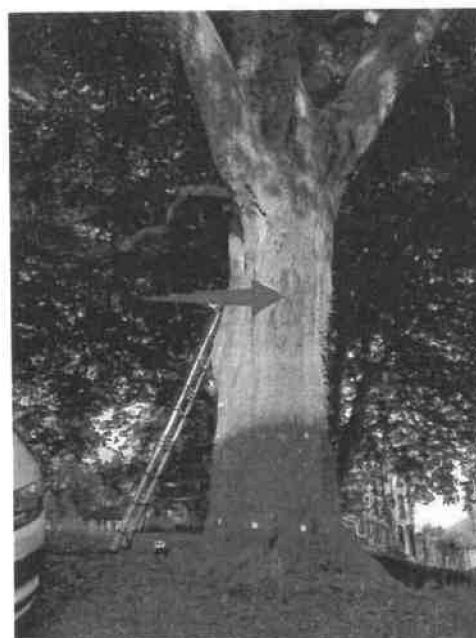
Area of 'bleeding' on stem.

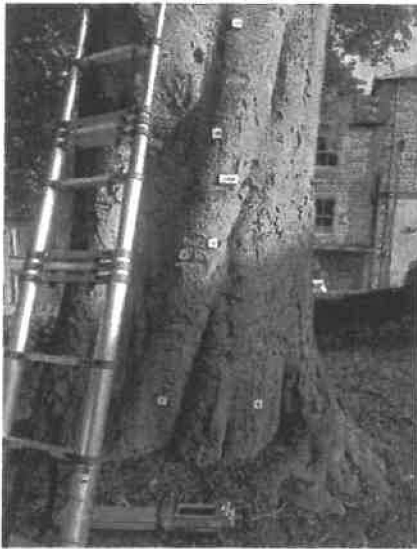
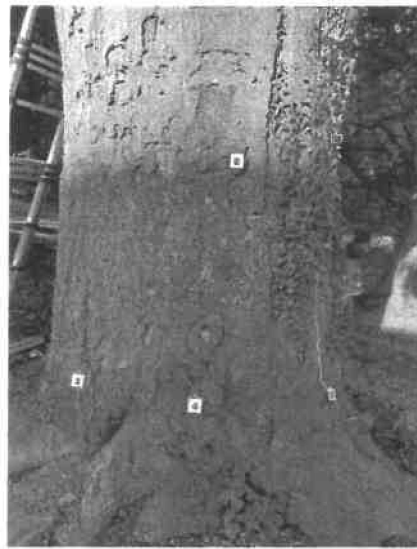
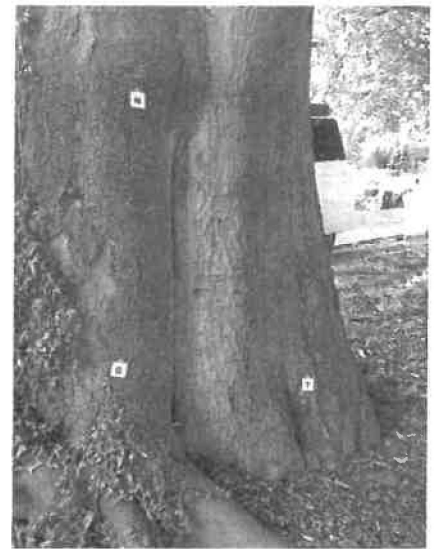
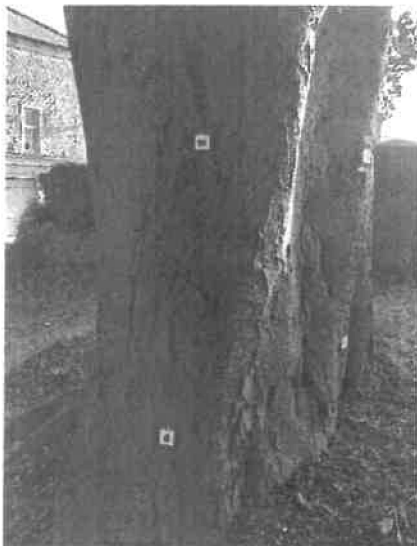
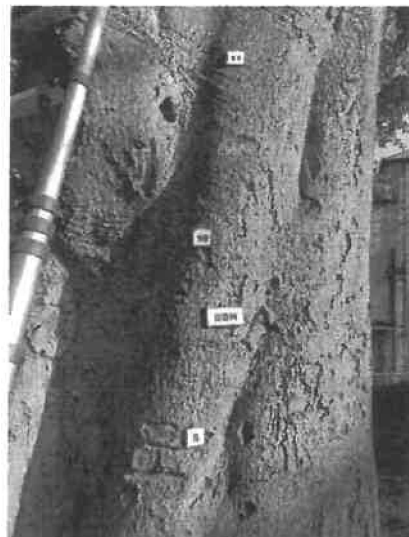
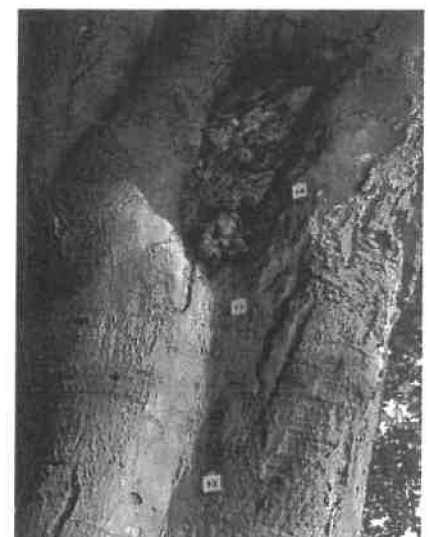
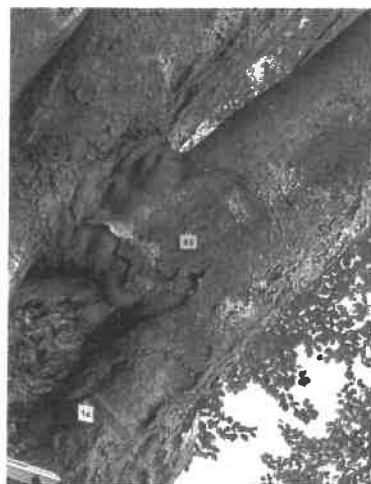
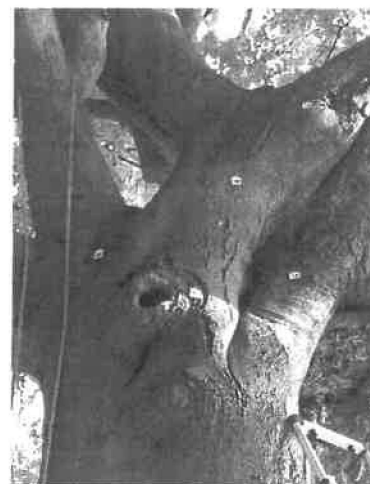
| Buttress assessment | There are no visual defects with the buttress area, 8x resistograph test were undertaken around the base of the tree, tag points 1-8, all these test results indicated strong structural wood around the tree, one of the results graphs is included in the appendix. | | | | | | | |
| Stem assessment | Resistograph tests were undertaken at points on the stem at tag points 9 – 12, these results indicated strong structural wood with no significant dysfunctional wood present. One of the results graphs is included in the appendix. | | | | | | | |
| Scaffold and secondary branches assessment | <p>Resistograph tests were undertaken at points on the stem / main branch unions at tag points 13 – 20, these results indicated some dysfunctional wood present. relevant results graphs are included in the appendix.</p> <p>These results show dysfunctional wood around the union of the limb that extends over the footpath. There are other areas of dysfunction around this large union of branches, but the area around tag 14 / 15 appears to be the worst affected.</p> | | | | | | | |

Tag locations where Resistograph testing took place.

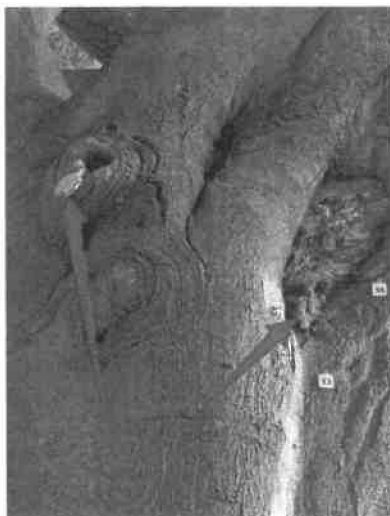
Two areas of visible fungal brackets identified as “Dryads Saddle”. Brackets are detreating due to age and exposure to the elements.

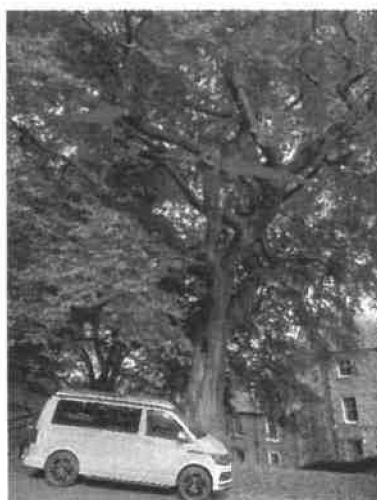
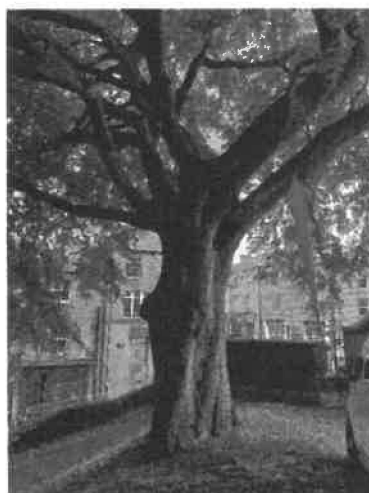
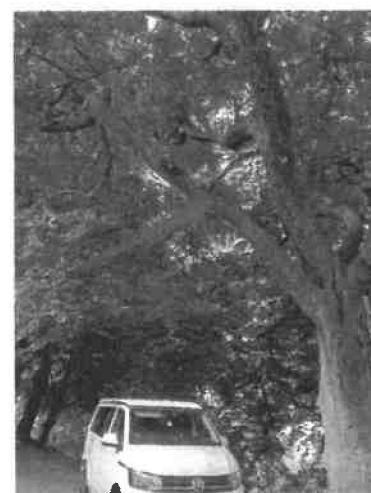
Old pruning wounds with visible signs of decay internally. The limb union joins the stem at the point where the dysfunctional wood is present, the limb extends over the public footpath. It is recommended that the limb is removed back to a suitable pruning point at the stem to minimise risk of failure over the path.

| Recommendations | Remove dead wood / crown clean.<br>Reduce crown by 2m in length (approx. 5%) to alleviate end loading and leverage action on branch unions.<br>Remove limb over footpath that is at union of decay pocket.<br>Photos inserted for further information in section 18. |

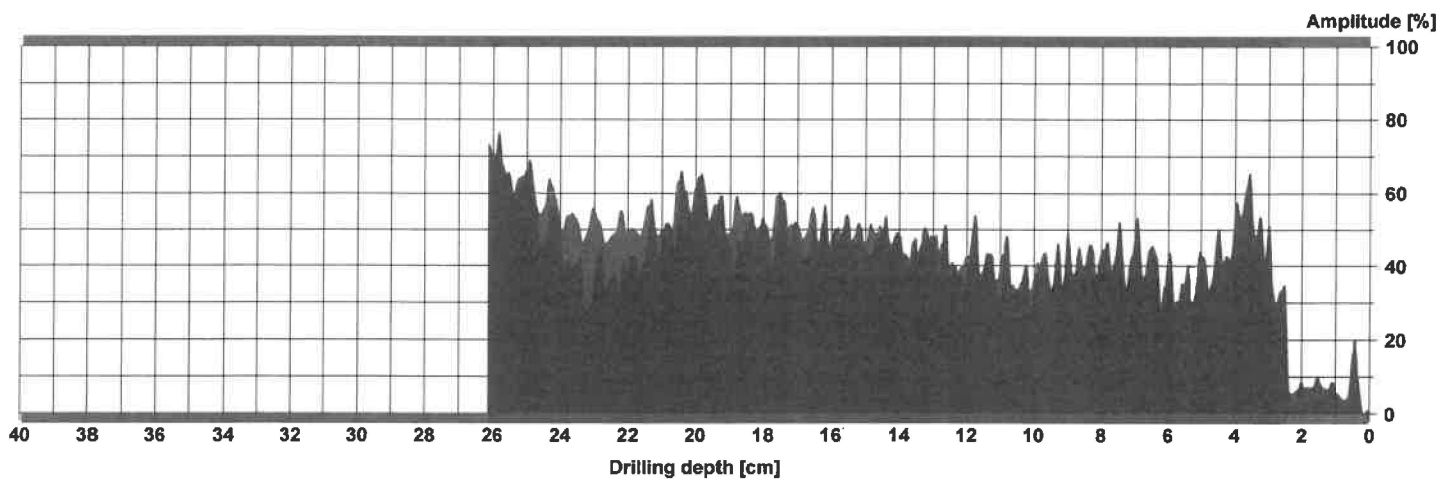
structural wood upto 26cm then drill retraction due to dense wood - indicating no defects.

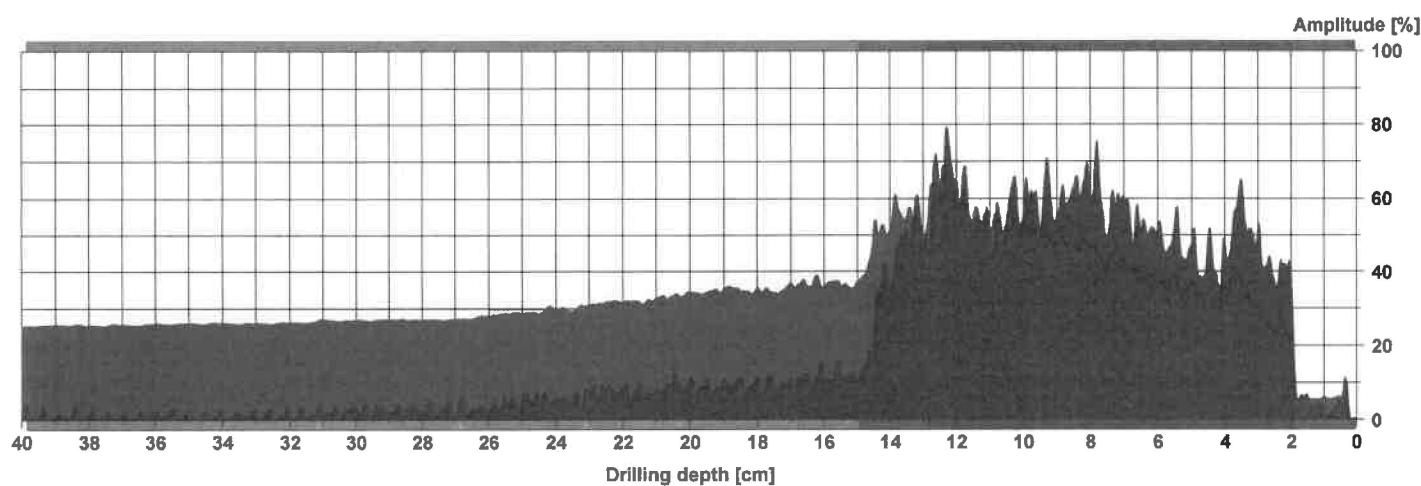
outer bark and structural wood upto 12cm then deteriorating to dysfunctional wood and internal cavity.

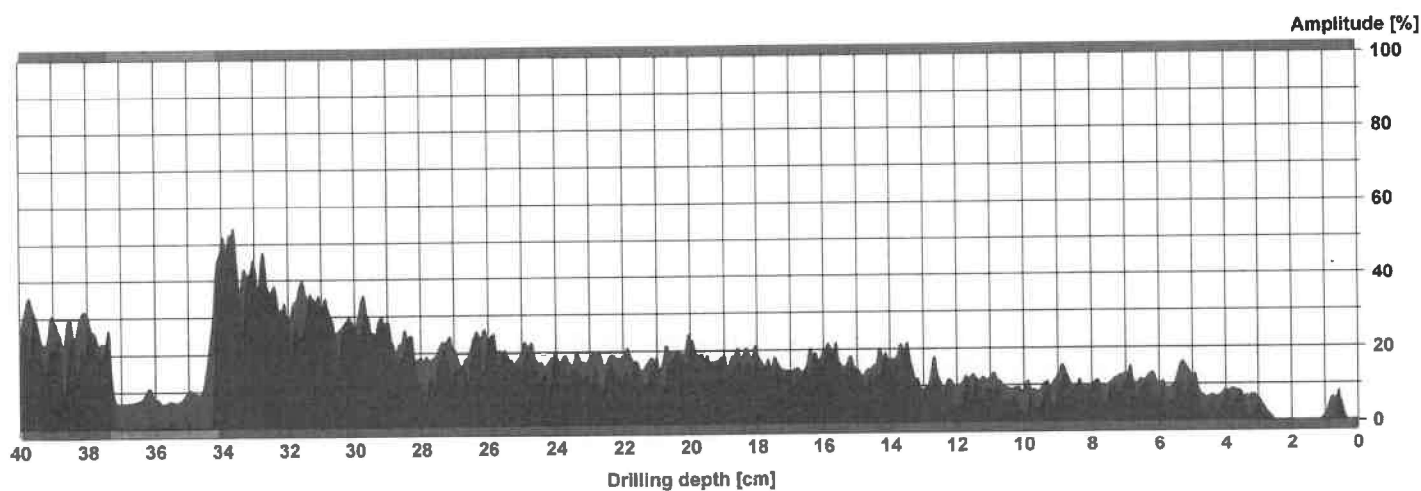
| ■ | From | 0,0 cm | to | 34,1 cm | : Dysfunctional Wood |
